Motor Boat Rinker 360 Survey Report

MOTOR BOAT	Rinker 360
HIN	[REDACTED]
DATE	[REDACTED]
REPORT NO.	[REDACTED]

Report completed by	Hatem Salama	Date	██████
Signature	xxxxxxxxxxxxxxxxxxxx	ID Number	AVI 00325 SAMS SA
Company on whose behalf inspection carried out	Buyer : Mr. ██████		
Report summary seen by	Buyer : Mr. ██████	Date	██████
Place of survey	██████████, ██████ On.		
Type of survey	Condition and valuation survey

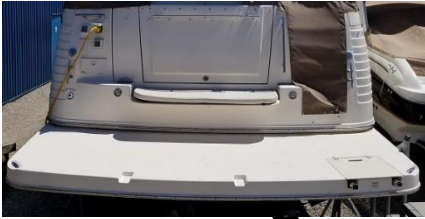
Swim platform found in average condition, signs of previous repairs apply on different parts of swim platform.

Observed scratches and crazing on swim platform at port quarter.

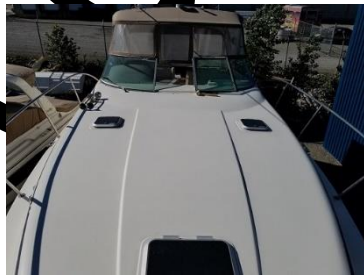
Deck found in good condition, no any signs of soft spots or flexes.

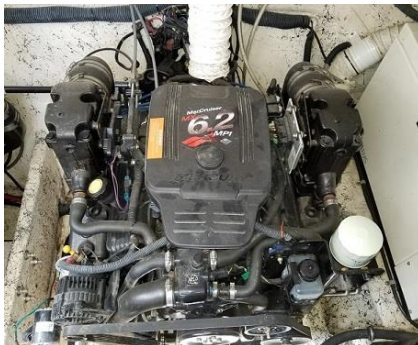
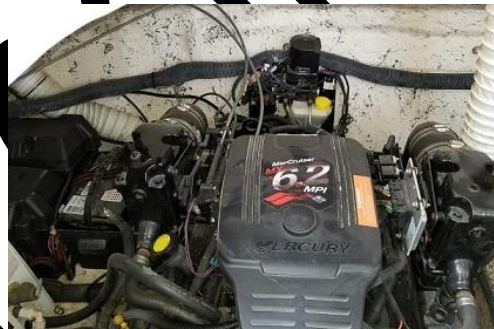
2 Mercruiser MCM MX 6.2 MPI, 6.2 Liters, V 8 Cylinders, water cooled stern drive engines.
Engines found in clean condition, fittings and parts found in good visual condition.

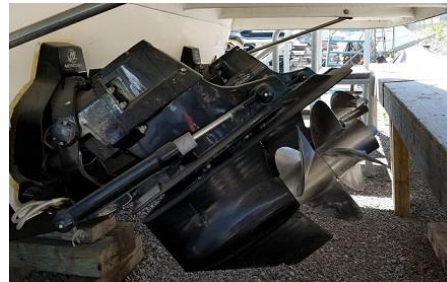
2 Mercruiser Bravo 2 Stern drive units.
Port stern drive found side leak at drive.
Port stern drive unit skeg and shear pin bottom part.
Observed a loosened clips at rubber tube.

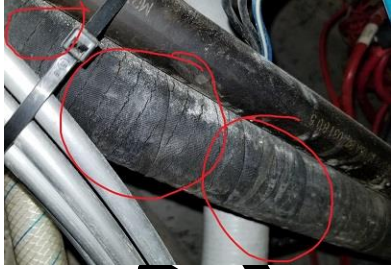
2.4	Fuel Lines	Yes	No ✓	NA	NS
<p>Both fuel lines on each side found cracked and in vey poor condition. Fuel hoses are not marine grade type.</p>

S.	Non Conformances & Remarks	Category	Recommendations
1	Both fuel hoses found in very poor condition, fully cracked, and not marine grade type	High	Replace with a CG marine approved type
2	Both blowers duct lines found ripped.	High	Replace duct lines accordingly.
3	Batteries missing safety caps on positive terminals.	Medium	Install safety caps on batteries positive terminals as per ABYC H-11
4	Generator cooling suction line seacock ball valve below water line found not to be installed properly, and missing backing plate and 3 bolts mounts.	High	To install seacock properly, by backing plate and proper fitting. As per ABYC H-27
5	Ball valve seacock below water line in midship compartment, not properly installed as missing backing plate.	Recommendation	To install seacock properly. ABYC H-27
6	White aft/anchor nav light pole on top of tower found not in place properly and dismantled, however lights tested and found operational.	High	To place the pole in proper position as shall be.

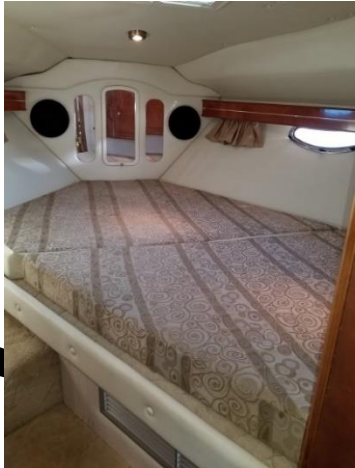
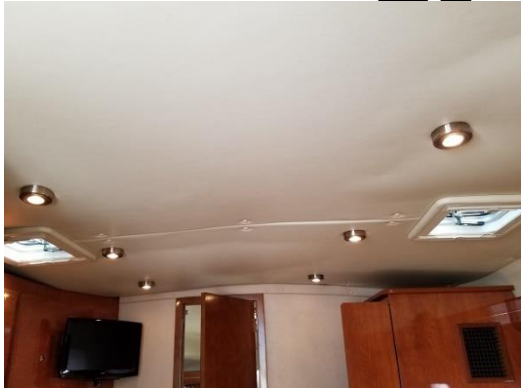
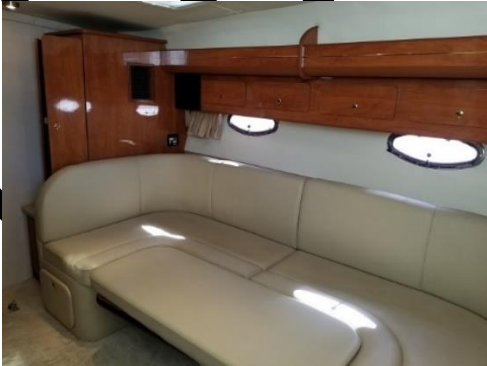
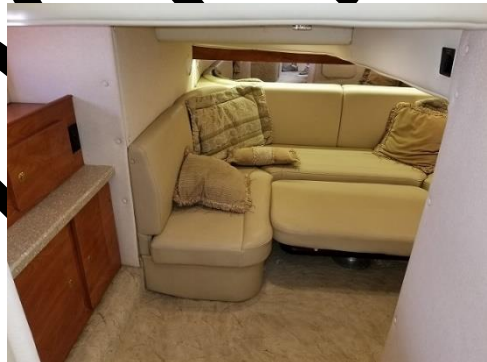
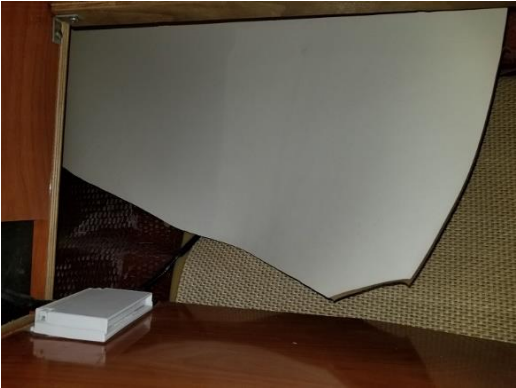
Cabinet in port side in V berth cabin., all side in hull leather panels are ripped and exposed.

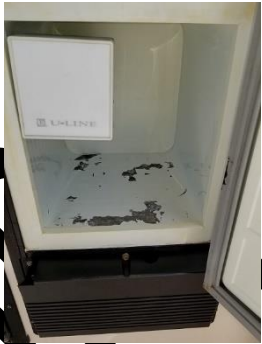
Freezer in cockpit deck found little rusted at inside.

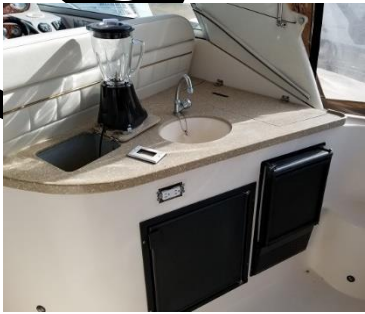
Garbage bin locker found broken at bottom part

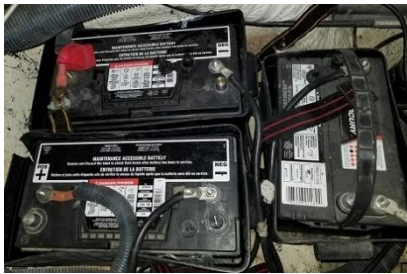
2 battery banks found in engine compartment.
 1 bank includes 2 batteries connected in parallel for engine cranking and house.
 2 batteries missing safety caps on positive terminals.
 Batteries found properly installed in acid proof trays.
 1 Battery for generator cranking, installed in acid proof tray, safety cap applies on positive terminal.

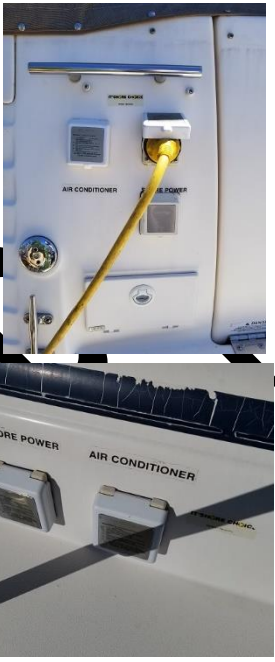
Only 1 shore power cable was connected to main shore power plug found.
Vessel missing one more shore power line for Air conditioner.
