Motor Boat Rinker 360 Survey Report

MOTOR BOAT	Rinker 360
HIN	[REDACTED]
DATE	[REDACTED]
REPORT NO.	[REDACTED]

Report completed by	Hatem Salama	Date	██████
Signature	xxxxxxxxxxxxxxxxxxxx	ID Number	AVI 00325 SAMS SA
Company on whose behalf inspection carried out	Buyer : Mr. ██████		
Report summary seen by	Buyer : Mr. ██████	Date	██████
Place of survey	██████████, ██████ On.		
Type of survey	Condition and valuation survey

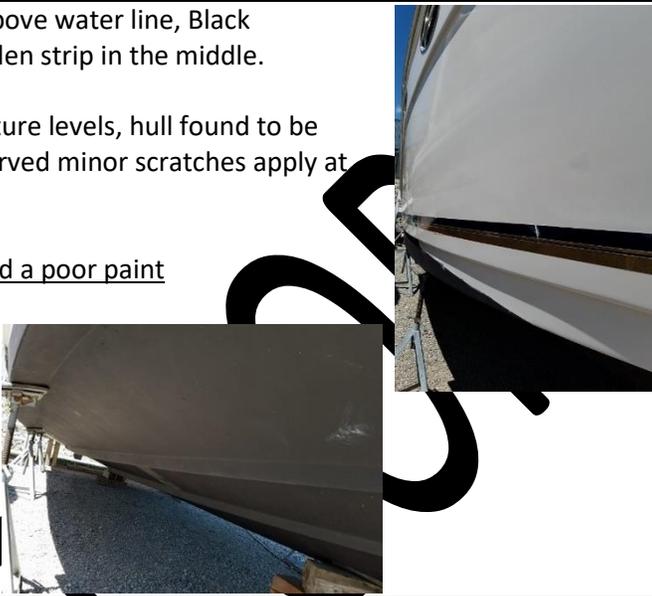
1.1	General Hull Condition	Yes ✓	No	NA	NS
<p>Fiberglass single hull, White gelcoat above water line, Black antifouling below water line, with golden strip in the middle.</p> <p>Hull in general showing medium moisture levels, hull found to be solid in good condition, however observed minor scratches apply at different places.</p> <p>Black fresh antifouling below, <u>observed a poor paint works at little parts below water line.</u></p>

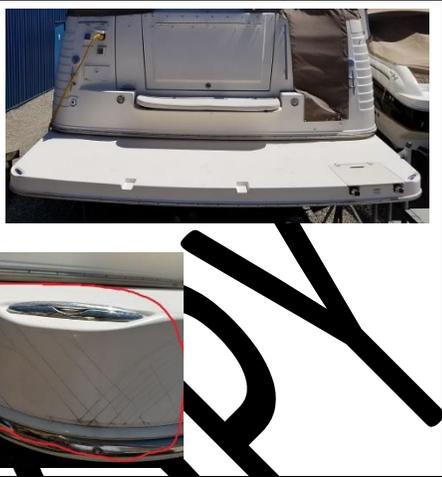
1.4	Transom / Swim Platform	Yes	No ✓	NA	NS
<p>Solid transom, showing medium moisture levels, however solid in good condition.</p> <p>Swim platform found in average condition, signs of previous repairs apply on different parts of swim platform.</p> <p><u>Observed scratches and crazing on swim platform at port quarter.</u></p>

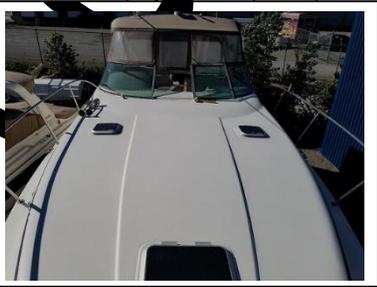
1.5	Deck / Flooring	Yes	No	NA	NS
<p>Deck found in good condition, no any signs of soft spots or flexes.</p>

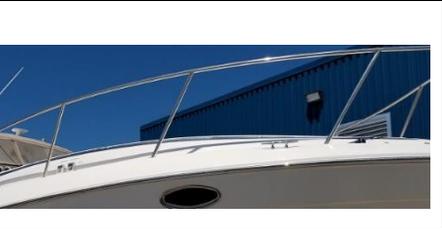
1.6	Stringers / Bulkheads / Frames	Yes	No	NA	NS
<p>Vessel's stringers and frames inspected from where accessible found solid, no any signs of damage or unus</p>					
1.7	Rails	Yes	No	NA	NS
<p>Stainless steel rails on deck found solid, and in good condition.</p>

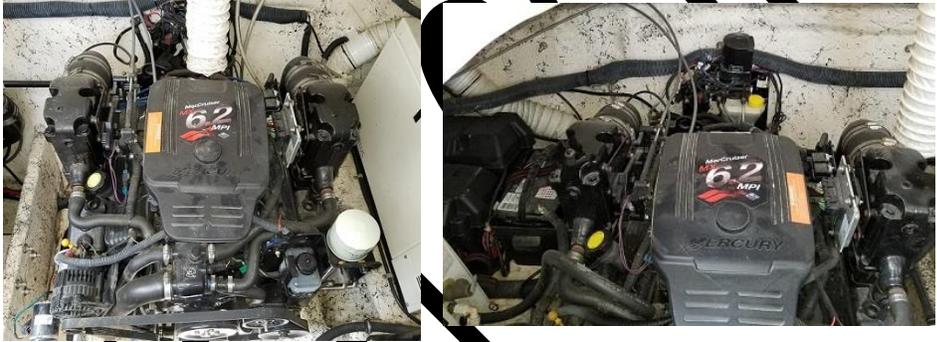
2.1	General Engine Condition	Yes	No	NA	NS
<p>2 MerCruiser MCM MX 6.2 MPI, 6.2 Liters, V 8 Cylinders, water cooled stern drive engines.</p> <p>Engines found in clean condition, fittings and parts found in good visual condition.</p>

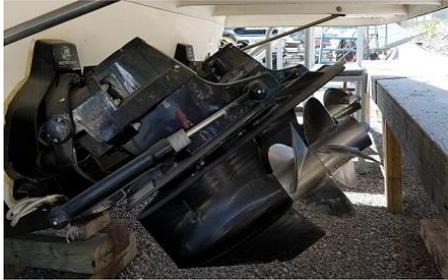
2.2	Stern Drive Units	Yes	No	NA	NS
<p>2 MerCruiser Bravo Three stern drive units.</p> <p>Port stern drive found little noise at idle.</p> <p>Port stern drive unit skeg found shaved at bottom part.</p> <p>Observed a corroded clips at rubber tube.</p>			✓

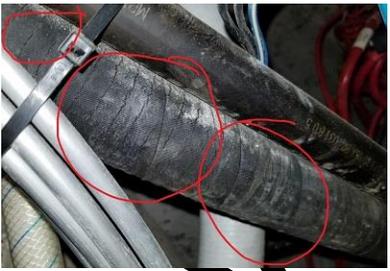
2.4	Fuel Lines	Yes	No ✓	NA	NS
<p>Both fuel lines on each side found cracked and in vey poor condition. Fuel hoses are not marine grade type.</p>

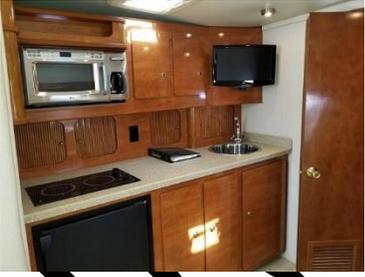
4.1	Galley	Yes ✓	No	NA	NS
Galley space located at port side in accommodation space, drawers, cabinets and accessories found in good condition.

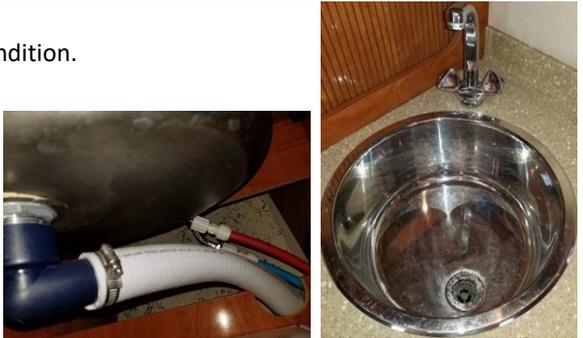
4.4	Coffee Maker	Yes ✓	No	NA	NS
Coffee maker attached to microwave oven, not tested.					
4.5	Galley Sink	Yes ✓	No	NA	NS
Stainless steel sink and faucet. Water and drain lines checked found in good condition.

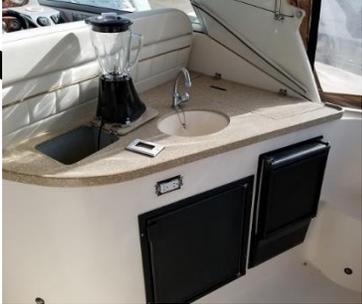
Garbage bin locker found broken bottom part

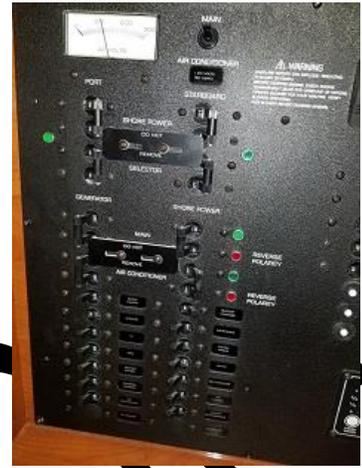
120 V, 60 HZ AC power system, source from shore power connection, and AC generator.
 Original AC power panel with main breaker.
 Power source switch double pole breakers between generator and shore power connections.
 All AC equipment are properly connected to AC breaker with switches.
 AC volt meter gauge and polarity indicator apply on panel.

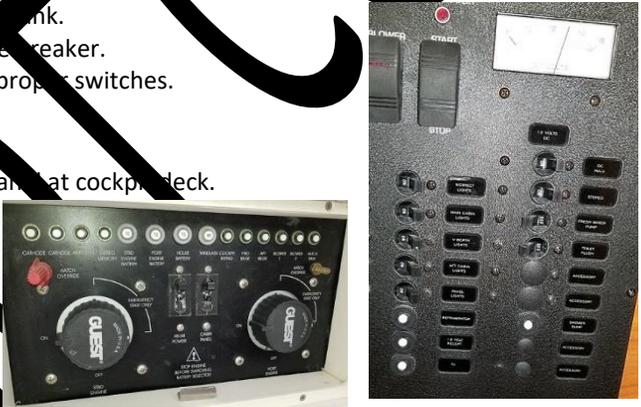
12 V DC power system, source from battery bank.
 Original DC power panel with main DC breaker.
 DC equipment connected to DC panel with proper switches.
 DC voltmeter gauge applies on panel.
 DC equipment fuse box on battery switch panel at cockpit deck.

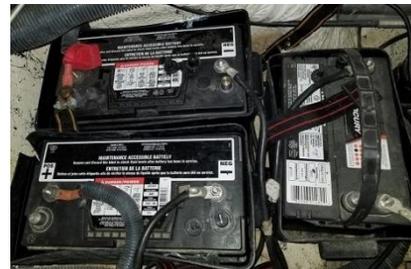
2 battery banks found in engine compartment.
 1 bank includes 3 batteries connected in parallel for engine cranking and house use.
 2 batteries missing safety caps on positive terminals.
 Batteries for engine properly installed in acid proof trays.
 1 Battery for generator cranking, installed in acid proof tray, safety cap applies on positive terminal.

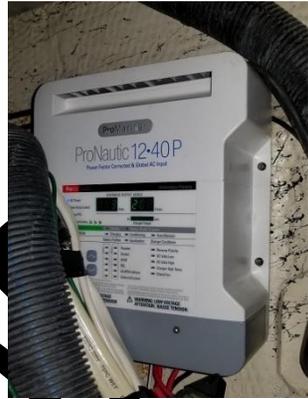
ProMariner 40 AMPS marine battery charger in engine compartment with digital light indicator.
 Battery charger properly connected to AC panel with AC switch.

Battery charger connected to batteries through proper DC over current protection 60 AMPS breakers for each battery bank.

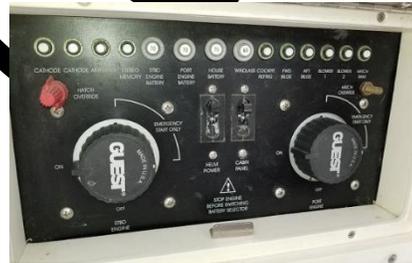
2 Guest battery switches one for each battery bank located on cockpit deck starboard side in enclosure compartment.

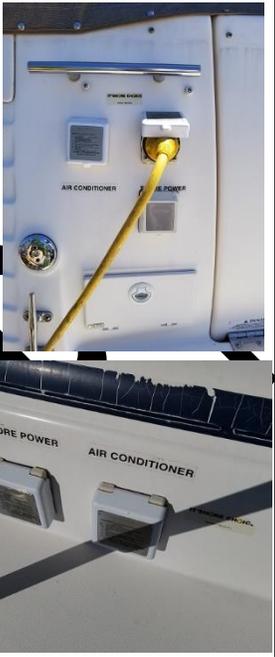
Only 1 shore power cable was connected to main shore power plug found.
Vessel missing one more shore power line for Air conditioner.

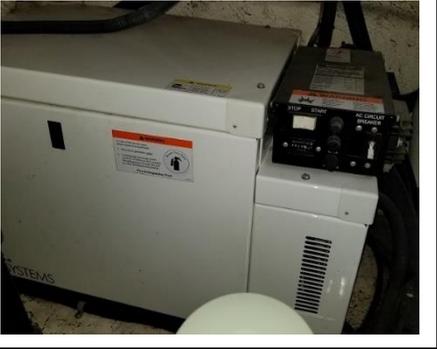
Kohler model 5E, 5 KW, gasoline marine water cooled generator, found in good visual condition.
AC circuit breaker properly supplied on generator, and starter.
Generators lines and parts found in good visual condition, not tested.

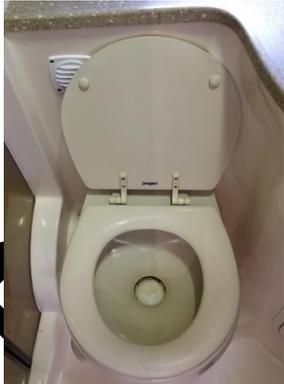
9.1	Toilet	Yes ✓	No	NA	NS
<p>Sealand marine Vacuflush system. Waste and water lines checked, in good condition. System was not tested, however powered it up for checking power.</p>
