Sailboat [REDACTED] Survey Report

SAIL BOAT	[REDACTED]
HIN	[REDACTED]
DATE	[REDACTED]
REPORT NO.	[REDACTED]

Report Completed By	Hatem Salama	Date	██████
Signature	XXXXXX	ID Number	██████
Company On Whose Behalf Inspection Carried Out	Buyers : ██████████		
Report Summary Seen By	Buyers : ██████████	Date	██████
Place Of Survey	██████████ Toronto, On.		
Type Of Survey	Condition And Valuation Survey.

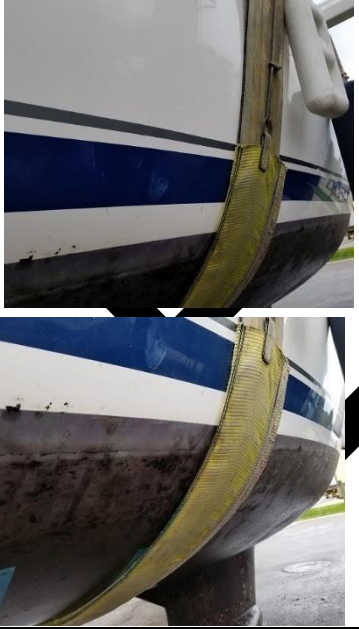
1.1	General Hull Condition
<p>Mono fiberglass hull, White gelcoat above water line, Black antifouling below water line, with Blue stripes in middle.</p> <p>Hull shows between medium and high levels of moisture. Observed previous repairs on each side of shell, however satisfactory no any delamination or soft spots seen.</p>

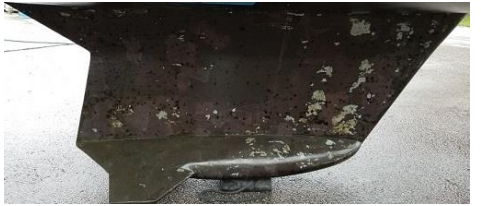
1.3	Keel
<p>Deep bulb, winglets fitted allast keel. Keel found in good condition. Stainless steel fittings checked found in good condition, no any signs of rust or damage seen.</p>

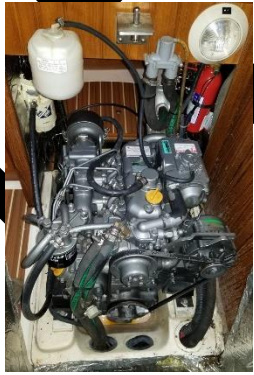
2.1	General Engine Condition
<p>Yanmar 3JH3E, 3 cylinders vertical water cooled diesel engine.</p> <p>Engine parts and fittings visually checked found good clean condition satisfactory.</p>

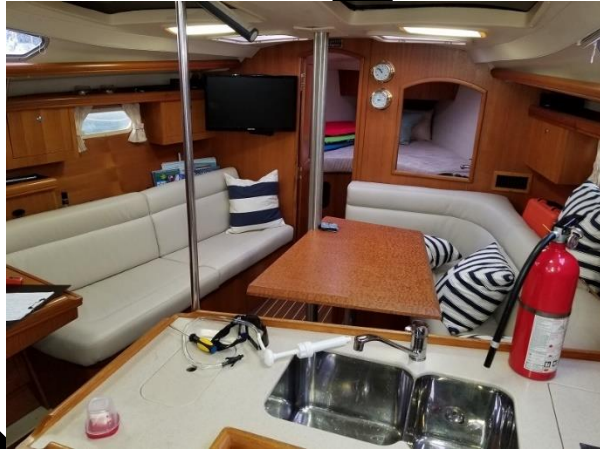
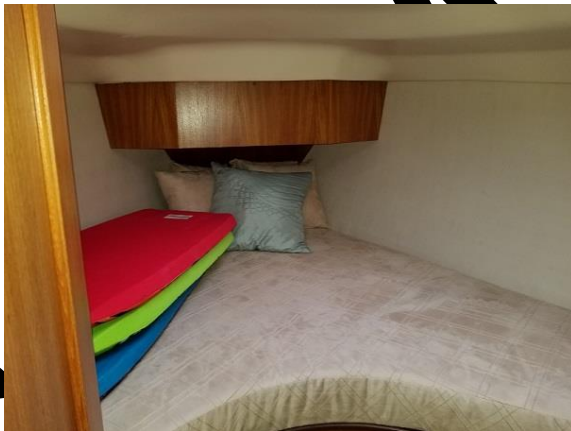
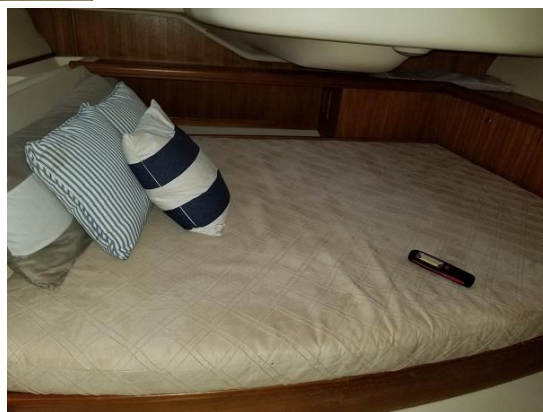
Modern traditional teak wooden finish interior and bulkhead interior found in good clean condition. V birth cabin, living areas at midship and aft cabin with double size sleeping space. Wooden panels flooring, furniture, drawers, cabinets, cushions found satisfactory.

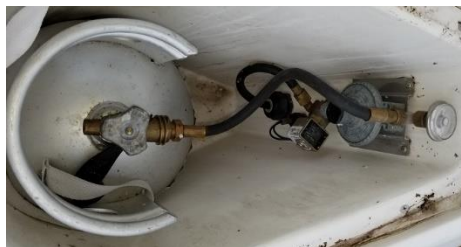
Propane.
Propane cylinder lockers at aft deck area.
Ventilation below bottles applies.
Regulator and gauge available.
Propane control DC cut off switch in galley, not tested.
No gas leak detectors found onboard.

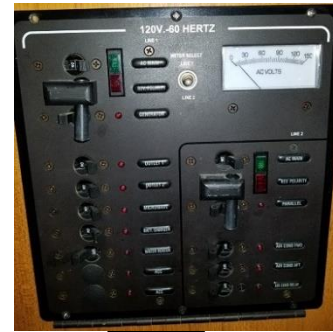
120V, 60 HZ AC power system, source through shore power.
2 Lines Original AC power panel with main switches.
AC voltmeter gauge, and revers polarity indicator on panel.
Power source switches available on AC panel for generator connection.

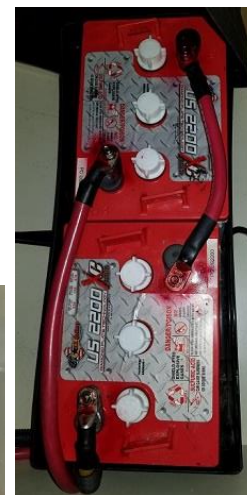
2 house batteries connected in series.
Batteries secured in anti-rattle proof tray.
No safety caps removed on batteries positive terminals.

1 Engine cranking battery.
Battery not installed in anti-rattle proof tray.
No safety caps removed on batteries positive terminals.

Batteries banks located below seating area in accommodation, **no proper ventilation applies to batteries storage area.**

16	House and cranking battery found missing safety caps on positive terminals.	Medium	To install safety caps on batteries positive terminals as per ABYC E-10.7.7.1
17	Engine cranking battery not installed in battery acid proof tray	Medium	Batteries to be well secured in acid proof tray. As per ABYC E-11
18	Waste line found connected to overboard seacock valve.	Recommendation	To cancel the bypass valve and line and block the overboard discharge valve as per Transport Canada requirement .
19	Noticed excessive movement on engine.	Recommendation	To replace engine mounts in order to avoid engine vibration.

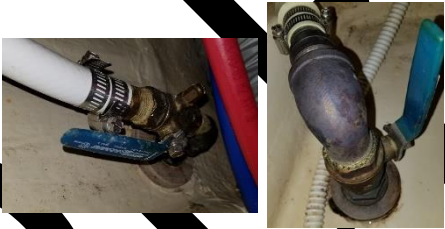
Seacock located in starboard quarter enclosed space missing handle.

Seacock located below galley sink and v birth sink, found frozen not turning.

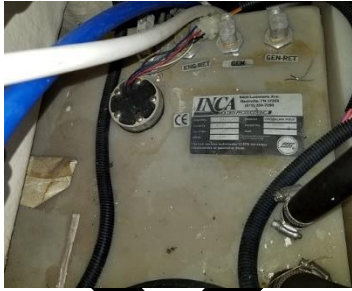
10.1	Fuel Tank
<p>Poly fuel tank capacity of 106 Liters, well secured in aft compartment.</p> <p>Tank's ventilation, hoses, and fittings checked found in good visual condition.</p>

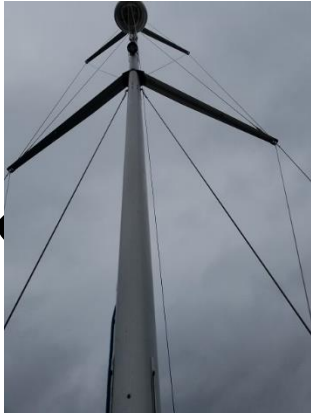
12.1	Masts / Mast Step
<p>Aluminum mast checked from deck level found in good condition, no signs of damage or corrosion observed.</p> <p>Mast keel step checked found in good operational condition, no signs of cracks or damage seen..</p>
