Azimut 62 Survey Report

POWER BOAT	Azimut 62
HIN	[REDACTED]
DATE	[REDACTED]
REPORT NO.	984.73.MBSR.28.24

ID Number	AVI 00325 IIMS : S1283
Person on whose behalf inspection carried out	Buyer : Mr. [REDACTED]		
Report summary seen by	Buyer : Mr. [REDACTED]	Date	11.06.24
Place of survey	[REDACTED]		
Type of survey	Condition and valuation survey

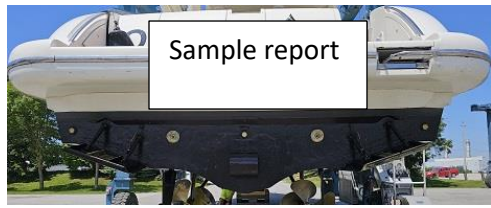
Transom structurally sound, no indication of soft spots or dull sound evident.
High moisture levels were obtained from transom panel where antifouling is applied.

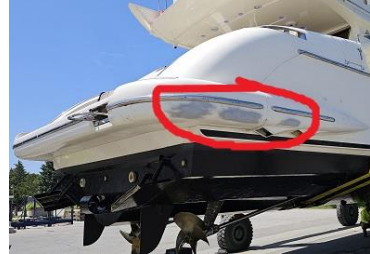
Moulded to the hull swim platform. Gelcoat discoloration and minor delamination detected in swim platform both quarters with high moisture levels.

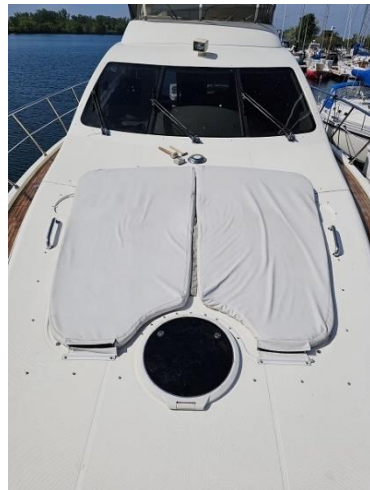
Antiskid FRP cored deck, Deck is in good general condition to the age of the boat, no soft spots or delamination evident.
Low moisture levels were mostly obtained from deck panel, higher readings detected around multiple deck fittings and hardware such as the accommodation vent and multiple cover snaps fittings on fly bridge skirt, and above port side window.
Fly bridge deck moisture readings were mostly low, elevated moisture levels toward the aft fly bridge deck fittings.

Recommendation : Deck fittings and hardware re-bedding is advised.

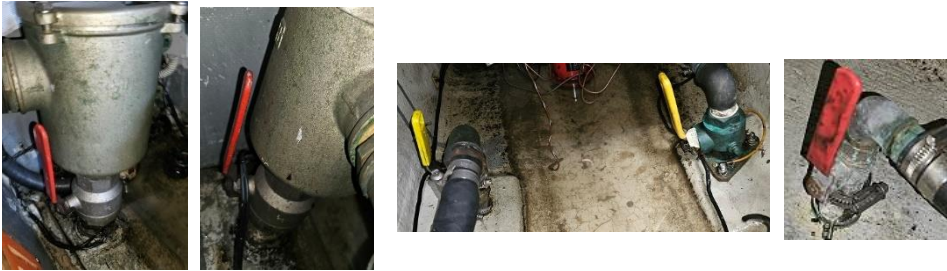
2 engines water cooling intake metal ball valve seacocks with built in water strainers are in serviceable condition.

Air conditioner water intake bronze seacock valve in serviceable condition.

Generator water cooling intake bronze ball valve seacock in serviceable condition.

Water intake ball valve bronze ball valve seacock in forward cabin bilge space in serviceable condition.

Note : Oxidation applies on bronze seacock valves. Maintenance is advised.

Recommendation: Seacock valves tested by turning only. Seacock valves and thru hull openings to be retested and inspected in water frequently to confirm watertight integrity.

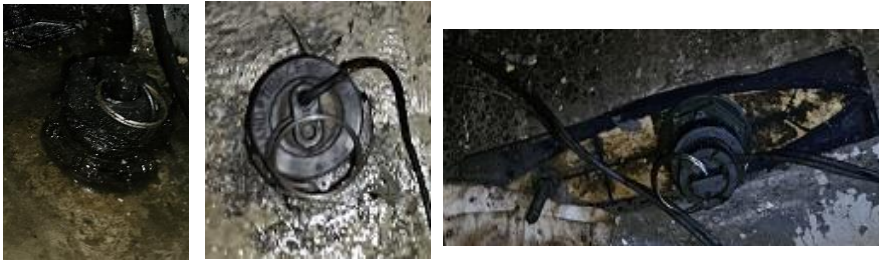
Electronic sensors below water line thru hull visually inspected.

Forward engine compartment sensor was partly submerged in bilge water.

Speed impeller thru hull sensor backing plate is molded, replacement is advised.
