Catalina 42 Survey Report

| SAIL BOAT | Catalina 42 |

| Type Of Survey | Condition And Valuation Marine Survey. | | |

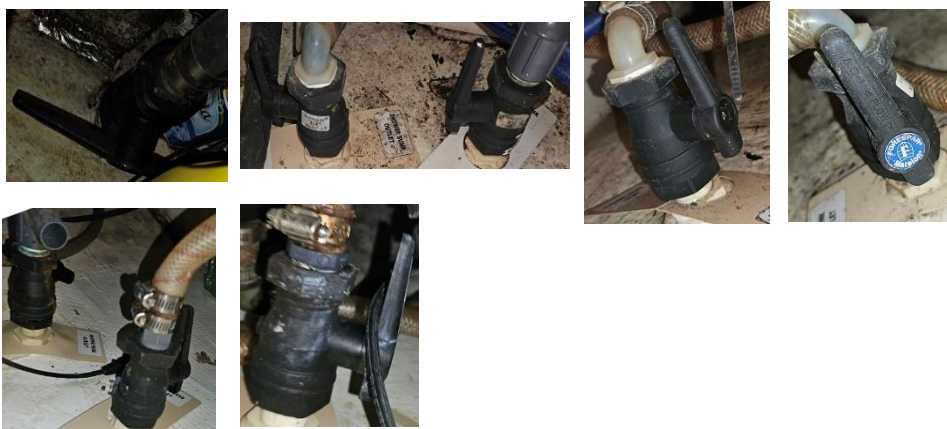
Engine cooling water intake plastic ball valve seacock in serviceable condition.
Galley sink drain line plastic ball valve seacock in serviceable condition.
Aft Toilet sink drain line plastic ball valve seacock in serviceable condition.
Aft toilet head water intake plastic ball valve seacock in serviceable condition.
Aft toilet shower sump pump discharge plastic ball valve seacock in serviceable condition.
Forward Toilet sink drain line plastic ball valve seacock in serviceable condition.
Forward toilet head water intake plastic ball valve seacock in serviceable condition.
Forward toilet shower sump pump discharge ball valve seacock in serviceable condition.
Forward toilet waste overboard discharge line plastic ball valve in serviceable condition.

Note : Multiple seacock hoses clamps are rusted, replacement is advised.

Recommendation: Seacock valves and below water line thru hull openings to be tested and monitored in water to confirm watertight integrity.

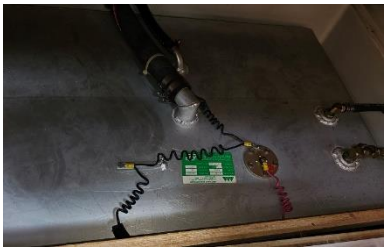
| | <p>38 gallons aluminum fuel tank in aft cabin seen from where is accessible, ventilation, hoses, and fittings in good visual condition, and rust free.</p> <p>Tank's grounding available.</p> <p>Tank is equipped with quick shut off valve found to be seized; maintenance is advised.</p> |

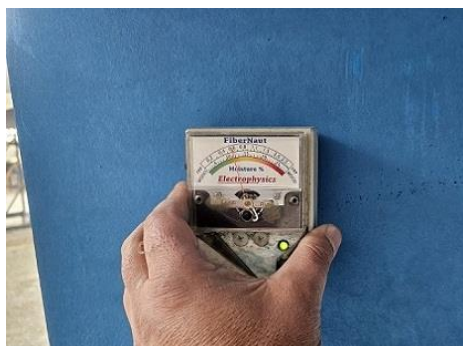
| | Item | Location | Reading | Remarks |
|---|---|---|---|---|
| 6 | Moisture | Rudder | Low | |

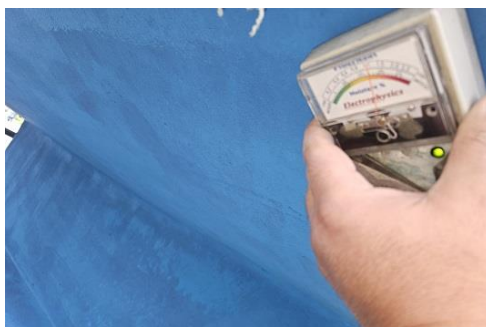
| | Item | Location | Reading | Remarks |
|---|---|---|---|---|
| 2 | Moisture | Midship area | Low-Moderate | Below water line |

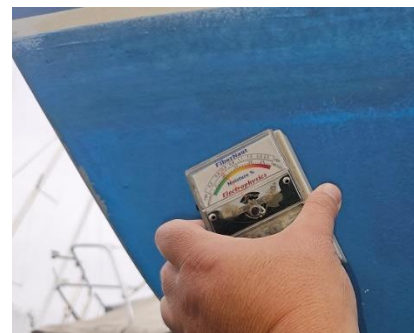
| | Item | Location | Reading | Remarks |
|---|---|---|---|---|
| 1 | Moisture | Bow area | Low | Below water line |

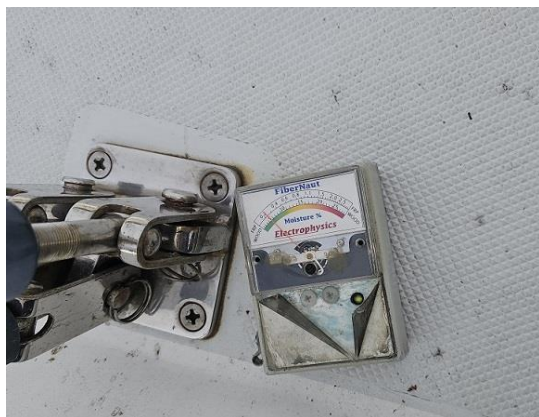
Deck general moisture readings

| | <p>Balsa cored antiskid deck in solid condition, hammer test did not proof any soft spots or delamination, low moisture levels were mostly obtained from deck panel, slight moisture elevation detected at starboard side deck midship.</p> <p>Recommendation: Starboard side deck fittings re-bedding is advised.</p> | |

| | Item | Location | Reading | Remarks |
|---|---|---|---|---|
| 8 | Moisture | Deck in general | Low | Slight moisture elevation at starboard side deck midship |
