Power Boat C [REDACTED] Survey Report

MOTOR BOAT	[REDACTED]
HIN	[REDACTED]
DATE	[REDACTED]
REPORT NO.	[REDACTED]

Report completed by	Hatem Salama	Date	██████
Signature	Private	ID Number	AVI 00325 SAMS SA
Company on whose behalf inspection carried out	Buyer : Mr. ██████		
Report summary seen by	Buyer : Mr. ██████	Date	██████
Place of survey	████████████████████ Toronto, On.		
Type of survey	Condition and valuation survey

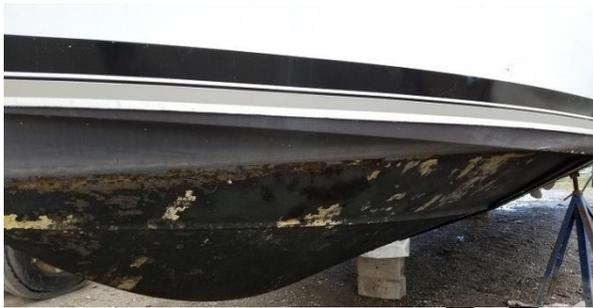
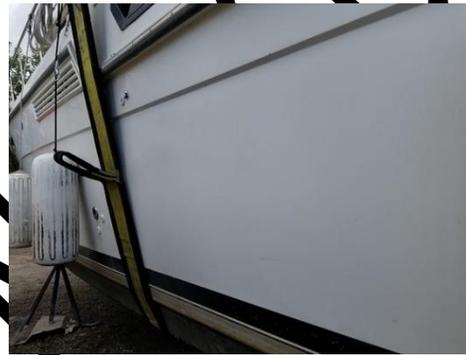
Mold construction solid fiberglass hull, White gelcoat above water line area found to be smooth and fair in good condition.

Black colour antifouling coat below water line in old poor condition, with signs of **peeling and Flaking at the bottom of the hull.**

Hull in general showing high moisture levels below water line area, typical for age of the Vessel with consideration of antifouling coat. All hull area was tapped, sound solid, no signs of degraded panels or delamination observed.

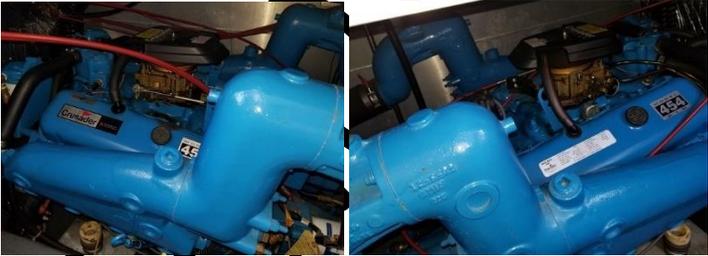
2.1	General Engine Condition
<p>Twin Crusaders 454 CID, V 8 cylinder, 7.4 Liter, marine inboard gasoline engine with heat exchanger.</p> <p>Engines visually inspected found to be in clean condition, no signs of oil spray or rust observed.</p>

<p>Recommendation: Engine to be inspected by qualified marine mechanic to determine the comprehensive condition of the engine if needed.</p>

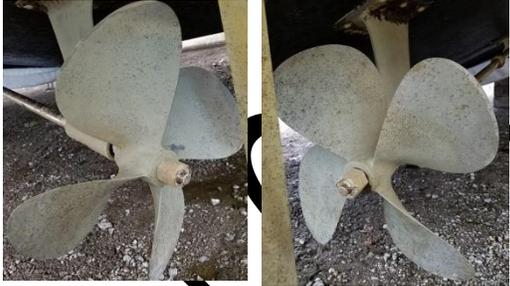
2.11	Propellers
<p>2 x 4 blades bronze propellers. Right handed prop on starboard side. Left handed prop on port side. Propellers blades, securing locks, struts, spinning units and shafts in good visual condition.</p> <div data-bbox="841 472 1351 758">

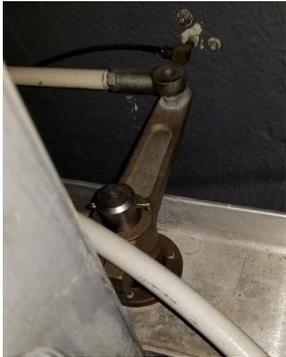
2.14	Steering Drive System
<p>Hydraulic steering system, Rudder shafts tillers and rod visually inspected from where is accessible, found in good serviceable condition.</p>

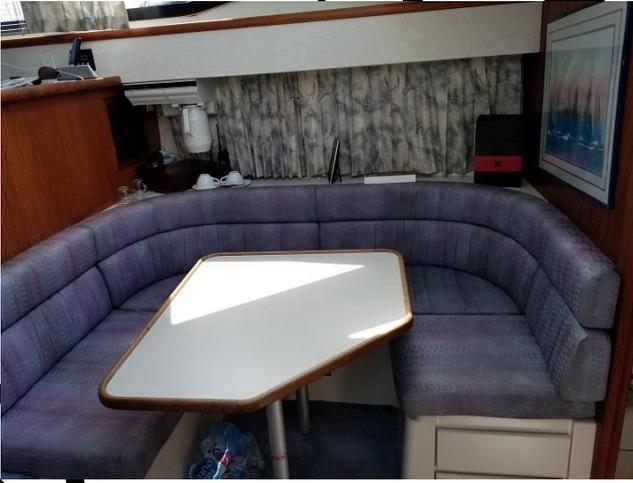
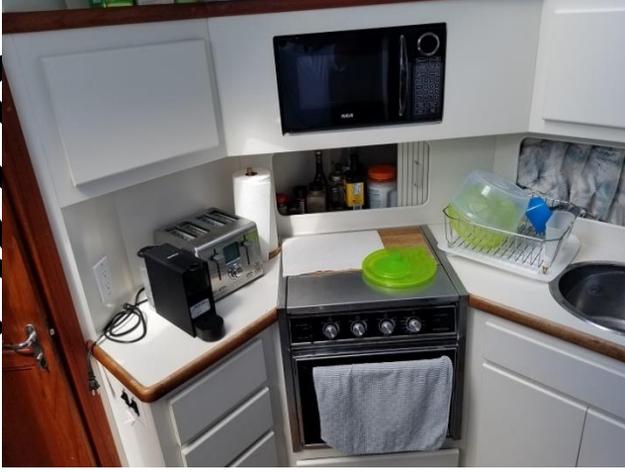
3.1	Interior
<p>Modern traditional wooden finish interior.</p> <p>V berth cabin forward.</p> <p>Forward toilet at port side with 2 access from salon and from v berth cabin.</p> <p>Galley space at starboard side and dining table at port side midship</p> <p>Main seating salon area midship aft with leather sofas</p> <p>Aft Cabin with toilet at starboard side.</p> <p>Flooring, wooden cabinets, drawers, and lockers in good condition to the age of the vessel.</p> <div data-bbox="690 672 1323 1155">

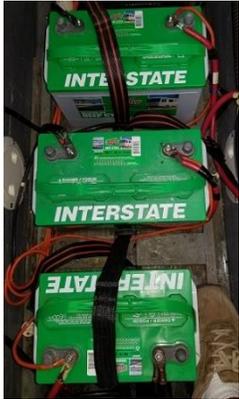
6.3	Batteries
<p>12V x 3 acid batteries one for each engine and one house. Batteries are not installed in battery boxes or trays. Batteries are missing terminal protection. Battery charger cables connected to batteries without DC over current protection.</p>

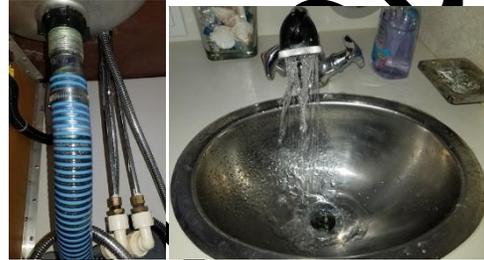
Stainless steel sink and hot/cold water faucet.
Water, drain lines and fittings in good operational condition.

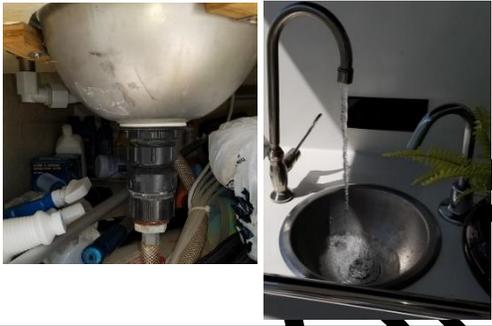
Stainless steel sink and faucet on aft deck tested.
Water drain partly clogged.

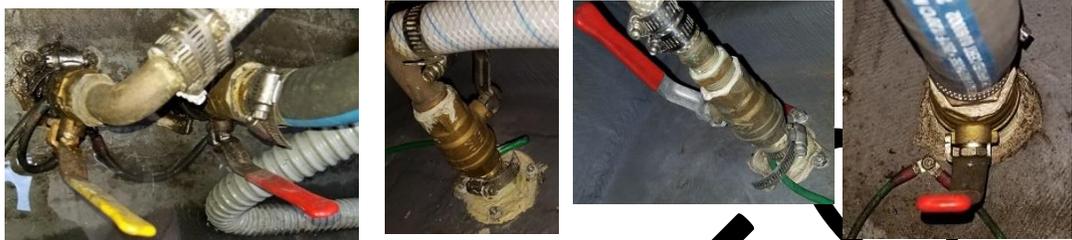
Engines cooling intake brass ball valve seacocks checked in good condition.
Generator cooling intake brass ball valve seacock checked in good condition.
Forward air conditioner brass ball valve seacock checked in good condition.
Toilet intakes brass ball valve seacock checked in good condition.

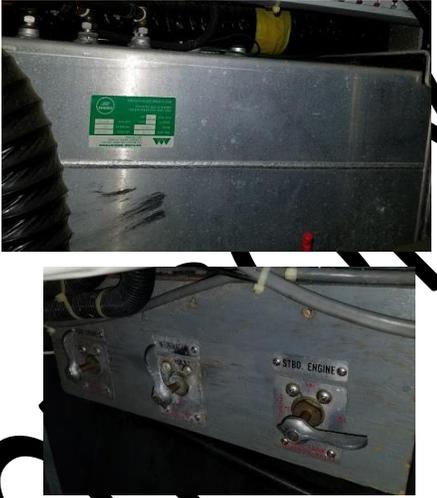
10.1	Fuel Tanks
<p>2 aluminum fuel tanks, 1 on each side of engine compartment, capacity 122 Gallons each. Ventilation lines, fuel lines, tanks grounding in good visual condition and rust free.</p> <p>Fuel distribution valves panel available in engine compartment starboard side.</p>

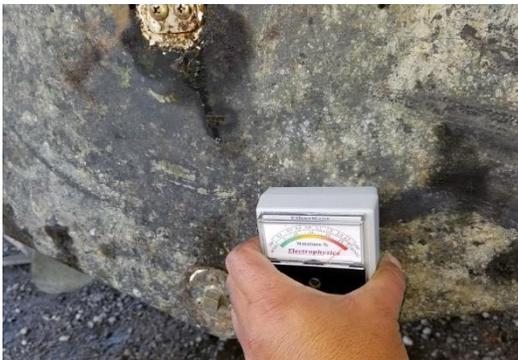
Transom

Note : Moisture meter readings on a fiberglass are only indicators, surface coating and antifouling bottom paint may greatly affect the readings.
