**I.I.S.**  
**Illinois Inspection Service**  
Specializing in EIFS & STUCCO Inspections  
(847) 767-9106

Buyer: Tithosh Thomas  
Address: 2294 Avalon  
City, State, Zip: Buffalo Grove, IL

Weather: cloudy / 33 degrees  
Last rain: 1 day  
Approx. age of property: 22 yrs.  
Product: Dryvit

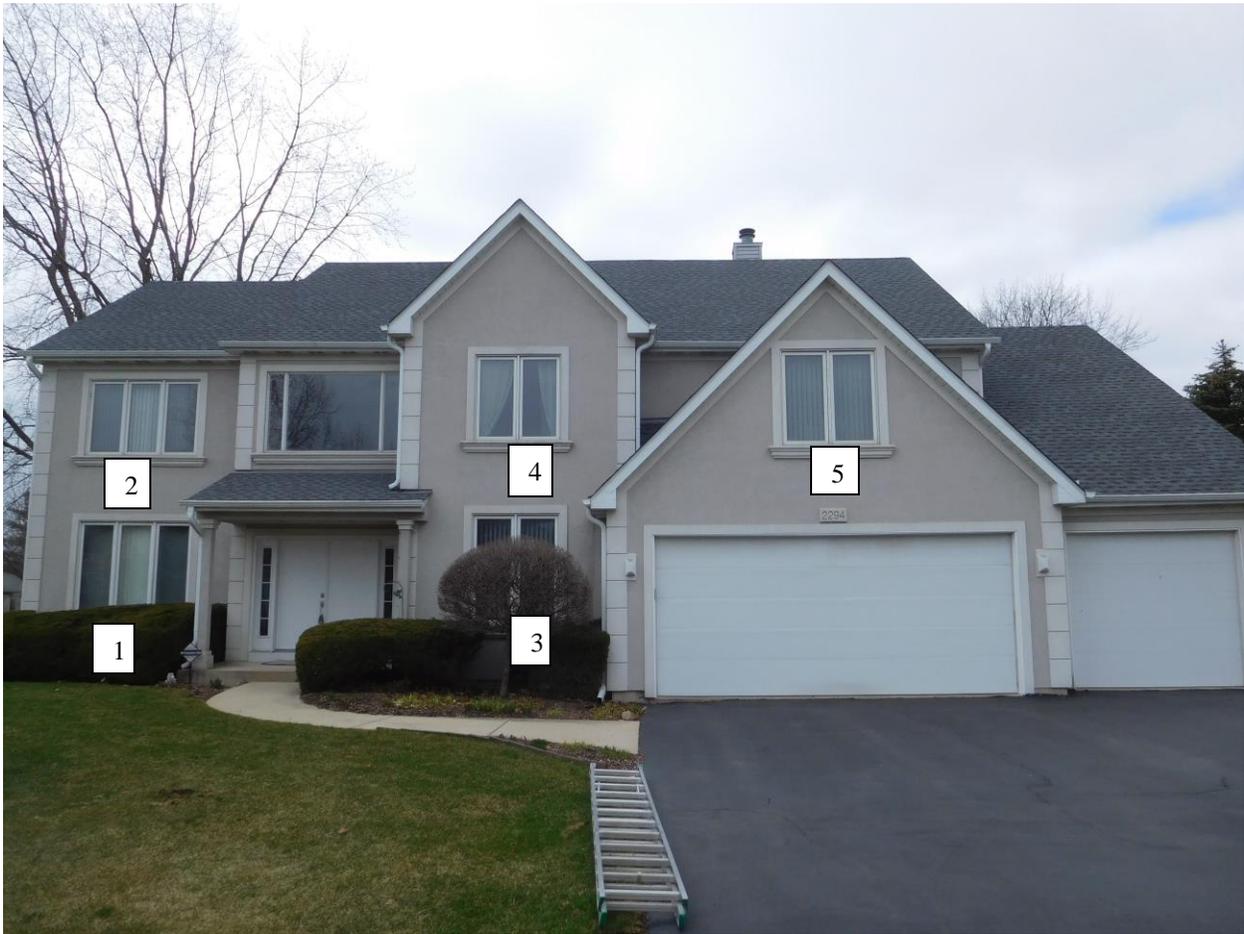
The moisture readings behind the EIFS system were a little high in several areas. I think if you caulk all the miter and mullion joints these areas should dry out over time. 0-19% moisture is acceptable; 20-30% if recaulked/reflashed should dry out over time, over 31% should be removed and investigated further. All soft substrate areas should be removed and replaced. (See attached photos)

- 1) 23% moisture reading
- 2) 20% moisture
- 3) 27% moisture
- 4) 21% moisture
- 5) 20% moisture

In general the EIFS installation appears to be done in a professional manner. You should repair the delaminating finish coat. Caulk all the miter and mullion joints.

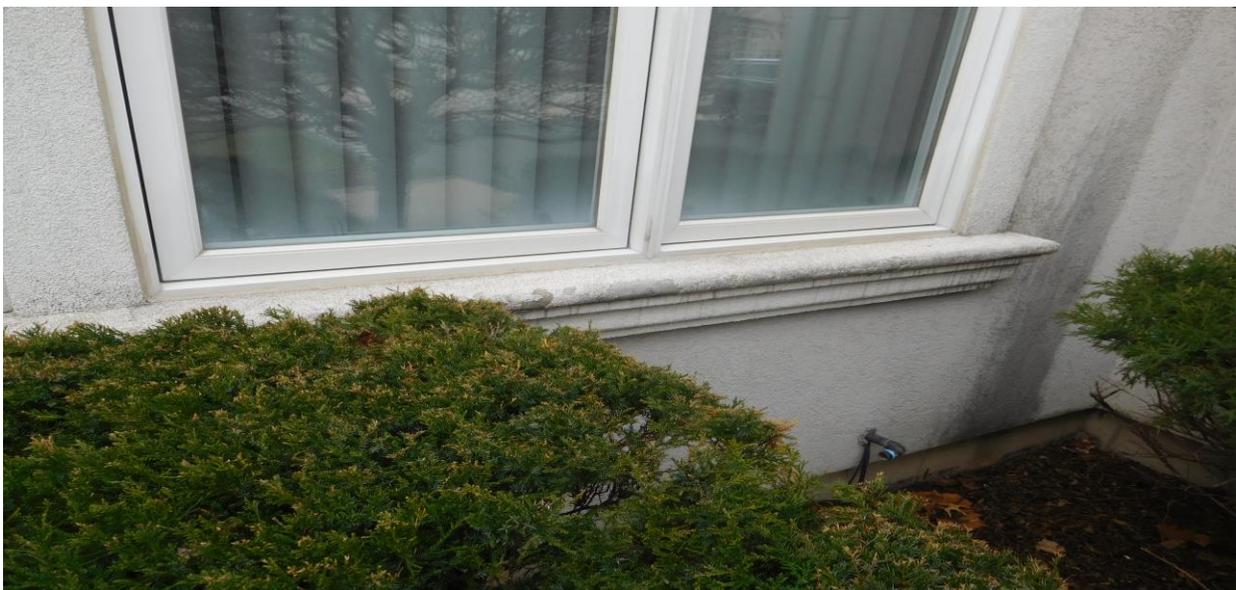
The EIFS system has finish coat delaminating off the lower right-side window. (See EIMA detail 1, Dryvit detail OS 0.0.01, and attached photos)

Finish coat is delaminating off the window sill
