I.I.S.
Illinois Inspection Service
Specializing in EIFS & STUCCO Inspections
(847) 767-9106

Date: 3/26/2022

Owner: Peter Tzakis
Address: 2479 Fawn Lake Circle
City, State, Zip: Naperville, IL

Weather: cloudy / 32 degrees
Last rain: 1 day
Approx. age of property: 23 yrs.
Product: Dryvit

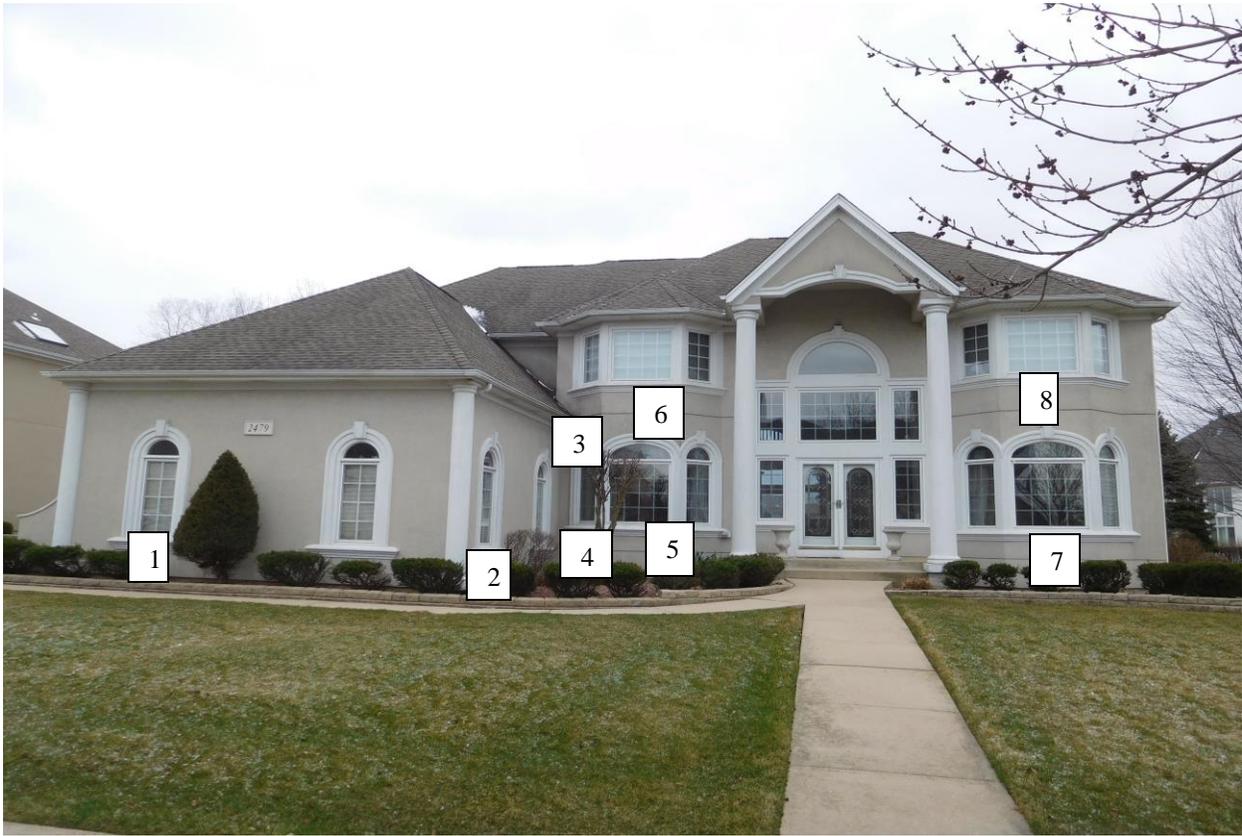
The diverter flashings are installed as per the manufacturer's details. But the moisture is still high under the flashing left of the front door. I think this flashing is inadequate for the conditions in this area and should be removed and replaced. (See EIMA detail 15, attached photos, and also reference EIMA and Dryvit Guidelines for the Inspection of EIFS Clad Houses)

- 1) 7% moisture reading
- 2) 6% moisture
- 3) 21% moisture under diverter flashing
- 4) 19% moisture
- 5) 7% moisture
- 6) 6% moisture
- 7) 7% moisture
- 8) 6% moisture

In general the EIFS installation appears to be done in a professional manner. You should repair the woodpecker damage. Remove and replace the inadequate diverter flashing.

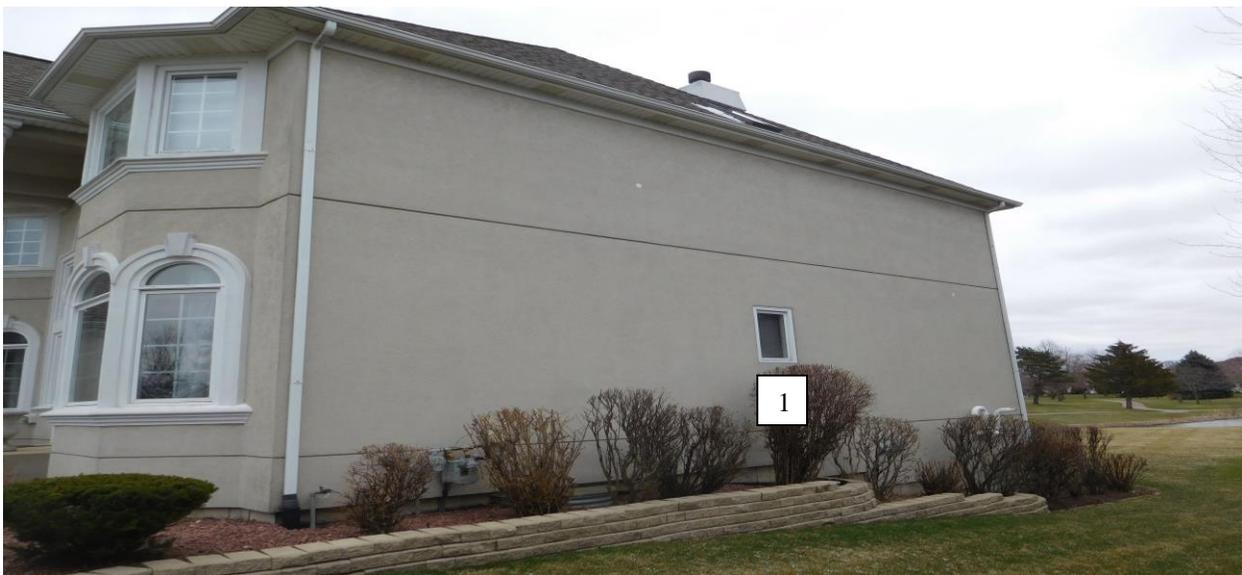
- 1) 7% moisture reading

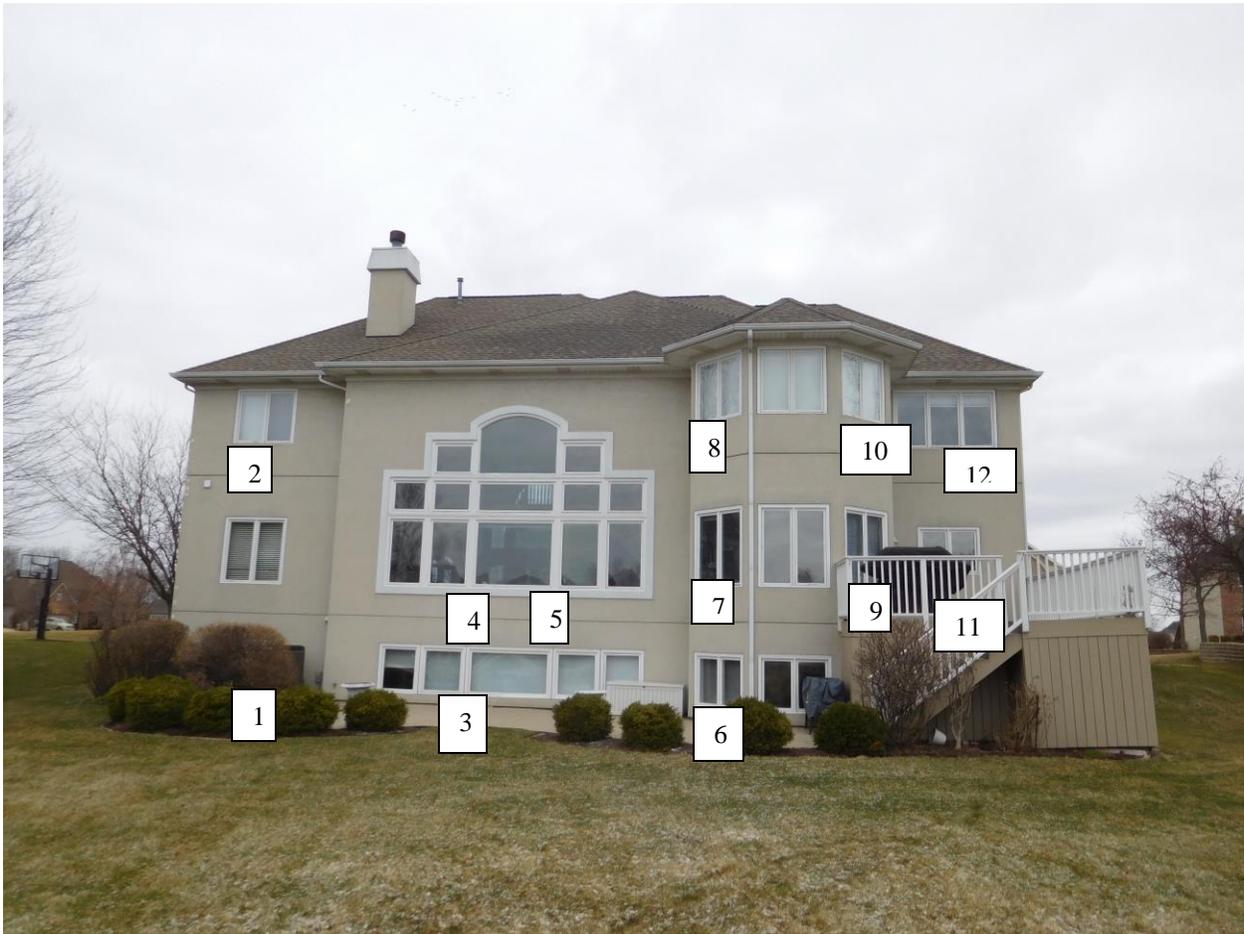
- 1) 12% moisture reading
- 2) 6% moisture
- 3) 7% moisture
- 4) 6% moisture
- 5) 8% moisture
- 6) 6% moisture
- 7) 7% moisture
- 8) 6% moisture
- 9) 7% moisture
- 10) 6% moisture
- 11) 11% moisture
- 12) 6% moisture

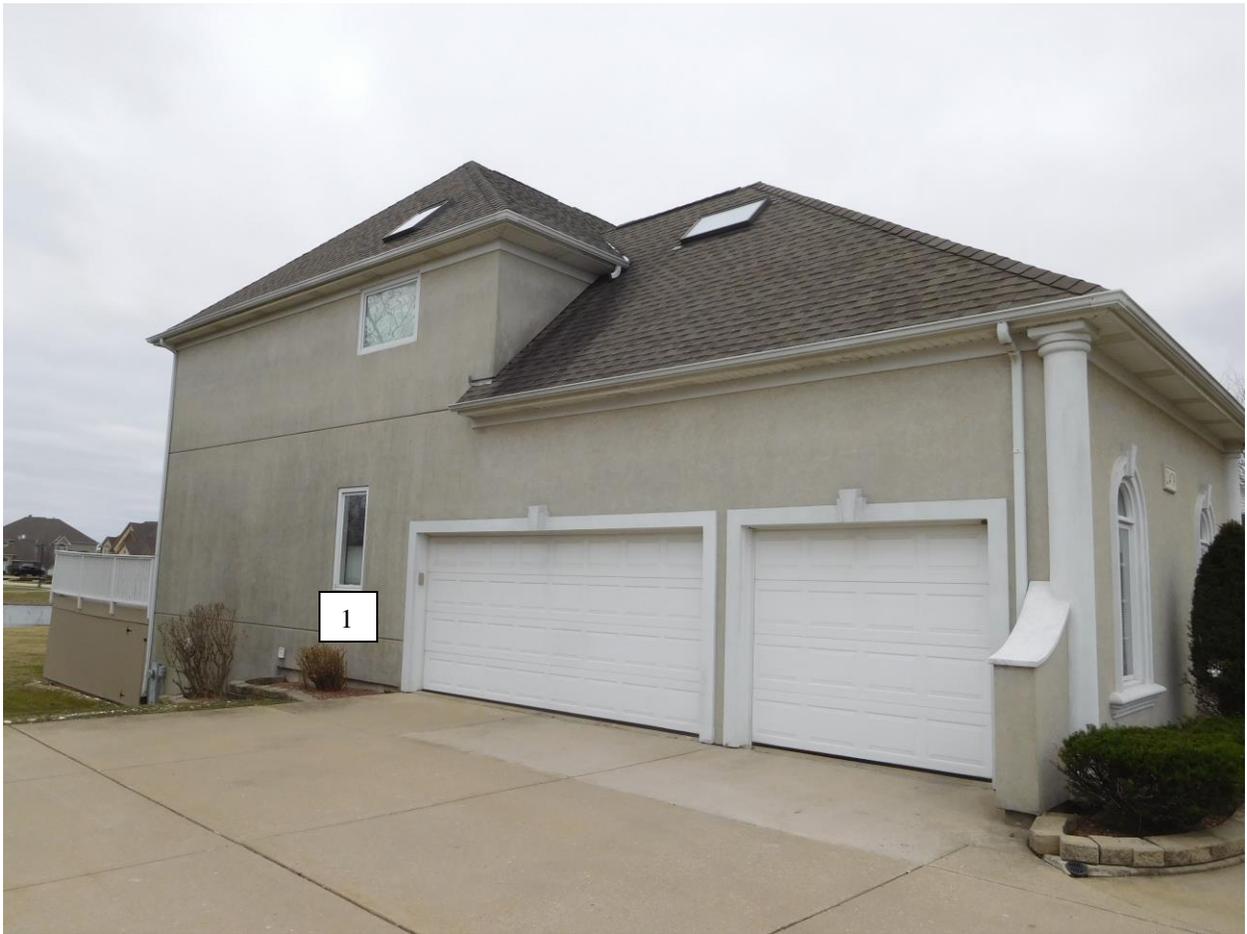
1) 10% moisture reading
