Arborist Appraisal of Trees

2302 Mar Vista Ave., Altadena, CA 91001

June 29, 2025

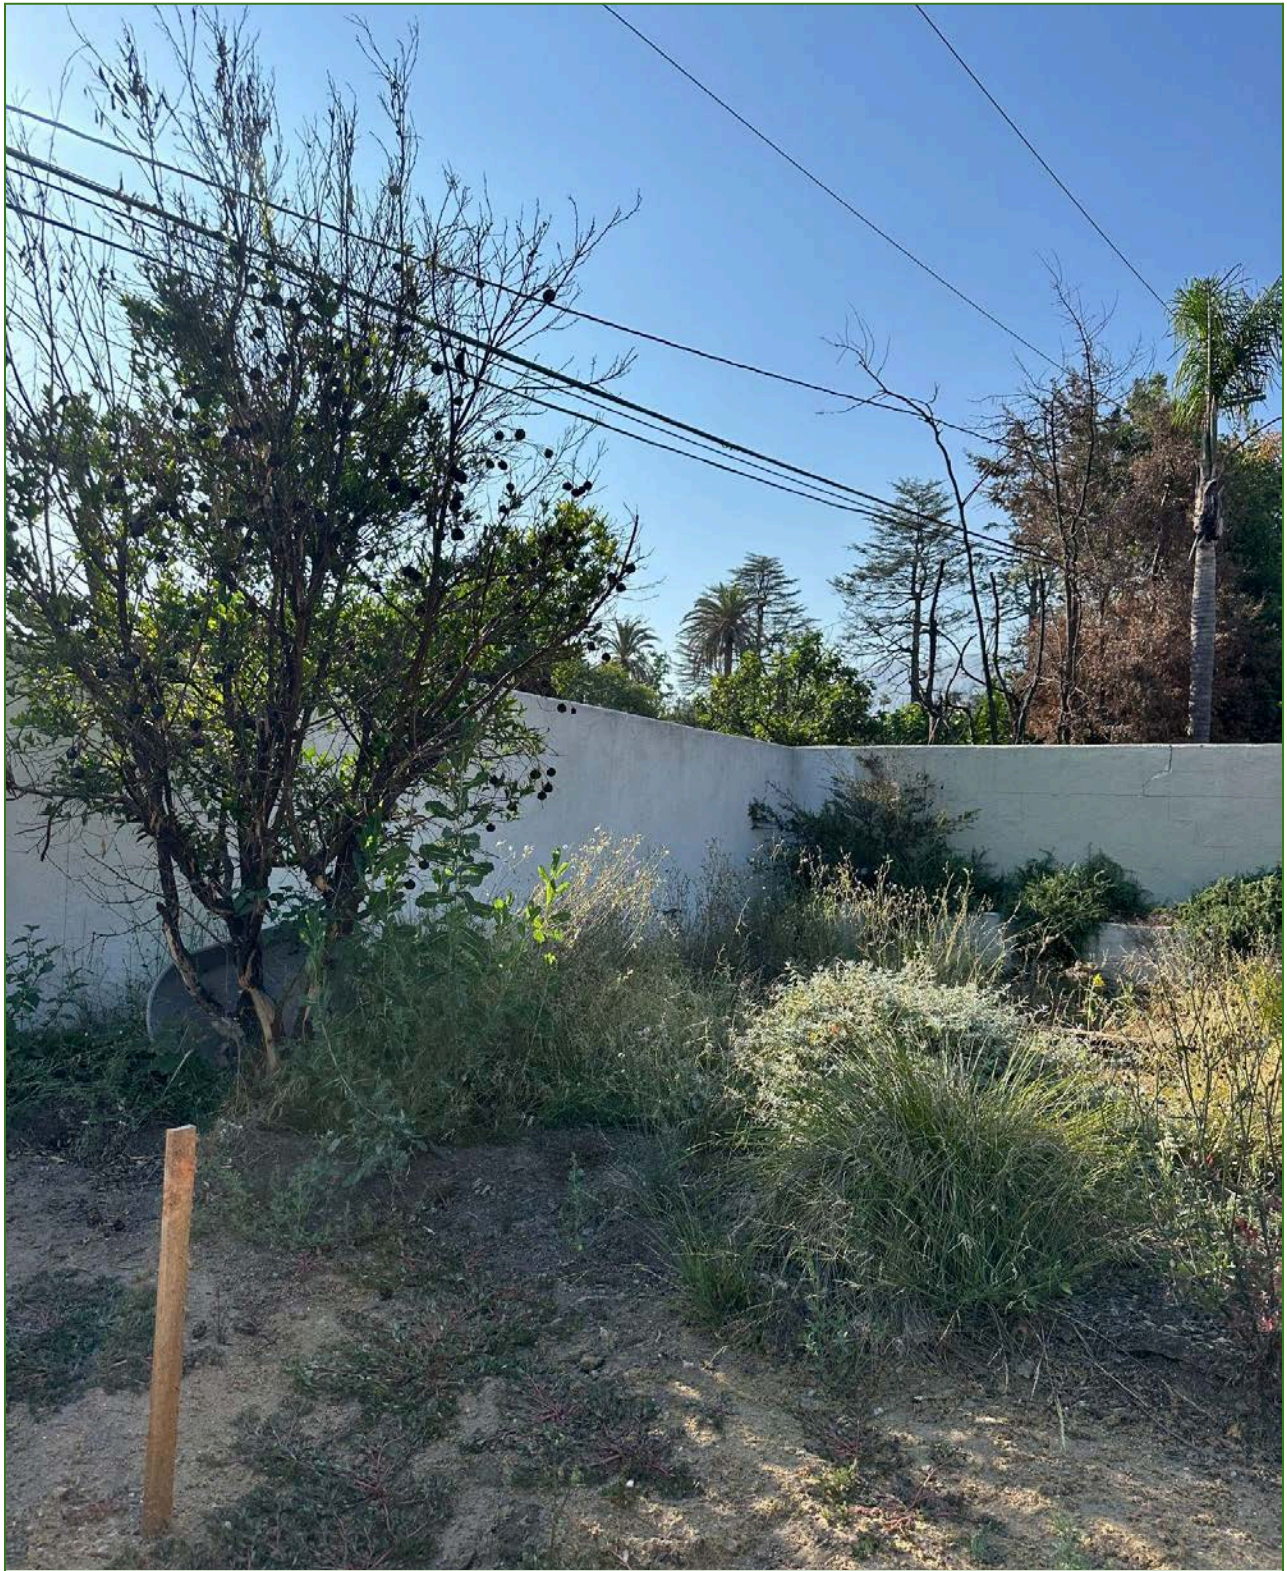
Image No. 1–After Fire: Mandarin Orange (*Citrus reticulata*) & various shrubs

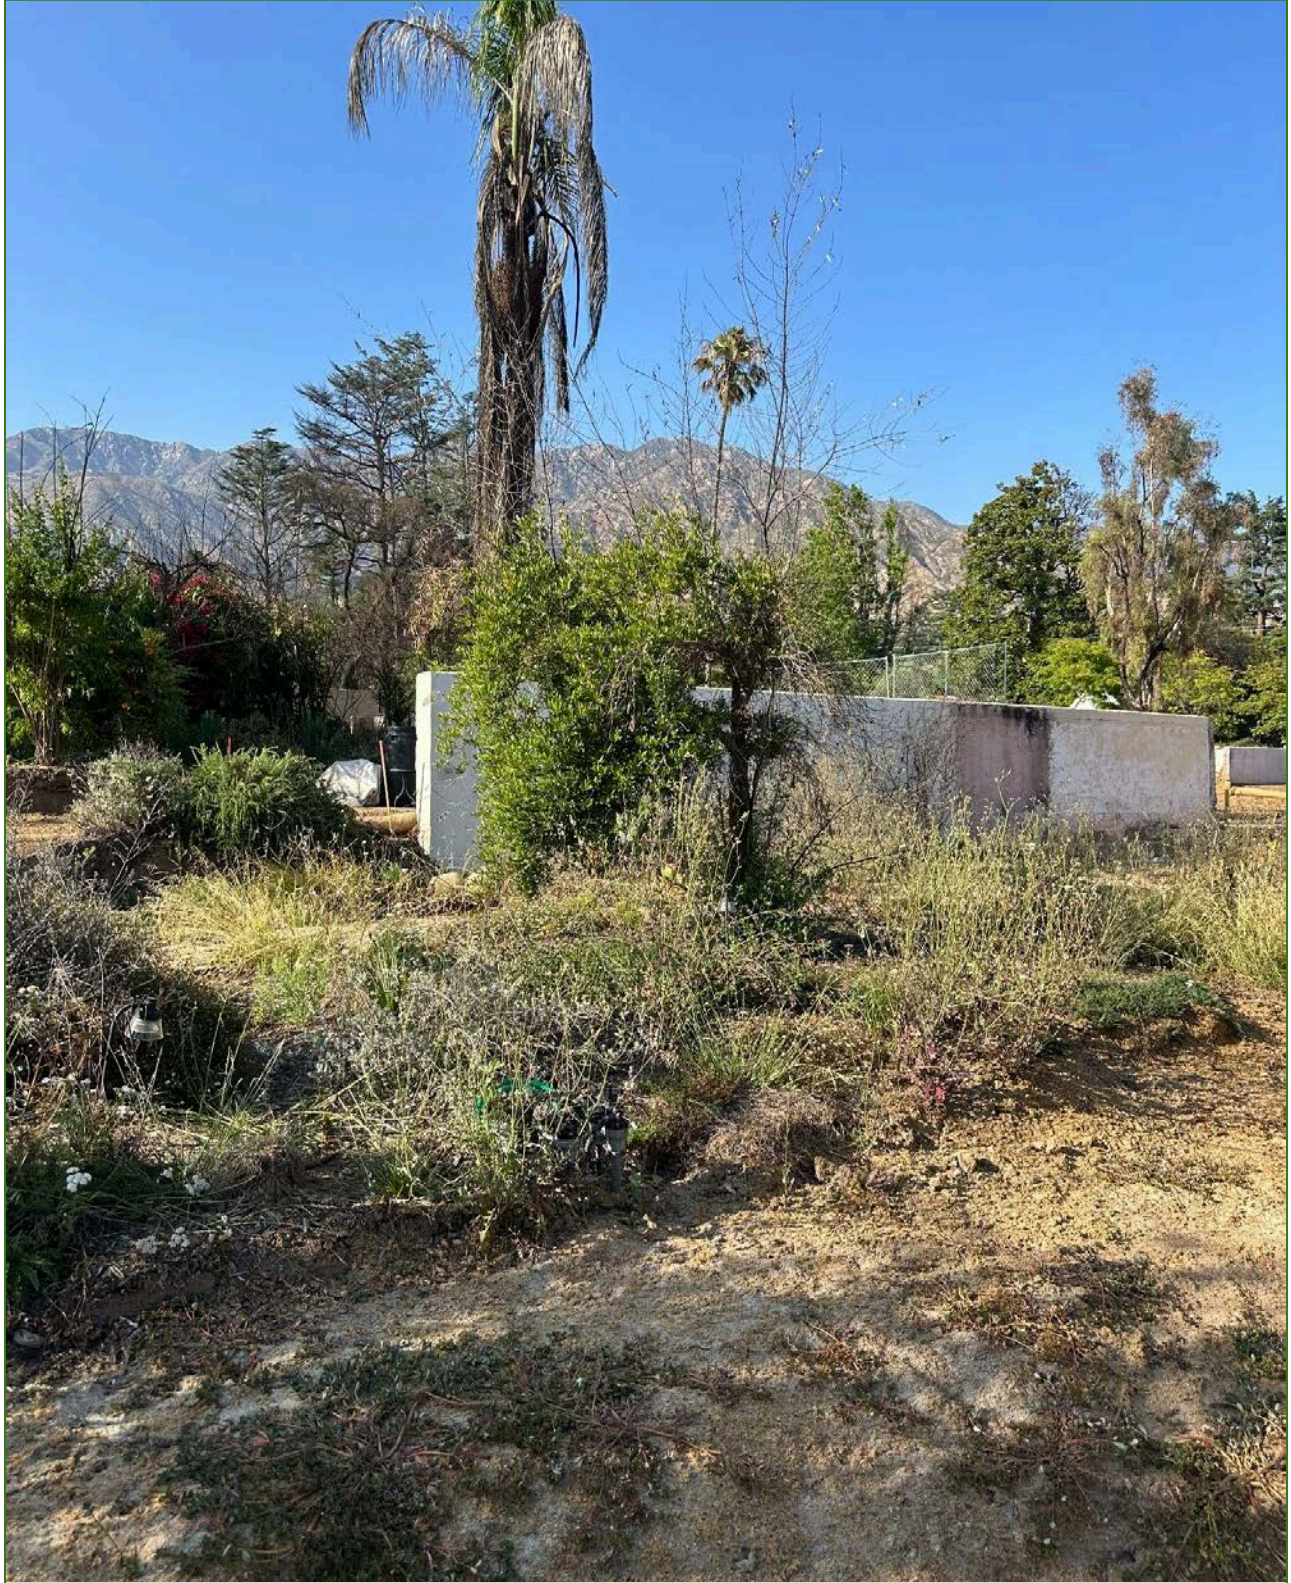
Image No. 2–After Fire: Various shrubs

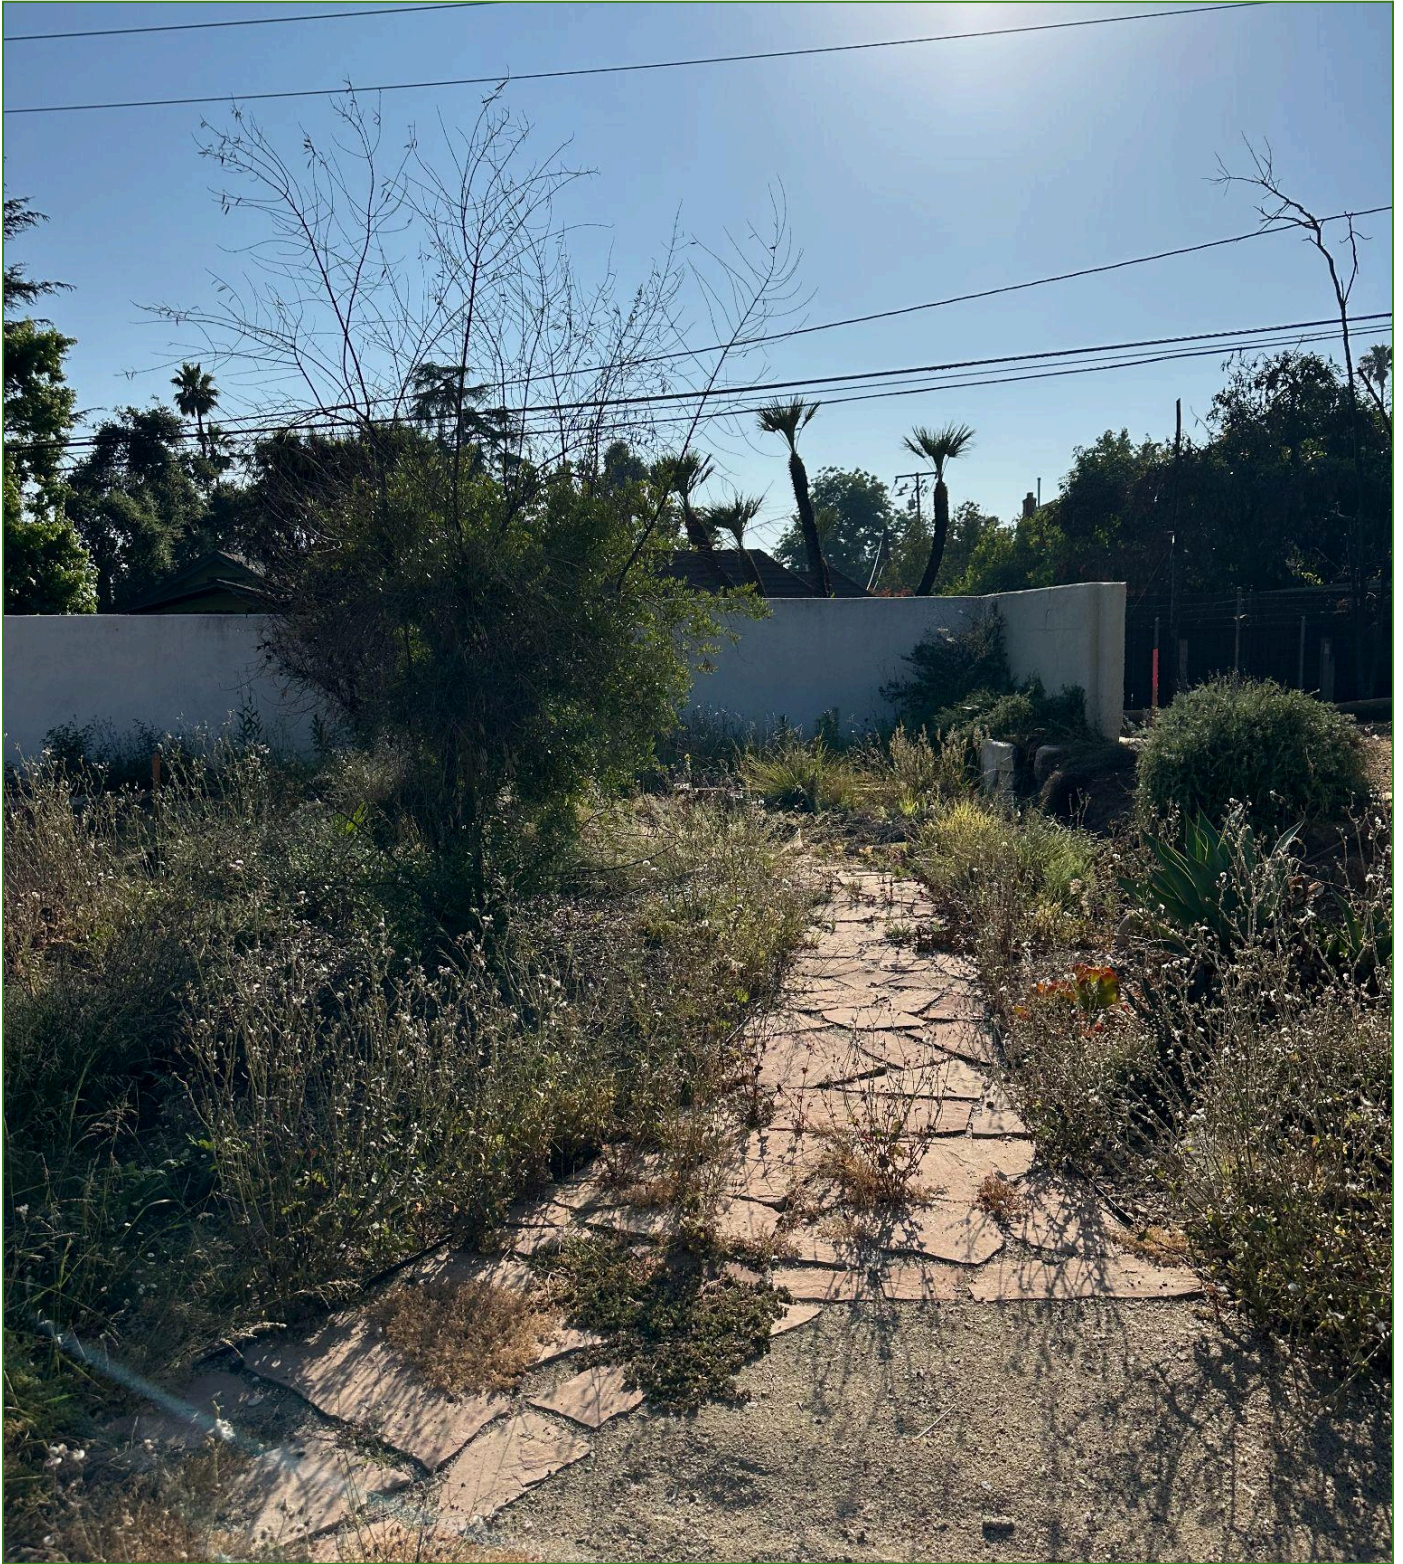
Image No. 3–After Fire: Fruitless Olive (*Olea europaea*) & various shrubs

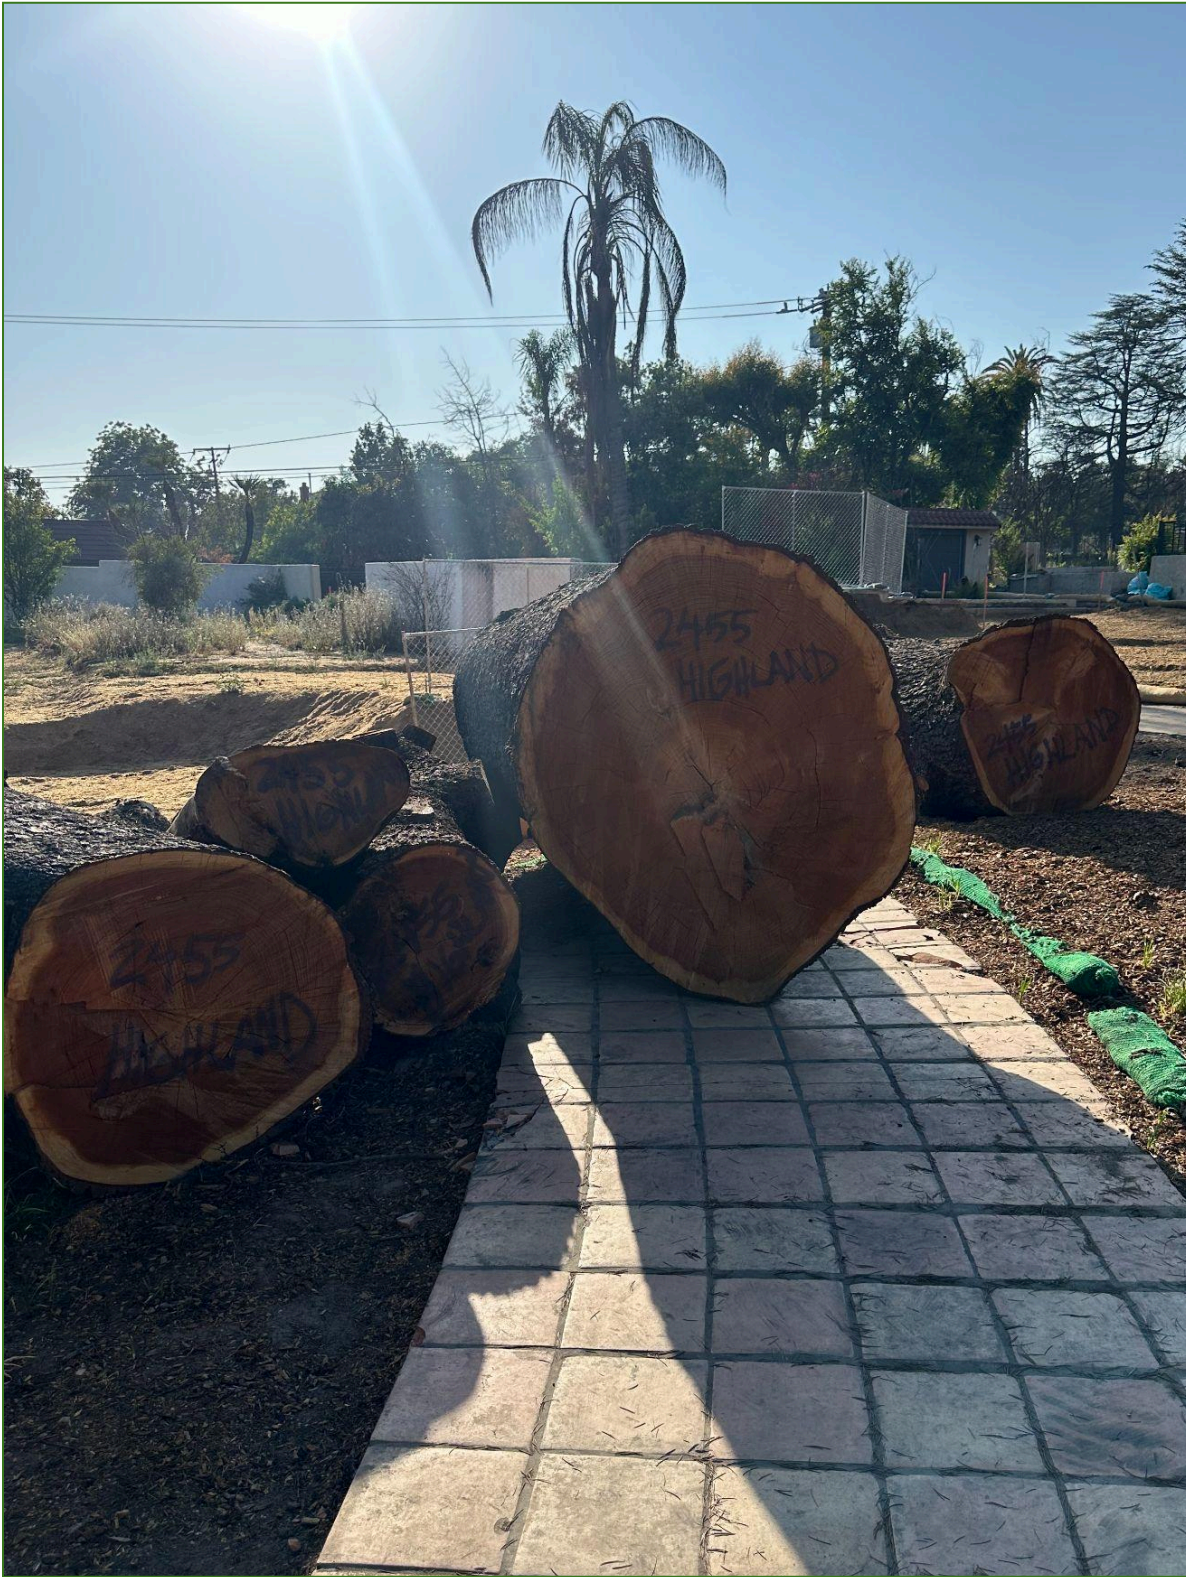
Image No. 4–After Fire: Deodar Cedar (*Cedrus deodara*)

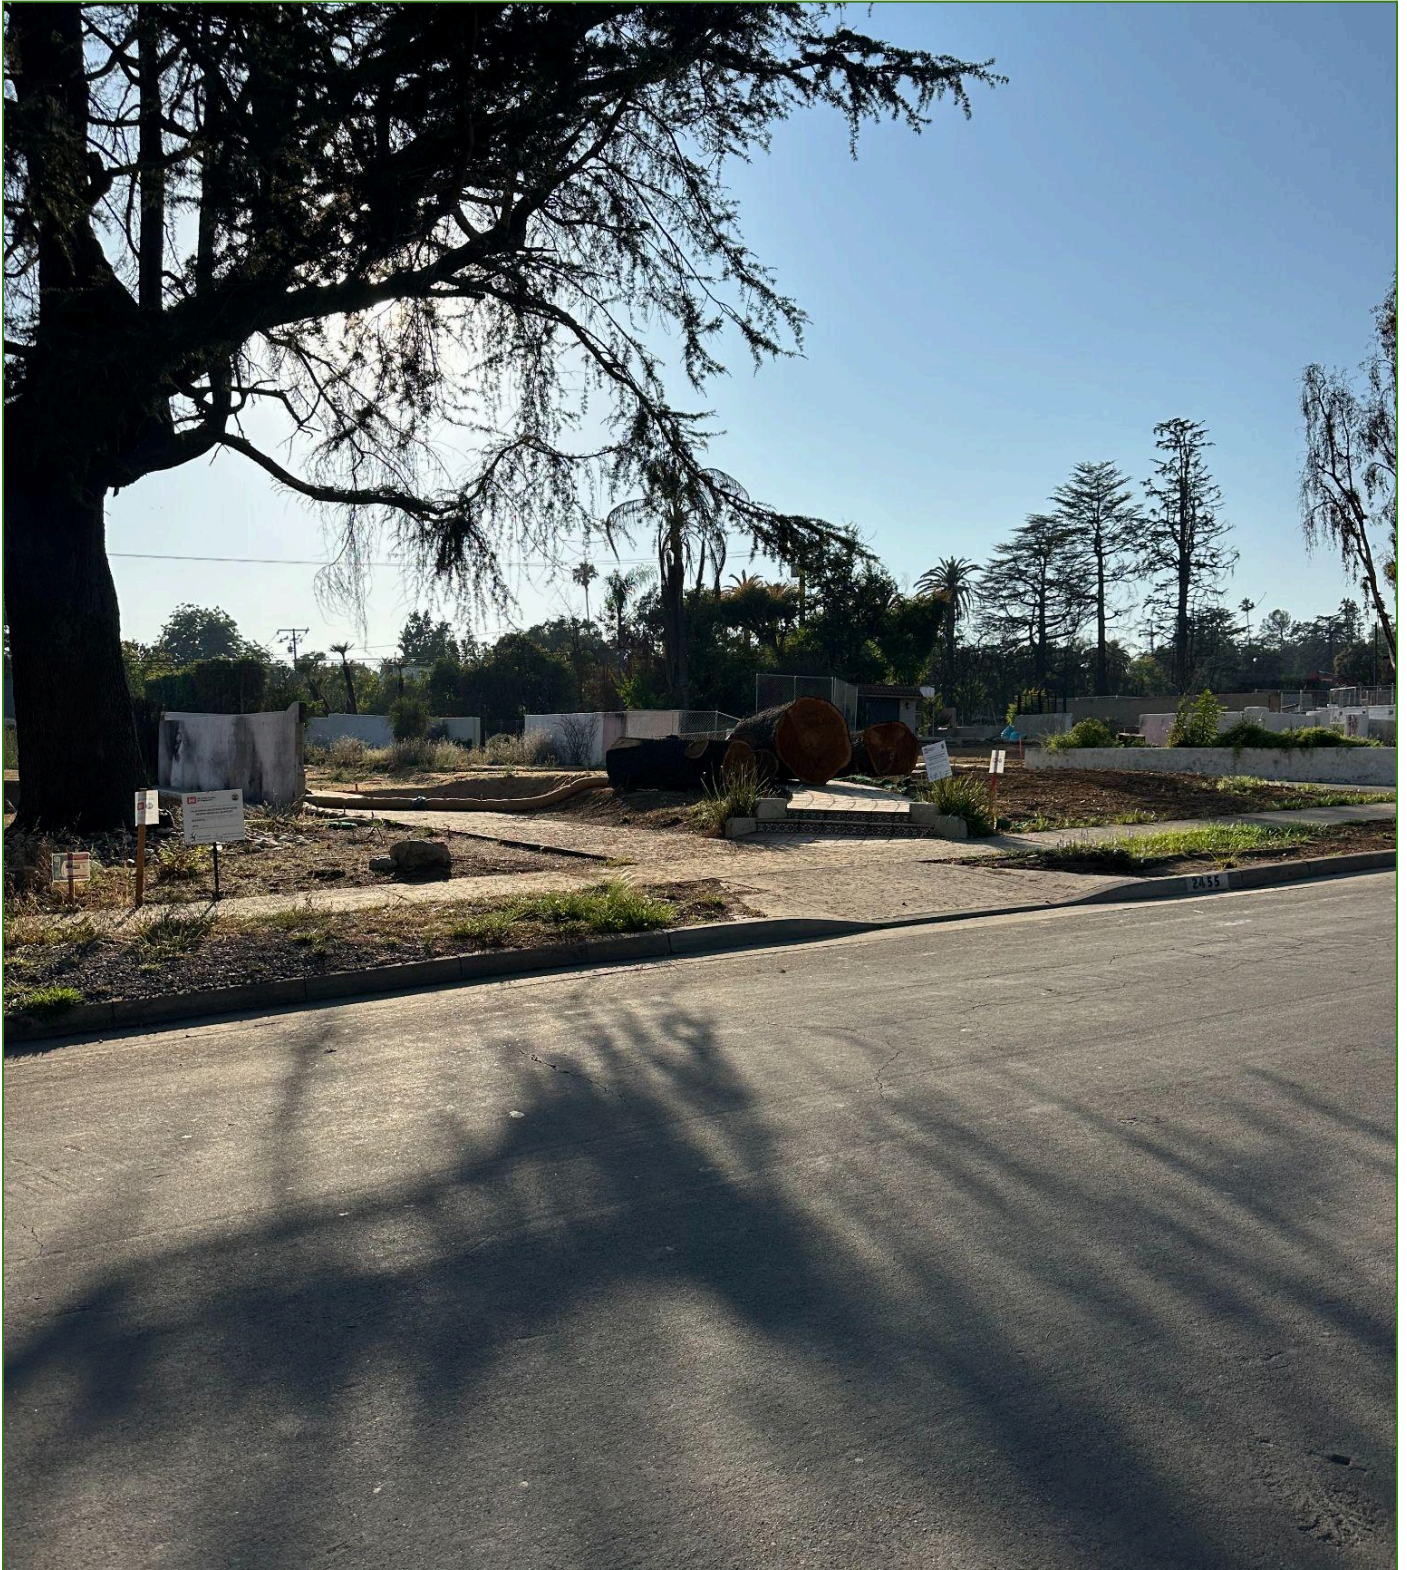
Image No. 5–After Fire: Deodar Cedar (*Cedrus deodara*)

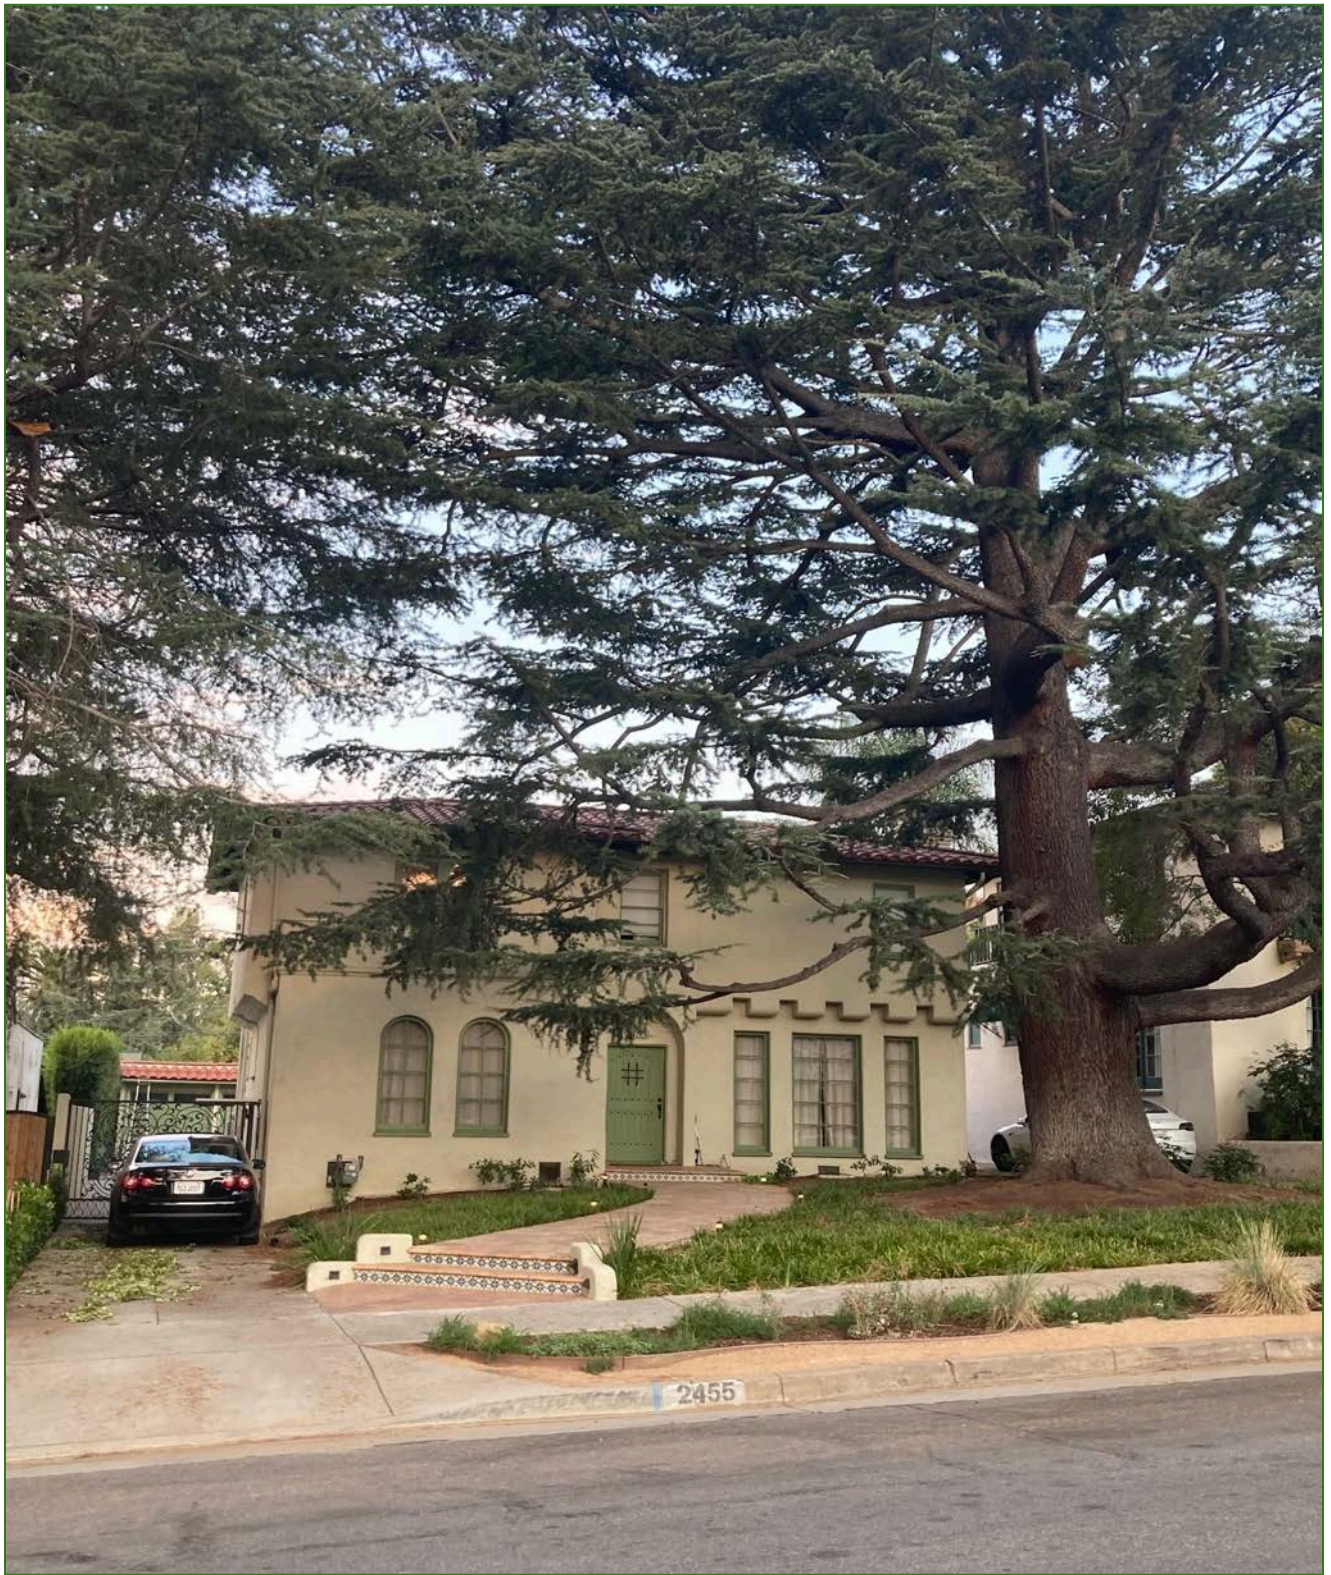
Image No. 6—Before Fire: Deodar Cedar (*Cedrus deodara*) & various shrubs

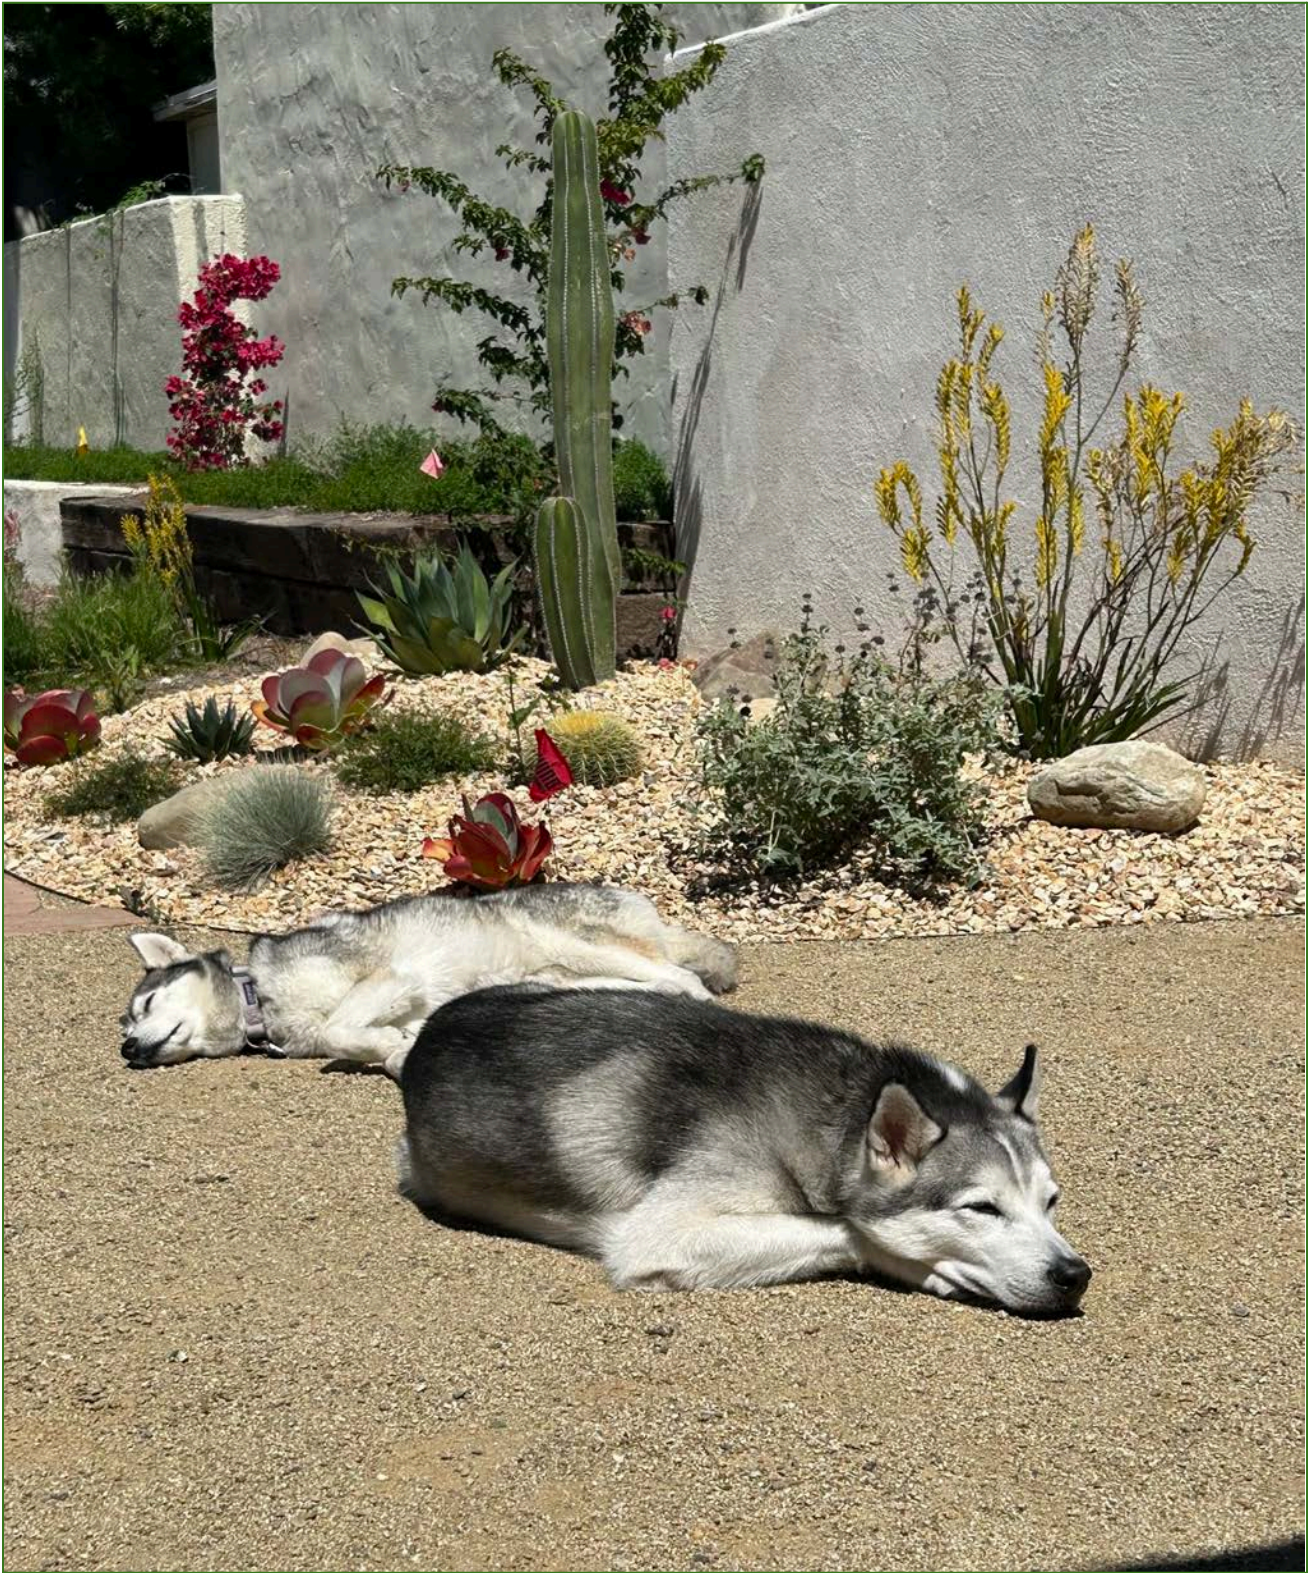
Image No. 6–Before Fire: Various shrubs

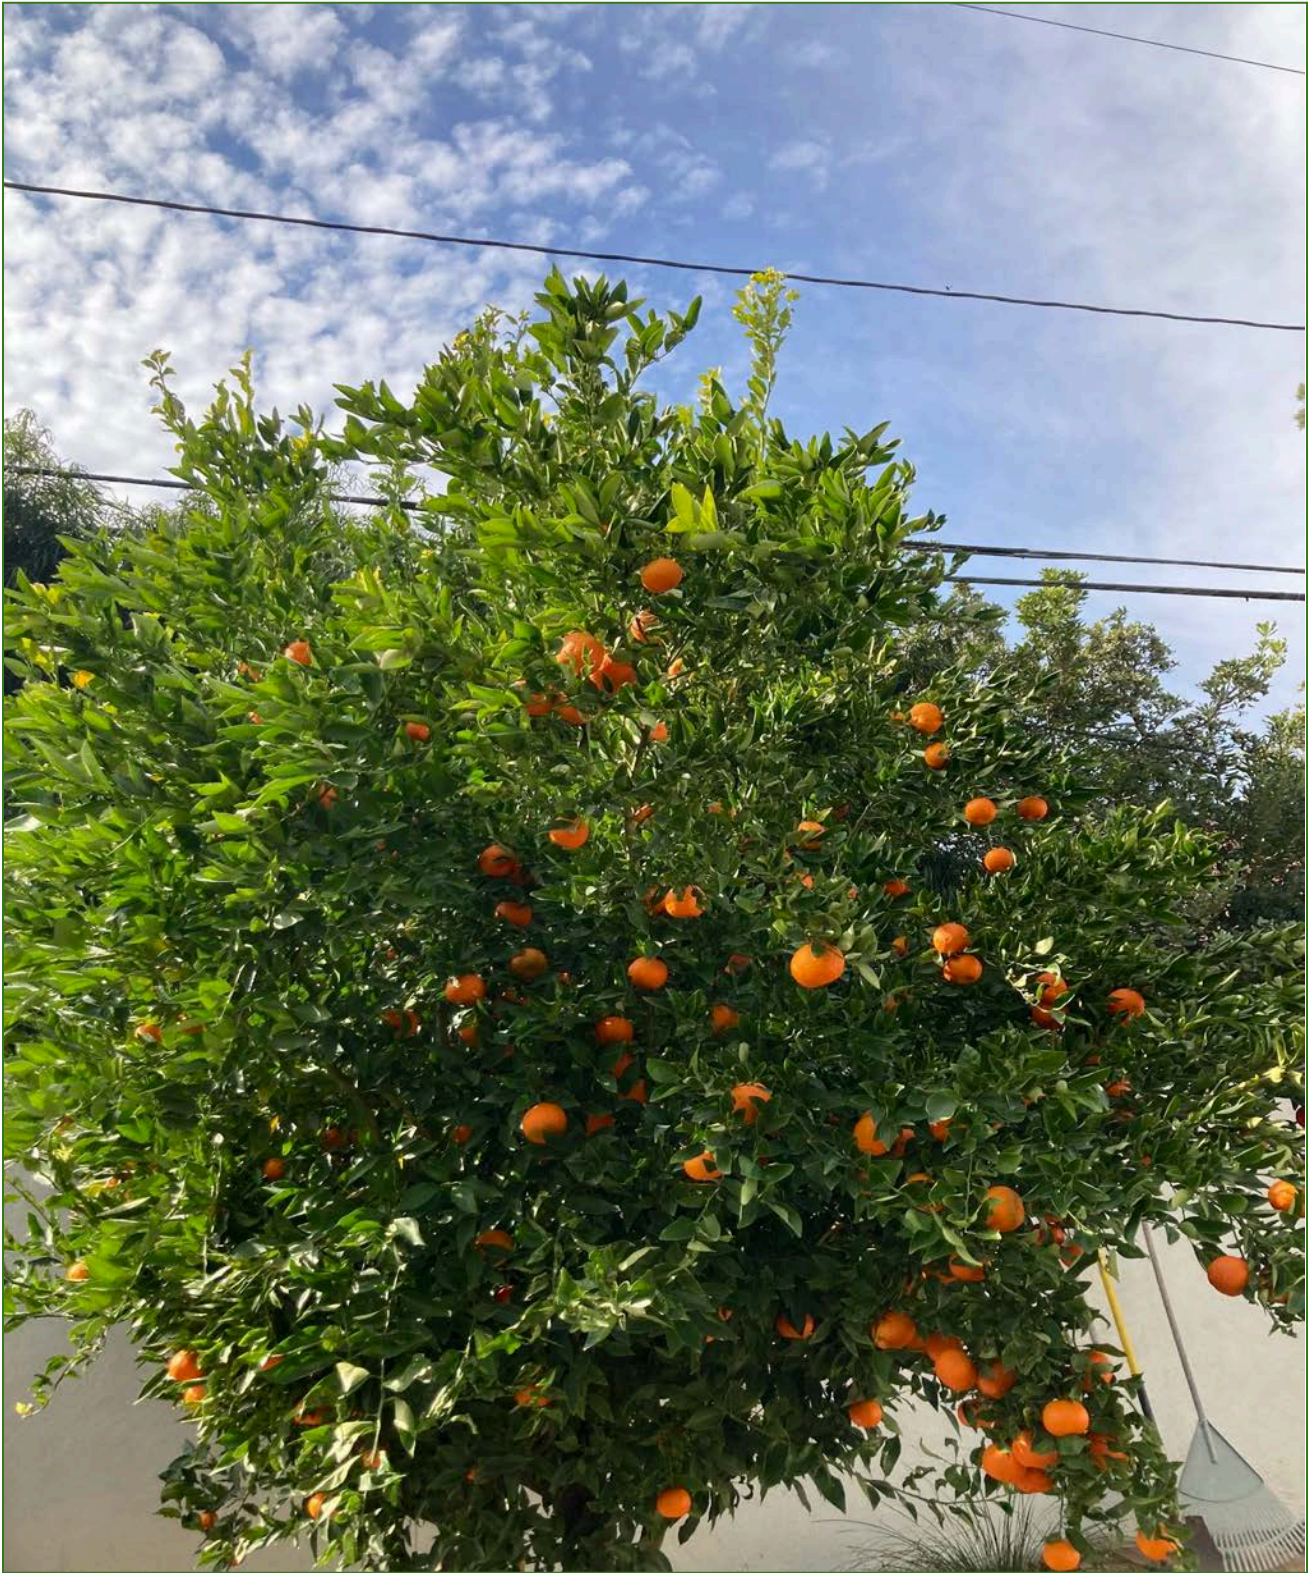
Image No. 6–Before Fire: Mandarin Orange (*Citrus reticulata*)
