Inspection Report

Property Address:
101 Sample Road
Summerville SC 29483

Cardinal Home Inspections, LLC

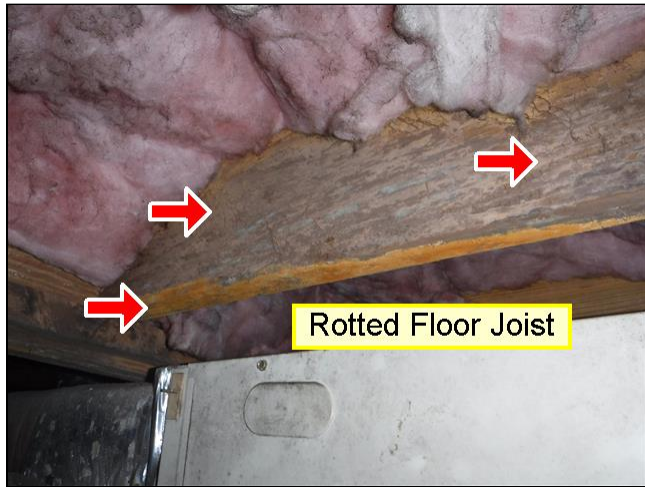
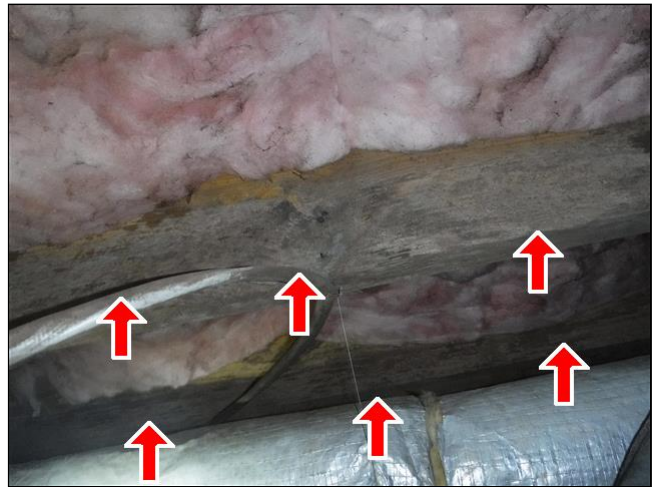
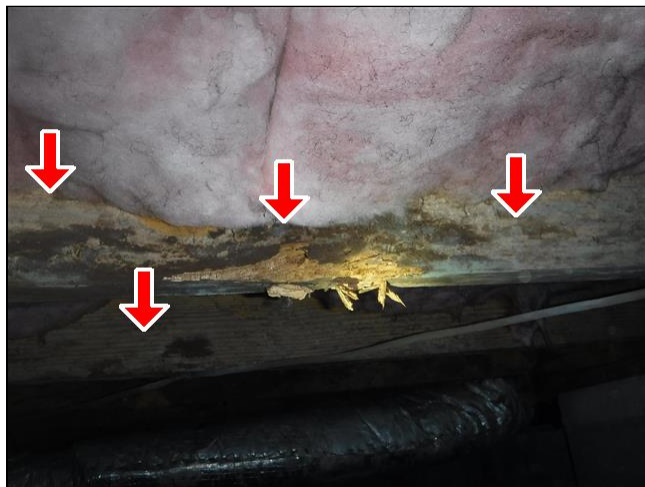
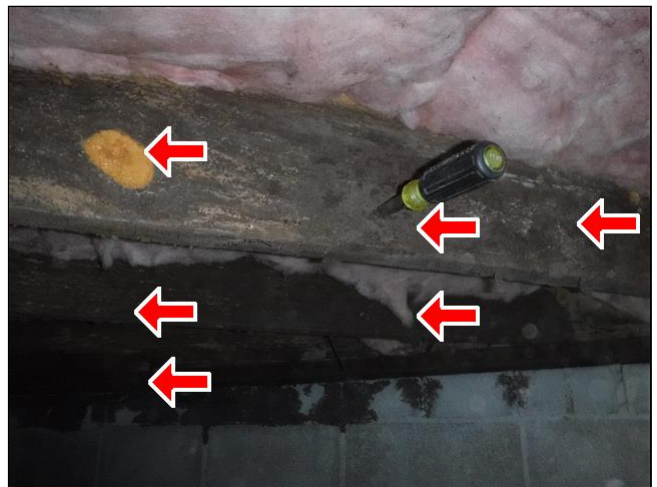
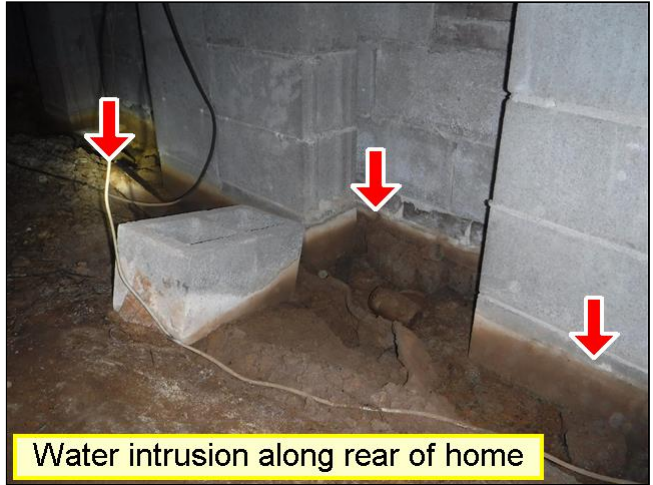
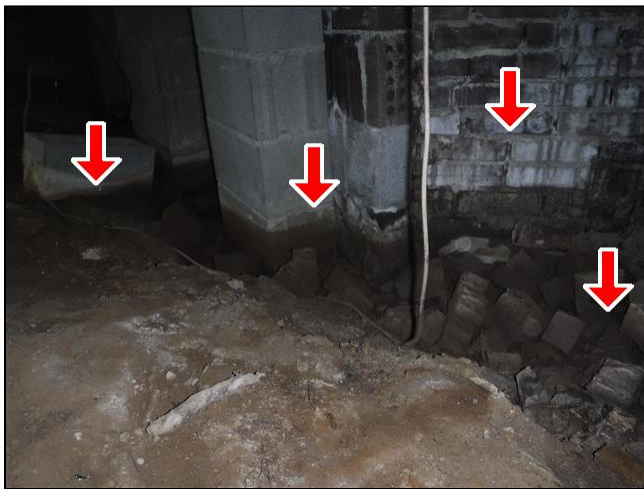
(1) The floor joist and structure are in poor condition below the sunken family room and kitchen areas. The air handler is located in the crawlspace and is pouring harmful condensation onto the ground under the home. There is also evidence that rain water runoff is entering the home along the rear. The floor structure needs replaced in areas and repaired in other areas under the sunken family room and kitchen. Recommend relocating the air handler to the attic or garage and recommend installing gutters on the home. These repairs combined are significant in cost and should be considered prior to purchase. Recommend contacting a general contractor for cost estimates.

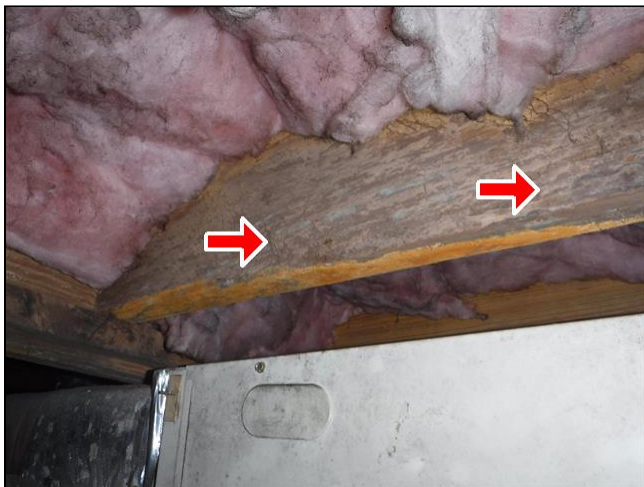
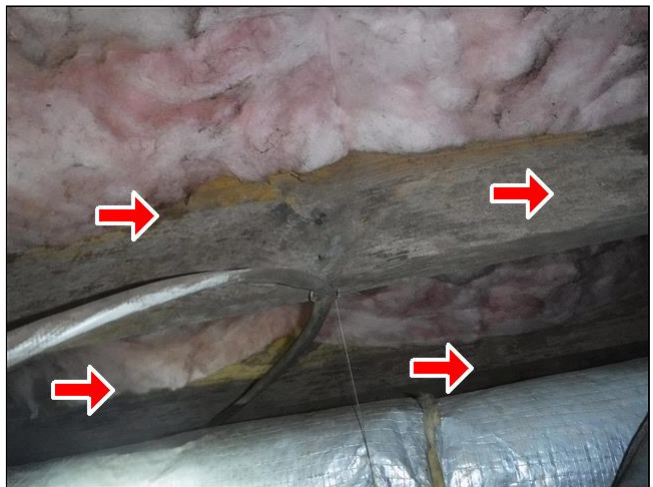
(2) Mold and fungus are present on the floor joist located in the crawlspace with wood moisture content reading at 29% in areas around the hvac unit. Recommend contacting a Mold Remediation company to remove mold from the crawlspace.

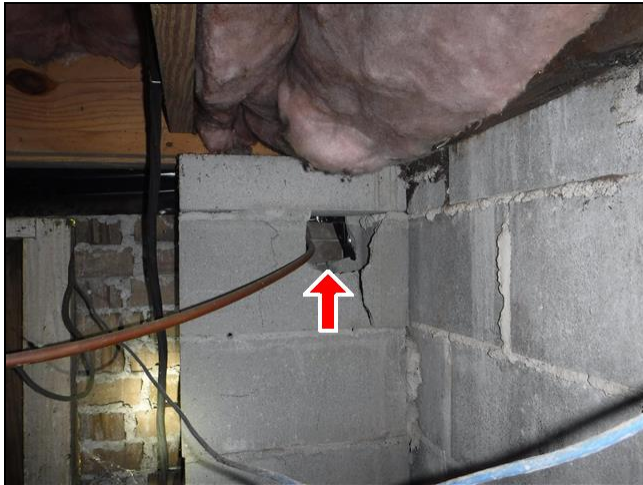
1.5 Item 1(Picture)

One masonry block column has been damaged/compromised near the rear crawlspace entrance and needs repair or replace.

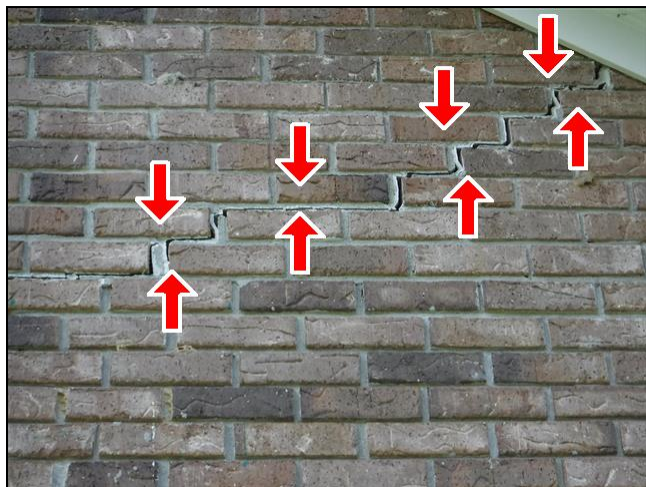
2.0 Item 1(Picture)

Brick veneer reveals a settlement crack at the front of the home above the right bedroom window. Recommend further investigation for repair.

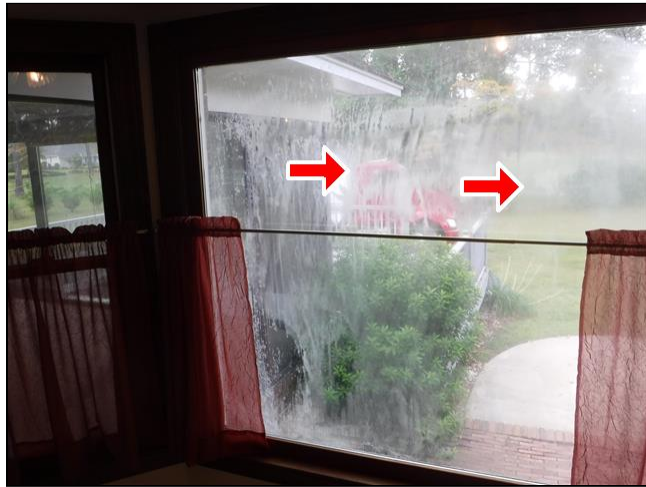
2.1 Item 1(Picture)

(1) Middle window at the dining area in the kitchen is cloudy due to lost seals and needs repair or replaced.

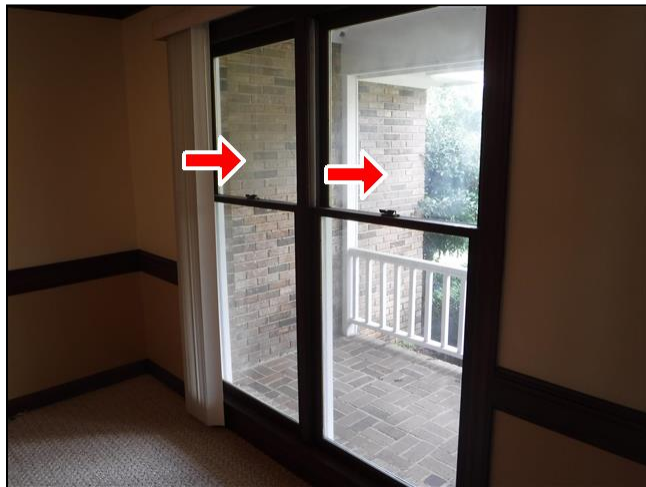
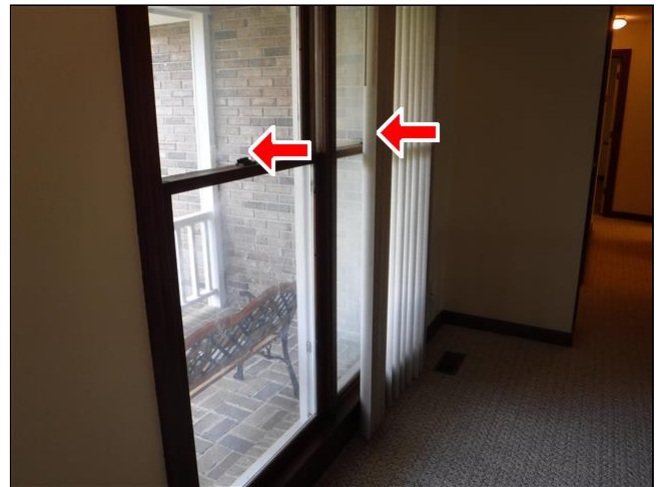
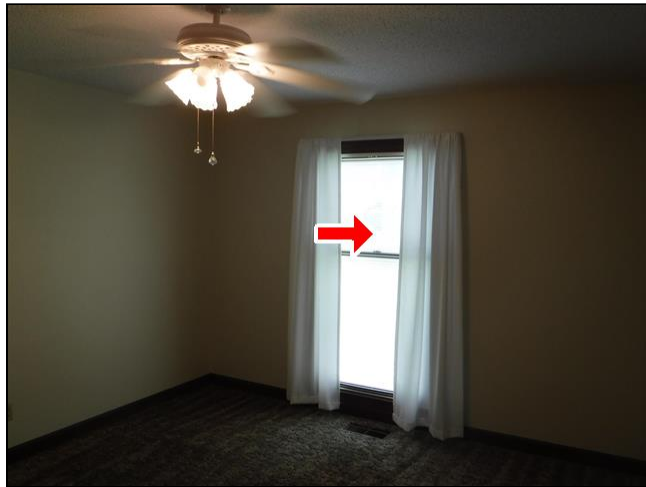
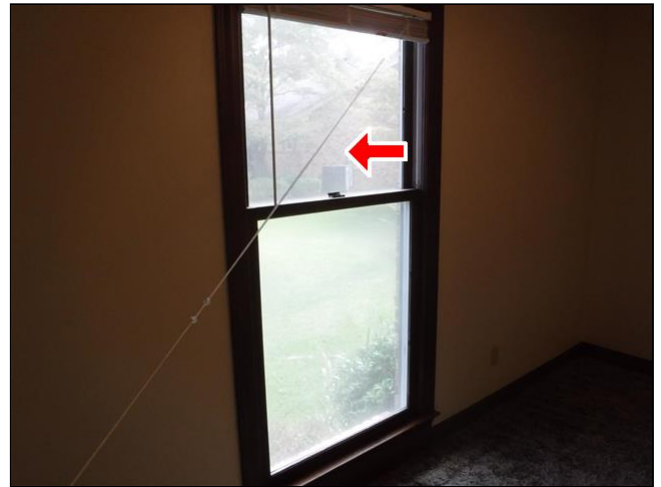
(2) Front windows located in the dining room, hallway, and both front bedrooms are beginning to show signs of cloudiness due to lost seals.

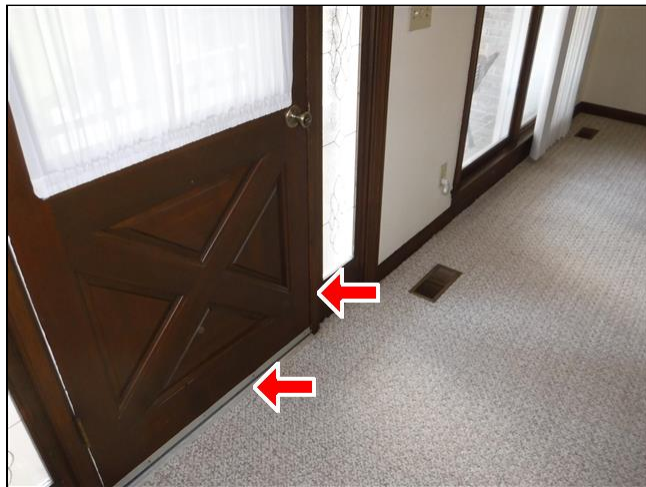
2.2 Item 1(Picture)

Front entry door rubs at the door jamb and threshold and is difficult to open.

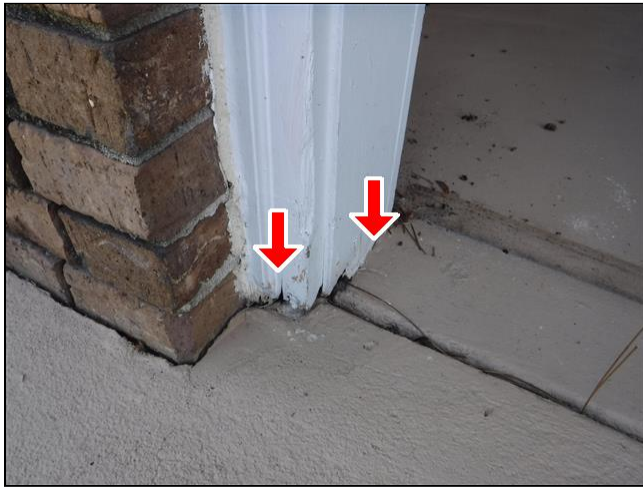
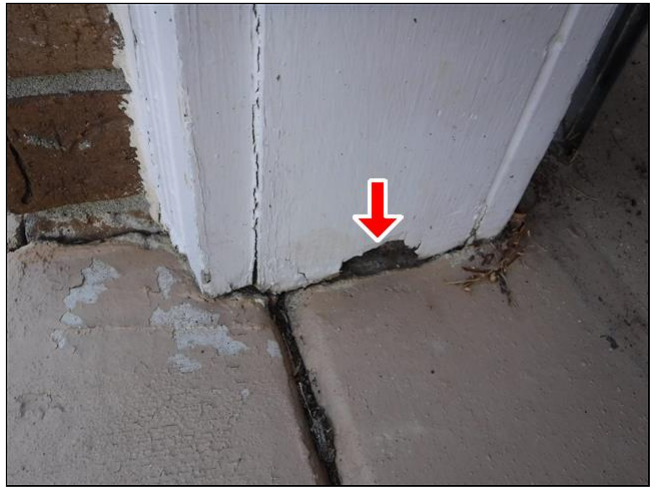
Wood casing at the garage doors reveals water damage where in contact with the ground and needs repair or replace.

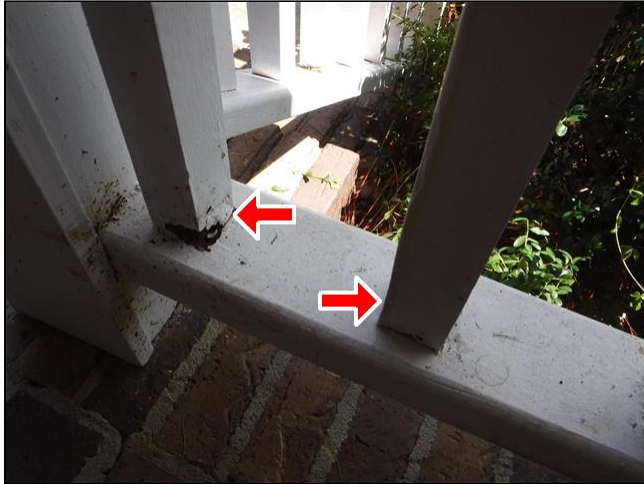
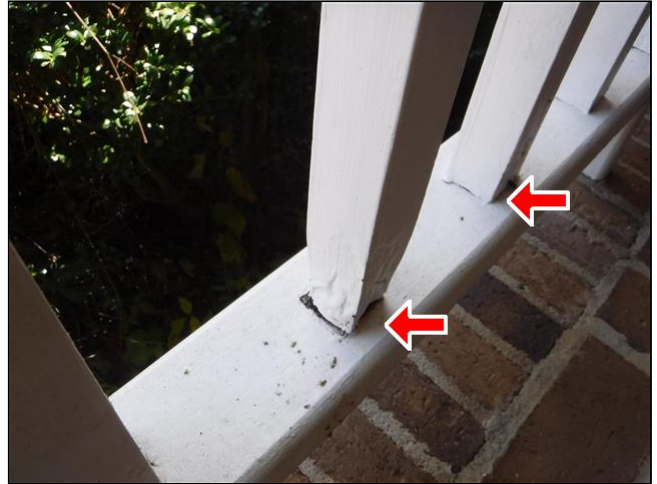
(1) Several pickets located at the front porch reveal water damage and need replaced.

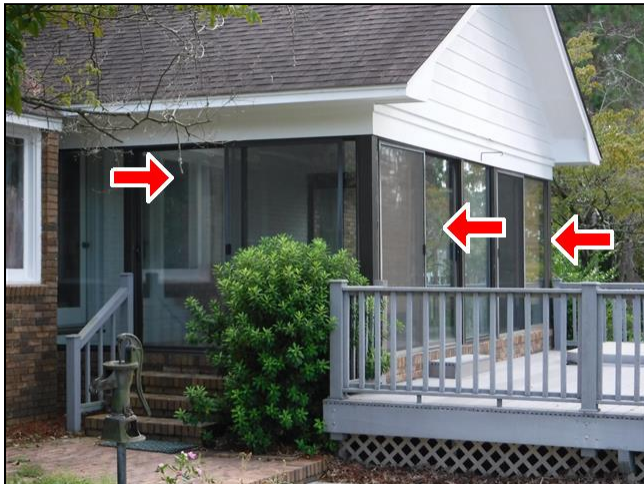
2.4 Item 4(Picture)

(2) Several glass panels on the rear sun room porch reveal cloudiness due to lost seals and need repair or replace.

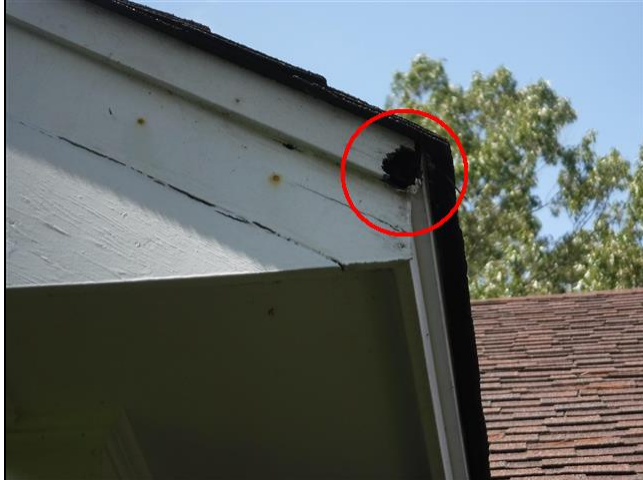
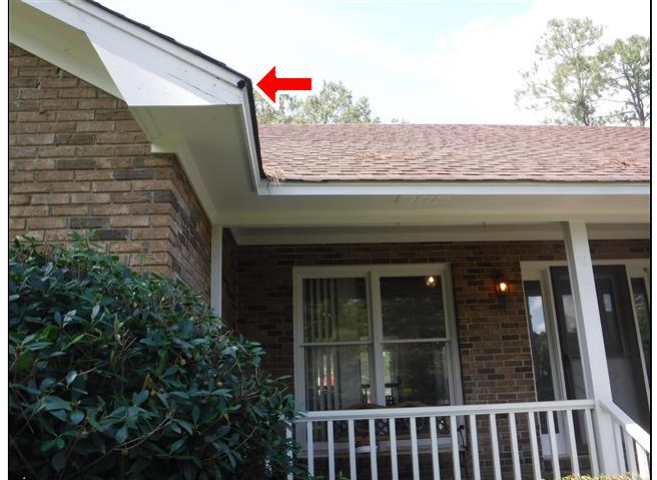
Fascia located at the front of the home above the right bedroom reveals critter damage and needs repair.

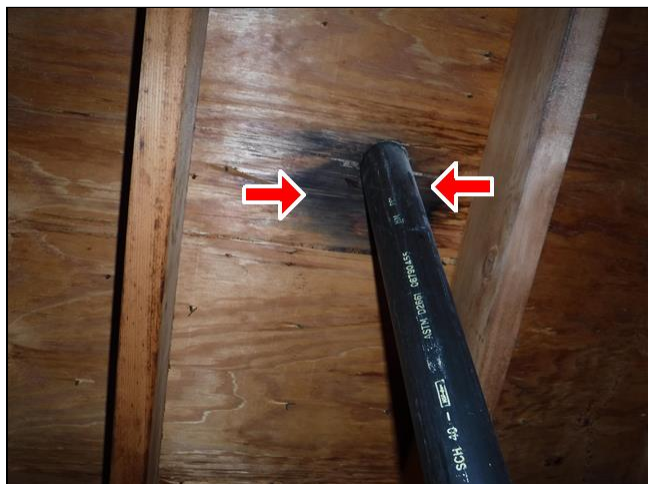
3.2 Item 1(Picture)

Plumbing vent pipes need caulking around perimeter of pipe and boot where boot flange has failed. These areas can leak if not corrected.

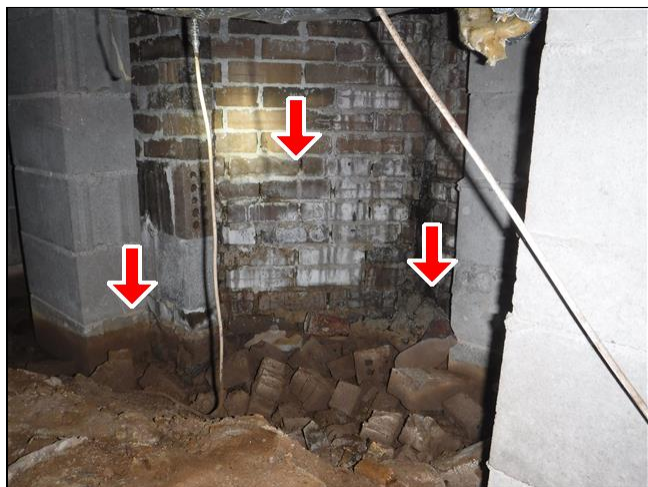
3.3 Item 1(Picture)

There is evidence of water intrusion in the crawlspace along the rear of the home and mineral deposits on the brick veneer the bay window. Recommend installing gutters and downspouts with diverters to keep water from entering the crawlspace.

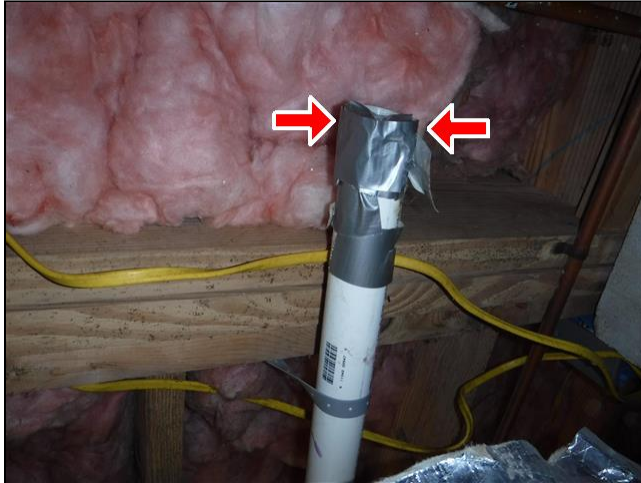
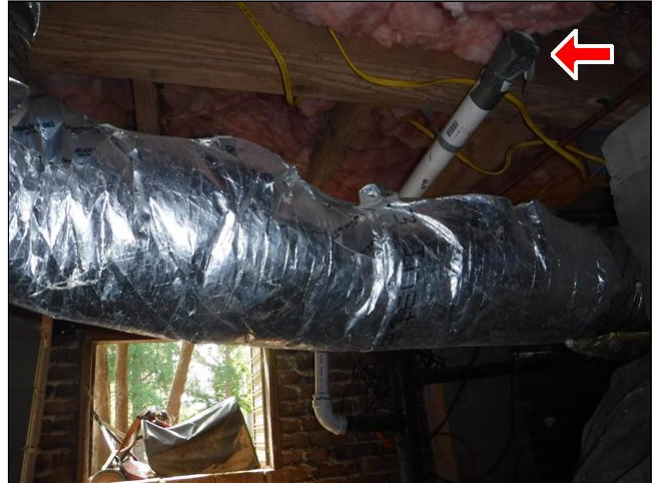
Drain pipe is missing either a studor vent or cap in the crawlspace below the master bathroom location (pipe is currently taped with duct tape).

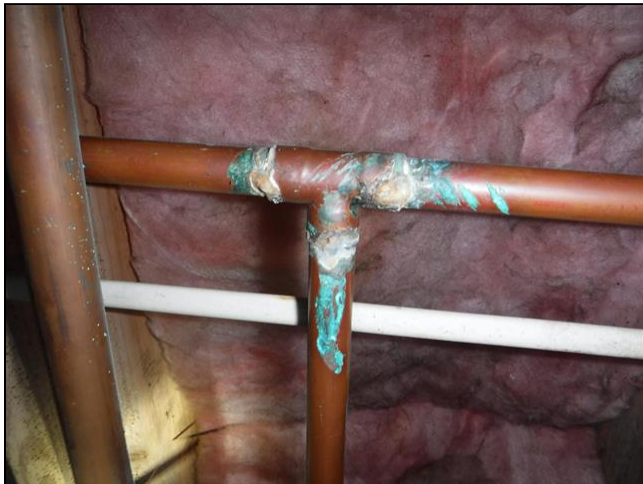
4.2 Item 1(Picture)

(1) Copper fittings located in the crawlspace are beginning to show signs of petina and should be monitored for potential pinhole leaks. No leaks were detected at time of inspection.

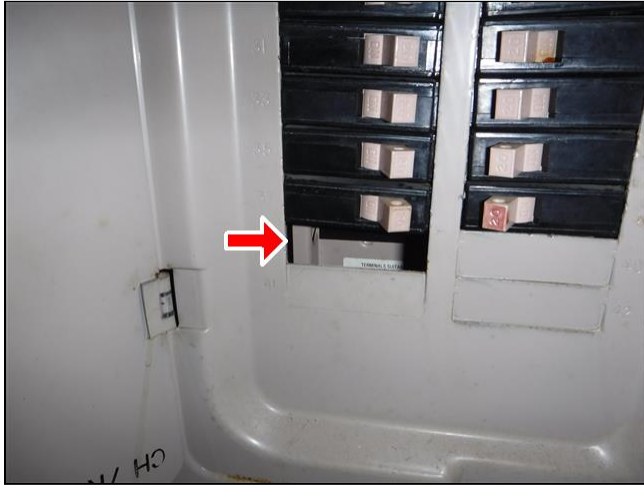
5.1 Item 1(Picture)

Main panel cover is missing a knockout exposing the buss bar. Recommend installing a blank panel or a spare breaker.

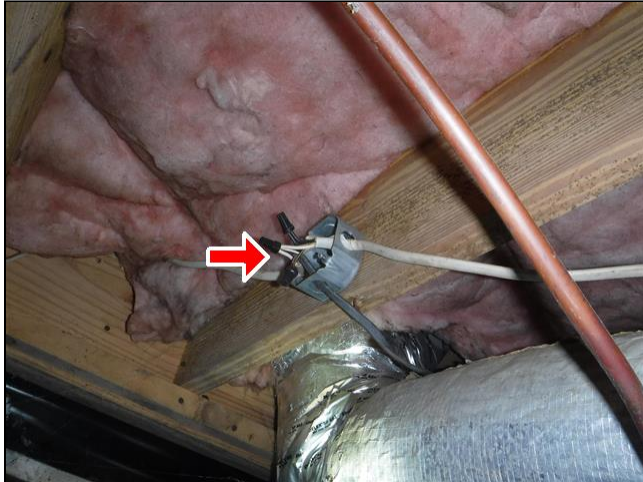
5.3 Item 3(Picture)

(2) One splice box located at the rear of the home near the crawlspace entrance is missing a coverplate.

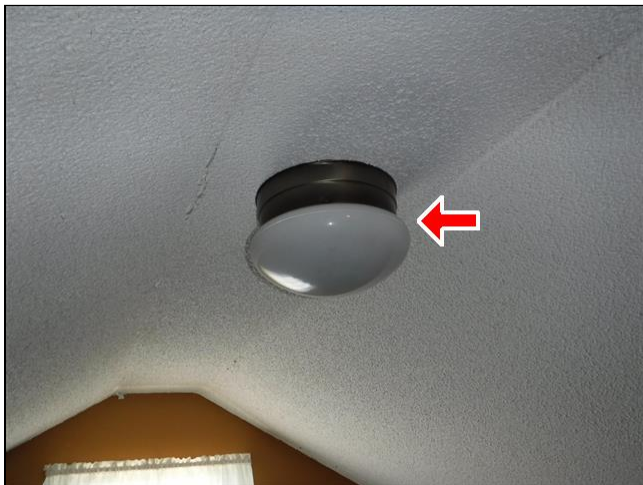
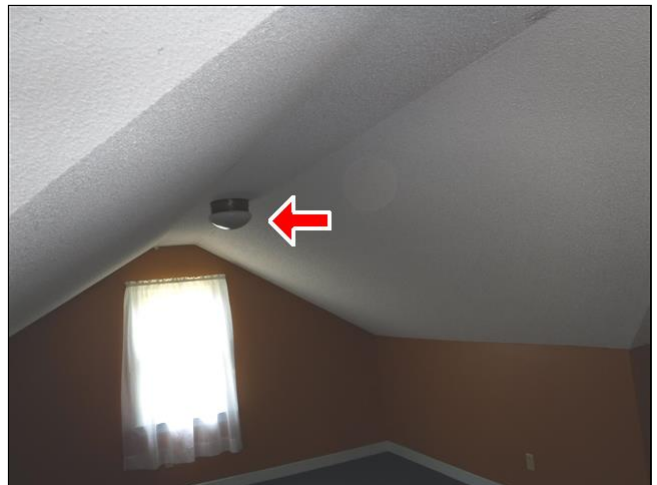
Ceiling light fixture located in the room above the garage needs bulbs replaced.

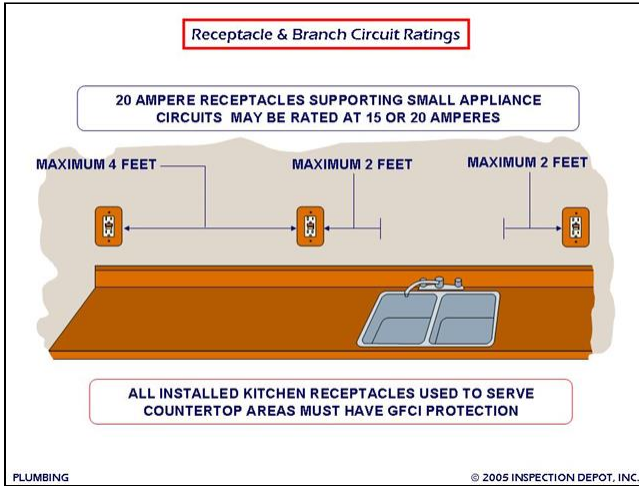
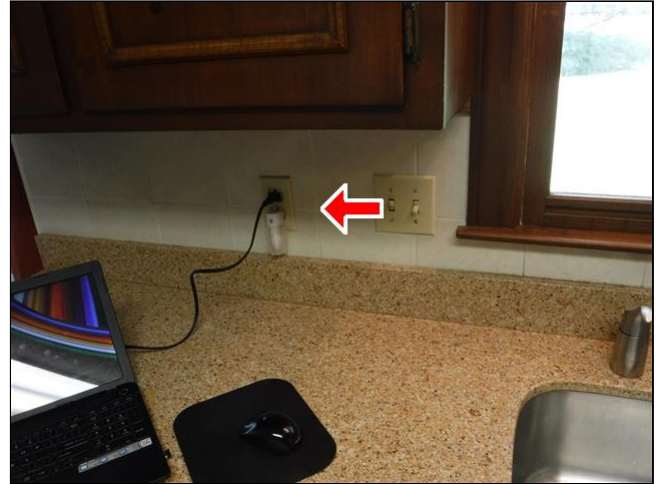
Recommend updating outlets located over all kitchen countertops to "GFCI" protected outlets.

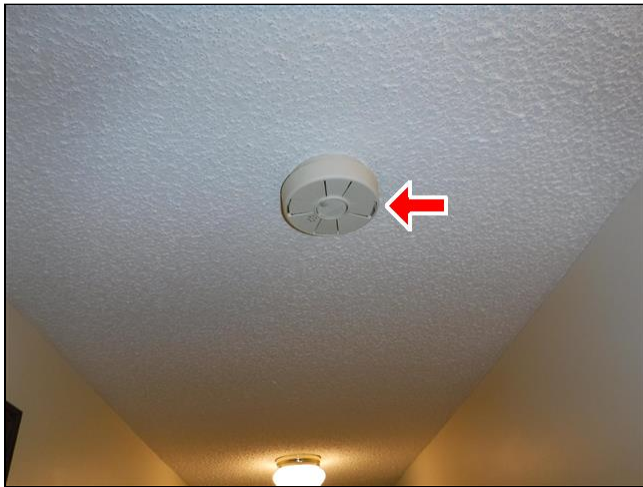
5.9 Item 1(Picture)

Smoke detectors did not work when tested. Recommend repair.

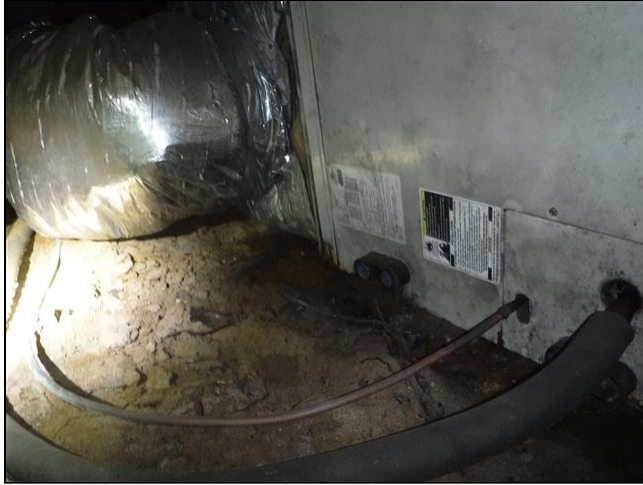
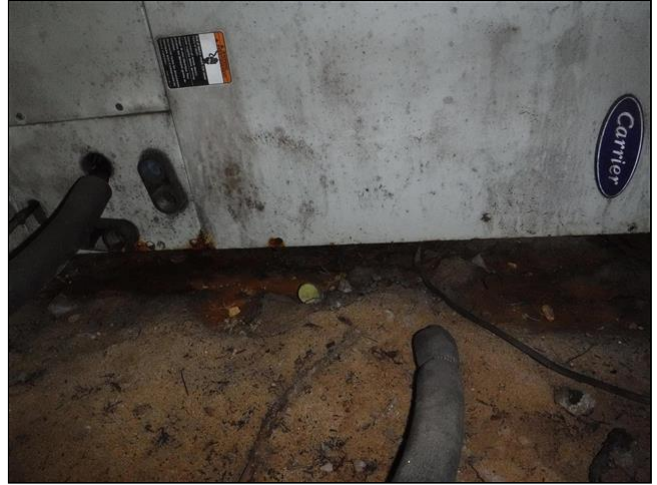
The air handler is in poor condition and is located in the crawlspace. The unit currently sits directly on the ground and is draining harmful condensation on the crawlspace ground. Recommend replace due to age and condition of the unit. When the unit is replaced I recommend that the unit be relocated to the attic or the garage to prevent further water damage to the structure of the home.

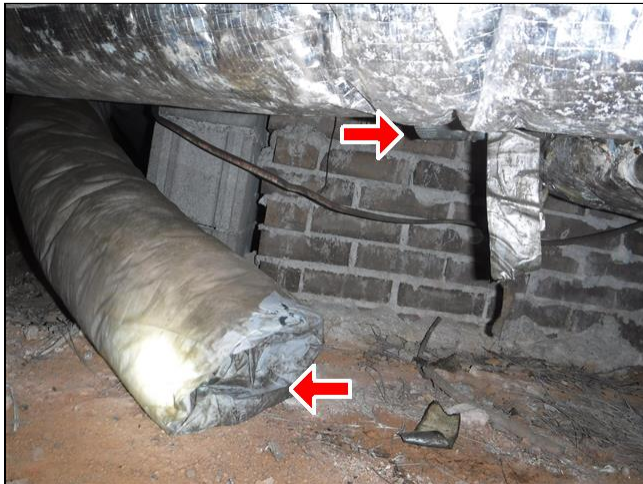
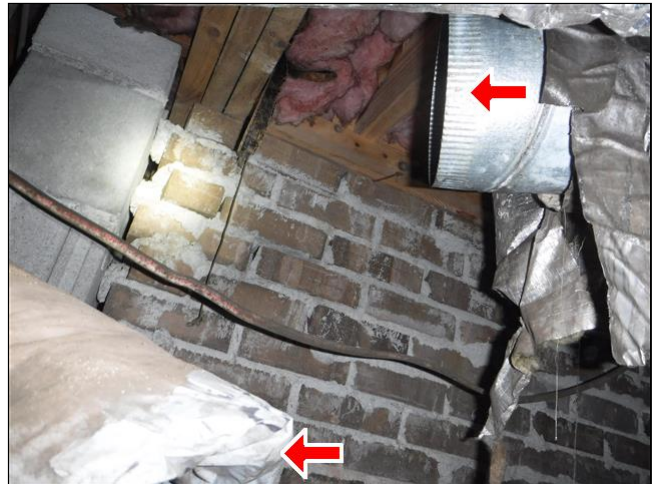
One duct hvac is disconnected in the crawlspace and needs repair.

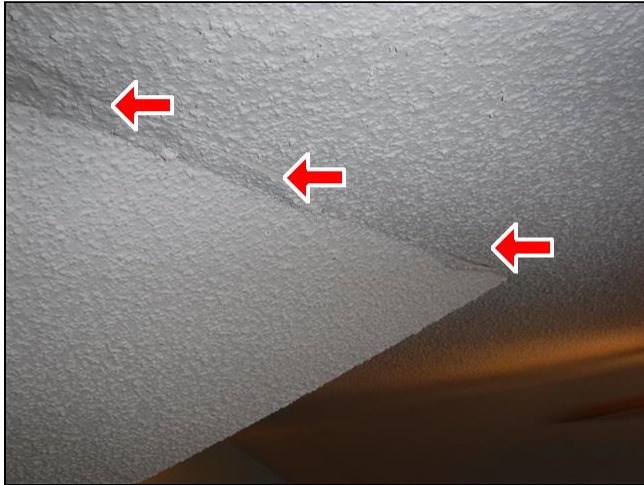
8.0 Item 1(Picture)

(1) Crack in tape joint at the ceiling located in the room above the garage is caused by shrinkage. Tape joint will not flex the same as the wood substrate and minor expansion and contraction will cause cosmetic cracks. (for your info)

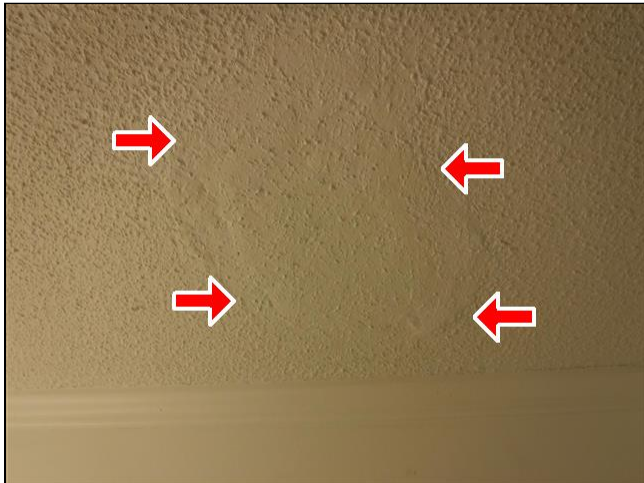
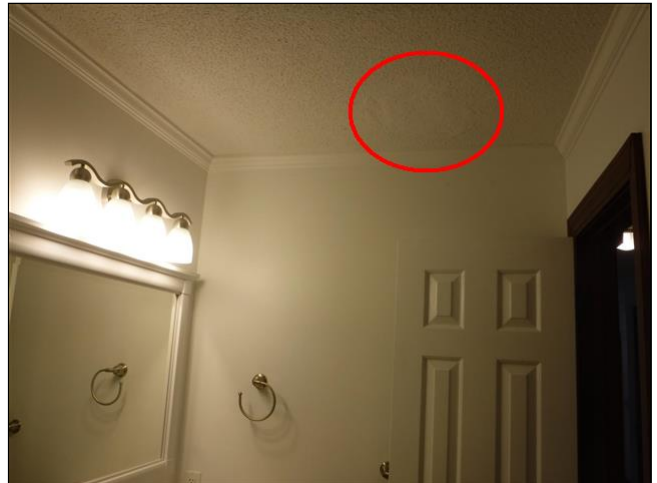
(2) Texture on ceiling shows signs of repair (cosmetic) at the Hall Bath.

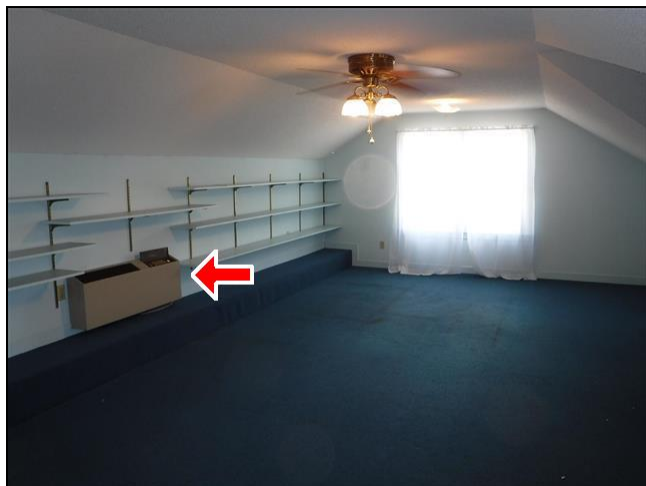
9.1 Item 1(Picture)

The hvac wall unit located at the room above the garage currently exhausts into the attic. Excessive heat and moisture can build in the attic when installed improperly. Recommend installing a drain pan under the unit (attic side) and a thermostatically controlled vent fan above the unit (attic side).

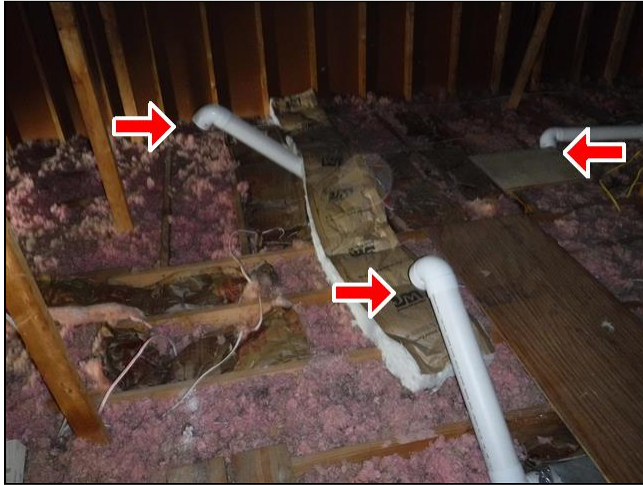
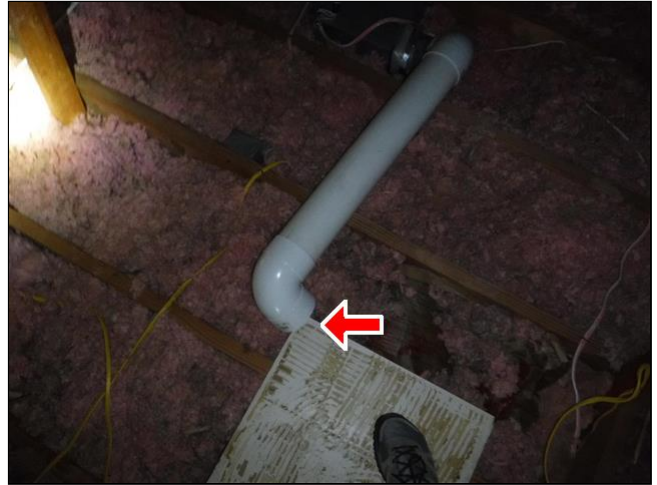
The bathrooms vents currently exhaust directly into the attic. Recommend the duct be extended to the roof vent for proper ventilation.
