Inspection Report

Sample Report

Property Address:
Sample Drive
Summerville SC 29486

Date: 5/19/2021	Time: 10:00:00 AM	Report ID: 202105102
Property: Sample Drive Summerville SC 29486	Customer: Sample Report	Real Estate Professional:

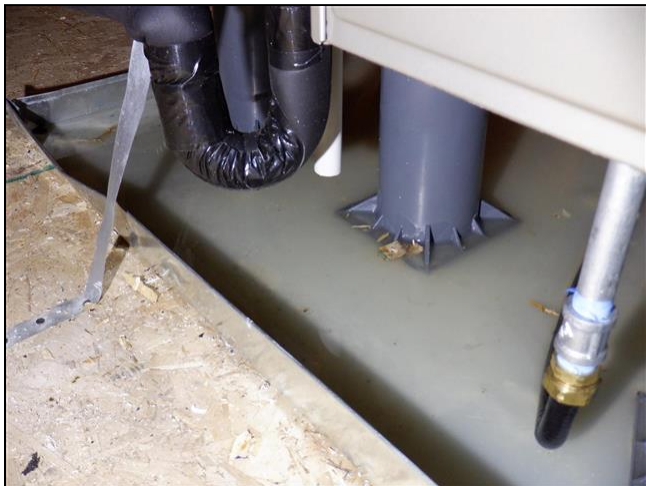
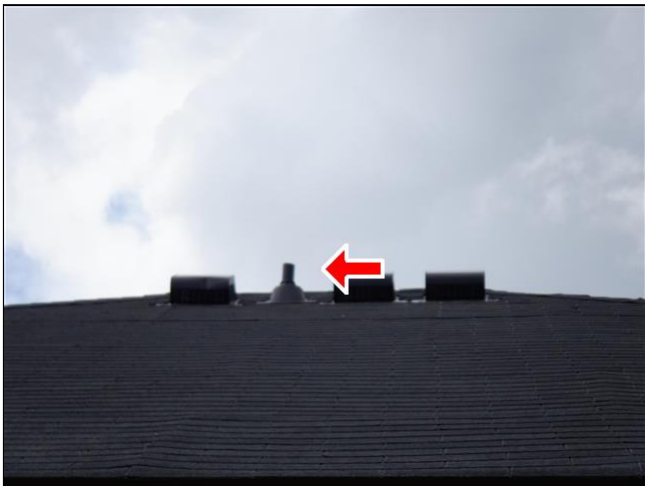
(1) Drain pan in the attic is full of water . This could be from a roof leak or hvac furnace vent missing top of the vent. Recommend further evaluation.

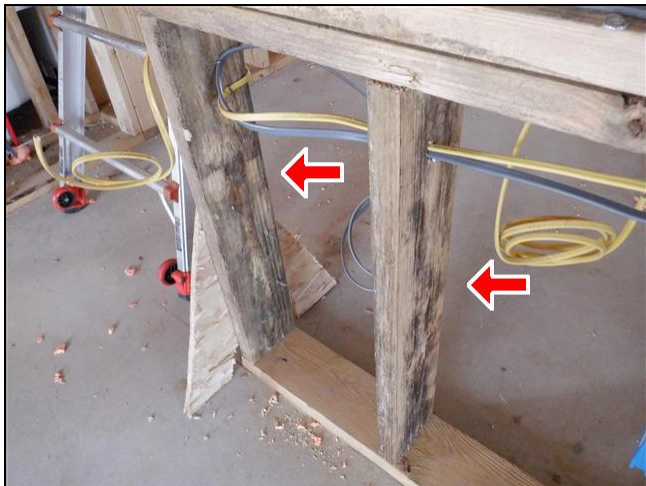
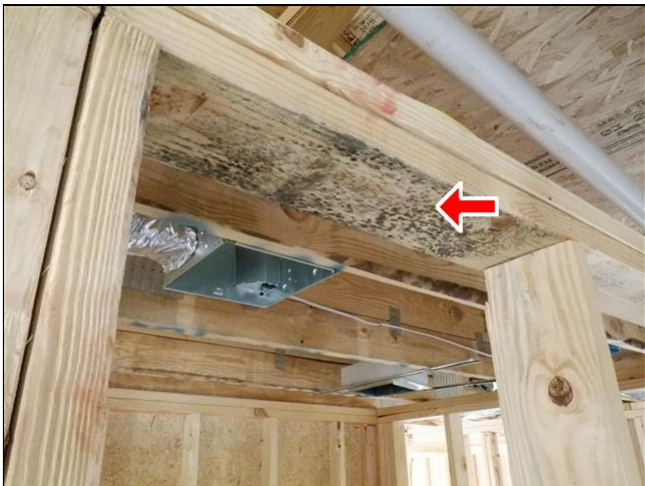
(2) There are signs of mold on the the framing members in the kitchen . Recommend treating with a mold sanitizing inhibitor such a Sporicidin.

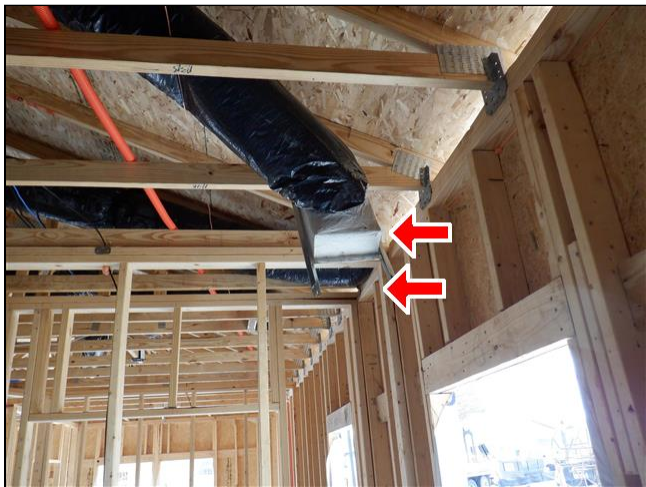
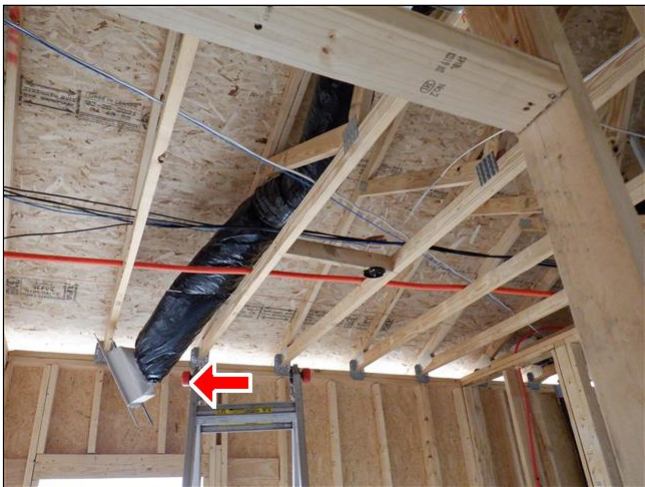
(3) Several of the supply ducts are hanging loose.

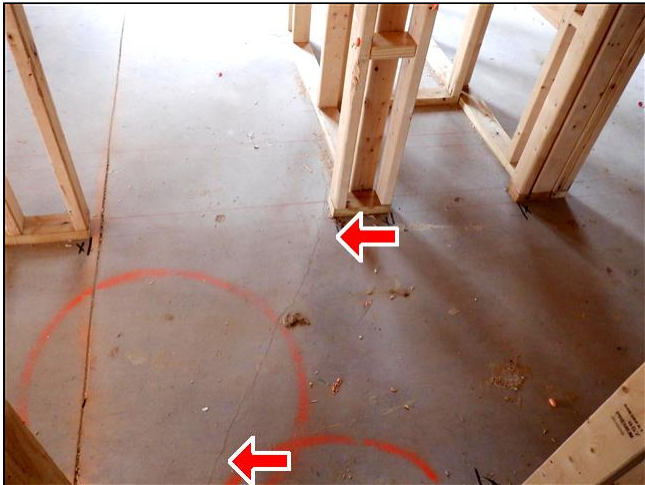
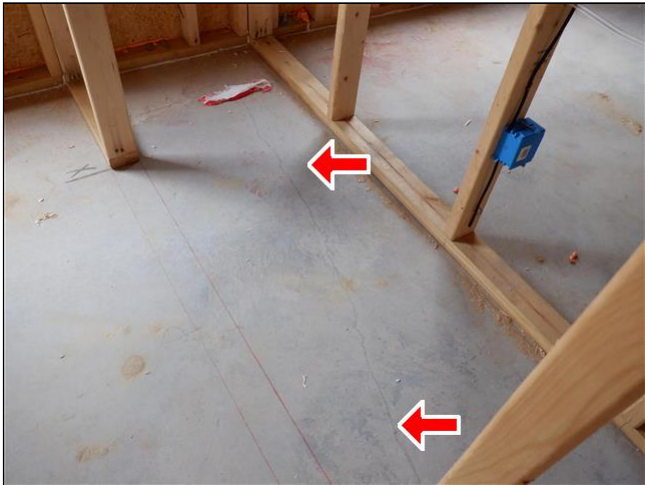
Concrete slab and a typical shrinkage crack on the left side of the home., (FYI)

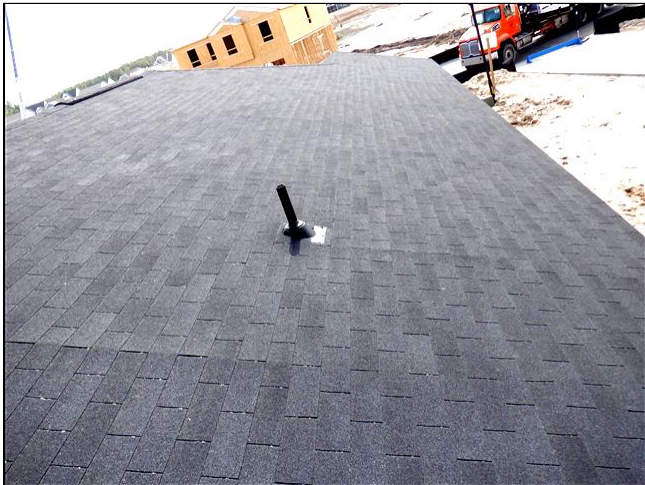
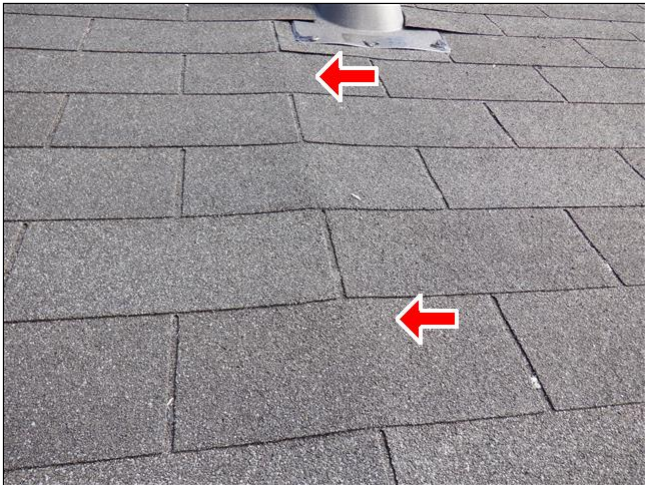
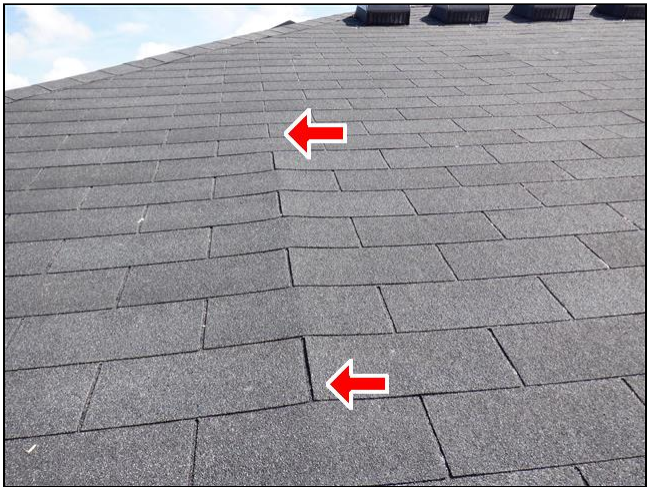
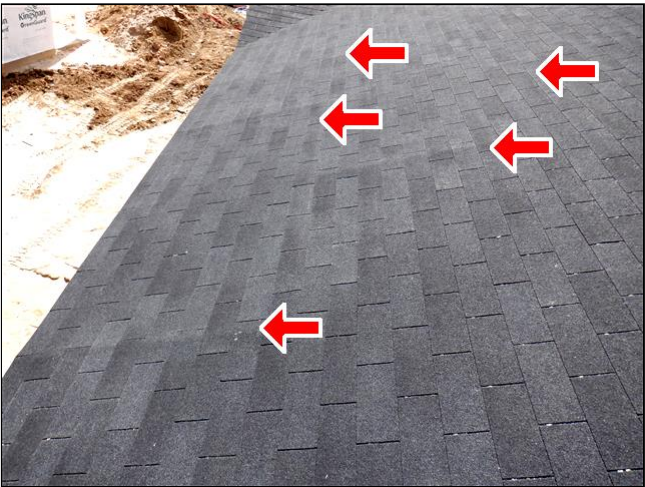
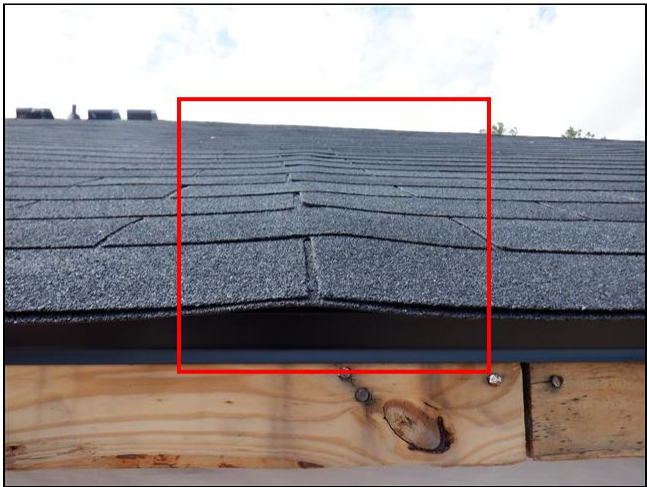
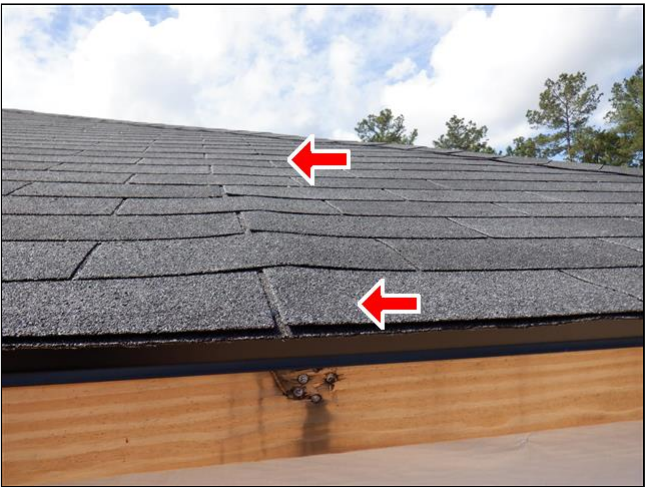
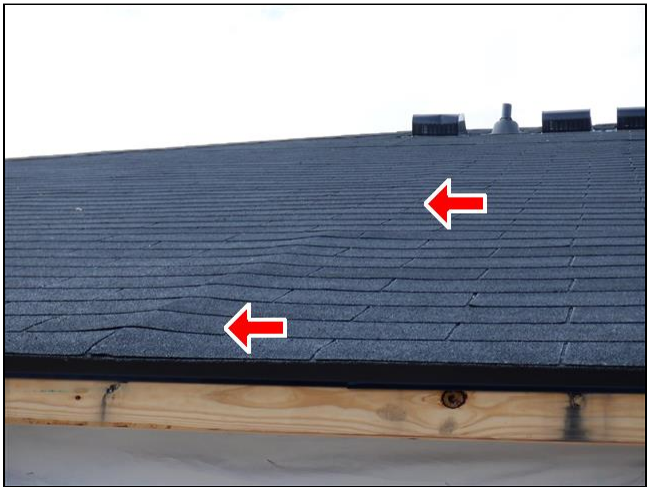
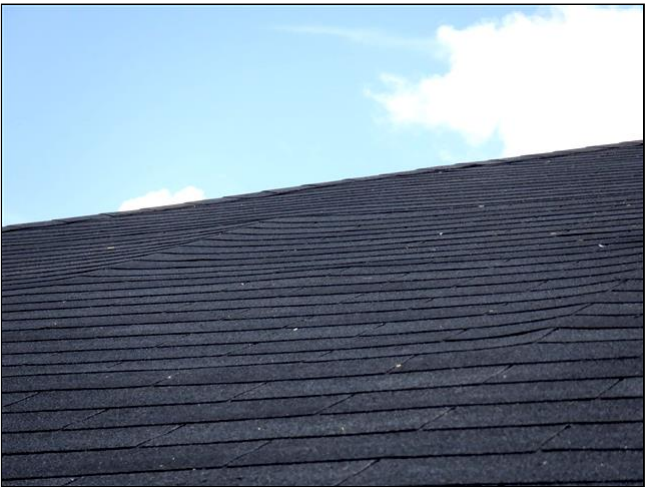
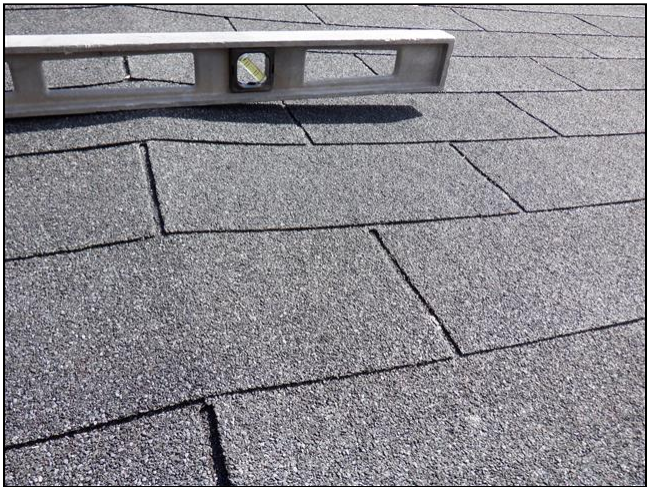
(1) Roof structure is uneven through out most of the roof structure . Recommend further evaluation and repair.

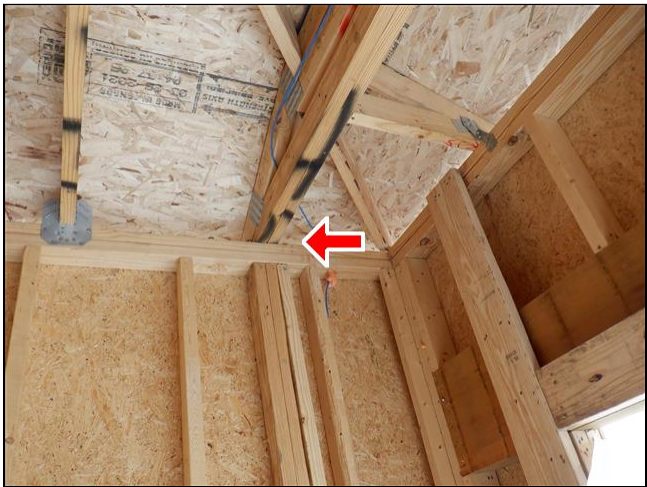
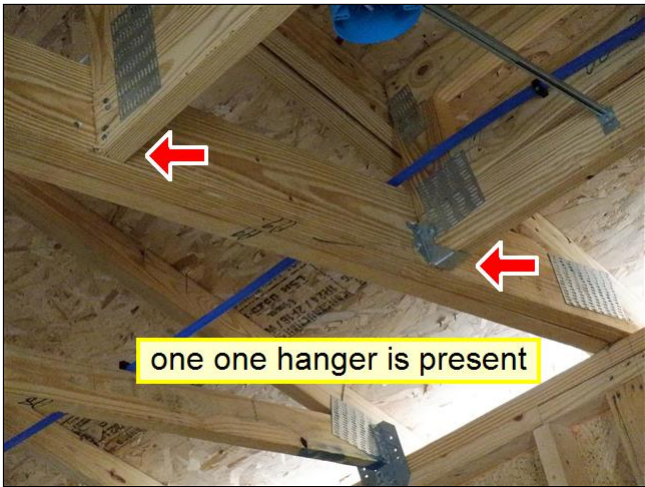
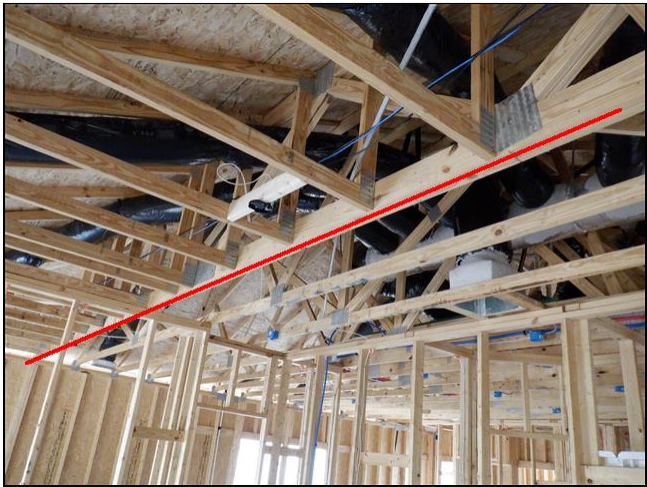
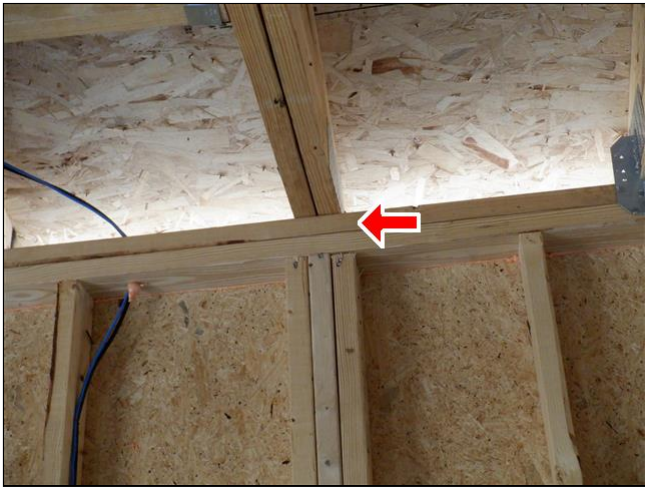
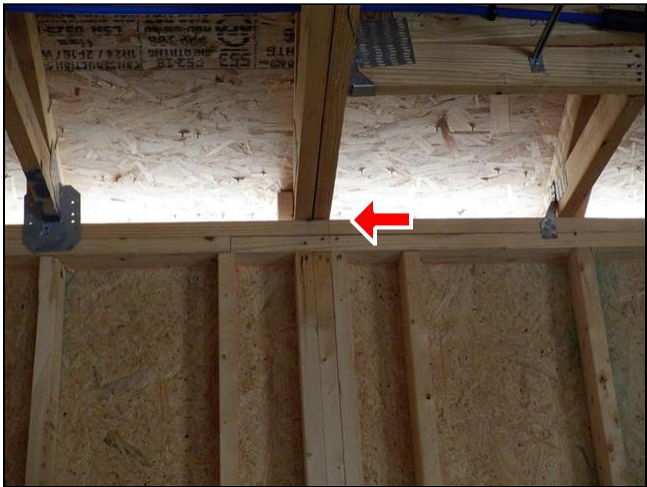
(2) Strapping is missing at several areas.

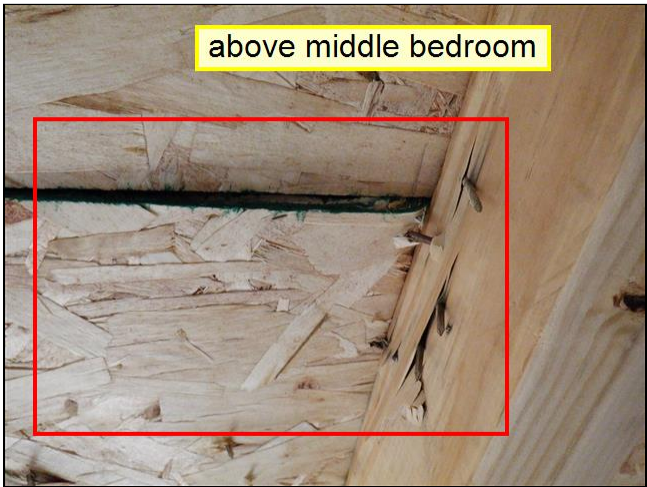
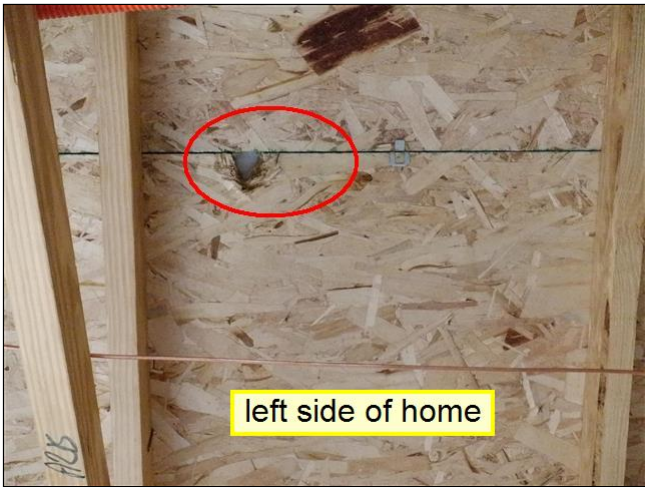
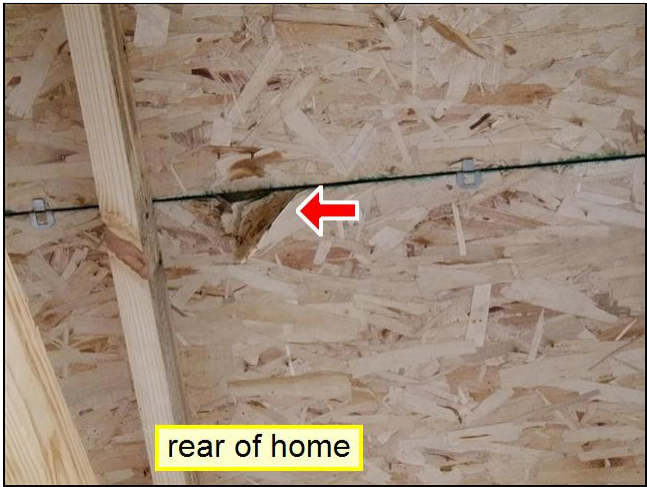
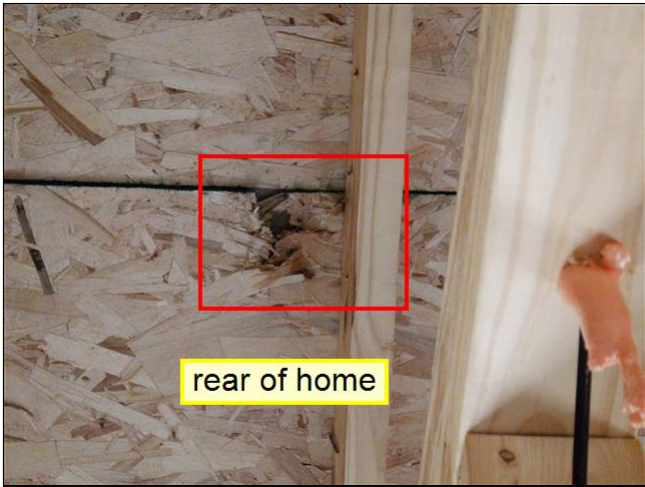
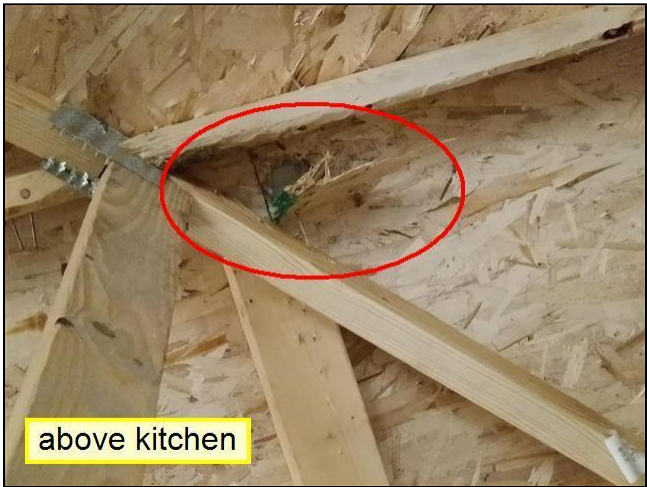
(3) Roof sheathing is damaged or has holes in several areas throughout the roof. Repair is needed.

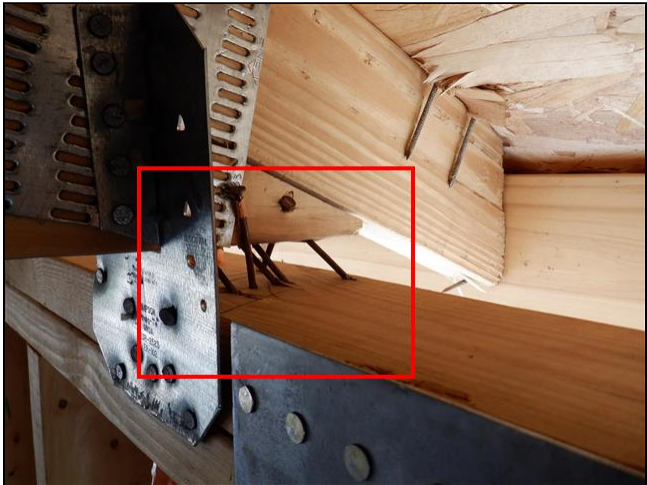
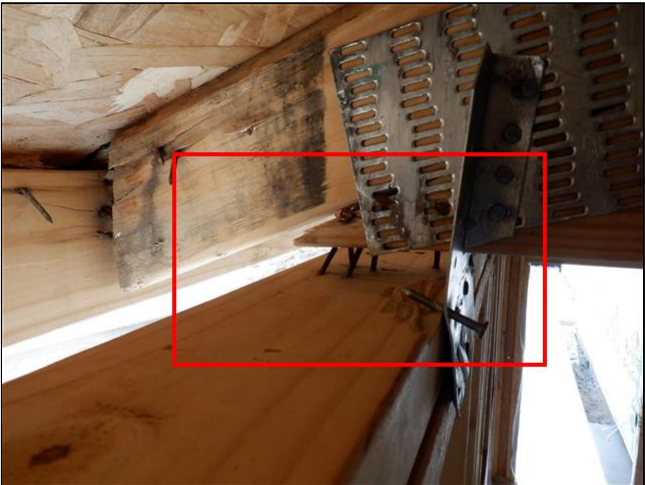
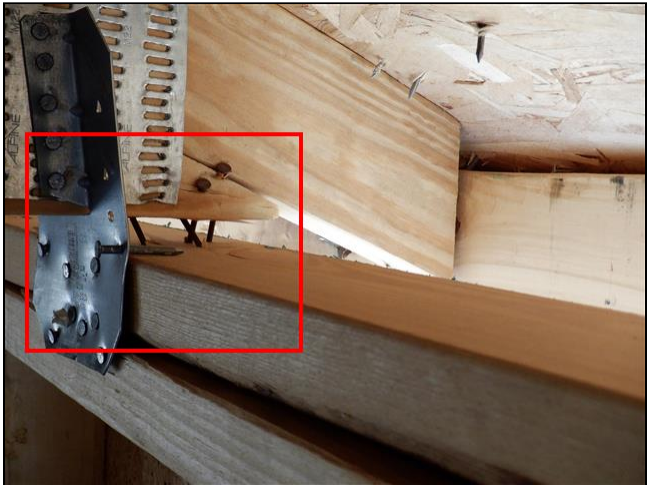
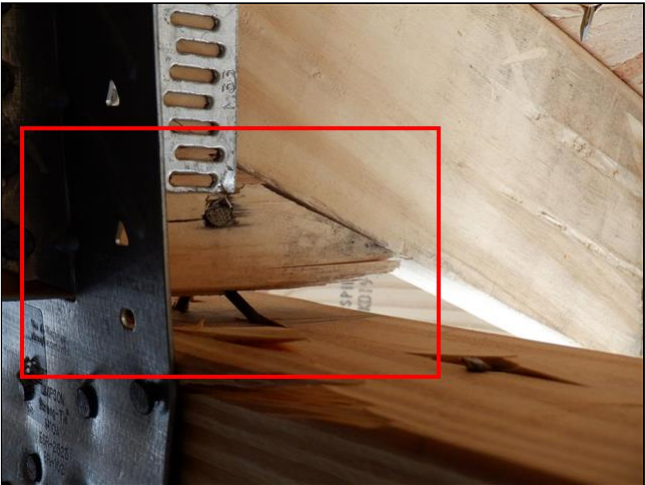
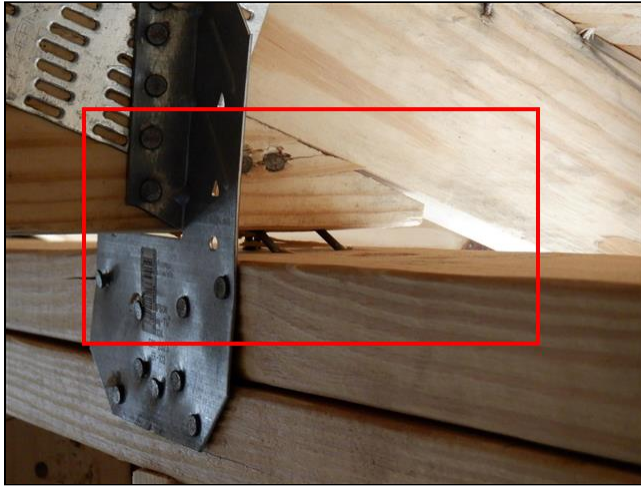
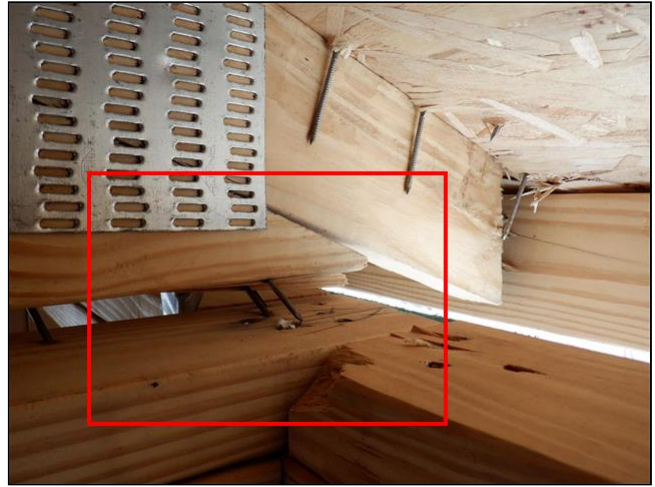
(4) Trusses are not supported by the sill plate at several areas on the left and right side of the home. Repair is needed.

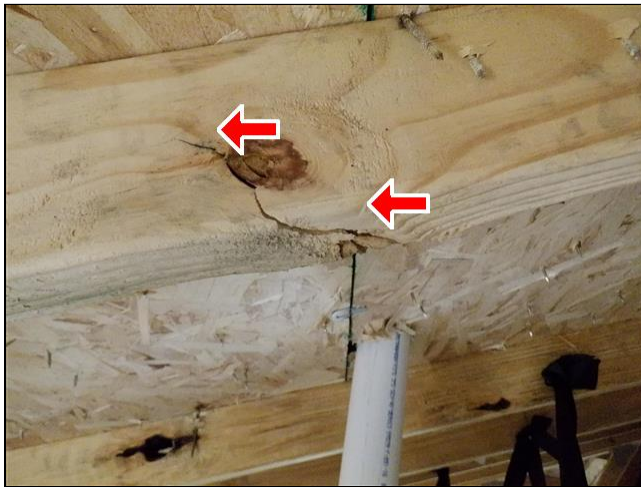
2.5 Item 26(Picture)

(5) There is a cracked truss above the middle bedroom / master closet areas

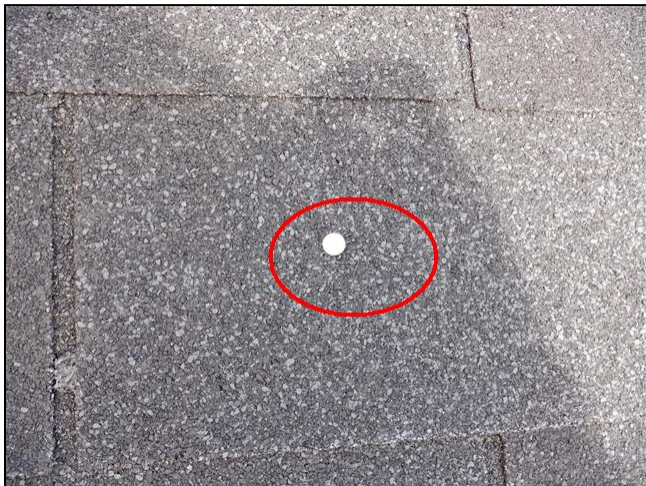
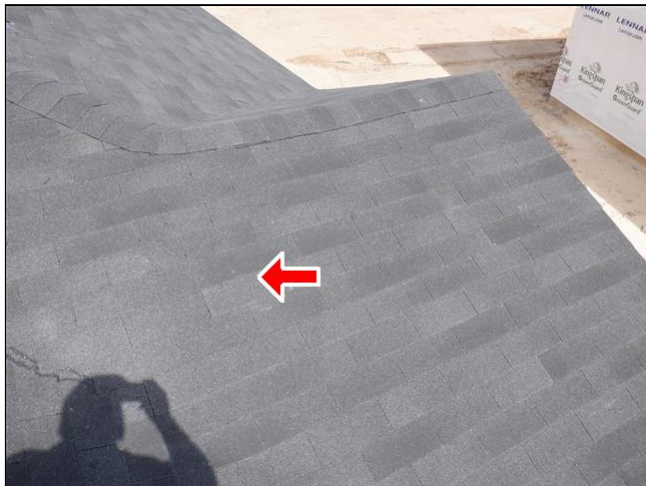
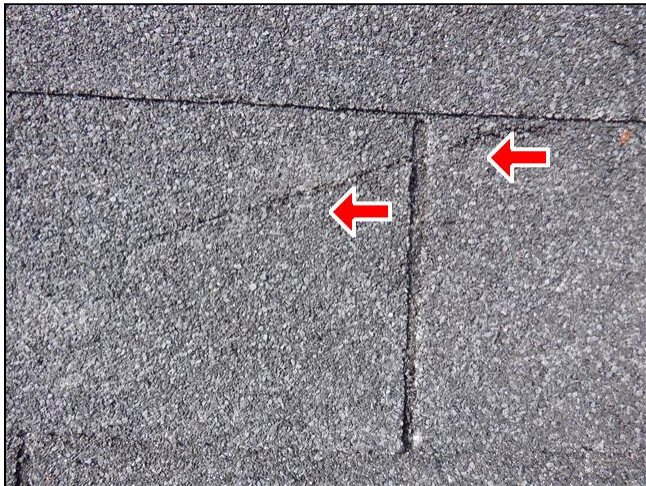
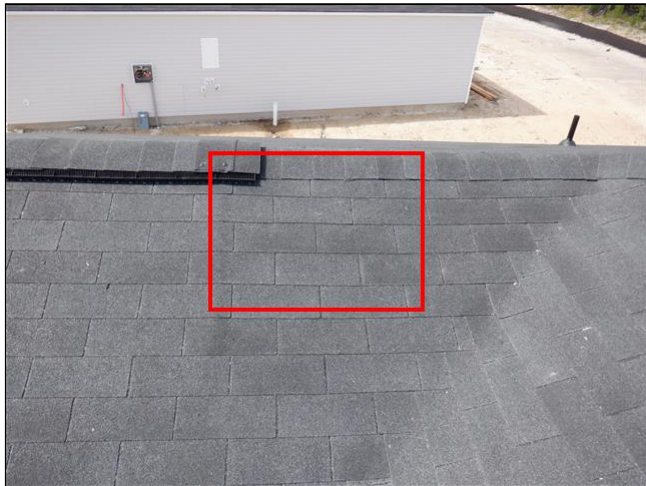
There is a nail that has been nailed through a shingle on the right side of the home. One shingle is cut at the ridge . Repair is needed.

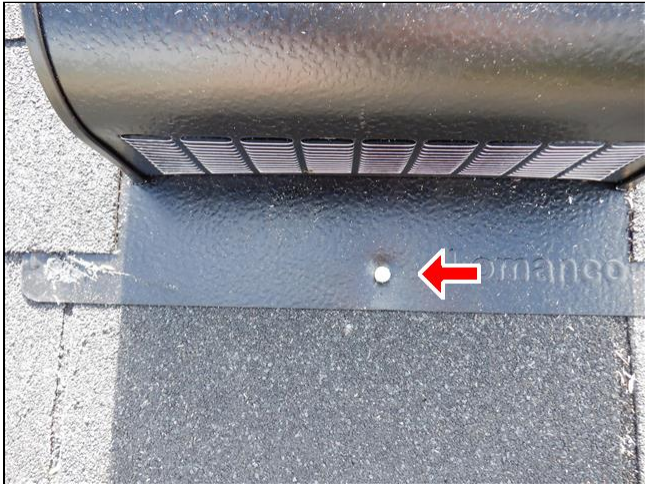
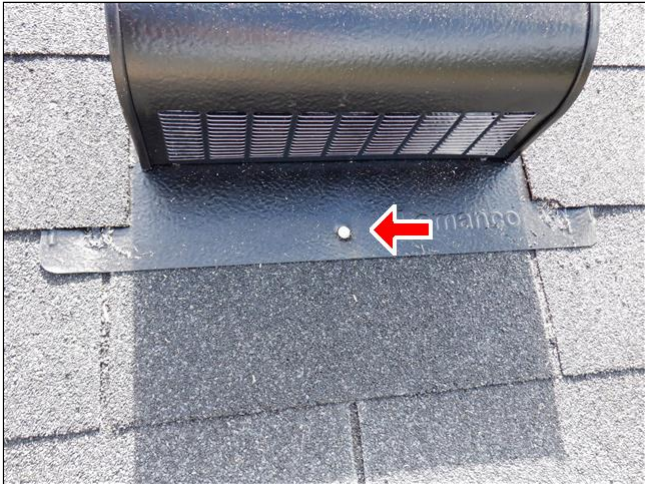
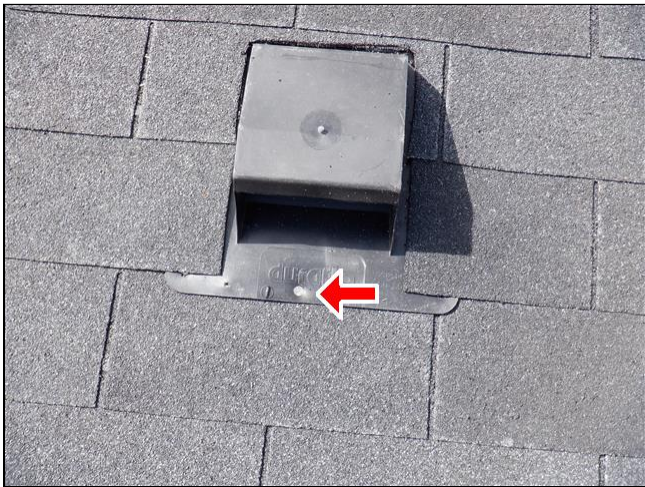
Several of the vent flashings have exposed nail heads that need to be sealed.
