13-IAGT-XXX (REFERENCE PROGRAM)

AIRFOIL THICKNESS AS A LIFE LIMITING FACTOR OF GAS TURBINE BLADES

Kevin Wiens, P.Eng.*†

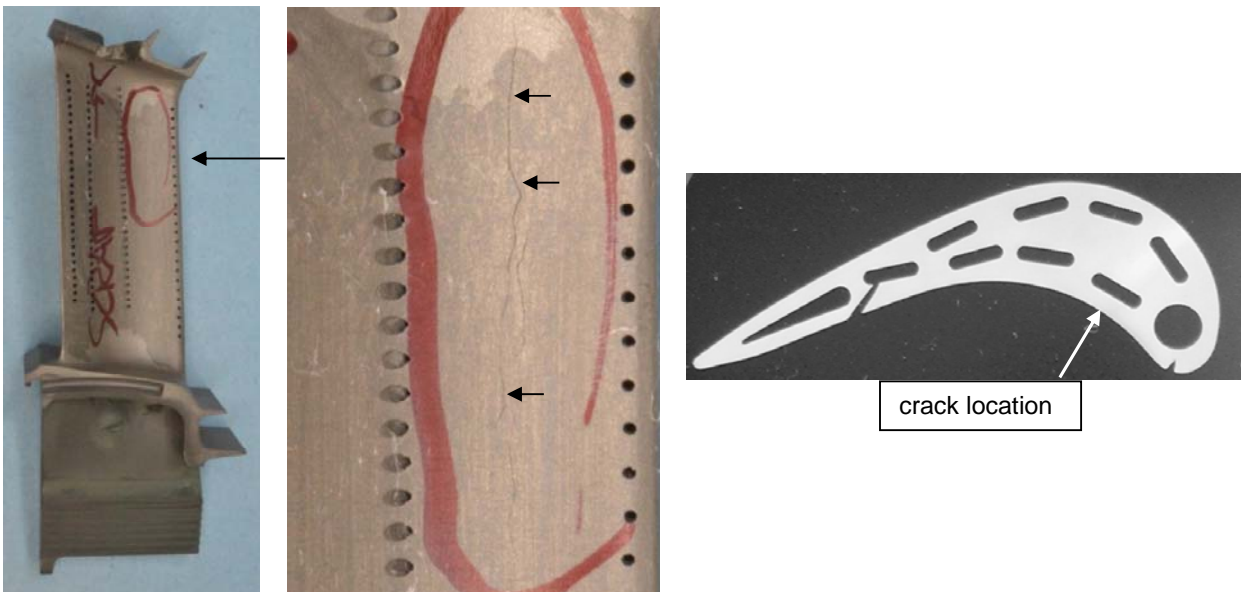
Figure 4 shows an aero derivative turbine blade which developed cracks in service through a thin region of the airfoil, in some cases leading to an airfoil breach. The cracks were prevalent in a population of blades exhibiting relatively thin airfoil walls. Four blades were found to be cracked in the set of 102 blades. Three of the four cracks were through the thinnest walls in the blade set. The fourth crack was in the lower quintile of the wall thickness distribution.

The cracks were oriented radially (parallel to the cooling passage) suggesting thermal stresses were prominent in their formation; had the centrifugal load been dominant, the cracks would be expected to occur in the axial (perpendicular to cooling passage) direction.

Figure 4. Radial cracking (right image) from a set of aero-derivative turbine blades.

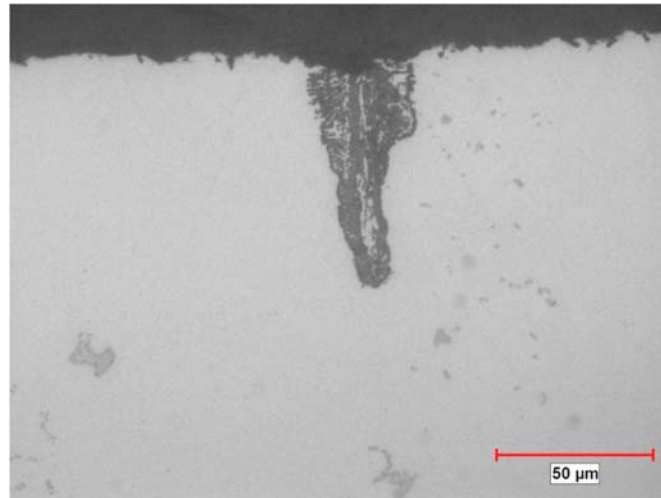
The crack was examined in cross section by optical microscopy (**Figure 5**). The crack path was straight and transgranular. The width of the crack tapered significantly along its length. These crack features are typical of thermal mechanical fatigue (TMF) cracking.

Figure 5: Optical micrograph of radial airfoil cracking through a thin airfoil wall.

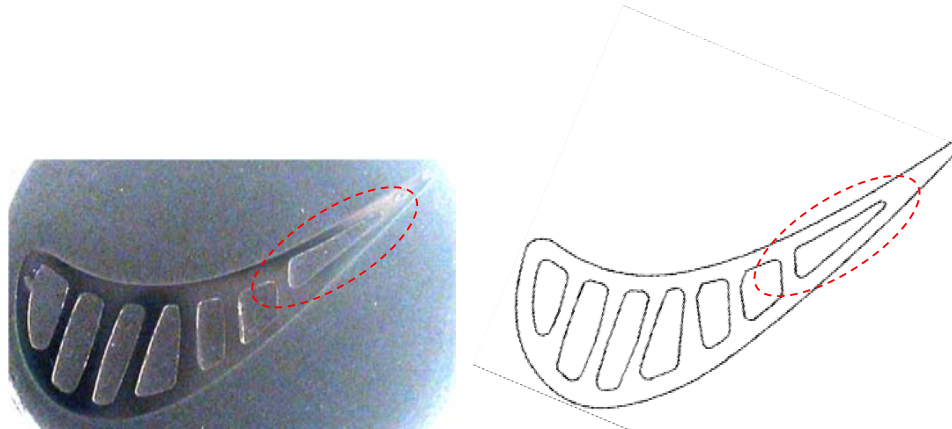
Figure 7 shows cross sections of aero turbine blades of the same type after service. The airfoil thickness near the trailing edge of the blade was found to be relatively thin (~40% below nominal) on the pressure side and thick on the suction side. Comparing the blade cross section to nominal it is apparent that the trailing edge cooling passage of the blade was shifted relative to the other cooling passages. This suggests the relatively thin wall was the result of casting core shift at manufacture. The common causes of thinning (service damage, material loss during repair) would not account for the thin wall.

Figure 7: Thin airfoil wall due to casting core shift of the trailing edge passage (image left). Proper alignment of the cooling holes is depicted image right.

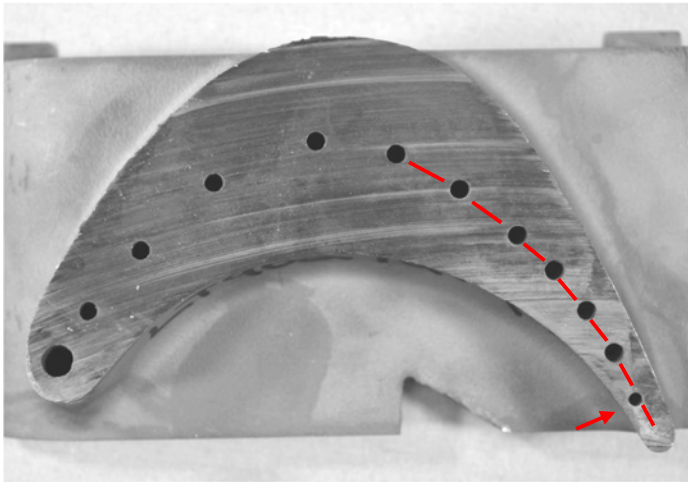
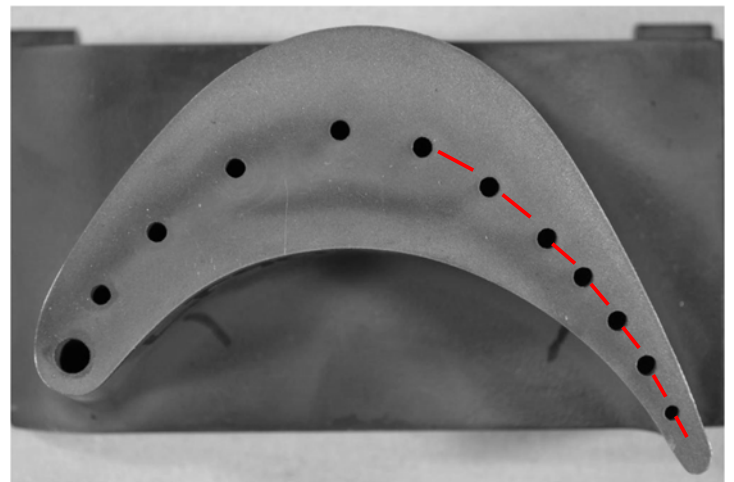
A set of turbine blades had a significant scrap rate due to thin airfoil walls following 3 service intervals. Cross sections of the airfoil revealed the thin airfoil region to be associated with a cooling hole which was misplaced relative to the camber line by approximately 0.020-inches. **Figure 8** shows two sectioned airfoils, one with a misplaced trailing edge cooling hole (thin wall, pressure side) and one from another set of blades, with the cooling holes centred on the camber line.

Figure 8: Misplaced trailing edge cooling hole (arrow). The airfoil section on the right shows a proper alignment of cooling holes along the camber line (dashed line).

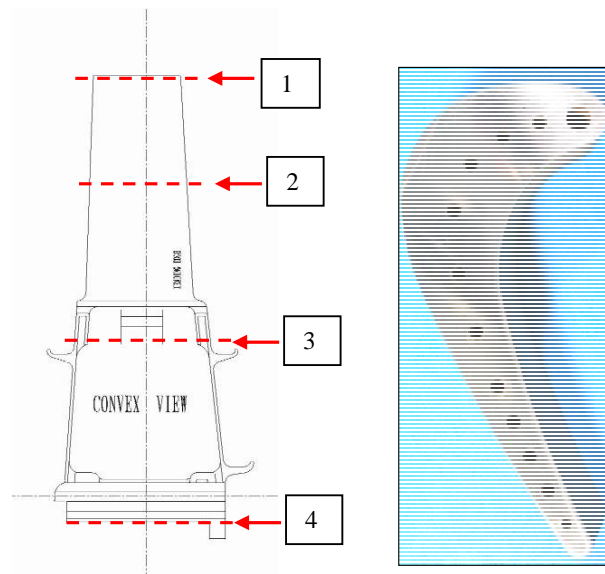
The airfoil cross sections also revealed a discrepancy in the diameter of the cooling holes. The cooling holes at the cross sectioned locations were found to be oversized by approximately 0.010-inches relative to measurements of the holes taken at the tip. **Figure 9** shows cooling hole diameters at the tip (exit) and root (entry) and at two locations further within the blade. Three blades were measured; one after 3 service intervals (3 repairs) and two blades after 1 service interval (no repairs). In each case, the cooling holes were restricted (smaller) at the tip and root, by approximately 0.010-inches. Also, the cooling hole diameter of the blade which had undergone 3 repairs was oversized as a result of multiple strip and recoating cycles applied to the internal surfaces.

Figure 9: Cooling hole diameters (in mils) of industrial turbine blades from three different sets.

The cooling holes are produced at original manufacture by a shaped tube electrolytic machining (STEM) process. The STEM drills holes from the tip which meet up with larger holes drilled from the root end of the blade. The STEM process is controlled by feed rate of the electrode and voltage. Variation of these parameters may result in corresponding variation in the diameter of the hole [3]. Accordingly, the restrictions of the cooling holes noted in Table 1 were likely produced by variation of the STEM process.

It was unlikely the cooling holes were intended to be larger within the blade while relatively restricted at the tip. The flow of cooling air in service would be metered by the restrictions. Therefore, any increase in cooling hole diameter within the blade reduces the wall thickness of the blade with no corresponding practical increase in cooling. A cooling hole with consistent diameter could be made 0.010-inches smaller and flow the same quantity of cooling air. The smaller hole would save 0.005-inches in wall thickness which would likely extend the life of the blade by at least one service interval.

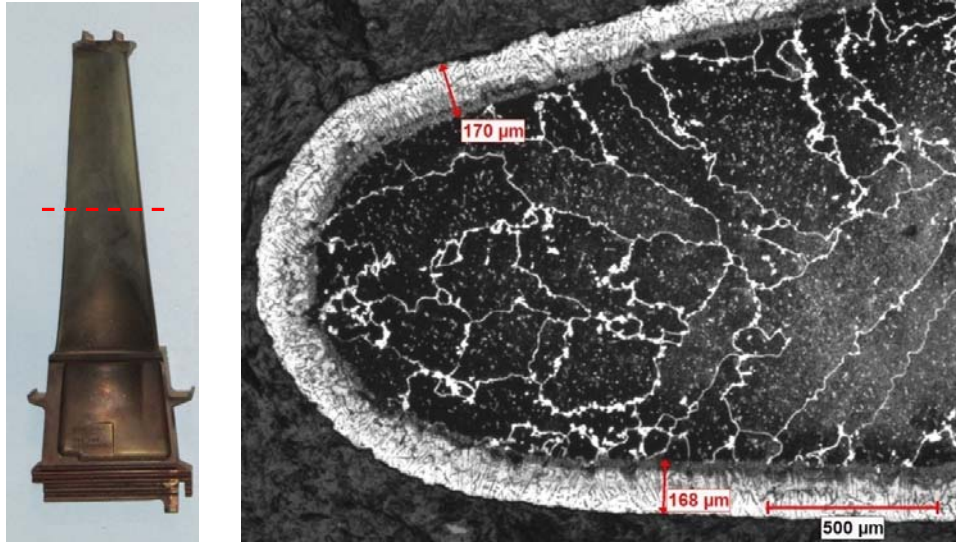
A set of industrial turbine blades was examined after a service interval consisting of approximately 50,000 hours of service under base load conditions (44 starts). Metallurgical examination of airfoil cross sections revealed the airfoil surfaces to be significantly oxidized. The oxidation damage resulted in an alloy depleted layer up to 170 microns thick at the trailing edge of the airfoil (**Figure 10**).

Figure 10: Alloy depleted layer (arrows) at the surface of a gas turbine blade airfoil.

The effective load bearing cross section of the airfoil would not include the depleted layer, as this layer was lacking the alloying elements (aluminium, titanium) responsible for strengthening the blade material.

The blade lacked a protective coating on all surfaces examined. The absence of coating was not the result of consumption during service, as the relatively cool regions of the lower airfoil were also lacking a coating.

Operation of the subject blade without a coating resulted in a significantly diminished life-span relative to a coated component.

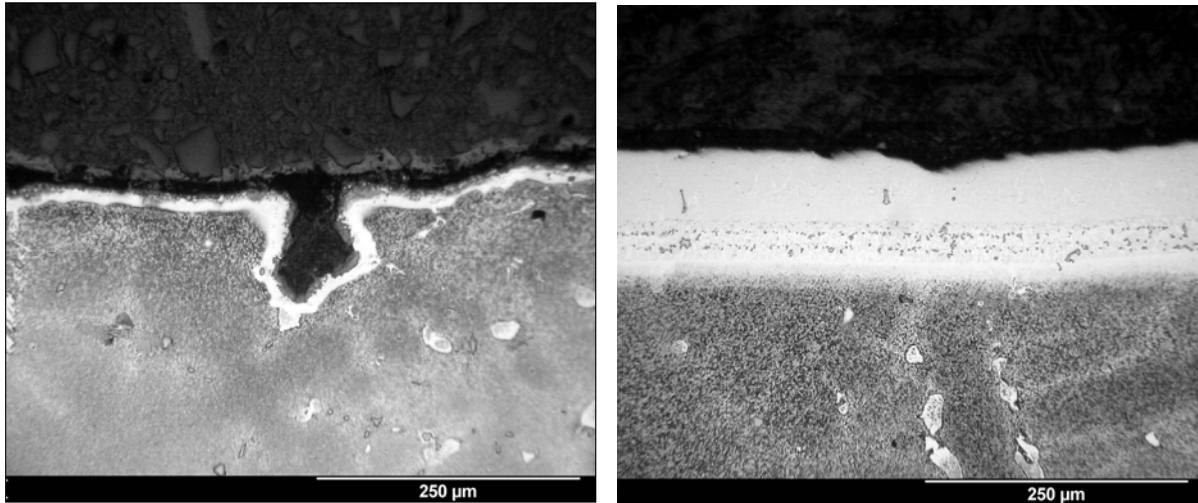
The internal surfaces of the first (non-repaired) blade set are shown in **Figure 11**. The internal surfaces showed sporadic coverage of the aluminide coating. Where coating was present, negligible degradation was observed. Regions without coating showed only minor alloy depletion, approximately 0.001-inch in depth.

Figure 11: The range of internal surface condition of an Industrial turbine blade after one service interval; base alloy depletion (white layer, left image) and undepleted coating (right image).

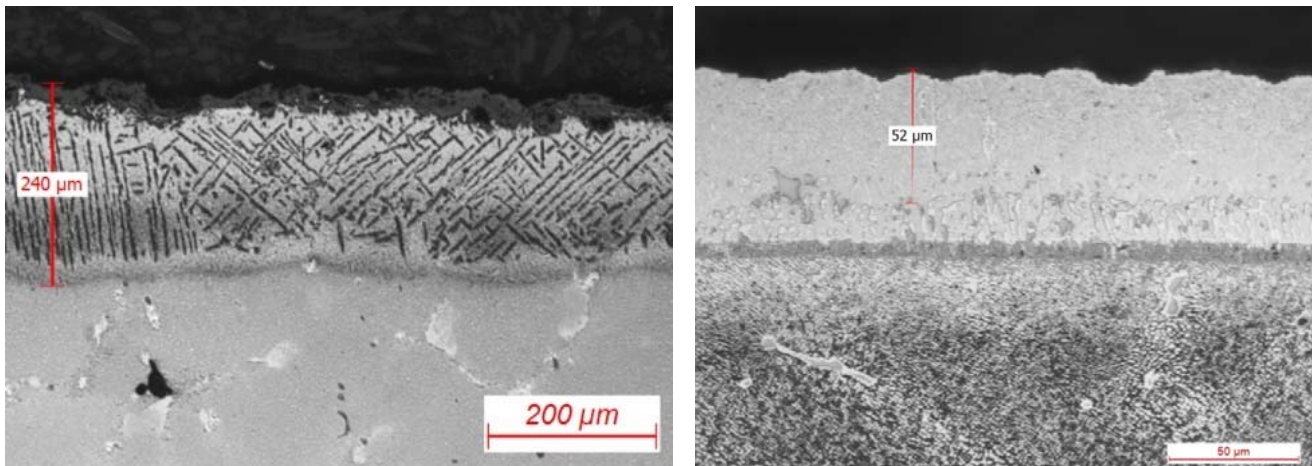
The second blade set (two service intervals, one repair) showed significantly greater base alloy damage of the internal surfaces (**Figure 12**). The effective wall thickness had been reduced by approximately 0.010-inches as a result of the oxidation.

Figure 12: The range of internal surface condition of an industrial turbine blade after two service intervals (no re-coat); base alloy depletion (left) and undepleted coating (right).

The internal coating protected the internal surfaces adequately for a service interval of 24,000 EOH, based on the degradation rate of the first blade (one service interval). Accordingly, the base alloy damage of the second blade (two service intervals) would have been substantially less had the internal surfaces been recoated as a part of the repair.

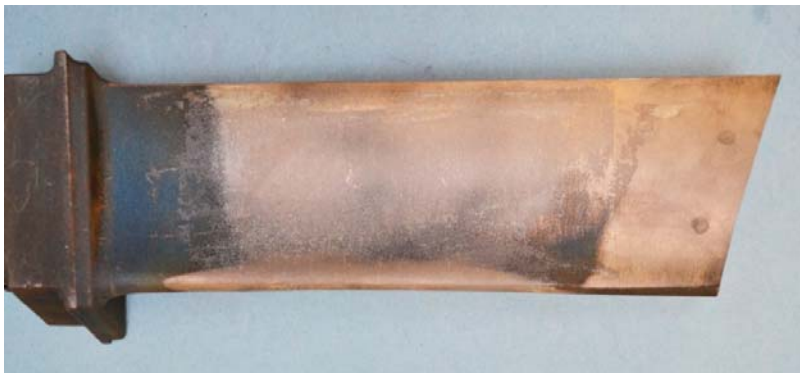
A set of industrial gas turbine blades were examined after the coating was stripped by an unknown party. The blades were deemed to be scrap due to insufficient wall thickness. The blades exhibited visual signs of grinding (lustrous, metallic appearance) of the external surfaces (**Figure 13**).

Figure 13: As received condition of the blade. Note the bright surfaces.

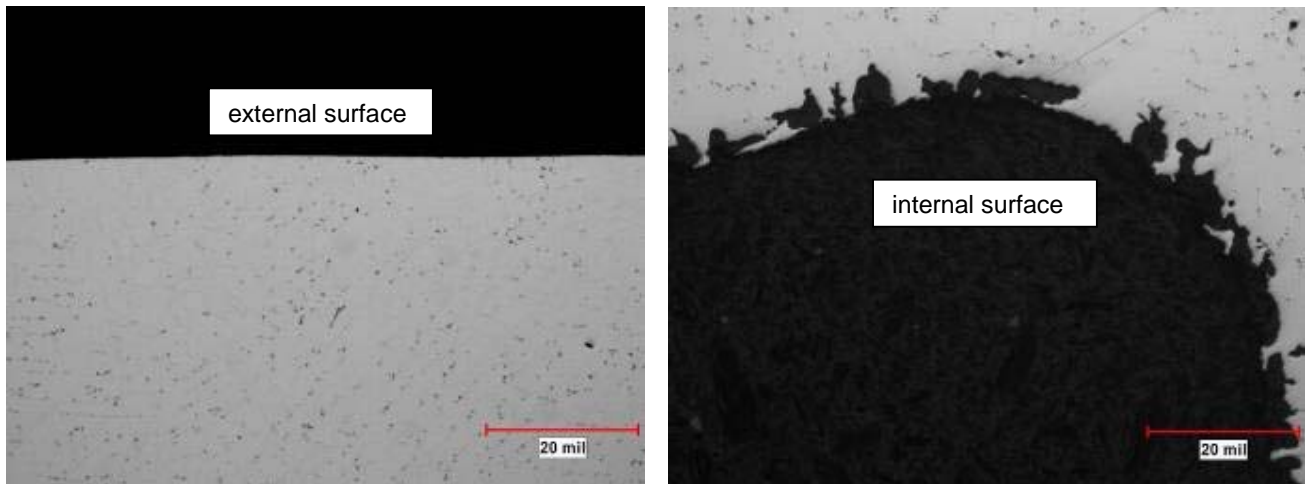
One blade was sectioned axially through the airfoil, polished and examined by optical microscopy. The internal surfaces were found to exhibit deep pitting (up to 0.008-inches); no evidence of high temperature oxidation attack was observed over the pitted internal surfaces (**Figure 14**). The external surfaces were smooth and free of oxidation and pitting. The apparent grinding of the external surfaces may have removed evidence of damage.

Figure 14: micrographs showing the external and internal surface condition of a blade stripped by an unknown party.

The absence of high temperature oxidation or hot corrosion scales suggests the cause of pitting was aqueous corrosion. The most common source of aqueous corrosion of a turbine blade is chemical stripping.

Pitting of the airfoil surfaces resulted in a reduction in the effective wall thickness of the blade, resulting in the early retirement of the subject blade set.
