11-IAGT-304

OPERATOR EXPERIENCE WITH NON-GAS PATH POWER TURBINE DISC CORROSION AS AN EMERGENT EQUIPMENT INTEGRITY THREAT

**TransCanada Corporation ([†]barry_ruggiero@transcanada.com)*

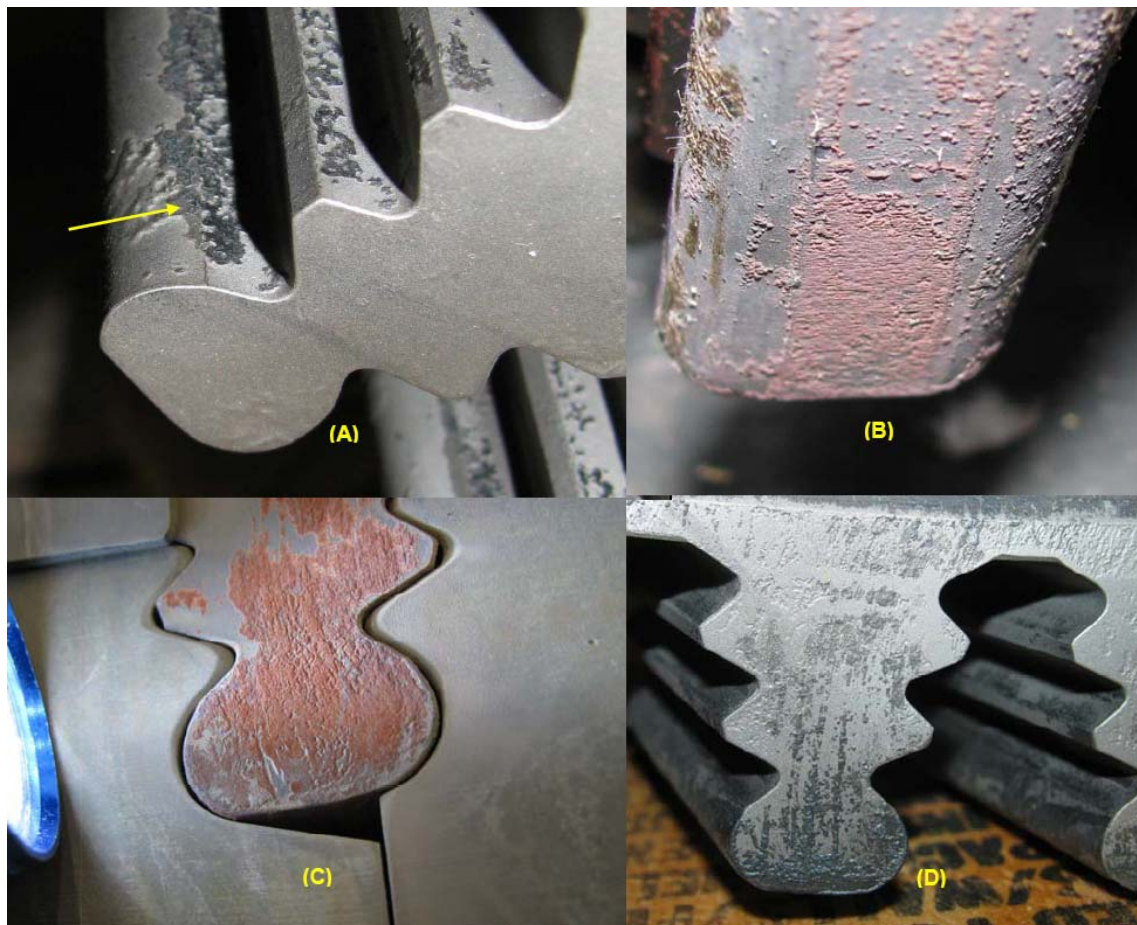
Depicted in Figure 1(A) are the contact lands of a blade attachment post, featuring a very tenacious, heavy grey-black scale deposit. Such scales have been investigated and have been found in some cases to show elevated molybdenum and sulphur in the scale, with products extending above the original surface some 27 um with a total reaction zone of 50 um. [1]

Of particular note in Figure 1(C) is the apparent extreme difference in resistance to corrosion between the rotor blade root (Rene 80) and the disc material (I901) even in similar thermal environments. Given the above, the post face and non-contact areas are considered subject to a different mechanism that is yet being investigated.

Figure 1: Example post conditions; A – Scale on serrations loaded surface (A-286); B – Scale on Post unloaded top face (I901); C – Post End face corrosion (I901); D – Identical disc (I901) after cleaning;

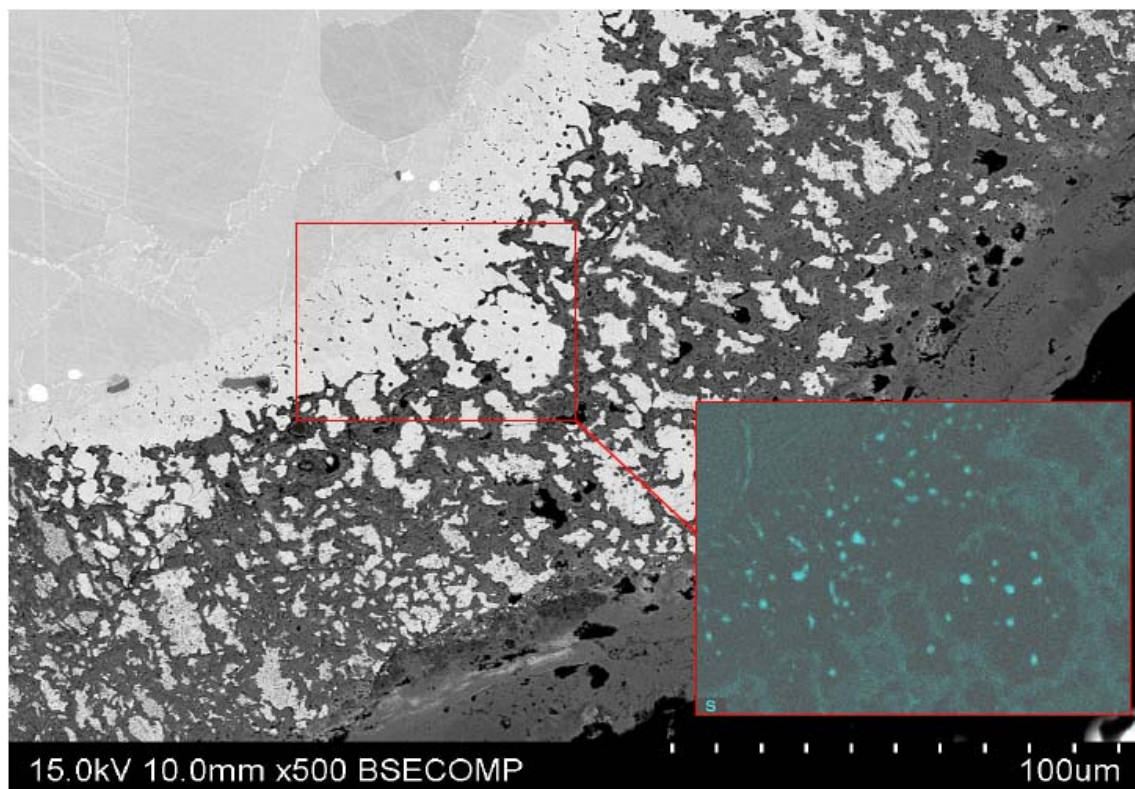
Figure 2 depicts a situation where sulfides have clearly found there way to a denuded area of a disc post base alloy. [4]

Figure 2: Sample corrosion on a post loaded serration (similar to Figure 1 (A)), featuring sulfide particles in a denuded zone under the scale. SEM Images courtesy G. White – RRRESI Materials Lab. [4]

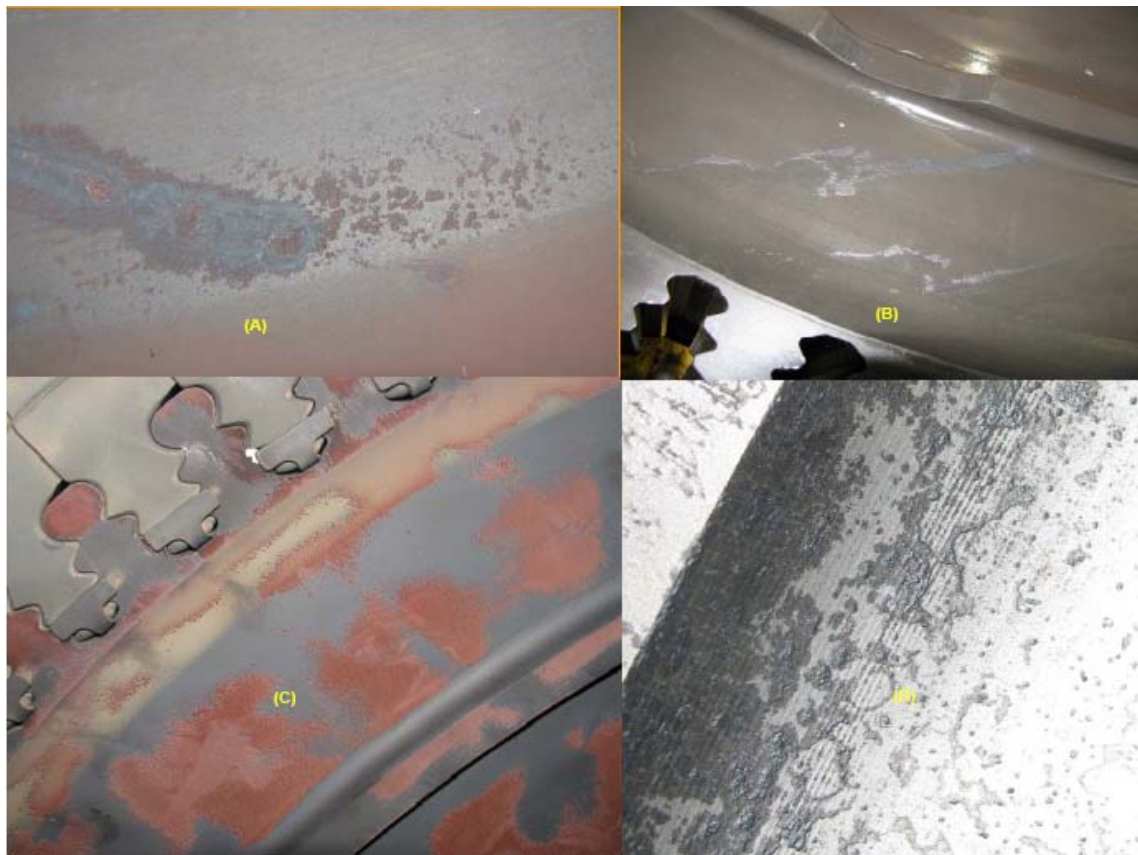
Disc Web regions have also been found to feature scales and pitting. In some cases, these are uniform, occasionally they feature random patched patterns, in some cases are correlated with streaks to disc features and in yet other cases, they bear features of contact with foreign contaminants. Figure 3 depicts several such examples.

Figure 3: A – Corrosion and pitting near a drip like deposit on a web (A-286), B – localized scaled drip like deposit (I901), C – Patchy corrosion areas that extend above original surface (I901) D – Same disc as C after cleaning.

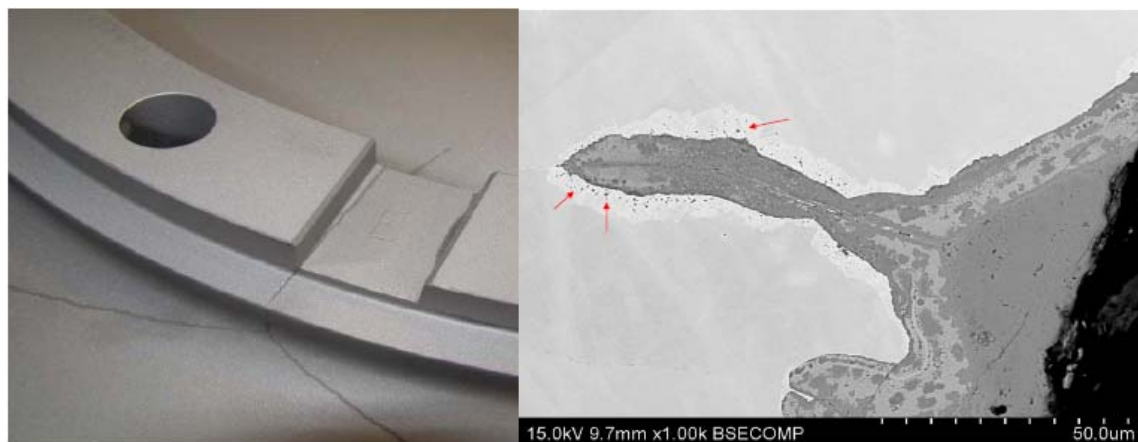
TransCanada have recently experienced three cracked discs where sulphidation has been identified at the initiation or has played a role in propagation.

Figure 4: A crack at a torque transmission feature and a corrosion spike identified near the origin, featuring a chromium depleted area and sulphides (identified by red arrows) under thick scale. SEM Image courtesy G. White – RRESI Materials Lab. [12]

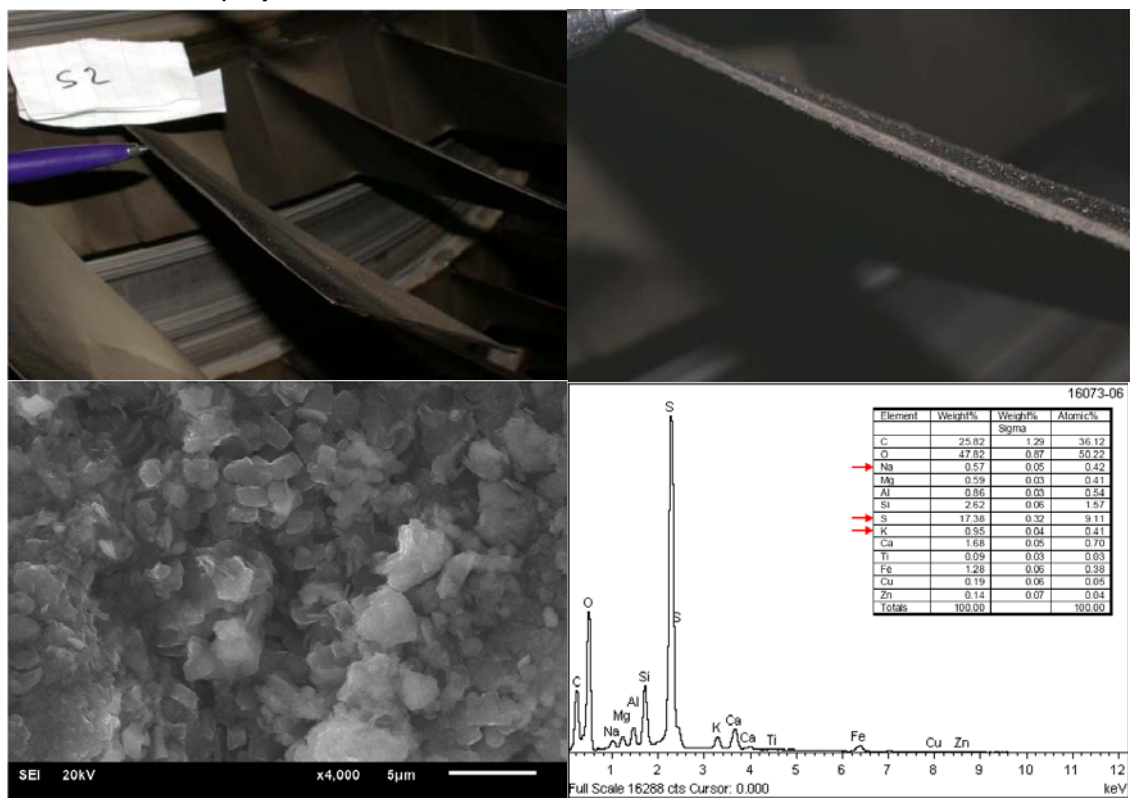
Figure 13: Richmond C/S: ESN 1750-116 IPC Stage Two blade deposits showing reactive species Na, S and K. GG was 3000 hours since last compressor wash. [45]

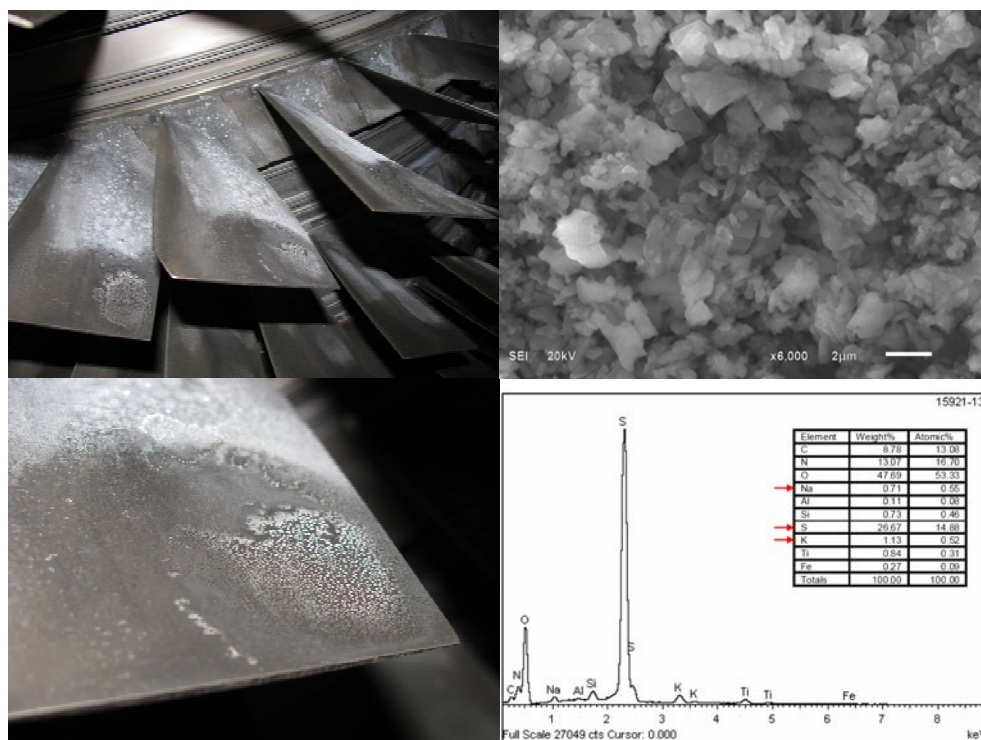
Figure 14: Deposits on IPC of ESN 1750-120 from Burstall (Sask) Compressor C/S. Engine was 530 hours since compressor wash. SEM Images from [46].

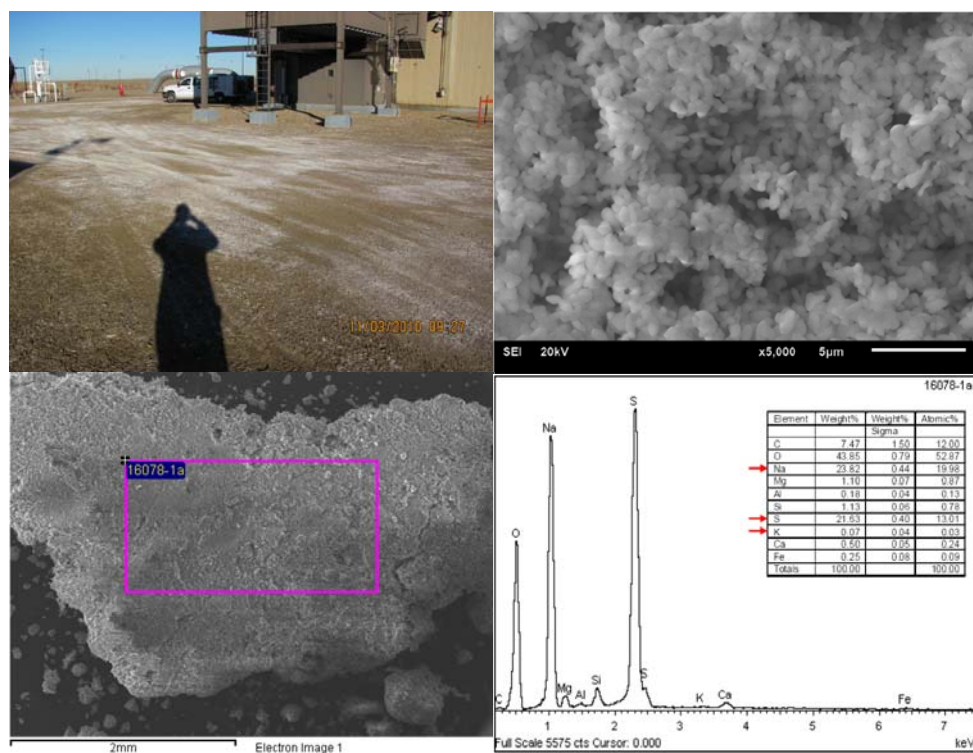
Figure 15: Jenner C/S (Alberta). Evaporite in yard and under plenum. SEM Images from [47].

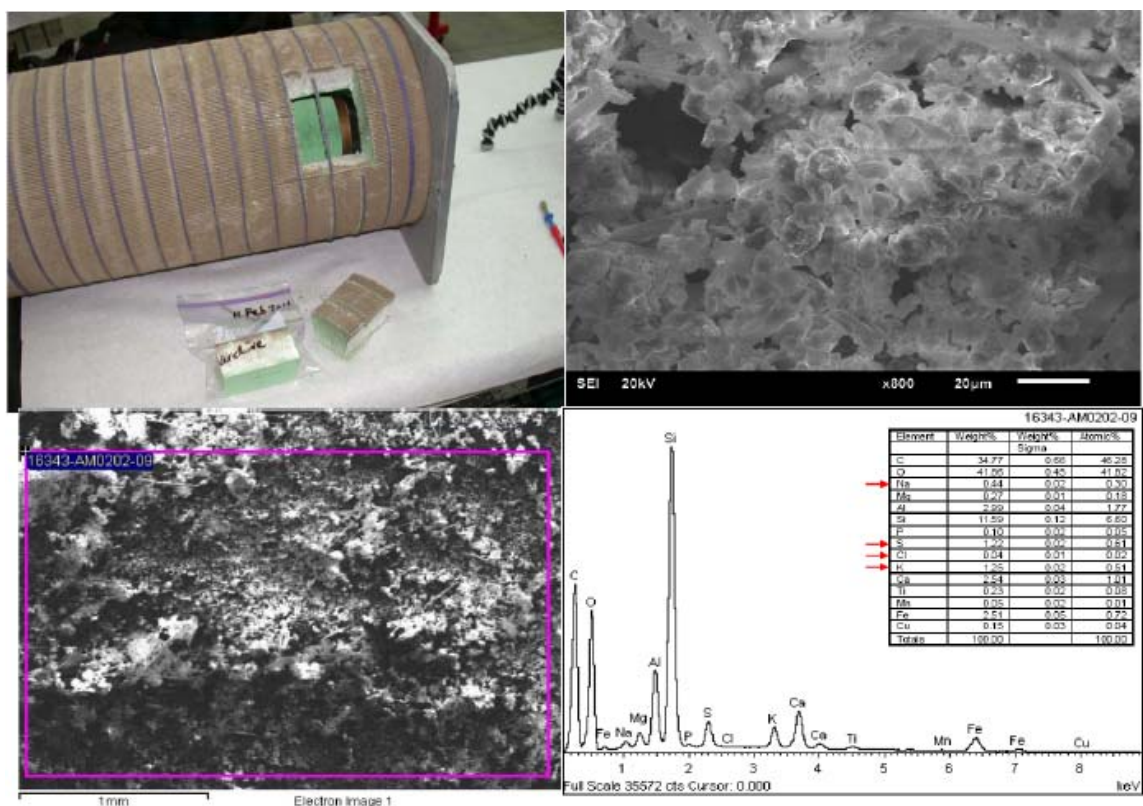
Figure 16: Monchy C/S (Sask) Filter Debris Analysis by SEM [48].

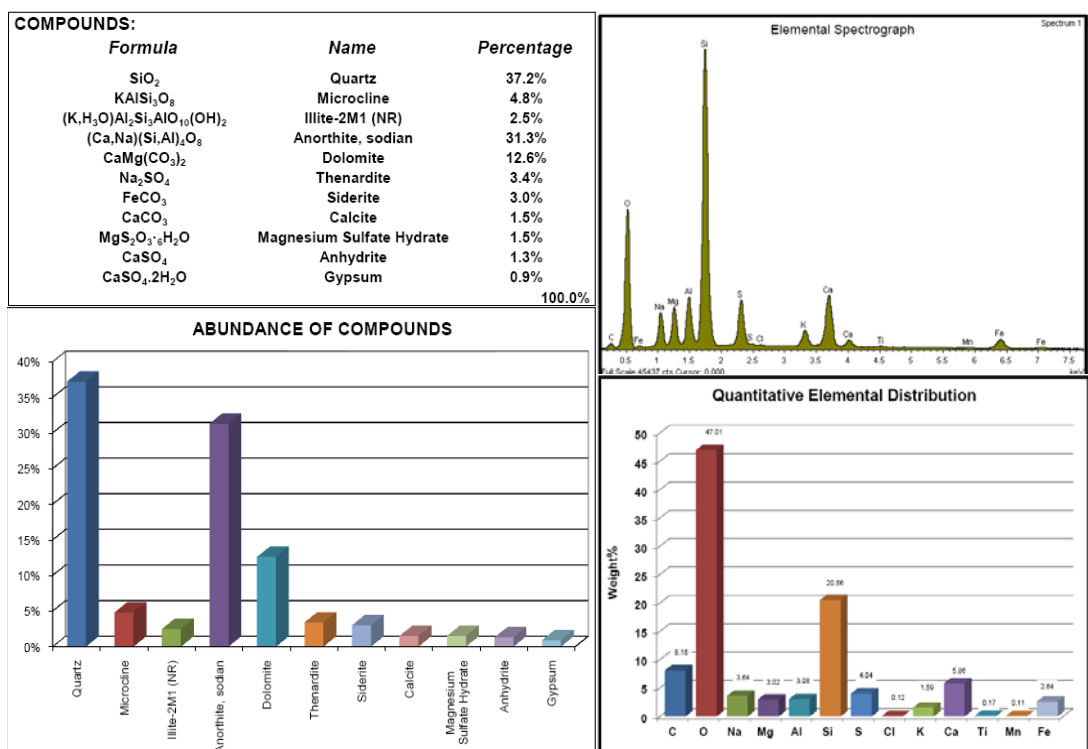
Figure 17: Monchy C/S (Sask.) XRD Analysis of gravel under filter hood. [48] This EDS & XRD analysis match what was in the filter (Fig.16). [48]

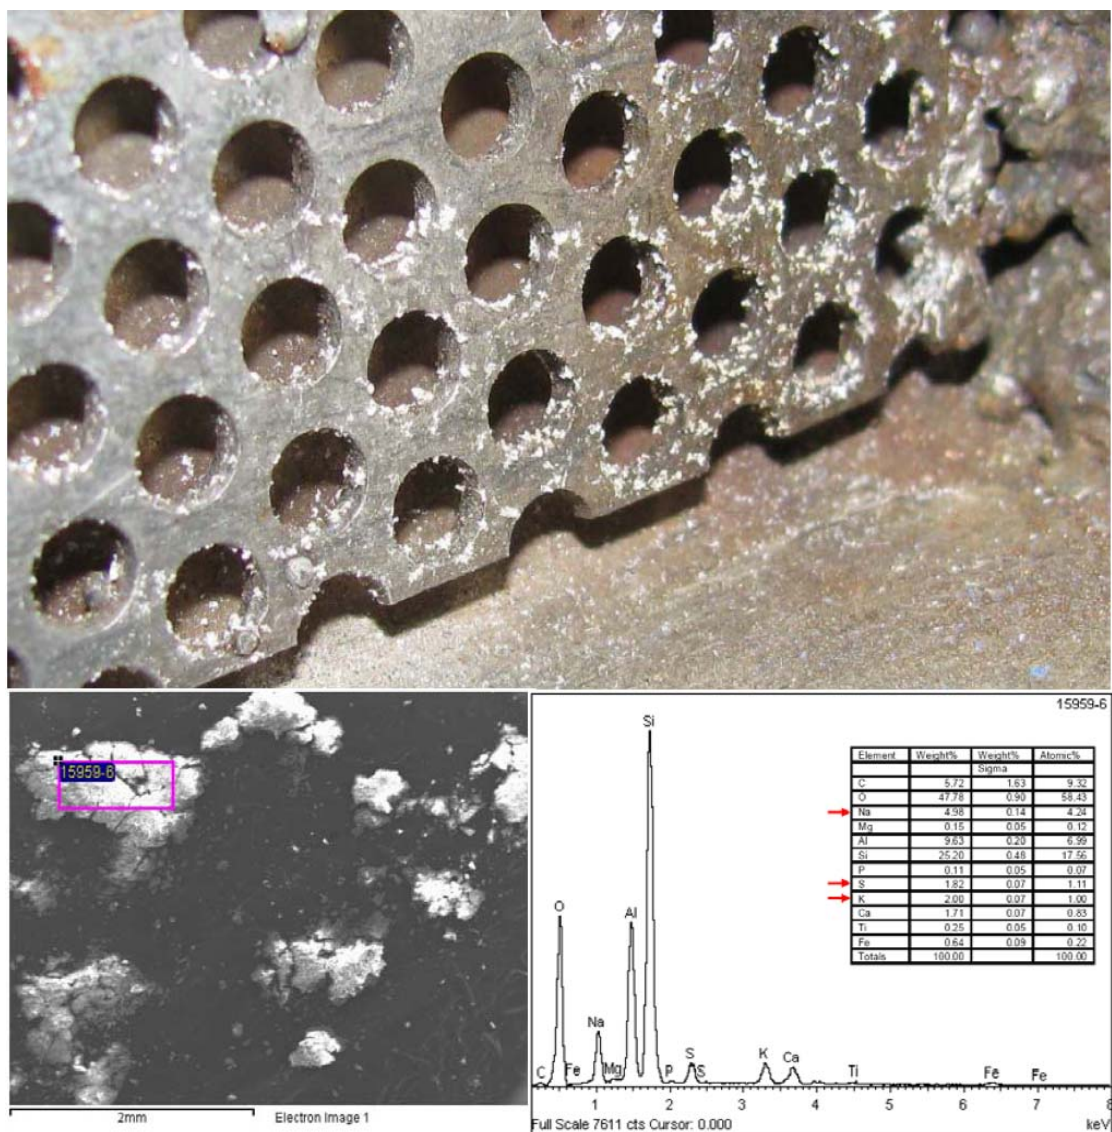
Figure 18: Latonell C/S (Alberta) White Crystalline deposits inside inlet plenum on acoustic lining, upstream of splitters. [49]

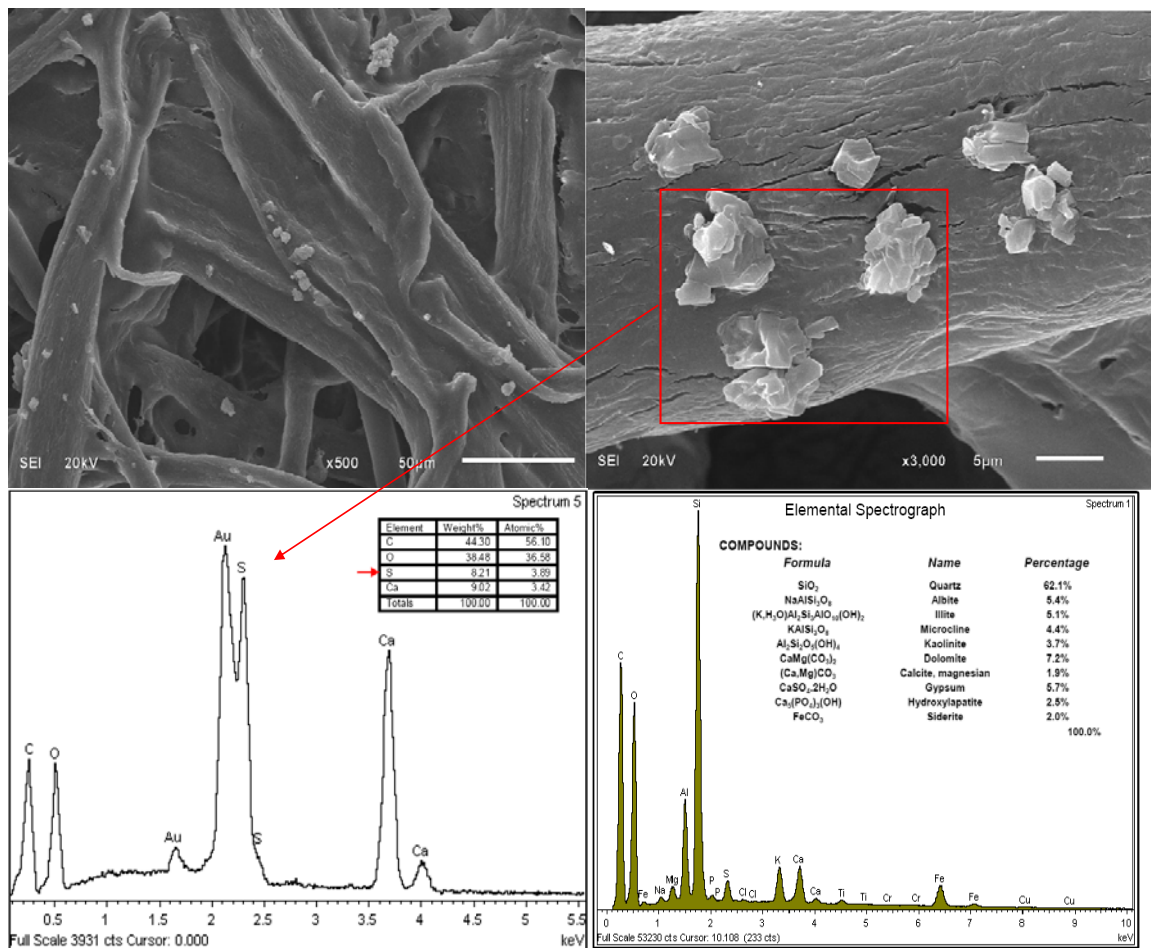
Figure 19: Inlet filter analysis from Latornell C/S. Lower Right Hand Side is XRD of filter inlet side debris with Gypsum, K and Trace Chlorine. Downstream side particle EDS shows Ca, S and O. (Au Sputter). [49]

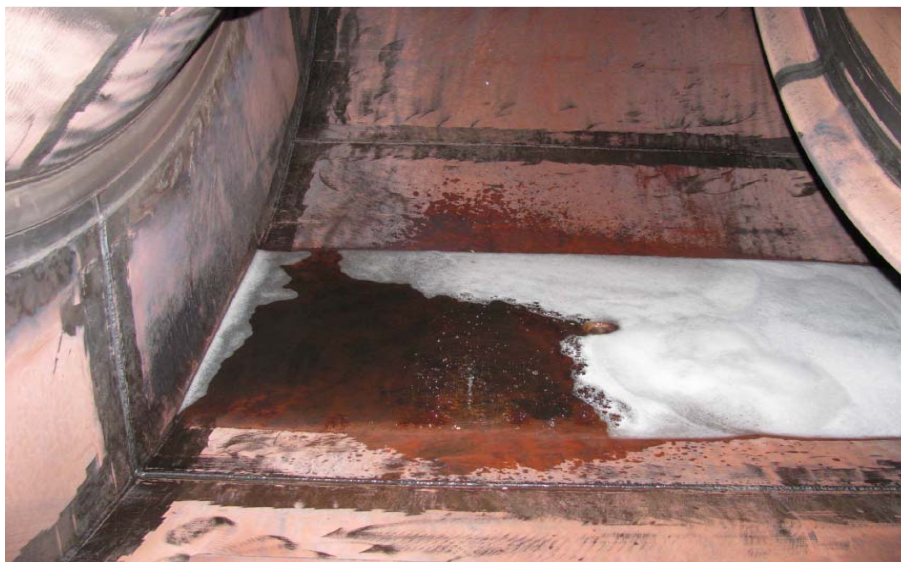
Figure 20: Appreciable amount of wash fluid reaching the exhaust system.

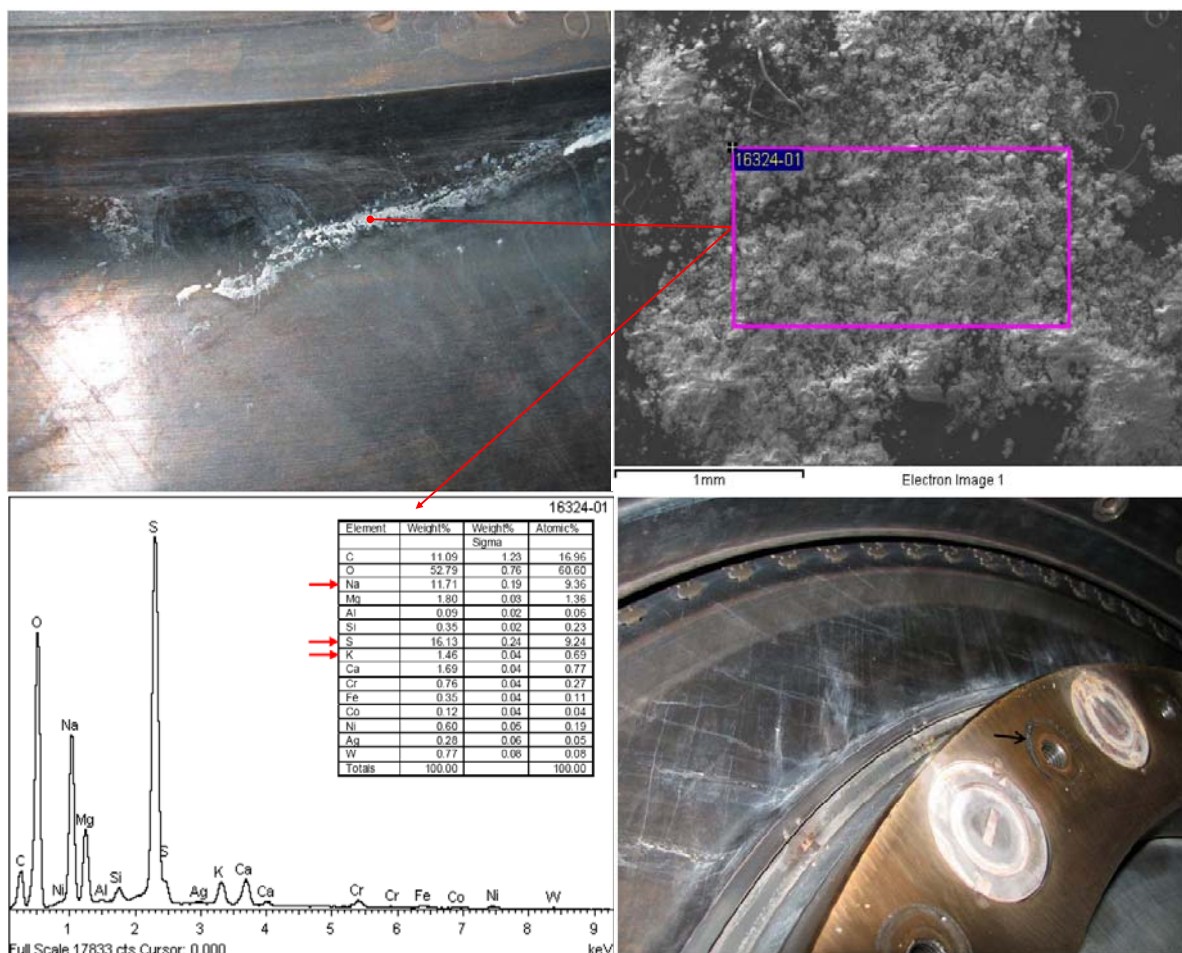
Figure 22: Vendor 2: prominent sodium and sulphur levels detected. Note the drip like pattern to the residue, which are suggestive that these were deposited when the unit PT was static as during soak wash. [52]

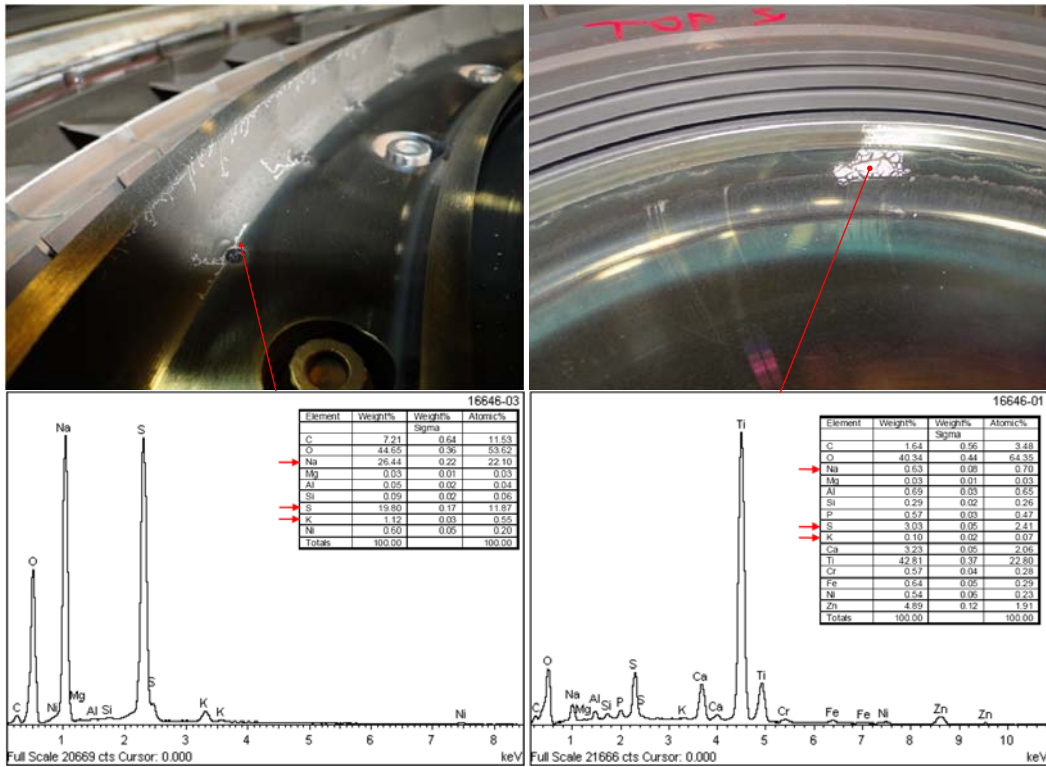
Figure 23: Vendor 3. Evidence of crystalline depositic having worked through secondary air systems and a “water mark” deposit with some apparent remnant anti-seize. [53]

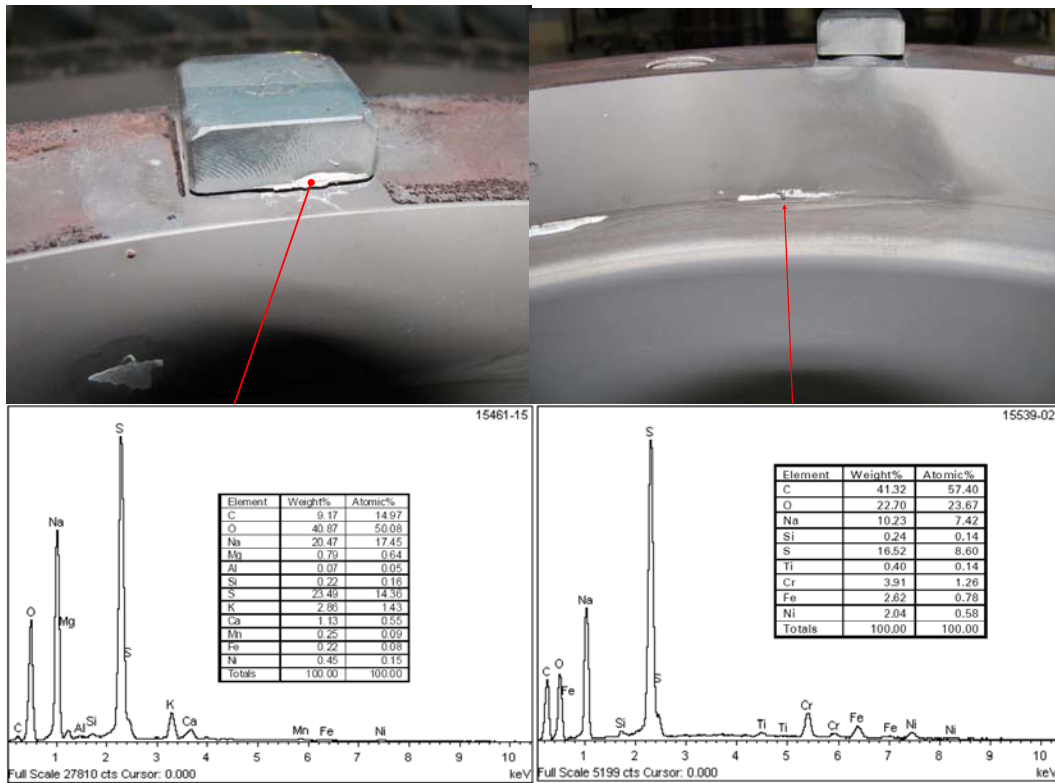
Figure 24: Deposits near torque transmission features on a power turbine from Red Deer River C/S (Alberta). [54]

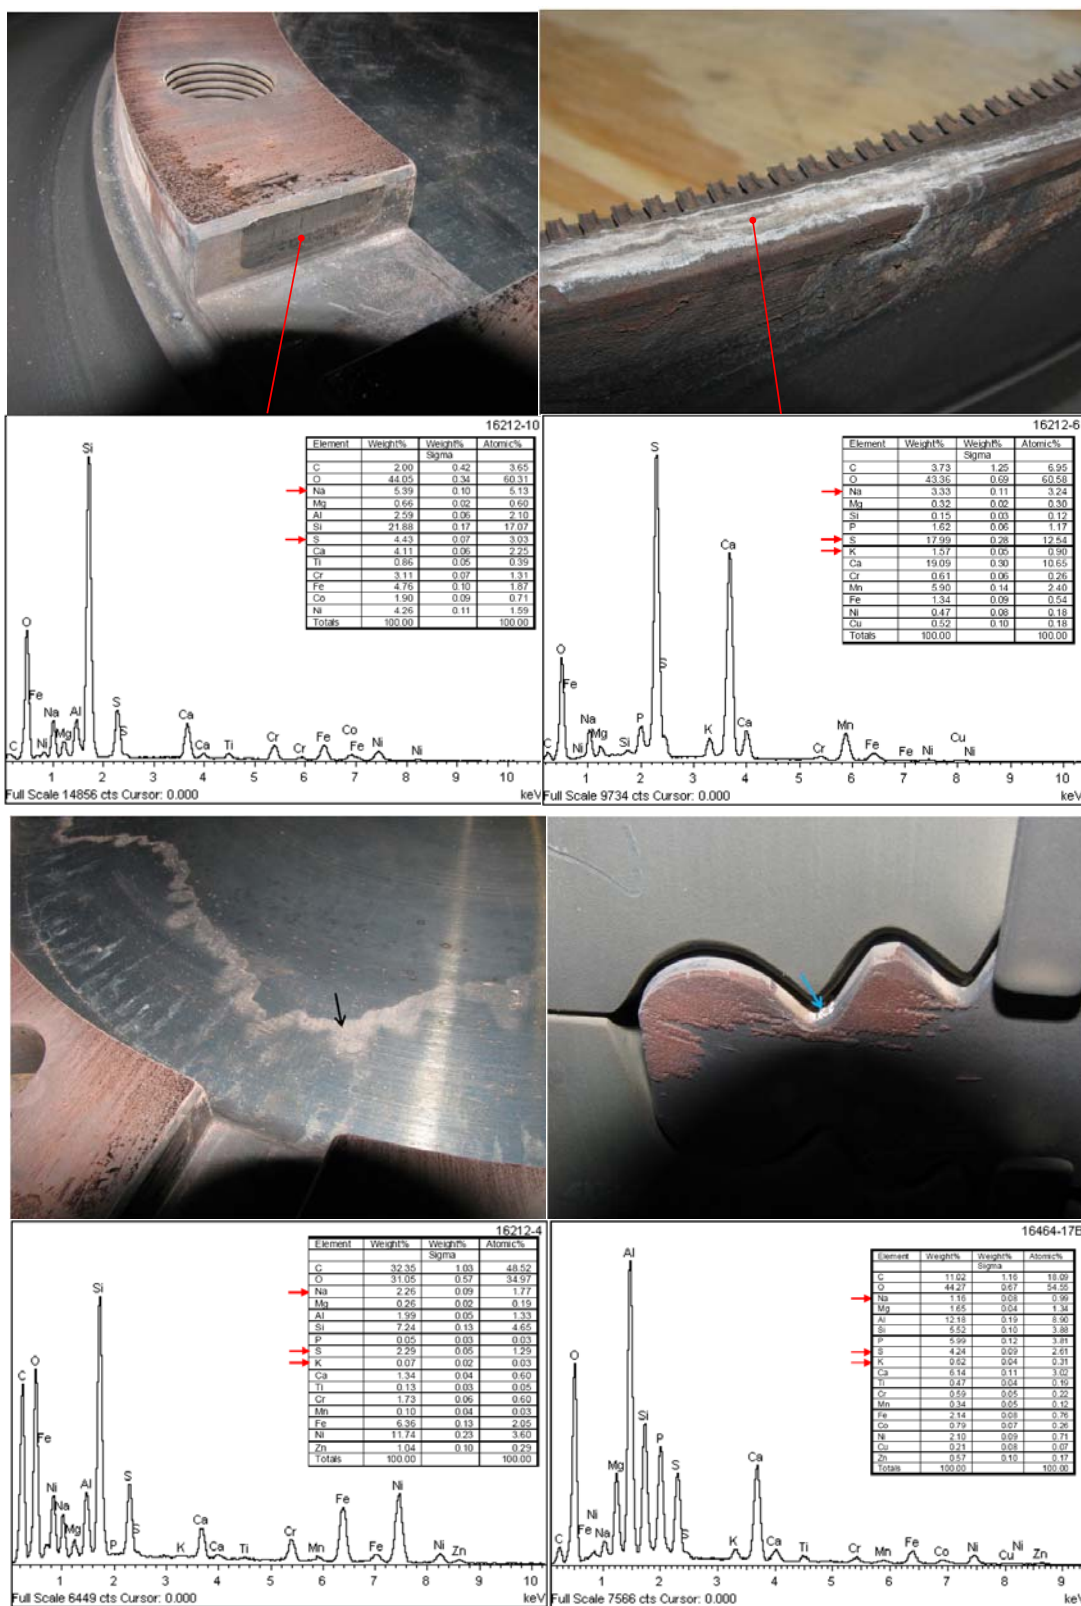
Figure 25: Analysis of deposits from a power turbine from Acme C/S (Alberta). [55]

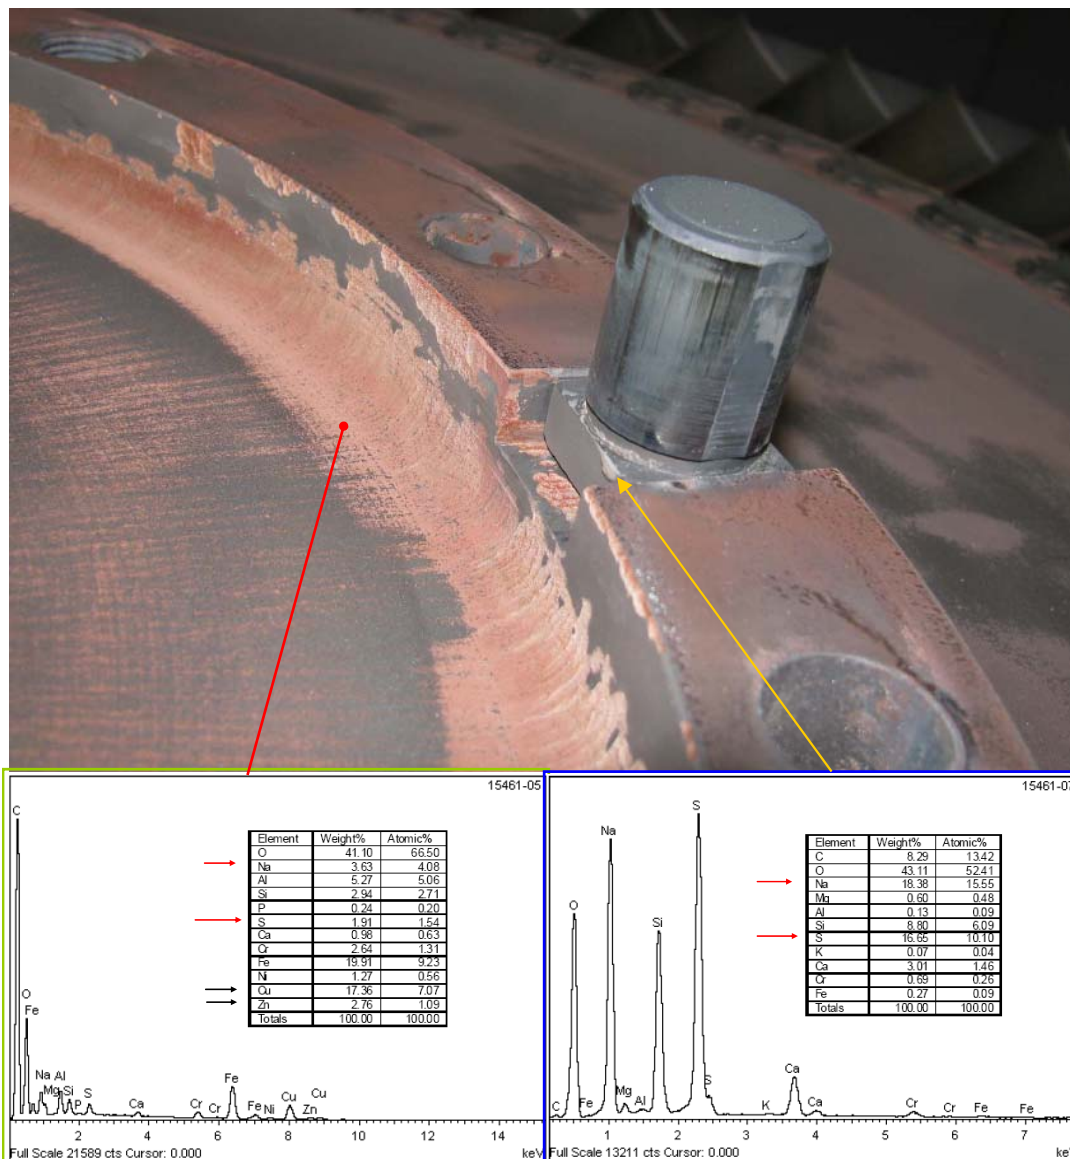
Figure 26 – Deposits and analysis from a PT from Berland River C/S (Alberta). [56]

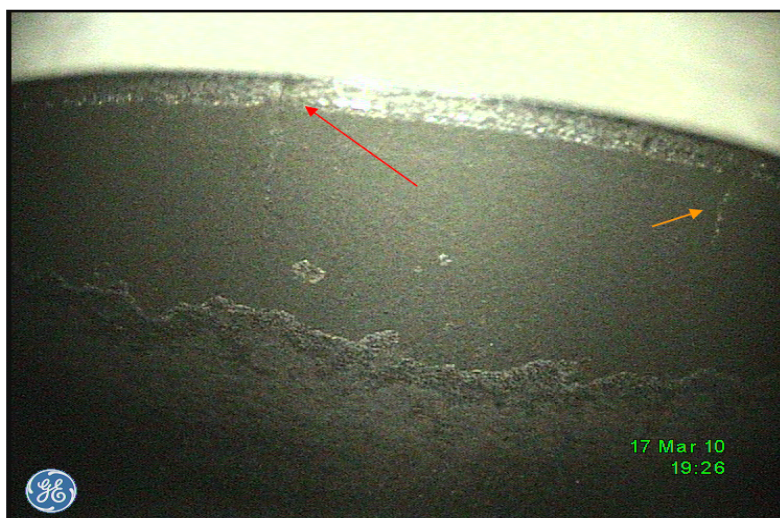
Case 1 - Boroscope Image – 1003170127.jpg; Was estimated at 3/16” at time.

Figure 27 – Small disc cracks identified via boroscope.

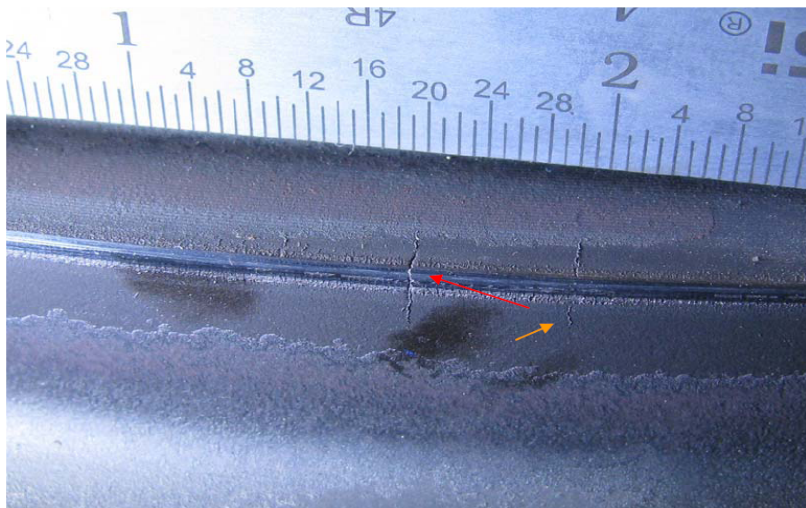
Case 1 - Indication near T-Pin Slot B – left hand later confirmed by UT.
