INLET FOGGING AND OVERSPRAY IMPACT ON INDUSTRIAL GAS TURBINE LIFE AND PERFORMANCE

Klaus Brun*†, Rainer Kurz**, Marybeth G. Nored***, Joseph M. Thorp****

The usage of an industrial inlet fogging and overspraying system on a 35,000 hp frame type industrial gas turbine in high pressure gas reinjection service was aimed to provide additional shaft power output and improved efficiency. However, operating experience has shown less than anticipated power increase and almost no efficiency change, while the gas turbines have experienced more rapid degradation. Consequently, a detailed study was undertaken to identify the principal degradation mechanisms and quantify their relative influence on the gas turbine's performance and life reduction. This study included a field assessment; review and analysis of the installation and operating data from the historical trend monitoring system; inspection of a rotor for fouling, corrosion, and pitting; materials analysis of the fouling deposits, rotor surface pitting, and inlet filter media; review of the function and effects of inlet fogging and overspray; assessment of the effectiveness of the current on-line/ off-line compressor washing program a

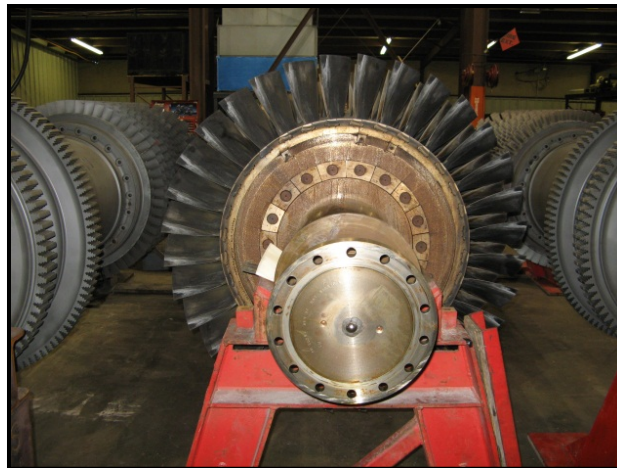
Figure 2. Rotor of GE 5002 Gas Turbine Prior to Overhaul

The above information (along with a previously performed water chemistry analysis) allowed for the analysis and determination of sources of deposits and corrosive agents inside the gas turbine (i.e., sources of undesired constituents that cause damage and degradation to the gas turbine during fogging, washing, and normal operation). Results from this investigation can then be further utilized in thermodynamic performance, life, and degradation studies. The results of the visual inspection and material analysis of the fouling deposit for different rows of one of the GE 5002 rotor are discussed below. Figure 2 shows a picture of the assembled rotor that was analyzed.

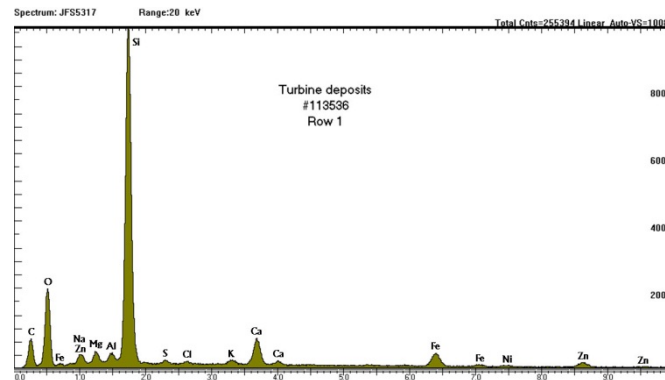
Figure 3. Compressor Deposits in Row #1

Deposits collected for each stage of the rotor were chemically analyzed for their constituents using Spectrum Analysis. Example results for blades from rows 1, 4, 11, and 16 are presented in Figure 3 through Figure 6. Figure 3 shows the composition of the deposits analyzed at the compressor row 1. A very high concentration of silicon is observed and low chloride (salt) quantities are seen. This is an indication of dirt deposits and, thus, for incomplete or inefficient inlet air filtration or inlet duct leaks. Filter saturation (discussed below) is a possible cause for the carryover of dirt into the gas turbine compressor.

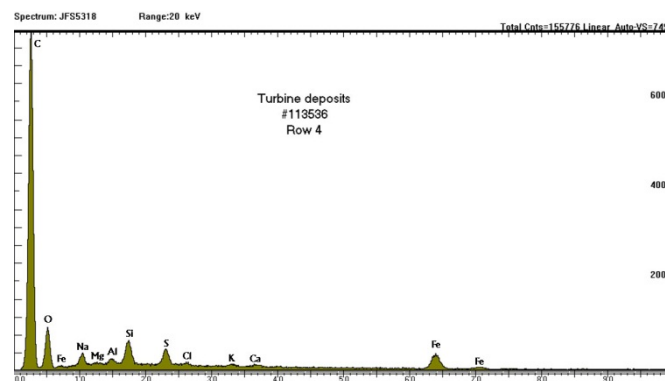
Figure 4. Compressor Deposits in Row #4

Deposits on blades in row 4 showed a high concentration of carbon deposits as shown in Figure 4. The chemical analysis performed for this study cannot distinguish whether this carbon is an indication of oils and waxes or pure carbon deposits. However, based on the visual examination, it is apparent that these are pure and hardened carbon deposits and not oils. These carbons are usually due to the ingestion of exhaust fumes from another combustion turbine or other internal combustion engines. Although these are hard to remove (once fully hardened onto the blade), they do not generally cause any significant performance degradation impact. Hardened carbon deposits in the first couple of compressor stages are

also an indication that the compressor on-line and off-line water washing program is not effective.

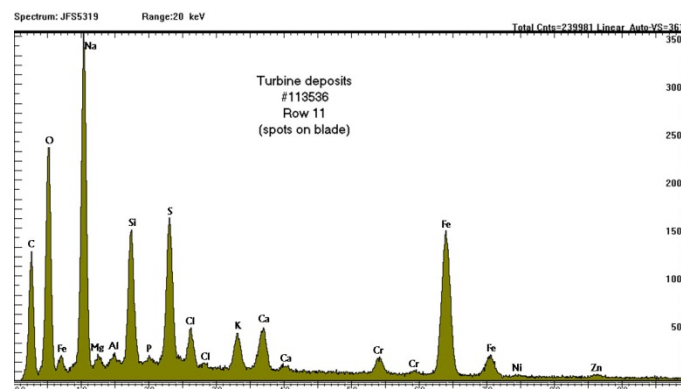
Figure 5. Compressor Deposits in Row #11

Figure 5 shows the blade deposit composition in compressor row 11. A high concentration of sodium and lower concentration of iron can be seen. Salts this far downstream in the compressor are a very clear indication that the on-line washing process carries the salts that were deposited in the first stages during normal operation downstream into the later stages where they are redeposited. These salt deposits become difficult to remove, as even off-line washing is not very effective in the downstream stages (Note: This strongly depends on crank speed and water wash rate).

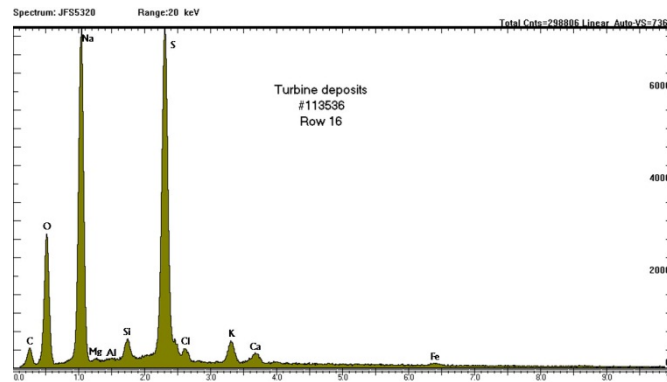
Figure 6. Compressor Deposits in Row #16

Figure 6 shows the blade sample composition found on the row 16 blades. Both sodium and sulfur are present in high amounts. The salt is likely due to redepositing of upstream salts during on-line water wash, but the origin of the sulfur is not clear. Typically, sulfur deposits in gas turbine axial compressors are found when the unit operates in an industrial area with

high ppm sulfur content in the air. However, in the case of subject site, the sulfur (in combination with the carbon deposits) is an indication that the gas turbine inlet is subjected to exhaust gases from itself or from other gas turbines that operate with a sulfur-containing fuel gas (as is the case here). Sulfur, in combination with moisture, leads to aggressive sulfurization corrosion. In the combustor and hot turbine section, sulfur compounds can cause hot corrosion.

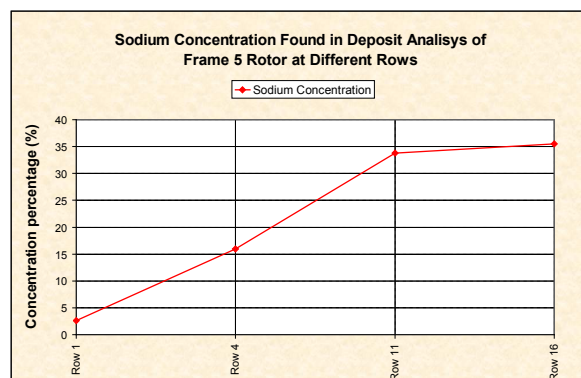
Figure 7. Concentration of Sodium in Different Compressor Rows

Blade surface erosion pitting is seen throughout the rotor, but the most severe is evident on compressor stages 10-15. This is consistent with the chemical analysis that shows highest salt deposits in the downstream stages. Figure 7 shows the concentration of sodium deposit as a function of blade number. A clearly increasing trend is observed.

Generally, all salts should be avoided in a gas turbine, and usually most salt deposits are found in the first stages of a compressor. In the subject case, the highest salt concentration is downstream in blades where even off-line washing is ineffective. The likely mechanism of these formations is as follows:

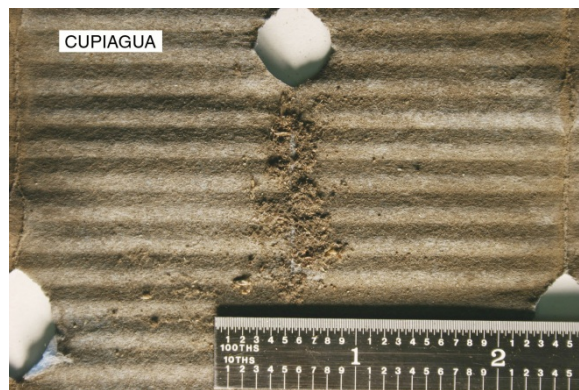
Figure 8. Inlet Filter Sample

As the inlet filtration provides a potential for the admission of foreign substances into the gas turbine, a filter sample was obtained and analyzed for saturation level, dirt permeation, and particulate blockage. The subject GE frame units utilize a three-stage filtration system with a high efficiency cartridge paper filter as the last stage. Testing of this filter has indicated filter saturation as can be seen in Figure 8.

The subject operator replaces these cartridge filters at the time of the overhaul of the gas turbine (approximately every two to three years). This generally is considered to be too long a time between filter replacements. Operators should replace their filters every 12 to 18 months, or when the inlet filter differential pressure exceeds the original-clean differential by 1.0 to 1.5 inches of water. In tropical environments, as is the case at the site investigated, there is a significant potential for filter media saturation. This is caused by (frequent, heavy) tropical rain wetting the dirty filter media which then allows the smaller dirt particles to be carried through the inlet filter pores with the moisture. The increased pressure differential across the filter caused by the sealing effect of the moisture enhances this process. Eventually, dirt will be present on both sides of the porous media filter and will be released into the gas turbine inlet with every subsequent rain event. The problem can be mitigated by improving the weather protection of the inlet filter housing using vanes, covers, or hoods.

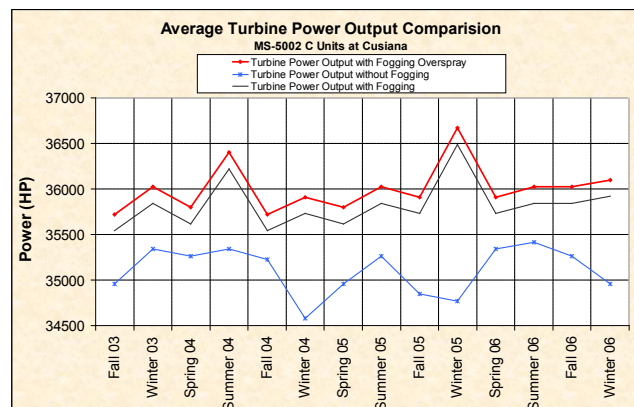
Figure 9. Average Turbine Power Output Comparison with Fogging and Overspray

Figure 9 shows an example of the predicted maximum power output of the 5002C gas turbine without fogging, with dry-fogging (99.5 percent saturation) and overspray fogging (102 percent saturation) operation. An increase of power between 1.5 percent and 5.1 percent (depending on ambient conditions) is achievable with dry fogging versus no fogging. However, the overspray fogging is seen to only provide a marginal benefit of less than 0.8 percent additional output power over dry fogging. Figure 10 shows the gas turbine's efficiency increase of fogging versus no-fogging. A very marginal (less than 0.5 percent) power increase is seen. Namely, fogging and overspray do provide a power boost but do not significantly improve efficiency. Also, the small relative benefit of overspray versus dry fogging operation should be evaluated in light of the significant amount of blade corrosion and, thus, performance degradation, the overspray is causing.

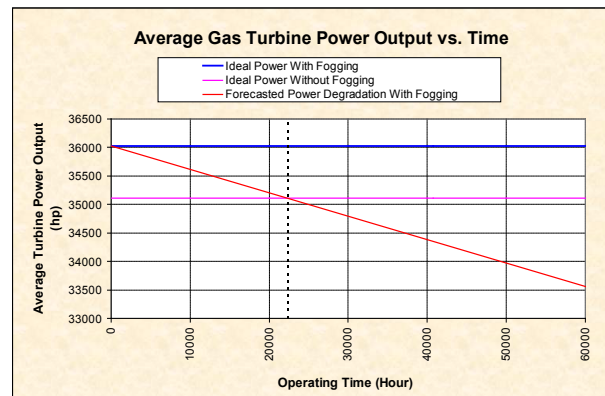
Figure 11. Average Gas Turbine Power Output vs. Time

Results of this study, shown in Figure 11, demonstrate that after approximately 22,000 hours of operation with full overspray, the gained power has been negated by blade degradation. Thus, over a typical rotor life of 60,000 to 70,000 hours, the net cumulative power due to overspray is a negative. One should note that this statement applies to overspray and clearly not to dry fogging. As long as all water is evaporated prior to entering the compressor inlet (i.e., no droplets), blade erosion due to water should be minimal.

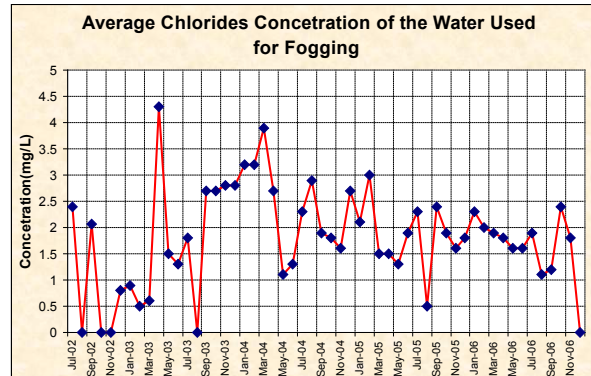
Figure 12. Average Chlorides Concentration of the Water Used for Fogging

Figure 12 shows a graph of the chloride concentration in the water utilized for fogging (from the site water analysis). Typical values range in the below 4.5 mg/L range.

Given the water spray rate during normal fogging/ overspray operation and assuming typical deposit efficiency, the total accumulated deposits over extended periods can be determined. Results show that each gas turbine ingests about 1,000 g of chlorides per month and about 200 to 400 g of these form deposits. Significant amounts of salts are, thus, seen to enter and possibly deposit inside the compressor. Some of these salts will form deposit layers that can subsequently break off in larger pieces and can cause downstream damage and degradation in the hot section turbine (including the potential for cooling passage plugging). These chloride deposits lead directly to blade surface fouling, corrosion pitting, and even rotor unbalance. Thus, the combination of continuous fogging, overspraying, and the use of not completely clean water are significant contributors towards performance degradation of the gas turbine.
