CONCRETE PAVEMENT STUDY

For Walden Section Seven

Job No. 13222

Walden Townhouse Association

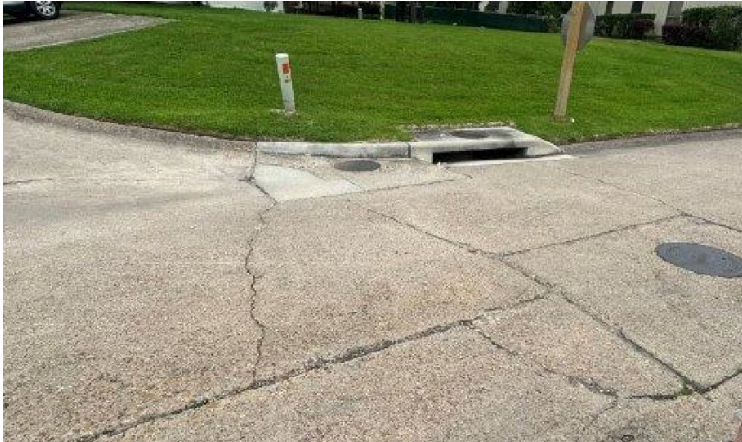
Area 1 Lakewood Dr. & Trail Hollow Dr. Intersection (Priority 2).

Concrete around the storm MH in the center of Lakewood Drive has cracked in panels on the north side but no areas have significant settling and poses no urgent need for repair next to the MH. Stormwater appears to drain away quickly from this area to the nearby inlet and does not appear to pond. If the broken area begins to settle then removing and replacing the concrete would be recommended. **Currently, it is recommended to tool clean and seal all cracks and joints at this location to prevent infiltration and future damage.**

Area 1: Cracking around storm MH and inlet

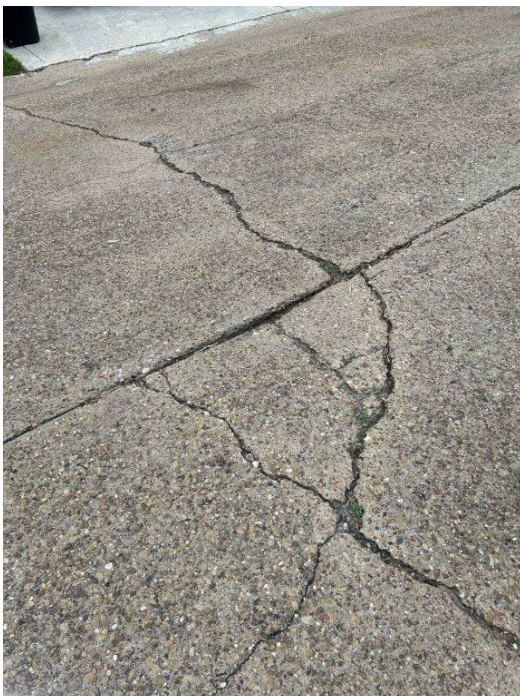
Area 2 Trail Hollow Dr. (Priority 1 -Seal) (Priority 2-Repair)

Near Block 16, Lot 3. The concrete has cracks exceeding 1/4" wide. There is a small area where the concrete has broken and has settled 1" from water infiltrating down to the subgrade. The pavement settling (sag) appears to have occurred in previous years (Trail Hollow has a lower cars per day average). **Recommend tool cleaning and blow out debris and seal cracks (Priority 1) to prevent further damage. Saw cut full depth to remove and repair a 4'x4' area in the future (Priority 2). Seal all joints after repair.**

Area 2 broken concrete with 1" settled pavement.

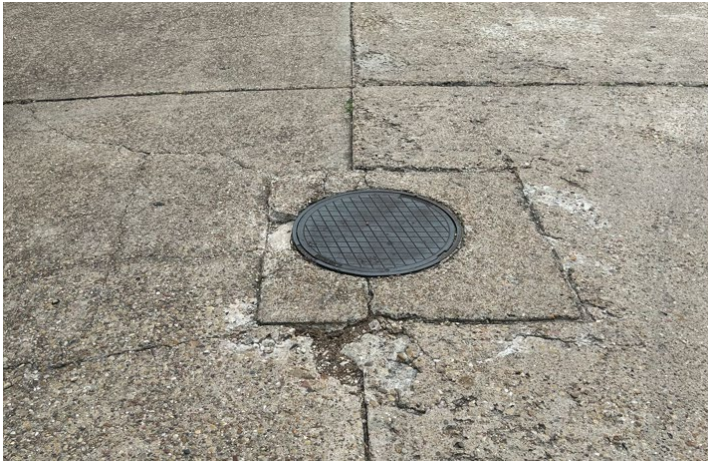
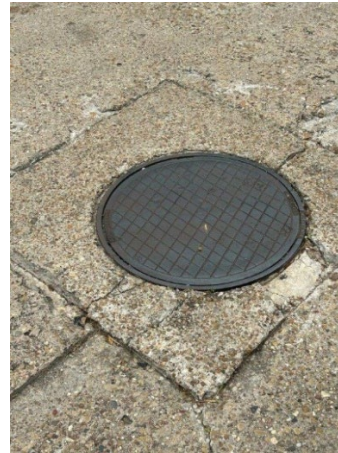
Area 3A Knollcrest Dr. at Trail Hollow Dr. (Priority 2)

The Storm Manhole at the intersection has an apron that is cracked and a large piece of concrete is missing. The MUD has been contacted to see if they will help with repairs and pour a larger apron that extends out 12" minimum on all sides. The road has cracking and chipping damage around the apron that could be from freeze-thaw cycles or heavy loads applied over the cracked apron. **The recommendation is to saw cut out damaged concrete and install a larger apron around the manhole (Approx 6'x6' apron), and repair adjacent paving damage Approx area measuring northward 8' from the road expansion joint for the full road width of 25 feet (Approx. 22 SY: 18 SY Paving, 4 SY manhole apron). Seal all joints.**

Area 3A with broken Apron around MH

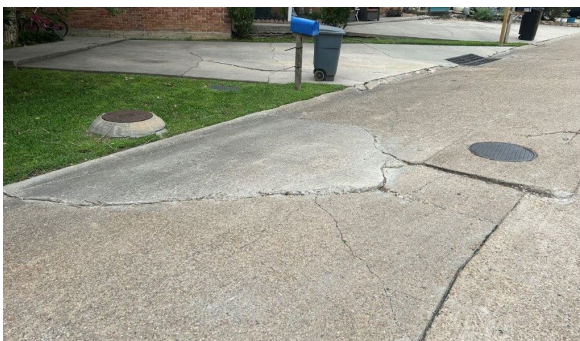
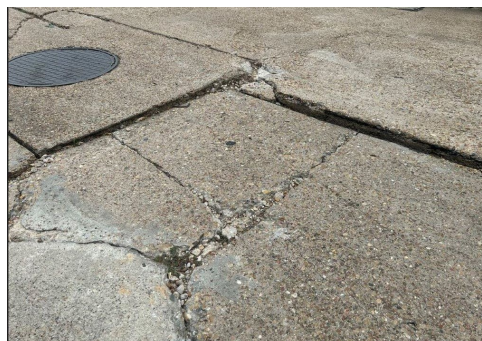
Area 3B Knollcrest Dr. north of Trail Hollow Dr. (Priority 1)

The storm manhole and roadway in this area have damage consisting of concrete settling below other panels, snapped-off edges, cracks, and chipping. The settling appears to be due to water infiltration and pumping from heavy loads and traffic volumes. The area appears to have had concrete replaced previously without using standard repair methods. The reason for prior repairs is not clear but may have been made due to a storm pipe issue based on the patch location. The pavement has settled 2" on the east side of the manhole. The repair will require cutting out and replacing concrete to provide a flush surface. The apron appears to be in good condition with one minor corner chip. **Recommend saw cutting full depth from the centerline of the roadway east to the curb, measured 2 feet south of the MH apron. Then saw cut full depth from the centerline of the roadway east to the curb measured 8' north of the MH apron. Remove and replace 18 SY paving on the east panel. Do not disturb the MH apron. Seal all joints. This is a minimum repair. The replacement of concrete for the full road width should be considered and will require an additional 18 SY of concrete on the west panels (ALTERNATE ITEM).**

Area 3B with damage around storm manhole. Pavement has settled 2" which requires replacement.

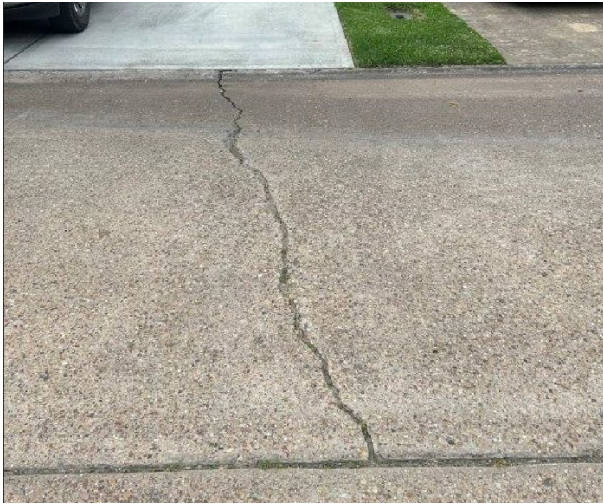
Area 4 Knollcrest Dr. near Block 6, Lot 3 (Priority 1)

The roadway has a significant 3/4" wide crack. There are signs that the paving is settling due to water infiltration through the crack that softens the subgrade and heavy traffic allows the concrete panel to settle. Ponding water is infiltrating down to the subgrade and can be seen as a waterline that is apparent 4 feet out into the roadway (dark area by the curb). **Recommend tool cleaning and sealing the crack to prevent further infiltration and halt settling.**

Area 4 has a 3/4" wide crack in concrete on Knollcrest Dr.

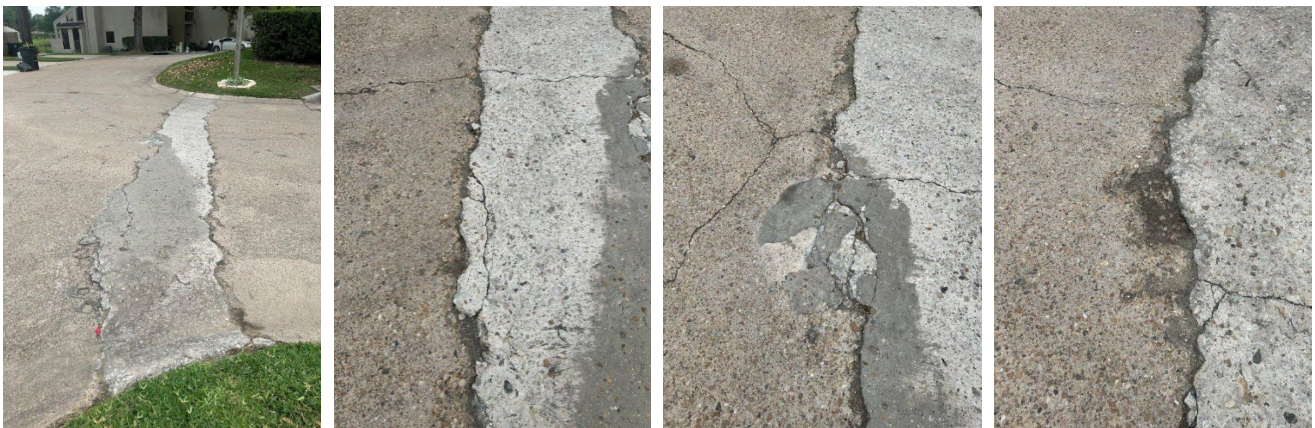
Area 5 Knollcrest Dr. near Block 2, Lot 6 (Priority 3)

The concrete roadway previously was chipped out to install conduit under the paving for streetlights. The removal and repair were done by breaking and chipping out the concrete. The repair was done without saw cutting to create a smooth butt joint. The edges do have some cracking and chipping, but the area does not appear to need immediate repair but the edge will continue to degrade from. This area should be monitored and re-evaluated in a couple of years and can be considered for repair in future repair phases. **Recommend cutting out an area approximately 4 feet wide (3 inches outside of the jagged joint minimum) for the full width of the street. Provide saw cut butt joints on both sides and seal the joints. Approx. 12 SY.**

Area 5. Concrete chipped out and replaced without saw cutting at northern end of Knollcrest.

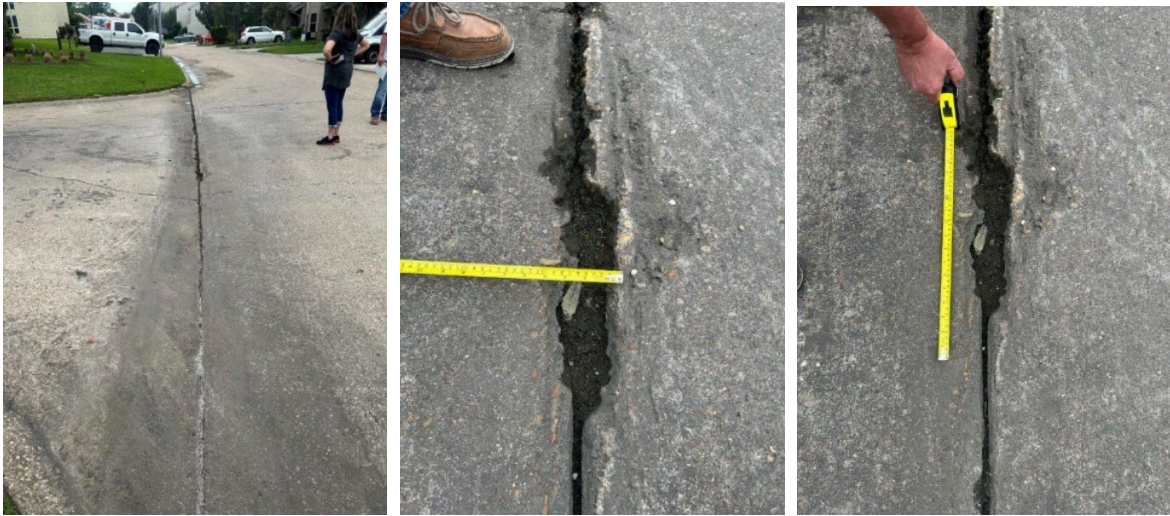
Area 6 Lakewood Drive: West Joint of Unnamed Connector Street (Priority 1)

The concrete expansion joint in this area needs to be sealed. The original seal is gone and water can infiltrate below the concrete. The joint has a couple of areas where the edge of the concrete has chipped and has created a larger crack/void for water to infiltrate through. Water appears to pond/stand in the joint after any type of runoff (rain, sprinklers, washing cars). The paving currently has not settled between panels and concrete patching in the chipped areas will not hold up. **Recommend tool cleaning to remove all dirt and debris and seal this joint in the first repair cycle to halt any infiltration. A backer rod should be used with the sealant to fill in the lower areas of the joint. Approximately 50 LF of joint sealant is required.**

Area 6 is an expansion joint that has deteriorated and allows infiltration. A sealant in the joint is needed to stop infiltration.

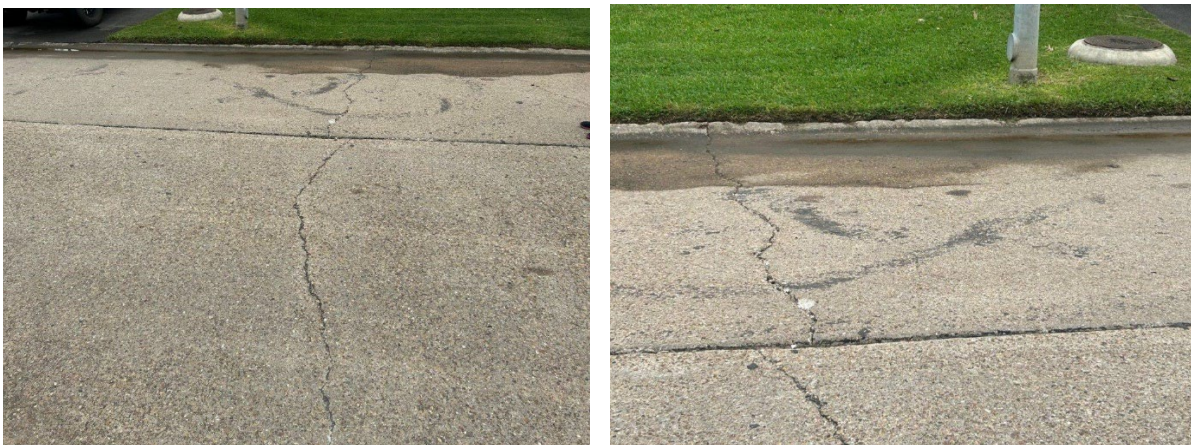
Area 7 Lakewood Drive at Block 2, Lot 2 (Priority 1)

The concrete at this location has a substantial crack across the full road width. The western panel has settled 3/4" measured at the centerline of the street. The ponding area is apparent from the watermark. **Recommend tool cleaning the cracks and centerline joint and sealing all joints and cracks in the area to prevent infiltration that can lead to continued future damage.**

Area 7 has a substantial crack that should be sealed to prevent further damage.

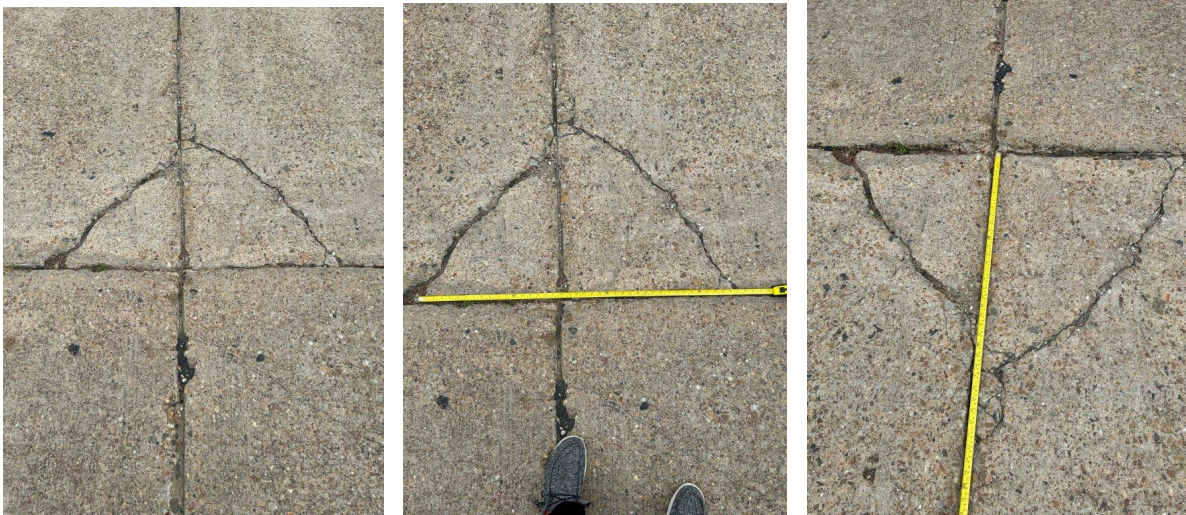
Area 8 Lakewood Drive at Block 4, Lot 2 (Priority 1 -Seal) (Priority 3-Repair)

The corners of the concrete at two adjacent panels have cracked at the centerline of the road. This indicates infiltration that has weakened the subgrade. Enough weight from many vehicles has cracked the corners and allowed the pieces to settle 3/4" below the adjacent panels. The general dimensions are 42" x 32" which will require a minimum repair area to patch of 48"x 48" or 2 SY. **Recommend sealing the cracks to stop infiltration and then monitoring (Priority 1). Include the location in a future concrete repair phase (Priority 3).**

Area 8 has broken corners due to infiltration and failed subgrade

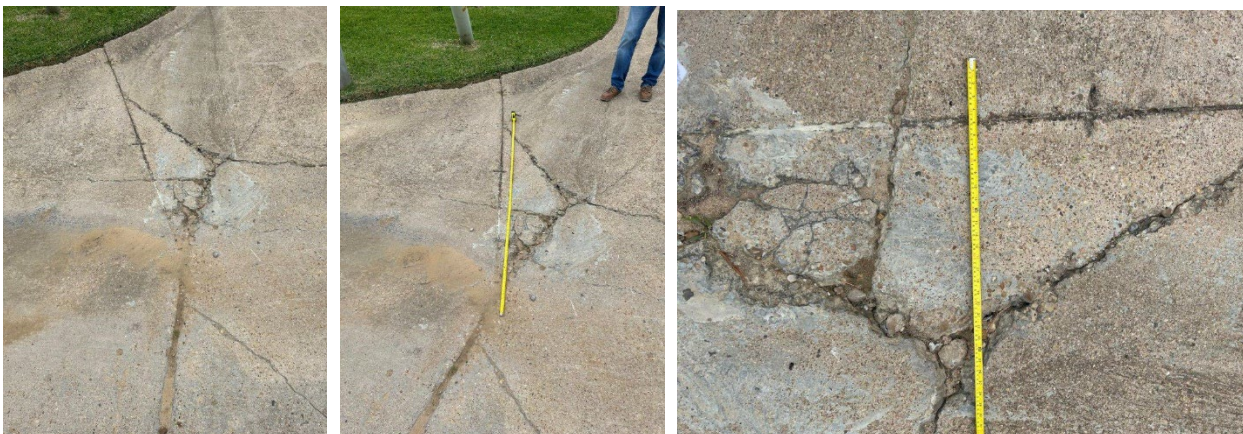
Area 9 Lakewood Drive at the intersection of Trail Hollow Drive (northern area) (Priority 2)

The northern area of the intersection has cracked into a triangular section measuring 6' x 2'. It appears the area has cracked to a soft subgrade and excess weight. This area will continue to degrade over time due to infiltration and softening of the subgrade and the frequency of heavy loads over the area. The area does look poor but the top surfaces are flush. This area should have a rectangular repair patch that is 3 to 6 inches outside of all cracked lines. The estimated repair area is 4'x8' min (4 SY). **Recommend saw cutting full depth to remove the damaged concrete. Remove and replace 4 SY of concrete in a rectangular shape (avoid acute/sharp angles).**

Area 9. A triangular cracked area on Lakewood Drive at the intersection of Trail Hollow Drive.

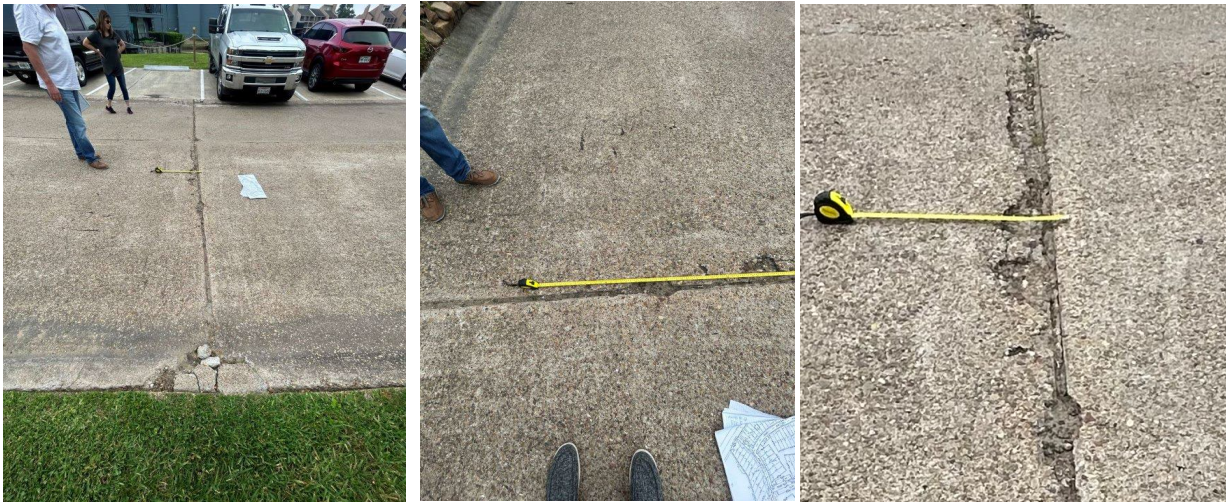
Area 10 Lakewood Drive near Parking Area (Priority 2)

The concrete joint at this location has edge cracking that appears to be due to infiltration and softening of the subgrade under the joint and heavy loading on the joint over time. The surface of the paving is still flush except for the broken edges and should be considered for repair soon. **Recommend saw cutting full depth two feet from the joint on the damaged panels for the width of each 12.5-foot wide panel (centerline to gutter).** Reestablish the expansion joint. Remove and replace 6 SY concrete pavement and seal all joints.

Area 10. Damage at the edge of the joint needs repair to prevent more damage.

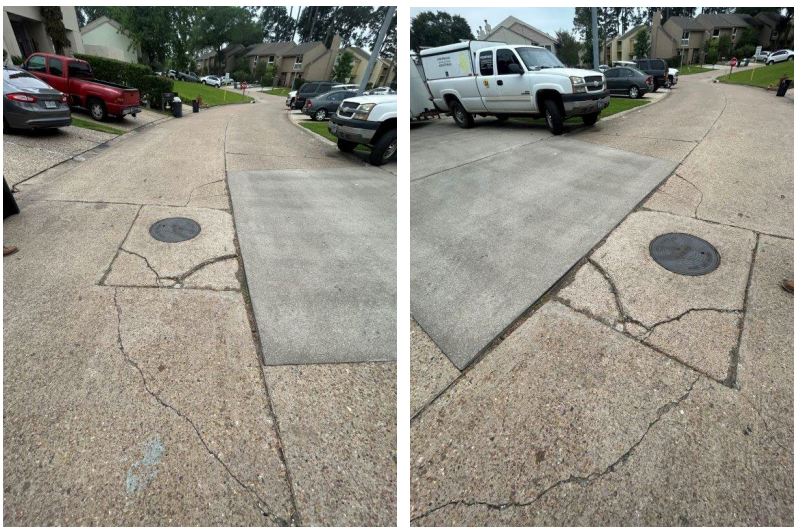
Area 11 Lakewood Drive near Parking Area (Priority 2)

The concrete in this area has cracked on both sides of a storm manhole and the apron around the manhole. The damage appears to be due to infiltration which has caused softening of the subgrade and heavy loads applied at this location. There is a previous area of concrete that was replaced adjacent to the manhole. It appears no joint sealant was used around the previous repair. **Recommend removing and replacing the concrete apron around the manhole (~70"x 60" = 3 Y).** Saw cut full depth 5 feet north of the MH apron for the full street width and approximately 5 feet south of the MH apron for an area of 16'x12.5' or 20 SY (not including conc apron). Replace 23 SY concrete in total for all repairs. Seal all joints including the previous repair area.

Area 11. Damage around storm MH.

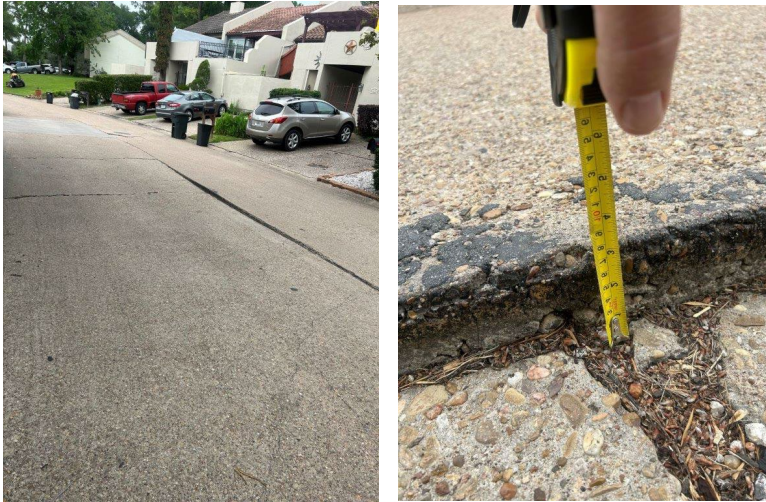
Area 12 Lakewood Drive near Block 13, Lot 4 (Priority 1)

The concrete at this location has settled in the west panel. Infiltration and softening of the subgrade along with heavy loads being applied have led to a 3" of settling between panels. The edge of the higher panel is black from tires rubbing the edge. This area needs immediate repair to provide a flush surface between panels.

Area 12 on Lakewood Drive has settled 3" as measured relative to the adjacent panel.

Recommend saw cutting full depth beginning at the joint of a previous repair area to a location approximately 35 feet south of that joint to remove all broken, cracked, and settled concrete. The approximate area is 35'x12.5' wide (49 SY). Seal all new and existing joints.

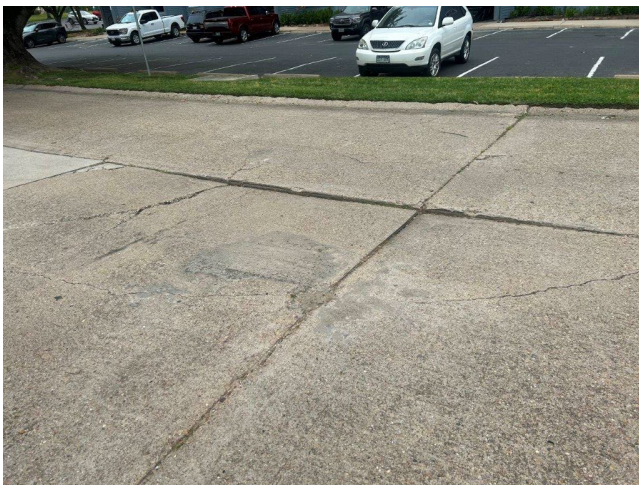
Area 13 Lakewood Drive near Block 13, Lot 4 (Priority 1)

The concrete at this location has settled 2" in the panels east of the centerline. Infiltration has led to softening of the subgrade. Over time heavy loads over the soft subgrade have caused settling, cracking, and broken concrete. The west panel has also developed cracks due to the soft subgrade. **Recommend saw cutting full depth and removing all broken concrete on the eastern panels from a previous repair patch to a location approximately 19 feet north (measured along the centerline). Saw cut perpendicular to the curb, remove and replace all damaged concrete (~30 SY). Install an expansion joint to replace the existing joint. Seal all joints and seal the cracks and joints on the adjacent western panels.**

Area 13 on Lakewood Drive has settled 2" at the centerline of the street.

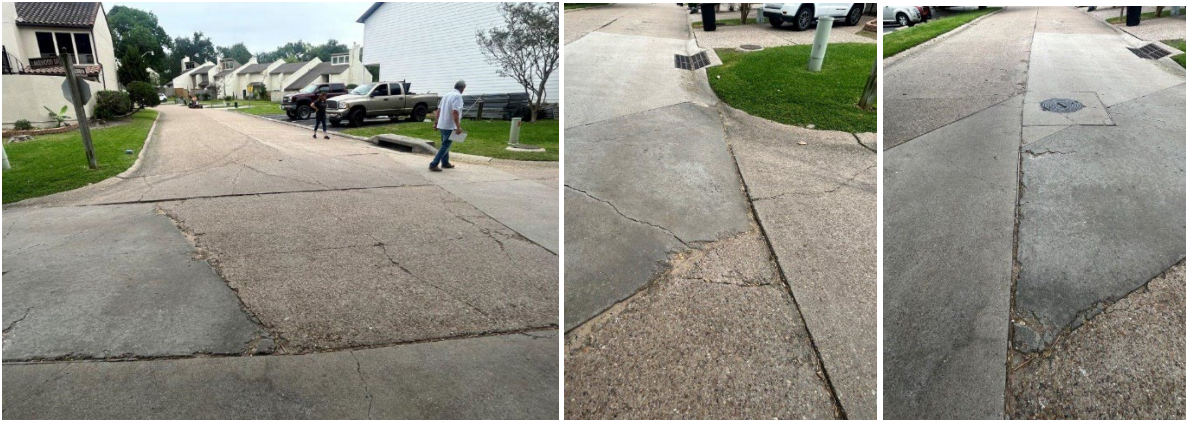
Area 14 Lakewood Drive at the intersection of Glenview Drive (Priority 1)

This area has several issues to address. Infiltration has led to the softening of the subgrade which has allowed the concrete to settle 2" between surfaces. The area has had previous repairs and appears the joints were not sealed and allowed infiltration. A previous storm pipe repair between inlets on Glenview to the west side of Lakewood Drive has a failed seal around the pipe in the inlet on Glenview. The failed seal has allowed stormwater to flow under the paving beside the pipe which over time has created a large void under the concrete. The concrete panel is slowly crumbling at the joint from heavy vehicles applying press at the top edge. The dowel bars between the panels appear to be the main support across the void and the western panel has stress fractures at the doweled location due to heavy loads. **It is recommended to saw cut full depth from the NW corner of the Glenview Inlet to the center of the roadway. Remove all damaged concrete. Seal around the storm pipe with non-shrink grout at Glenview. Reestablish all existing joints. Repair the subgrade. Repour all concrete areas. Seal all joints and any cracks on adjacent concrete panels. Approx. 67 SY concrete.**

Area 14. Concrete is cracked, broken, and settling at the intersection.

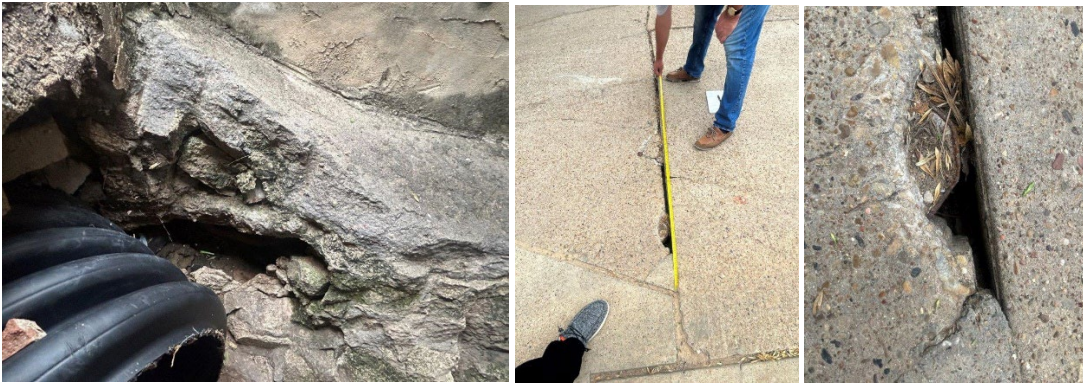
Area 14. A failed seal around the storm pipe has led to voids under the paving and chipping off material at the edges.

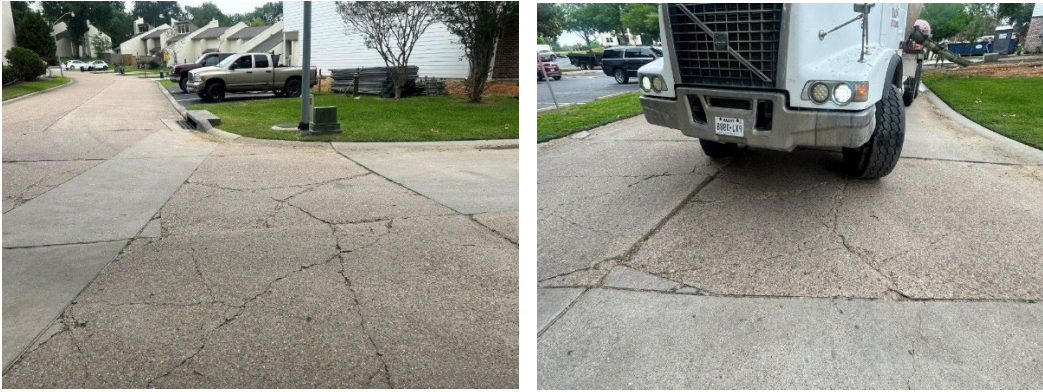
Area 15 Lakewood Drive at the south side intersection of Glenview Drive (Priority 2)

The concrete at this location has many cracks running in all directions. Infiltration has softened the subgrade and repeated heavy loads on the pavement have cracked up the concrete. Some minor patches have been filled in small areas. The area requires replacement, however, it can be included in the second phase of improvements. **It is recommended to remove and replace the concrete in this area between previously repaired areas. Reestablish expansion joints and seal joints. This area varies from 10 to 12 feet wide by the full width of the road of 25 feet for an approximate area of 30 SY.**

Area 15. Replacement of Panels required.

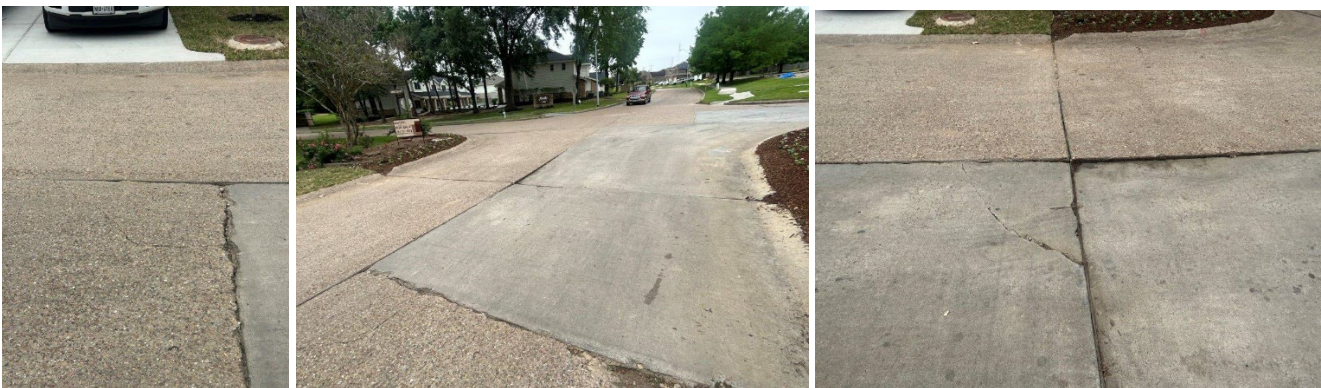
Area 16 Lakewood Drive at the intersection of Melville Drive (Priority 1)

The concrete at this location was replaced in more recent years but is failing again. Picture 1 indicates this repair joint did not have a smooth saw cut joint on the north end where it meets up with the existing concrete. It also has a large corner of the existing concrete broken off that needs to be repaired. Previous repairs did include some expansion joints along the centerline and at the existing joint locations, however, the joints were not sealed and allowed infiltration, pumping, and settling. This area was inspected after a rainfall event. Picture 3 shows the 2" settled pavement and broken corners. When storm runoff flows to this location, the water ponds where the pavement has settled (lowest point). As vehicles roll over the concrete (heavy loads), the water is forced out from under the concrete (pumping). The saturated and softened subgrade fails and the subgrade material is forced out with each pumping action leading to the settling and broken edges. Failure to repair this area can lead to adjacent panels cracking and breaking and creating a larger repair area. **It is recommended to remove concrete at the next butt joint north of the jagged joint to capture all broken corners and cracked concrete (approx. 10 feet to the joint). This will be all the concrete west of the centerline to the north side of Melville Drive. Replace all expansion joints at previous locations. The area is approximately 45 feet long, 25 feet wide, plus the radius return area. Approximately 75 SY of Concrete. Seal all joints.**

Area 16 with a jagged edge butt joint, 2" settled area, cracks, and broken corners.

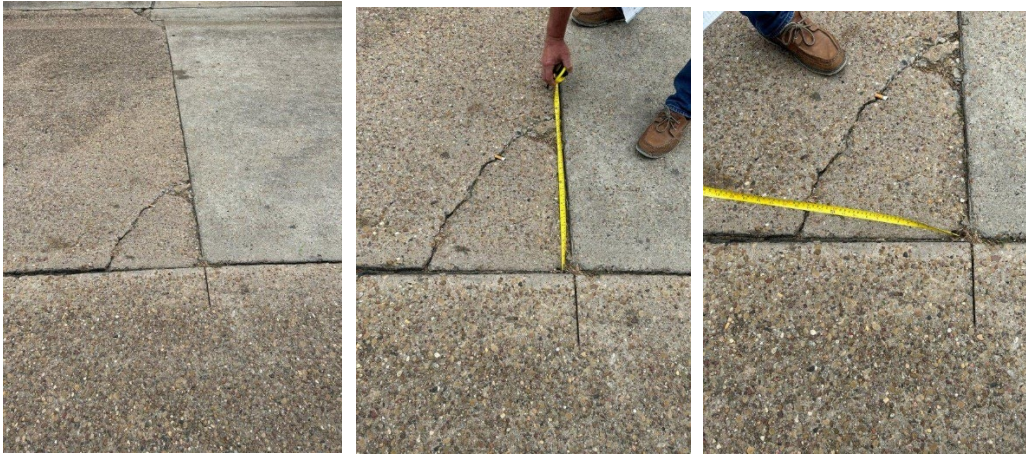
Area 17 Glenview Drive near Block 9, Lot 3 (Priority 1 seal cracks) (Priority 2 repair)

Area 17 has cracked corners at a butt joint where a newer section of concrete was joined up with this existing slab. The new concrete joints were not sealed and the existing seals along the centerline have been missing for many years. Infiltration has softened the subgrade and heavy loads have snapped the corner off near the center of the roadway. The adjacent south panel has settled approximately one inch. Glenview is a less traveled crossroad in Section Seven. The location appears to have a good grade to let water flow away and is considered not critical for immediate repair. **It is recommended to include this area in a future repair phase. Saw cut, remove, and replace approximately 3 feet (min) of concrete north of the centerline adjacent to the newer concrete panel for the full width of the north panel (4 SY). Seal all joints after repair (Priority 2). Temporary crack fill is recommended to help prevent any further settling or damage (Priority 1).**

Area 17 with broken corners and a settled portion of a panel

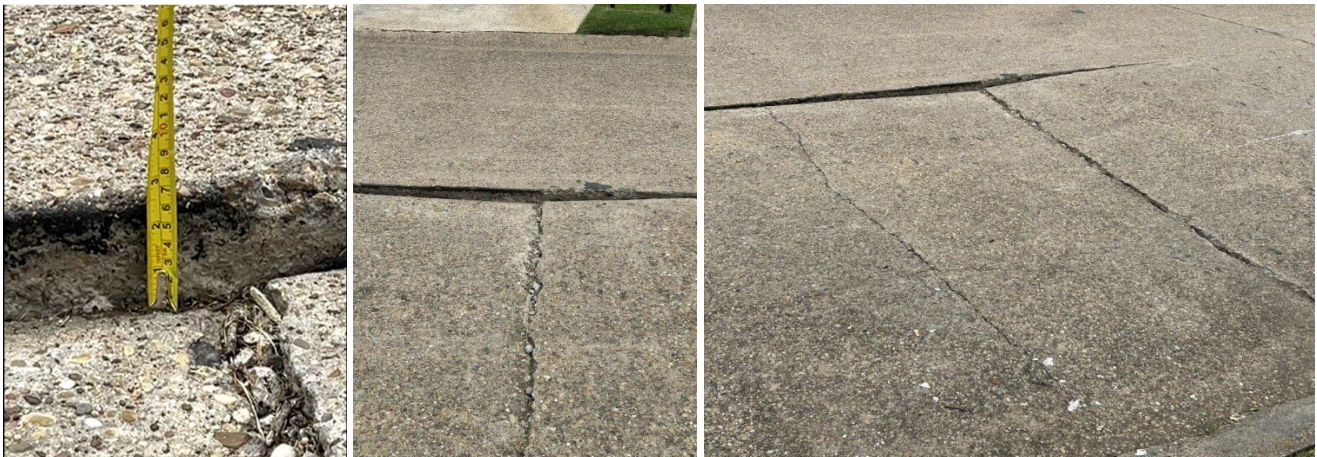
Area 18 Glenview Drive near Block 9, Lot 5 (Priority 2)

Area 18 has pavement that has settled 3 inches on the south panel measured at the centerline of the road. Infiltration has softened the subgrade and the panel has cracked in three places. Heavy loads from vehicles have slowly allowed this area to “pump” and slowly remove subgrade material, leading to the settling as shown in the pictures below. This area needs repair as soon as possible but can be considered with a second phase of repairs. Note in Picture 3 below, there is a concrete joint to the right of the picture (near the top). **It is recommended to saw cut approximately 20 feet (west) of the existing expansion joint, remove, and replace all concrete for the full width of the south panel (30 SY). Seal all joints after the repair.**

Area 18. Three-inch settled and cracked panel. The panel has 3 significant cracks in the pavement.

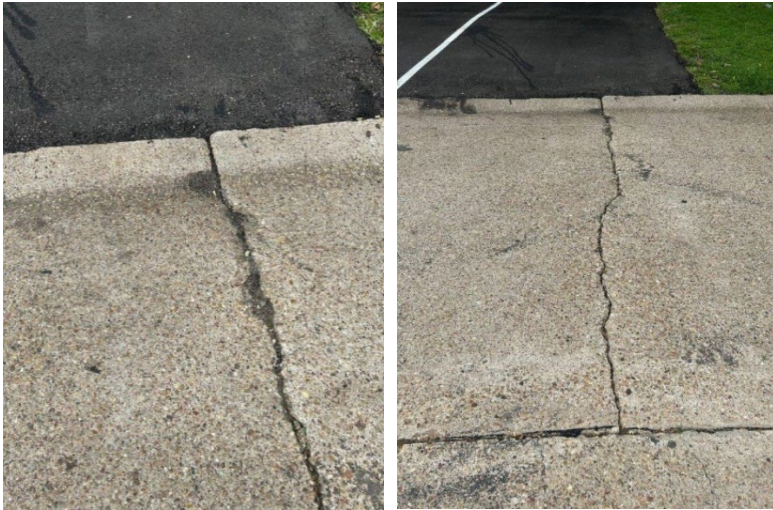
Area 19 Glenview Drive near the East Parking Area (Priority 1)

Area 19 is near the far east end of the parking area. There is a large crack with a 3/4" wide opening. **It is recommended to tool clean the crack and fill the void with a sealant to prevent infiltration, which can lead to future repairs.**

Area 19 on Glenview has a significant crack that will allow infiltration.

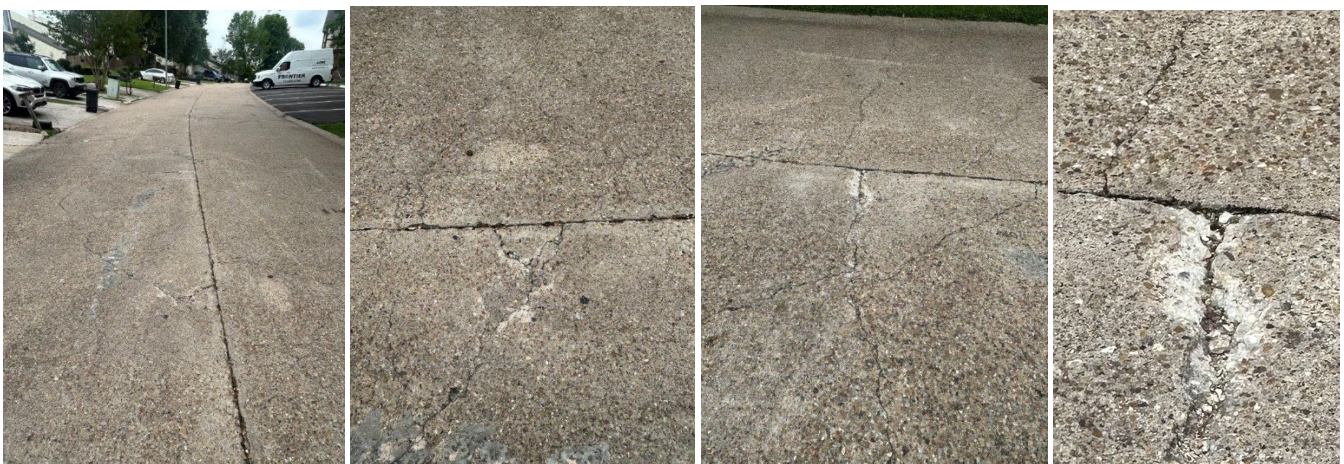
Area 20 Glenview Drive near the intersection of Knollcrest Drive (Priority 2)

Area 20 is a panel on the south side of Glenview that has severe cracking. There is no remaining joint seal which has allowed infiltration and softening of the subgrade. The soft subgrade with heavy loading has caused the cracking over time. As seen in the pictures below, the vehicular loads press down on the surface at the crack and force the top edges to press hard against each other and chip the concrete away at the top. Freshly chipped concrete was observed during the inspection. **It is recommended to remove and replace the south panel of concrete from (but not including) the concrete apron at the intersection of Knollcrest (the area with curved curb return will remain) and measured back approximately 44 feet to encompass all of the worst cracked areas. Saw cut full depth for the 12.5-foot wide south panel. Seal all joints after concrete repair and seal all adjacent cracks to deter further issues. Approximately 62 SY.**

Area 20 on Glenview near Knollcrest has a significant area of cracking which has led to surface damage.

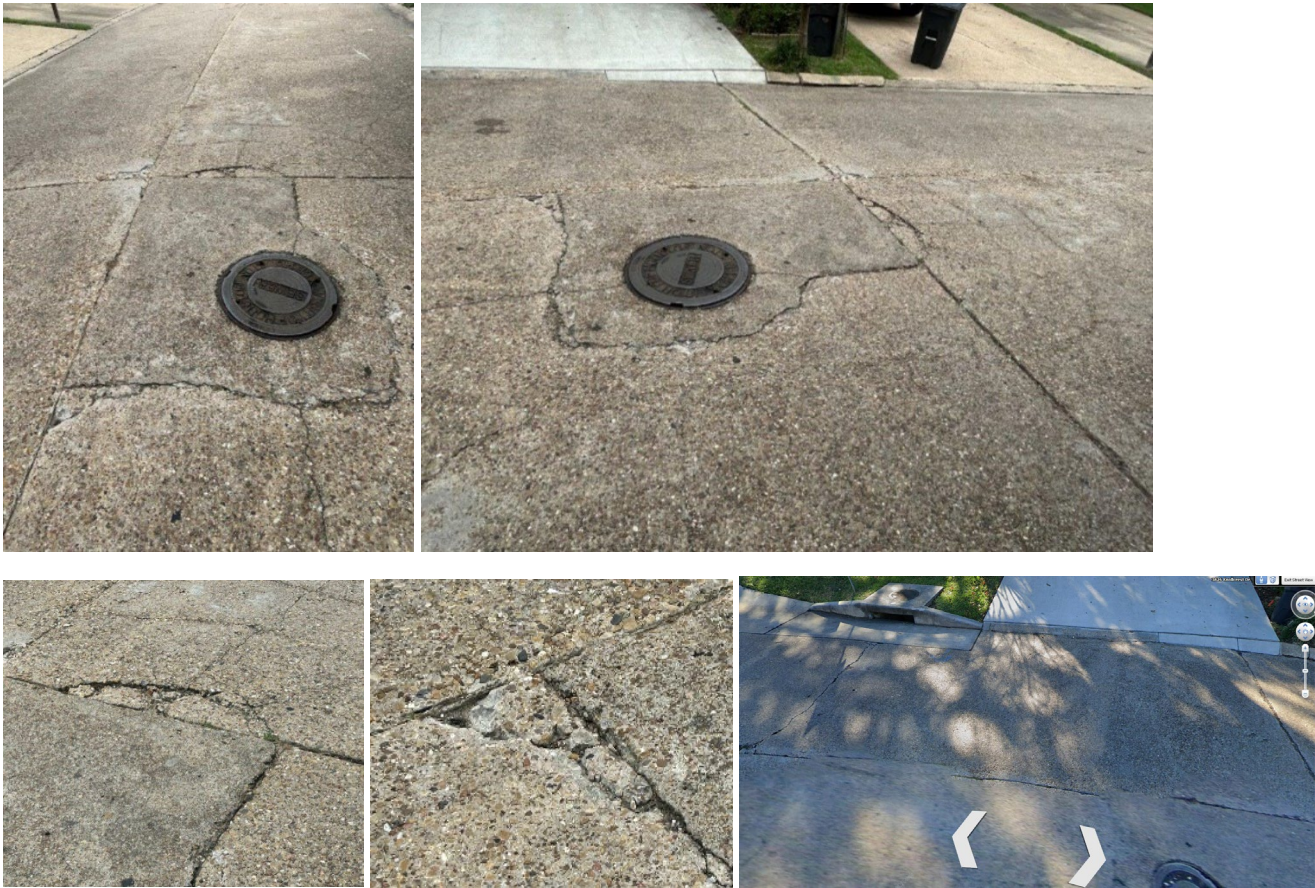
Area 21 Knollcrest Drive just north of Glenview Drive (Priority 2)

Area 21 has an existing storm manhole with an irregularly shaped apron surrounding the MH cover and frame. No sealant exists along expansion or butt joints and the apron was made without a saw cut and joint sealant. Although the surface has remained mostly flush, the concrete has broken and chipped from a soft subgrade near the joints and cracks due to infiltration and should be considered for repair in an upcoming repair phase. **It is recommended to locate the extent of the cracks, saw cut the full depth of concrete, then remove and replace the concrete in this area. Create a new square apron around the manhole (5'x5' min). Reestablish all expansion joints at existing locations and seal all joints. Butt joints should be saw cut and sealed when the concrete can withstand saw-cutting. The repair area is estimated to be approx. 10' long measured down the centerline and the full width of the west panel at 12.5'. The repair area will cross an expansion joint 3 feet south of the manhole. The apron is approximately 3 SY and the concrete paving is approximately 12 SY. Seal all expansion and butt joints and large cracks northward near the inlet on the east panel.**

Area 21 on Knollcrest. Irregularly shaped manhole apron with concrete cracking and chipping around the perimeter.

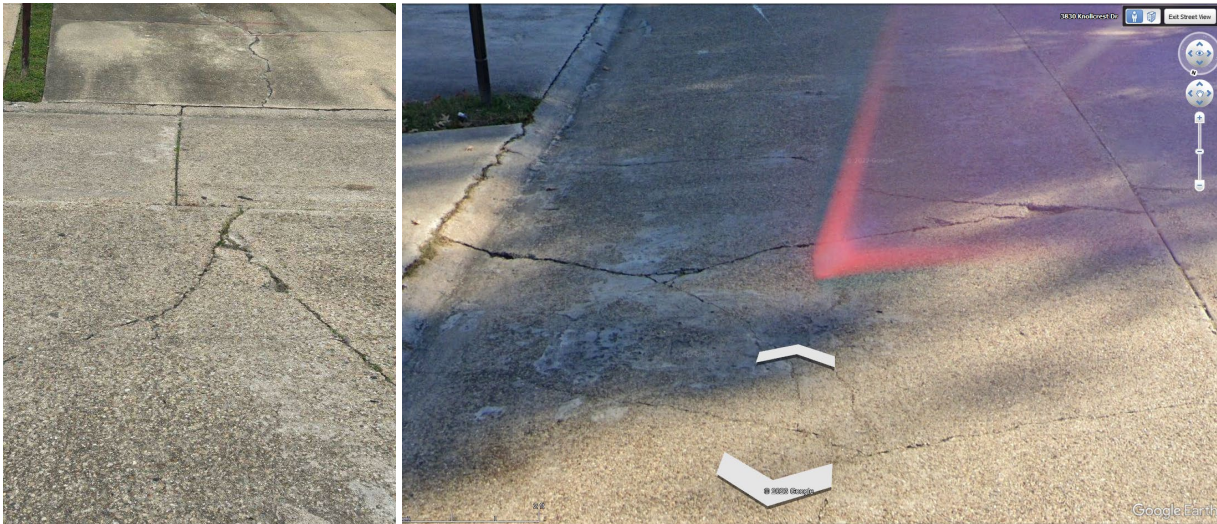
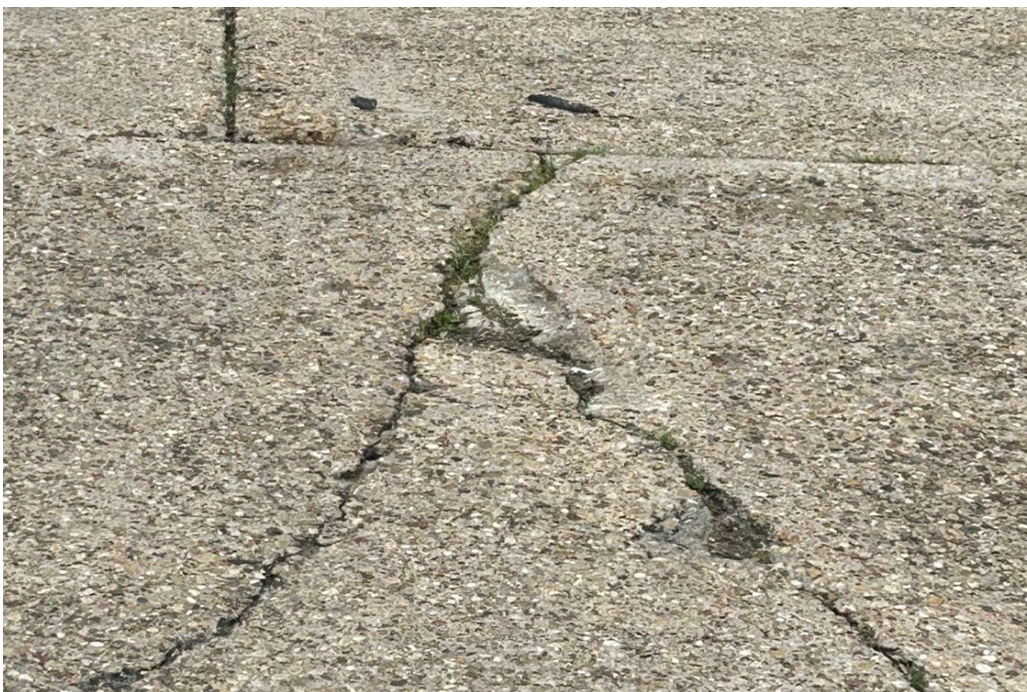
Area 22 Knollcrest Drive near Block7, Lot J (Replat) (Priority 1-Seal) (Priority 2-Repair)

Area 22 is an area that has cracked and is chipping away near the centerline of the street where two cracks merge and form a small acute angle. The subgrade appears to be softened due to infiltration through the joints. Fresh chipping from vehicular loads and tires hitting the weak point was observed during an inspection as shown by the lighter-colored concrete where the two cracks merge. **Recommend saw cutting full depth a minimum of one foot beyond the worst cracked areas, remove the broken and cracked concrete on this western panel, and replace the concrete pavement. The area will be the full width of the west panel (12.5 feet) and an estimated length of 12 feet to remove the failed material (17 SY). Reestablish the centerline expansion joint. Create butt joints at each end to tie into existing concrete. Seal all butt joints and expansion joints. Interim repairs should include tool cleaning of the cracks and sealing the cracks to help prevent infiltration and future damage.**

Area 22 on Knollcrest has merging cracks leading to chipping away from frequent vehicular loads and impact from tires.
