March 30, 2021

Drainage Evaluation on Common Area

Bleyl Project No. 12735

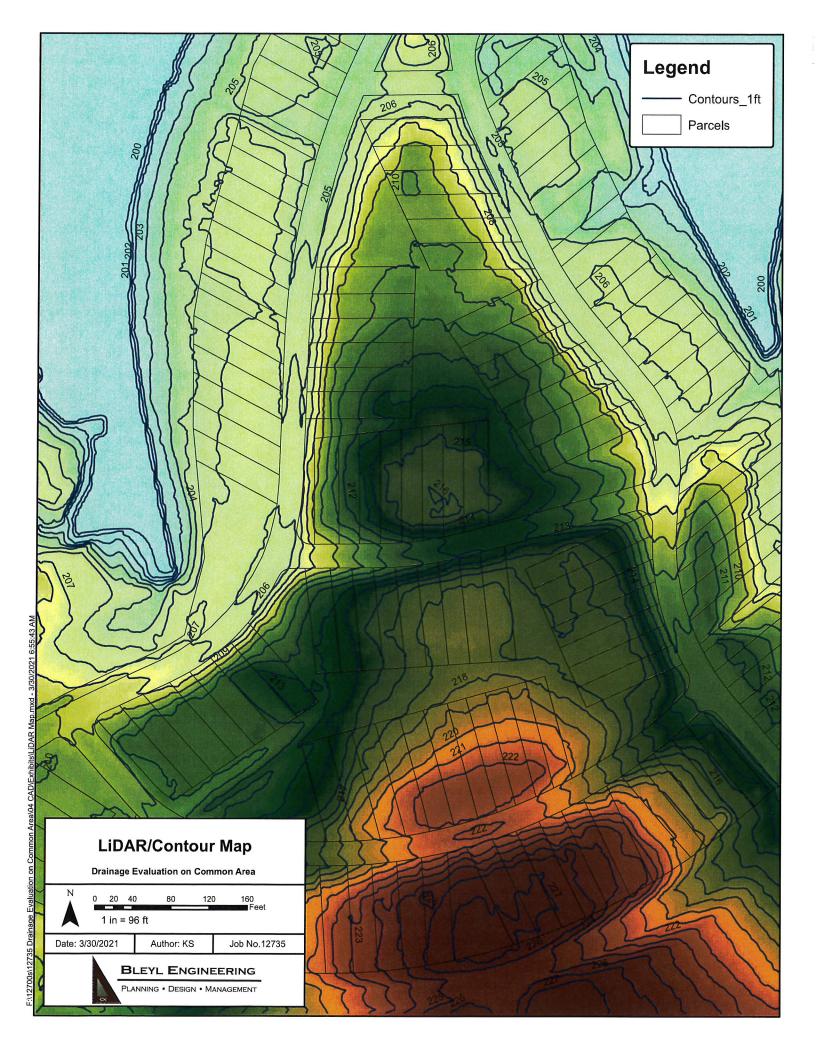
Attachment A

The natural topography of the land within GBR M generally slopes from a high southern point then to the east, west, and north. From our site visit, it is evident that storm water in GBR M will generally flow overland, until it reaches a street where it is captured and conveyed through storm sewer (located within road right-of-ways and easements) to Lake Conroe located along the northern properties in Section 7. We do not have detailed data on the size of the storm sewer within Section 7. Small area drains were found along the backyards of the properties that reported drainage issues in GBR M. These area drains appear to be connected to each other by 6-inch HDPE pipes and then most likely outfall in the street gutters/curb inlets, but this could not be confirmed.

The natural topography of the land within GBR L generally slopes from the east to the west. From our site visit, it is evident that storm water will flow overland, until it reaches a street where it is captured and conveyed through storm sewer (located within road right-of-ways and easements) to Lake Conroe located along the northern properties in Section 7. A small berm runs parallel with the properties of interest, about 15 feet off the property line, and the land in between the berm and property line appeared to be relatively flat, but LiDAR shows that storm water should flow towards Glenview Drive.

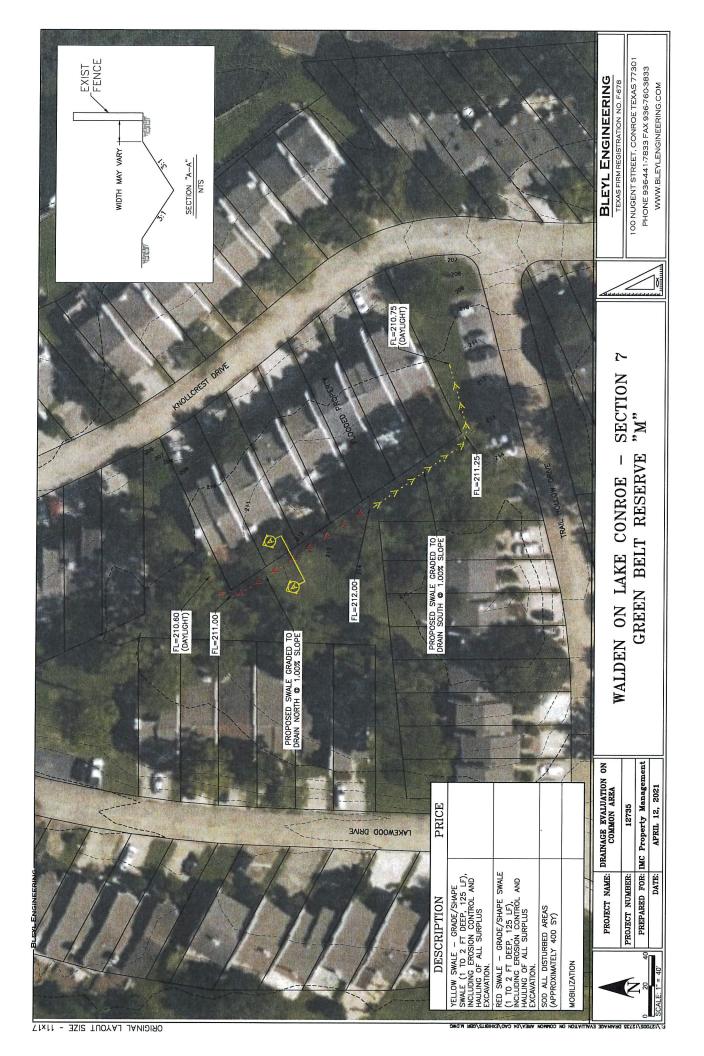
Attachment C

Based on our findings, the properties located by GBR M have drainage issues because the general terrain slopes towards the buildings. If the properties in GRB M haven't experienced drainage issues in the past, then it is possible that the area drains located near the property lines have been rendered ineffective over time due to the buildup of debris or settlement of the flow lines. Bleyl believes that these properties would benefit from two swales that are graded to direct the flow of stormwater north and south along the property lines as shown in **Attachment C**. This will allow for stormwater to flow over the ground and away from the homes. The two swales will daylight on either side of the properties to allow for stormwater to flow overland to Knollcrest Drive.

In the attached exhibit for GBR M, we show both swales starting at an elevation of 212.00 and are graded at an approximate 1.00% slope away from each other. We also propose 3:1 side slopes for both swales, the width will vary depending on the depth throughout the swale. There are existing trees and utilities that may be in conflict. The shown alignment of the swales may be adjusted to avoid existing trees and utilities.
