# *Best Choice Home Inspections*

## Property Inspection Report

3167 Oak Tree Ln, Tim Buk Too, VA 00000

Report# 21051969

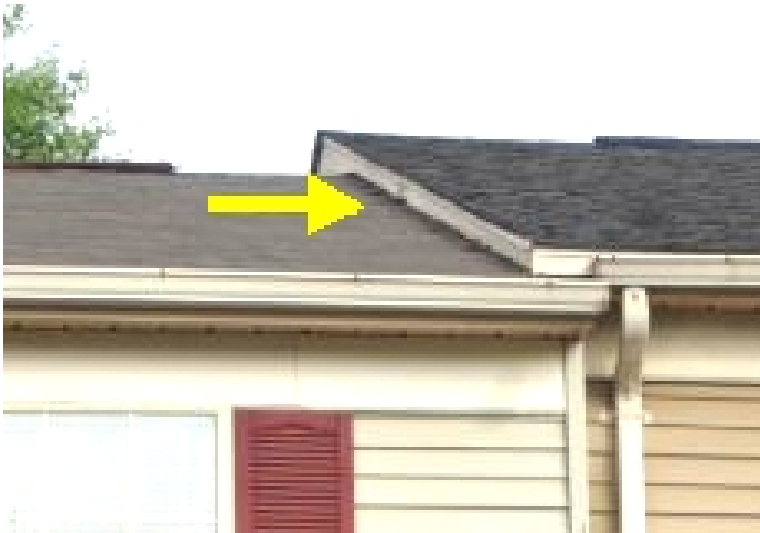
Loose shingle noted along front edge of roof; repair or replace as necessary

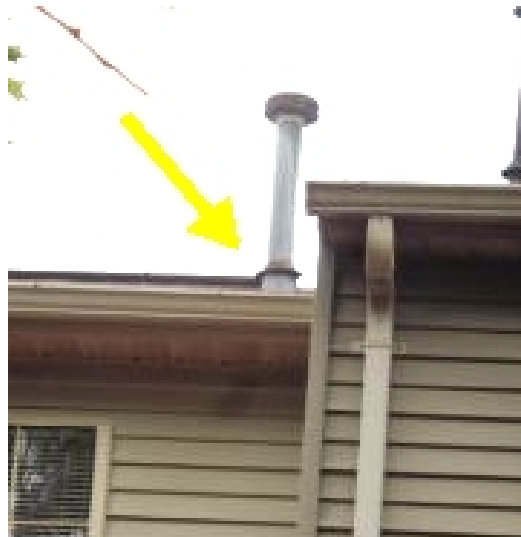
Furnace vent has rust; repair or replace as necessary..

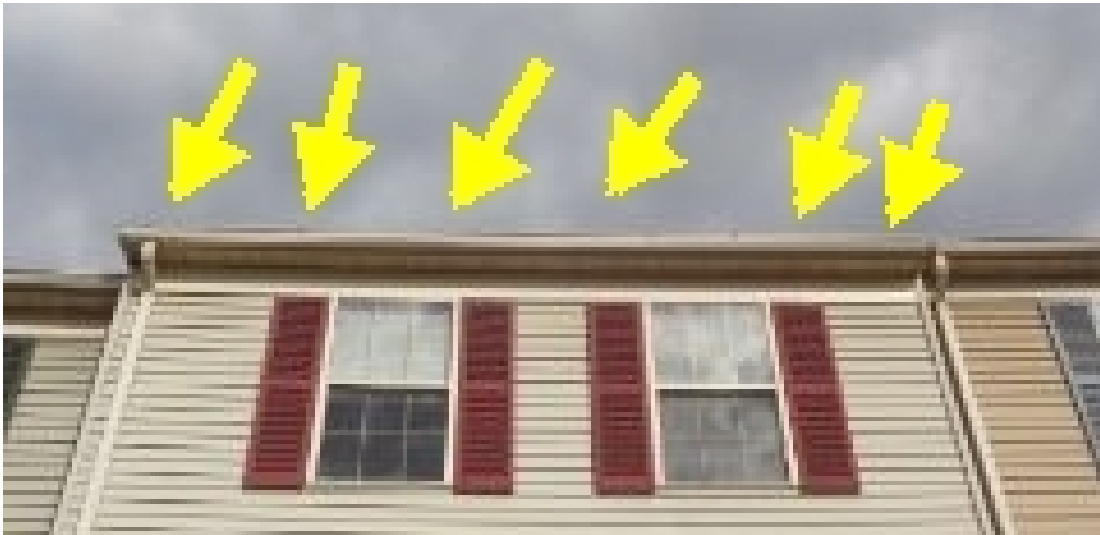
Rusted gutter nails are generally found when gutters get backed up from clogging; repair or replace as necessary

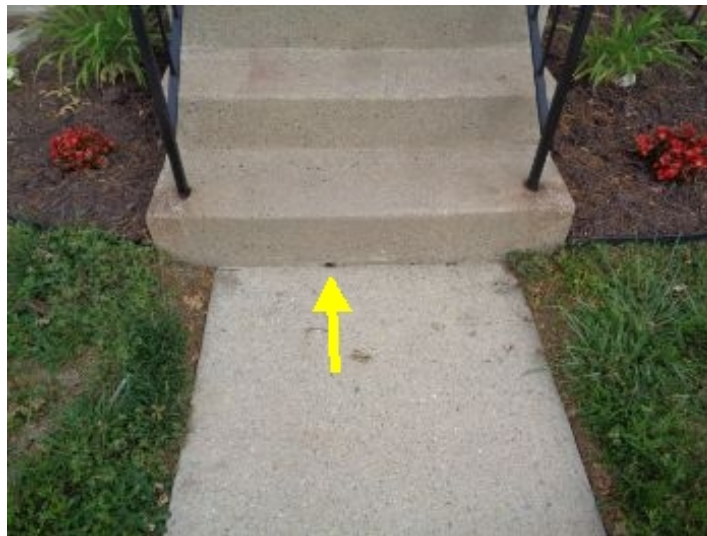
Stoop has opening at drainage line that can lead to drainage beneath front stoop, which can lead to other moisture related conditions including mold; repair or replace as necessary

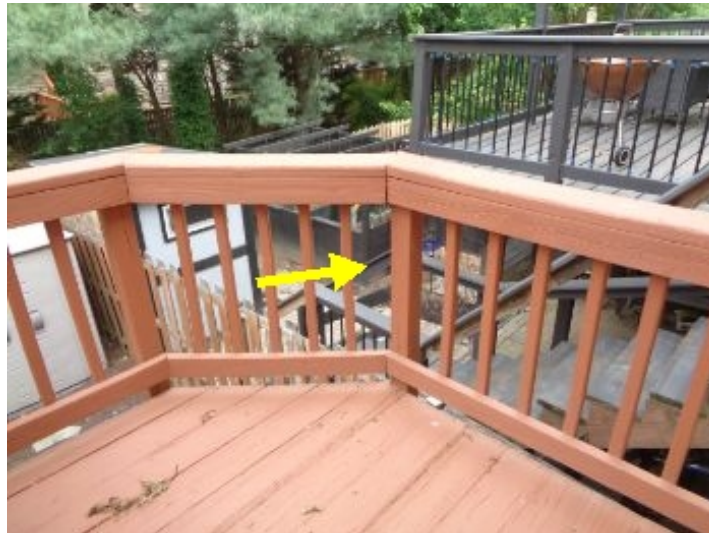
Deck rail balluster spacing should be no more than 4"; repair or replace as necessary

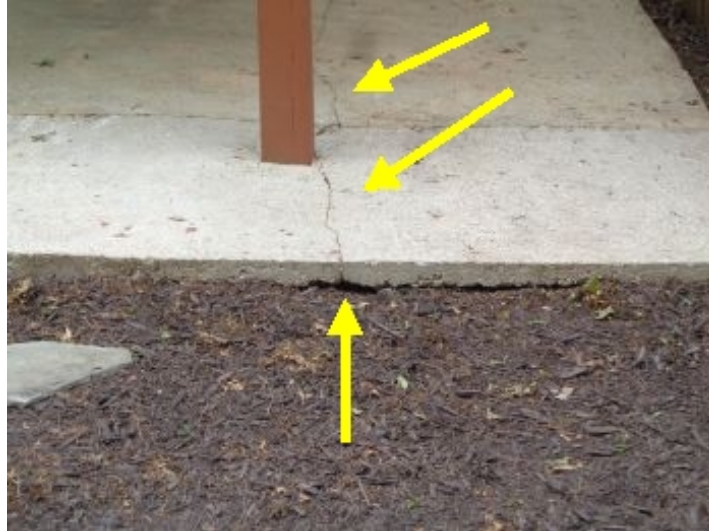
Patio is cracked, probably due to uneven support underneath the slab; repair or replace as necessary

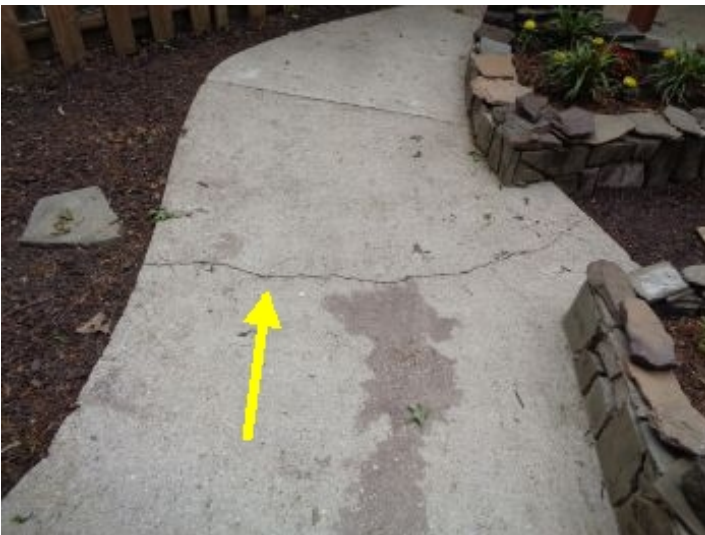
Common cracks noted; keep sealed to help prevent further damage

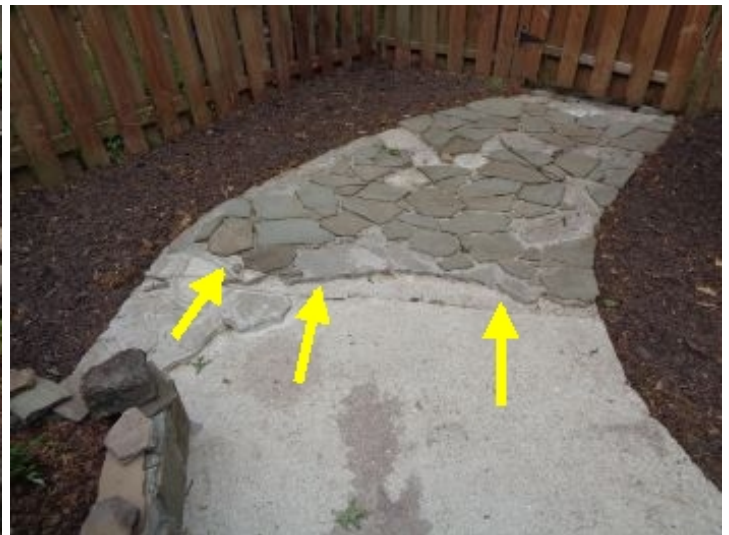
Uneven surfaces are a trip hazard; repair or replace as necessary

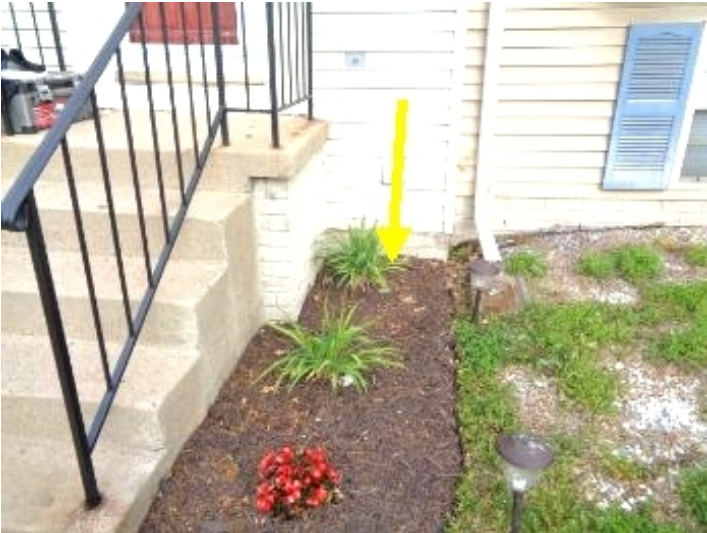
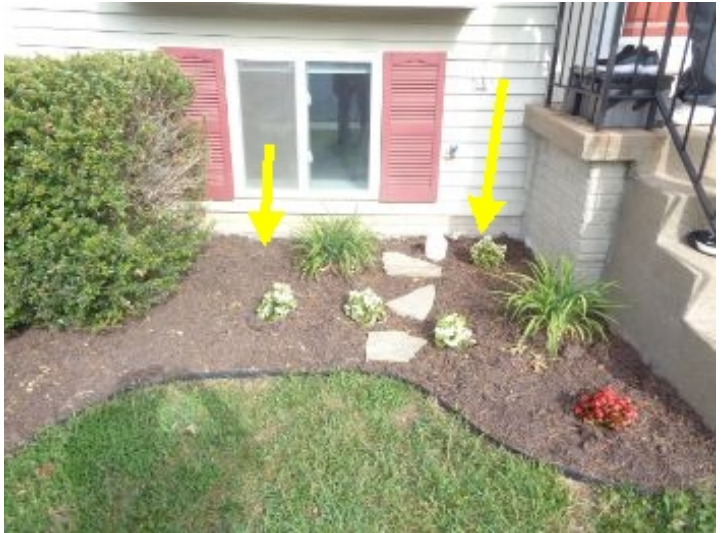
Improper soil slope toward foundation walls noted in various areas around perimeter of home can lead to moisture intrusion and other moisture related conditions including mold; repair or replace as necessary

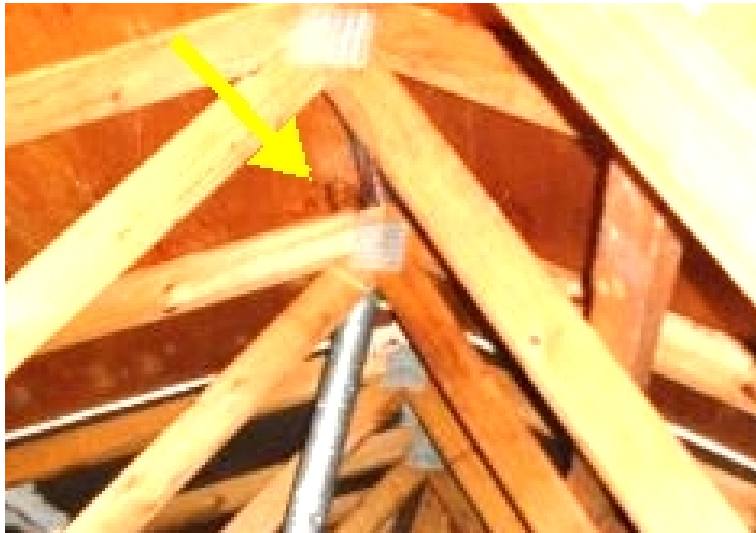
Stain noted at ridge line is also sitting close to bathroom ventilation vent, which is discharging at the same area of ridge vent and may or may not be causing staining; repair or replace as necessary

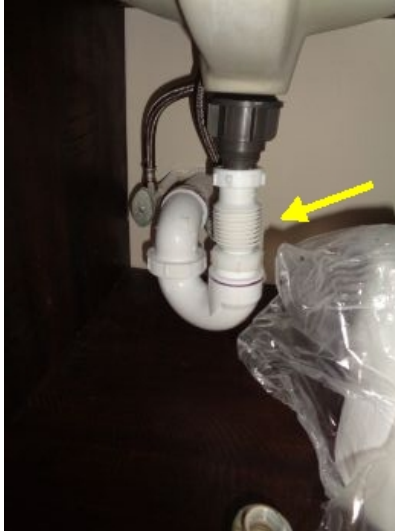
Temporary drain line should be replaced with a permanent drain line..

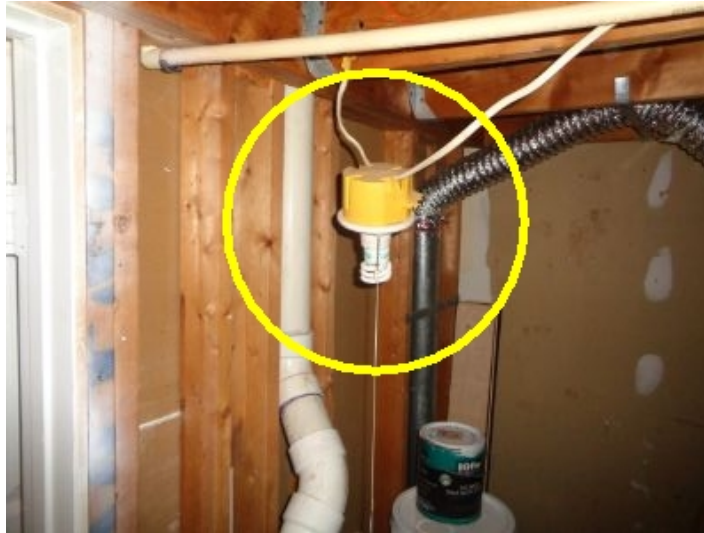
Lighting assembly is not fully installed in basement; repair or replace as necessary

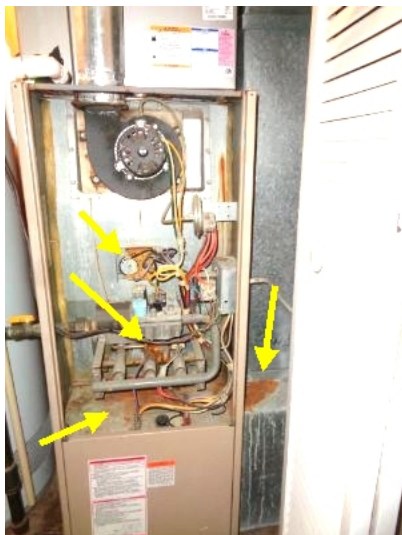
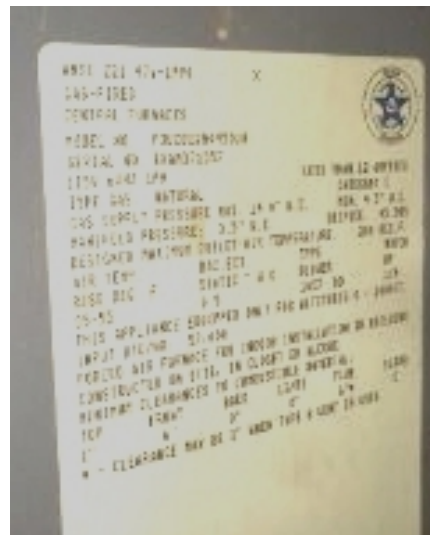
Furnace and ductwork is full of rust, and burners are burning with too much yellow; it is recommended that furnace be fully evaluated by a qualified hvac contractor and repair or replace as necessary

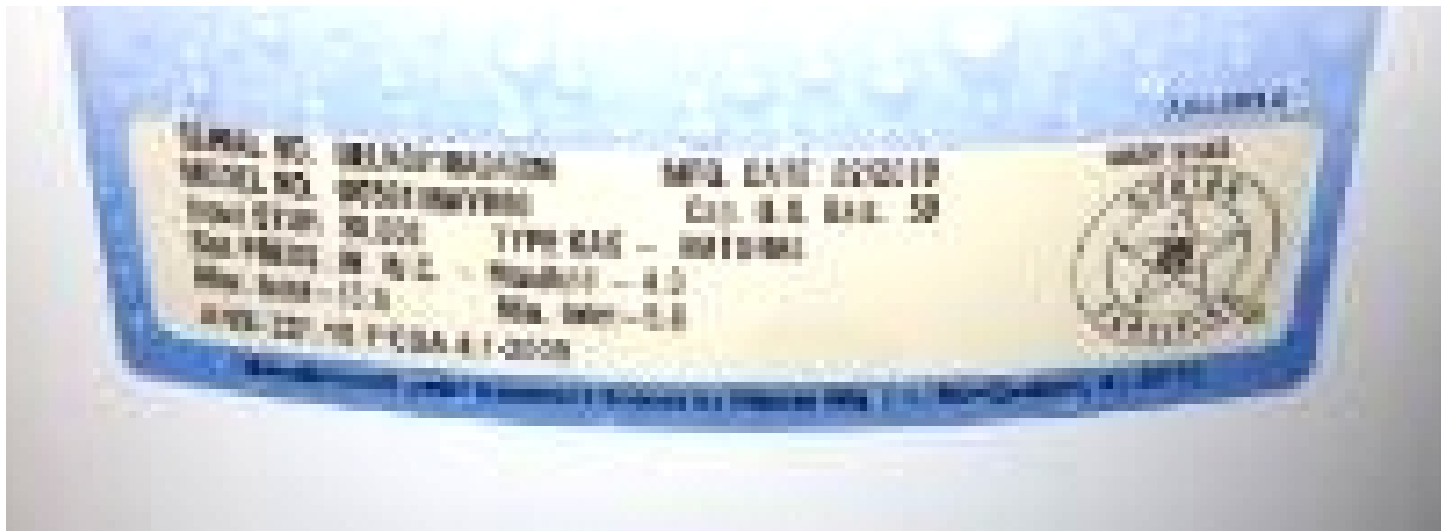
- Water heater info pictured
- Water Heater heat exchanger is showing signs of breakdown; repair or replace as necessary
- Age
