# LAND SHARK

# REPORT OF MARINE SURVEY

### LAND SHARK

CONDUCTED BY  
MICHAEL CUNNINGHAM

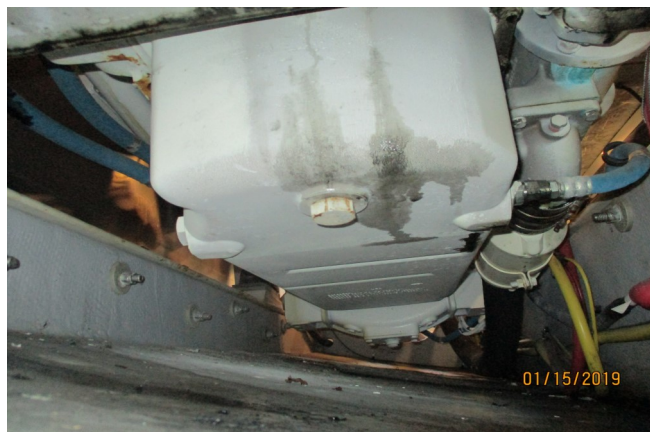
Molded FRP longitudinal stringers and pan structure, in conjunction, rubber dampened adjustable motor mounts are bolted to the structure and used to adjust the shaft alignment as well as secure the engine to the hull stringer structure. Good/poor/A good wire brush cleaning is recommended.

Isolated areas beneath the engines. Engine fluid and loose debris falls into bilge. Appears to be in good condition.. Clean

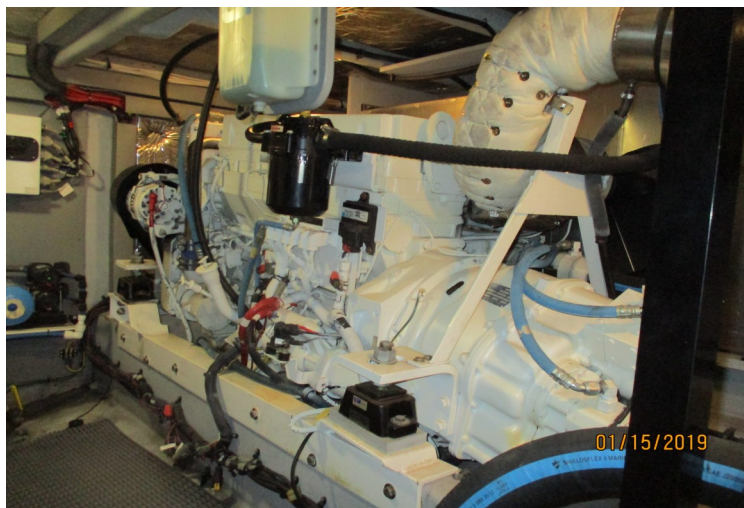
Engine Bonding:	Blocks should be bonded to the grounding system E-11.16.1; E-11.15.2.1 Minimizes stray current damage from the DC fault to the block. Lack of bonding is also a significant AC shock hazard. Bonding also helps minimize side flashes in lightning strikes. ABYC E-11.16.1 If a DC grounding system is installed, the DC grounding conductor shall be used to correct metallic non current carrying parts of DC machinery and engine blocks to the engine negative terminal or its bus for the purpose of minimizing stray current corrosion and ensuing a fault current path in the event of a short circuit. (see page 31) Adequate.
Lubrication:	Levels were within the dipstick marks. Visual inspection of engine oil showed that it was free of diesel fuel odor, visible metal particles and water born contaminants. No olfactory or volumetric evidence of fuel migration.
Fuel/Lube Transfer:	Each tank has a fuel pump, oil changer in the engine room not tested.

Belts & Pulleys	Normal tension. Recommend placing on a maintenance schedule
Exhaust System:	Wet, Hose to pipe connections are double clamped where sighted, The exhaust gases enter a waterlock muffler on the aft side of the engine, then exiting through fittings under water exhaust. No leaks sighted. Recommend being placed on a maintenance schedule.
Engine Gauges:	Smart craft vessel view: tachometer, temperature, oil pressure, volts appear operational.
Engine Synchronizer:	Synchronization is provided by a Glendenning mechanical unit, appears to operate at time of survey.
Engine Wiring:	Supported.
Engine Ground:	Multiple engine blocks, including gensets, must be bonded together. Reason: Backup negative return path if engine ground connection becomes poor. ABYC 11.5.4.4 Multiple Engine Installation If a boat has more than one engine with a grounded cranking motor, which includes auxiliary generator engine(s), the engines shall be connected to each other by a common conductor that can carry the cranking motor current of each of the grounded cranking motor circuits. Out-board engines shall be connected at the battery negative terminals

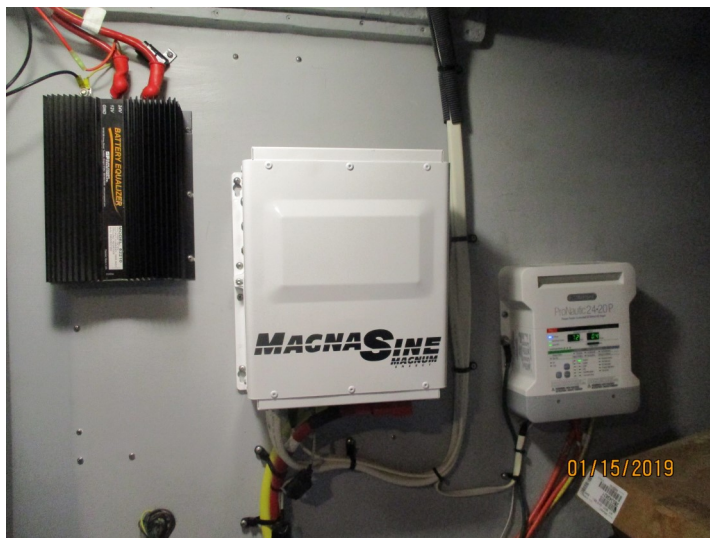
Wiring:	Conductors shall be supported throughout their length or shall be secured at least every 18". (ABYC 11.14.4.1.9); ABYC 11,14,3,6.4 Connections were of marine type fittings. ABYC 11.14.4.1.4 When AC and DC conductors are run together, the AC conductors shall be sheathed, bundled or otherwise kept separate from the DC conductors. ABYC E 11.14.4.1.6 Conductors shall be routed as far away as practicable from exhaust pipes and other heat sources. Unless equivalent thermal barrier is provided, a clearance of at least nine inches between conductors and dry exhaust components, shall be maintained. Conductors shall not be routed directly above a dry exhaust.
Charging System: Engine Alternators:	Engine mounted alternators will keep the batteries properly when running at cruising speed
Battery Charger:	ProNautic 24.20p charger 24V ; Magna Sine inverter charger #MS4024, operational at time of survey. located in engine room. The battery charging systems (alternator and battery charger or inverter/battery charger) installed on your yacht are designed to charge conventional lead-acid batteries. Before installing gel-cell or other new technology batteries, consult with the battery manufacturer about charging system requirements. ABYC 31.5.5.9.1 Battery chargers shall be selected and set, or adjusted, to charge the battery at the current and voltage appropriate for the size and type of battery or battery bank(s).

Battery Equalizer: Bonding:	Model 52210 24v/12v, Located in the engine room. The bonding system is mostly well established where sighted. A separate bonding test was not performed and a corrosion meter was not used to establish the level of protection. However, the bonding system uses individual green insulated wire and appears to be serviceable where sighted. Bonding and Lighting protection are a matter of individual interpretation of the principals involved. The ABYC suggests bonding all metallic below waterline thru-hull fittings and to construct a Cone of Protection for lighting protection. See Bonding section in the ABYC section E-1& E-4-611.14.5.2 Metals used for the terminal studs, nuts, and washers shall be corrosion resistant and galvanically compatible with the conductor and terminal lug. Aluminum and unplated steel shall not be used for studs, nuts, and washers
Ground System:	Negative to engine block.

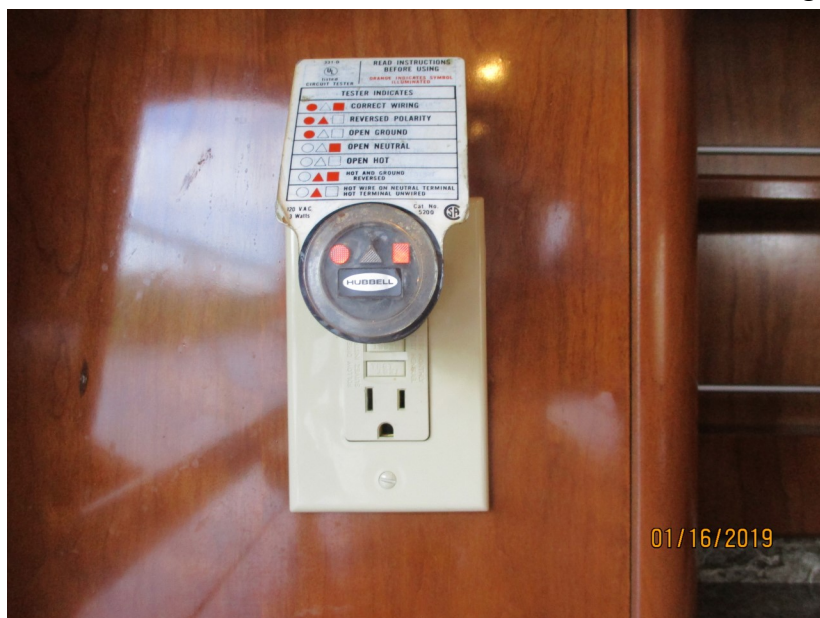
- Wire Type (size and rating):** Size and rating, where sighted, appears well routed and supported, ABYC E-11.14.1.1.1 and .2 serviceable ,adequate, Original equipment/ ABYC 11.14.4.1.7 Conductors that may be exposed to physical damage shall be protected by self draining loom, conduit, tape, raceways or other equivalent protection. Conductors passing through bulkheads or structural members shall be protected to minimize insulation damage such as chafing or pressure displacement. Conductors shall also be routed clear of sources of chafing such as steering cable and linkages, engine shafts and control connections. No chafe protection where routed through bulkheads.

- Inverter:** Power inverters shall provide isolation of the AC output from the DC supply circuit. ABYC A31.5.3. The DC grounding conductor shall be connected from the metallic case or chassis, to the engine negative terminal or its bus. Non sighted.

Note: Install fusible link or other type over-current protection for inverter dc power supply adjacent to batteries./ Install label at main electrical panel providing warning that dc to ac inverter is installed aboard.

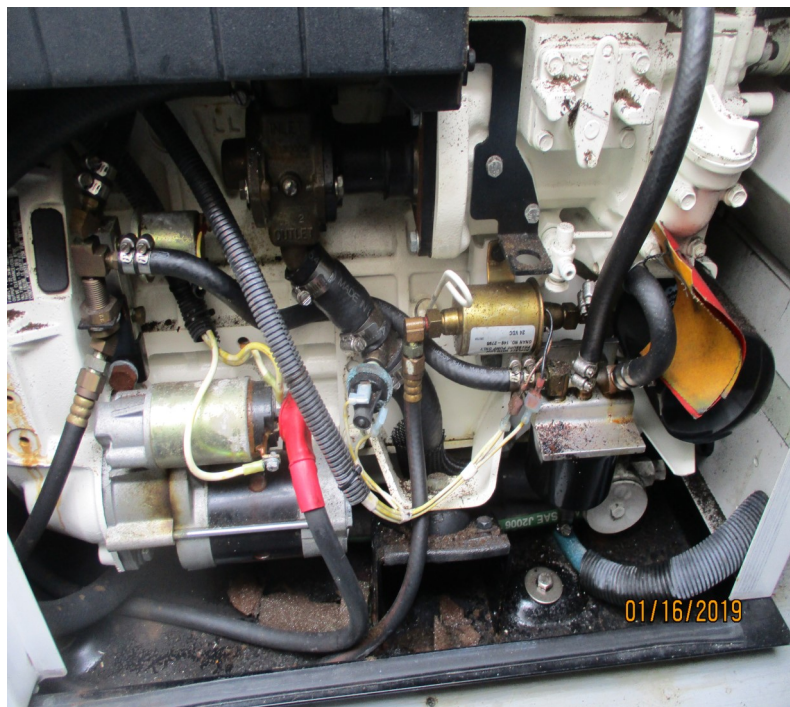
Manufacturer:	Model Onan120/240 volts 60 Htz, 17MDKBP-5703B 17KW @ 1800 rpm
Year installed:	Not reported
Re-build History:	Not reported
Location:	Machinery compartment, Access to the generator is good.
Gauges:	Remote control/gauge panel at main electrical panel, temperature, oil pressure, volts. Operated
Appearance:	The generator was found in good condition: noted no surface corrosion or rust in any area; along with no evidence of fluid leakage.
Mounts;	Steel/Neoprene isolation mounts on a stainless steel good condition
Fluid Levels:	Oil and coolant appeared normal
Seacock/Strainer:	Seawater intake, Bronze ball valve, with inline strainer, good condition
Cooling system:	Fresh water cooled with heat exchanger
Exhaust System:	Wet through water lift muffler with overboard discharge; Good condition
Hoses and Clamps:	Double clamped, to be placed on a maintenance schedule
Belts & Hoses:	Good condition, although recommend being placed on a maintenance schedule and monitor for status changes.

Wiring:	Supported
Ventilation:	Natural ventilation system
Health Threat/ Noise nuisance	No apparent health threat/ nuisance
Warning labels:	Labels are readable
Insulation:	A sound deadening shield was not fitted over the unit.
Filtration System:	Plumbed with racor in line fuel/water separation and engine mounted elements.
