## Site Observation Summary

Date: August 20, 2020  
To: Village of Michiana – Attn: Michael Mintz  
From: Edgewater Resources, LLC  
Subject: Summary of Observations from 8/5/2020 Site Visit

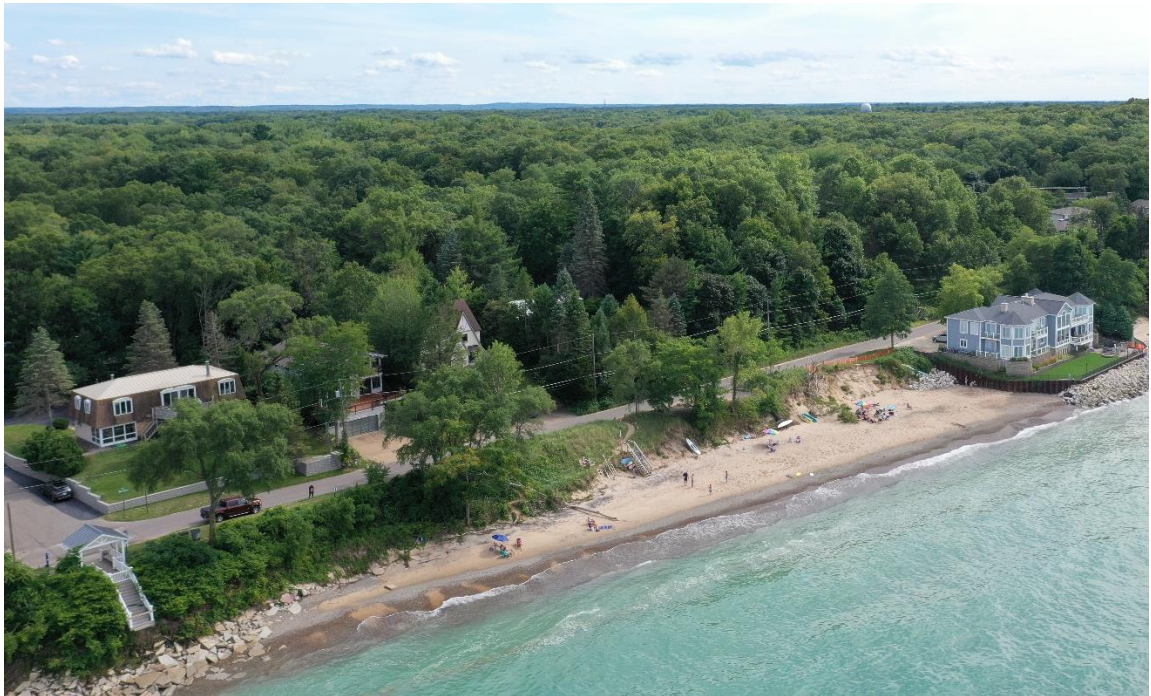
Figure 1: Photo of Stop 38, 8/5/20

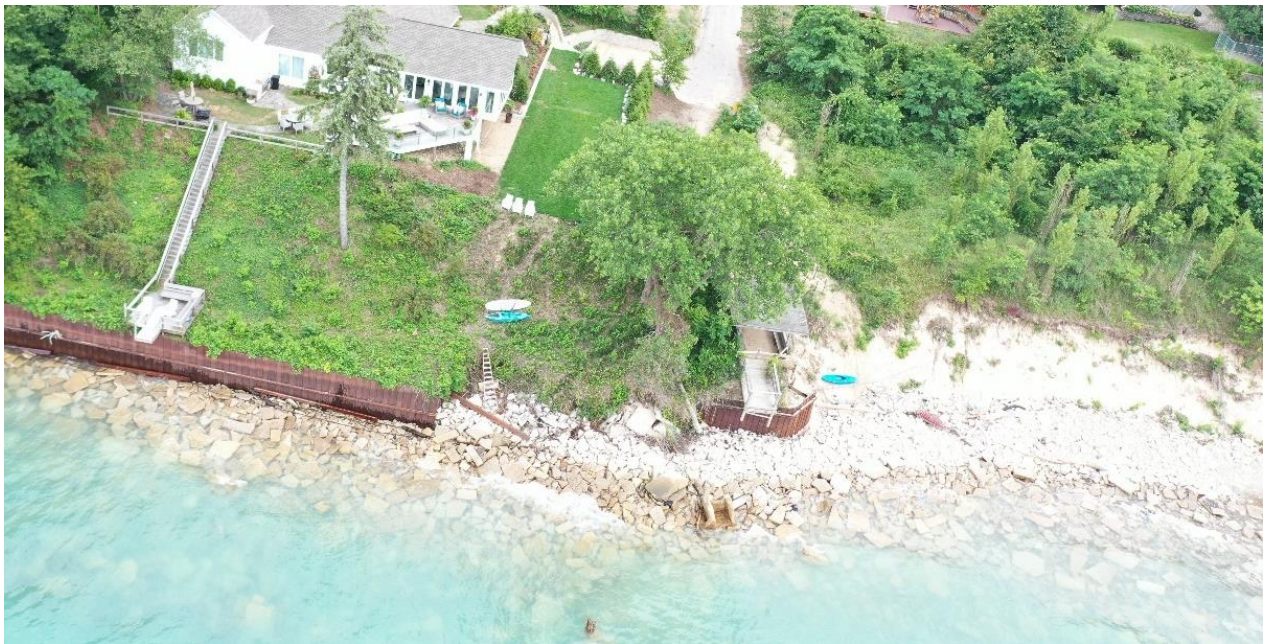
Figure 2: Drone Photo Stop 43, 8/5/20

The existing steel seawall runs approximately 15' - 20' along Lake Michigan and has a 10' section that cuts back on a 45-degree angle towards the dune. The seawall is currently being flanked on the south side due to wave diffraction around the structure and the lack of shore protection on the Ginther Property on the south side. The adjacent north property has a steel seawall and an open riprap/vegetation shore area that is 25' until the Stop 43 seawall begins. The shoreline along this break area is experiencing sloughing due to waves overtopping the broken concrete riprap. A substantial amount of concrete riprap exists throughout this entire shoreline area and apparently was installed in the 1950 - 60's in an attempt to save Old Lakeshore Drive, which eventually failed. The footings holding the timber pavilion structure were exposed on the south side and the timber stairs are not in working order. The beach stop is closed due to the lack of safe access to the beach from the erosion.

- A. Regrade repair/install stone toe protection at the base of the front seawall to prevent scour
- B. Install a sandbag system along the 45 degree and connect the system to the Ginther sandbag project. The sandbag system should be installed to achieve a crest elevation of 590' minimum (Low Water Datum +12.5')
- C. Move timber pavilion landward to prevent additional deterioration or possible loss of the structure

- A. The entire shoreline would benefit from the installation of an armor stone revetment. The existing concrete riprap would be utilized as the base for the revetment. The armor stones should be installed in such a manner to ensure positive interlock of the armor stones. The newly placed armor stone would be on top of geotextile fabric and mattress stone (8"-12" diameter). To prevent funneling of wave energy between Stop 43 and the Gintners, the revetment should either continue across the Gintners or terminate back into the dune to prevent future flanking.
  - B. The north side of the property will require a larger armor stone revetment along the water's edge where the seawall is not present.
-

- C. The most robust solution includes the extension of the front seawall to connect to the north property and the extension of the 45-degree segment on the south side back into the dune. The installation of the seawall will still require an armor stone revetment to prevent scour, however, the size of the revetment would be smaller than described in recommendations A and B.

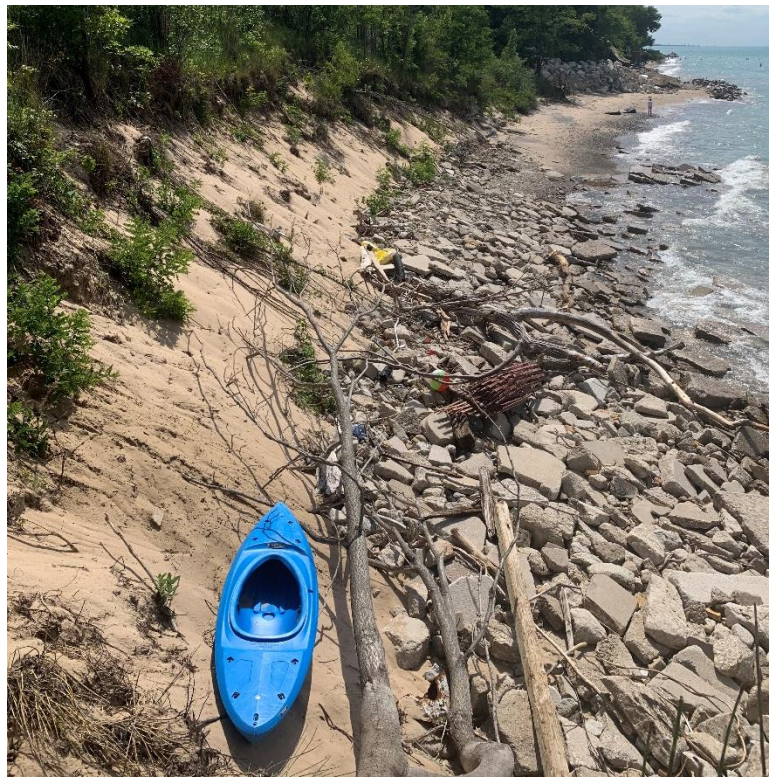
Figure 3: Photo of Concrete Riprap Facing Southwest, 8/5/20

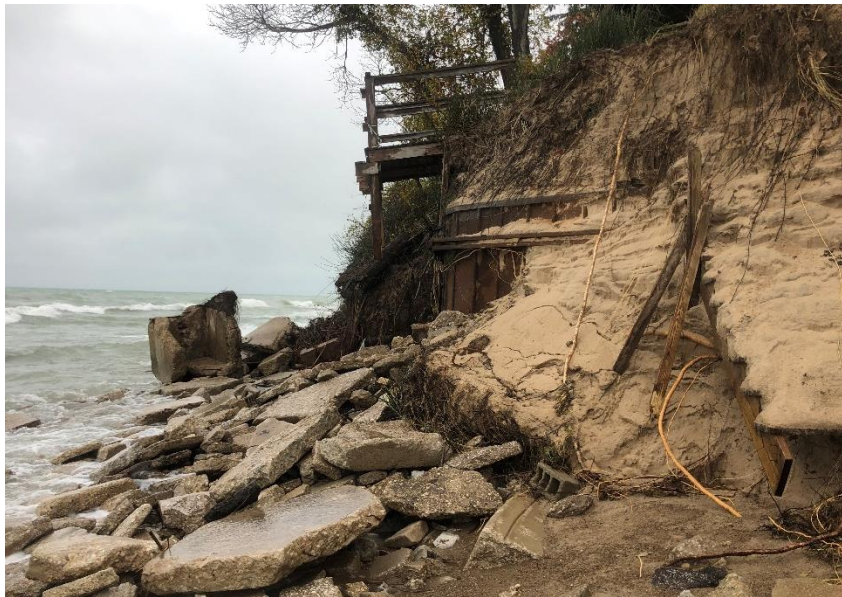
ER has been involved in the Gerber Project (4 properties south of Stop 43) since June 2019 and a review of the photos of Stop 43 was reviewed as part of the current scope to illustrate the dramatic change. As shown in Figure 4 below, the front seawall was barely exposed, and the return wall was starting to appear. A substantial amount of sand was present at this time. It is apparent due the increased lake levels, the Fall/Winter/Spring storms and lack of ice protection during the Winter resulted in a substantial amount of erosion.

Figure 4: Photo of Stop 43 Seawall Facing North, 10/29/19

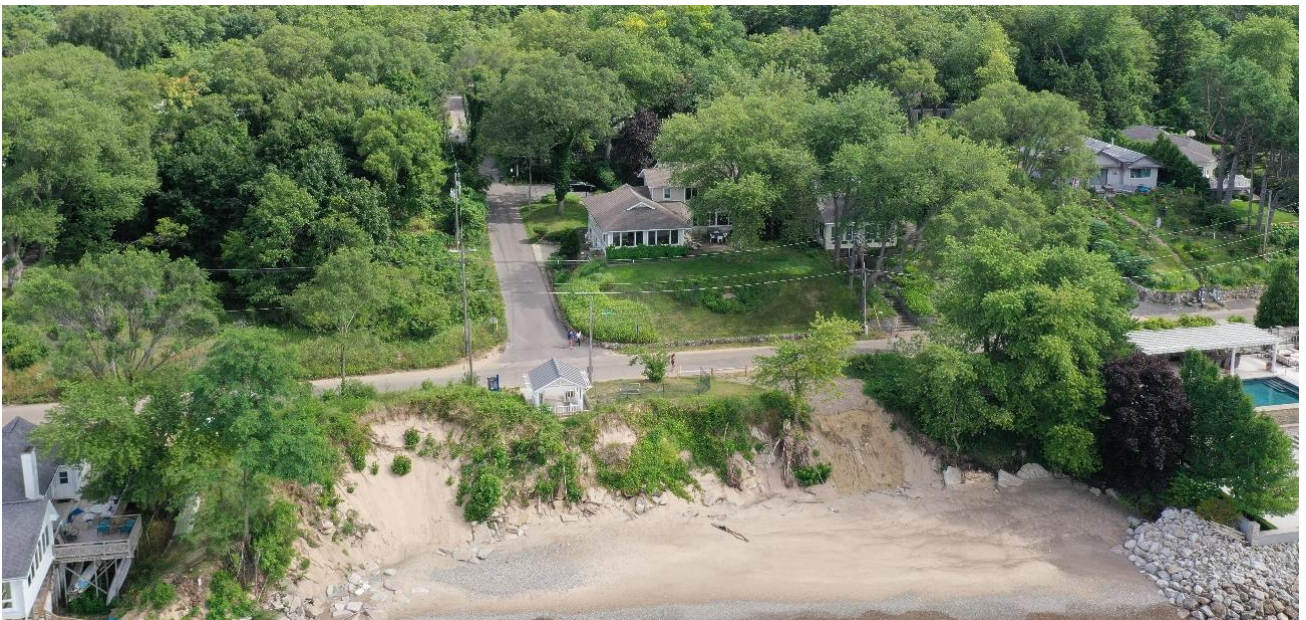
The bluff is experiencing erosion at the toe of the slope due to the lack of shoreline protection. The existing gentle beach slope allows the wave energy to run up the beach and erode the toe. Additionally, it is suspected that stormwater runoff from the adjacent roadways could be contributing to the erosion on the face of the bluff, especially near the pavilion.

Figure 5: Drone Photo Stop 39, 8/5/20

- A. Install a sandbag system along toe of slope. The sandbags would need to be placed to ensure they are at an appropriate elevation and have scour protection in the front. The sandbag system should be installed to achieve a crest elevation of 590' minimum (Low Water Datum +12.5'). The proposed system would need to connect to the adjacent revetment projects to prevent any funneling of wave energy.
- B. Install roadside stormwater mitigation that could include a drainage system to reduce the sheet flow coming down the road and off the pavilion hardscape

- A. The entire shoreline would benefit from the installation of an armor stone revetment. The armor stones should be installed in a manner which would ensure positive interlock within the stones. The newly placed armor stone would be on top of geotextile fabric and mattress stone (8"-12" diameter)
-

- B. An access stair system could be constructed with steel piles across the revetment to assist with public beach access
- C. The pavilion structure area could be better protected by a steel sheet pile wall with a revetment in front.

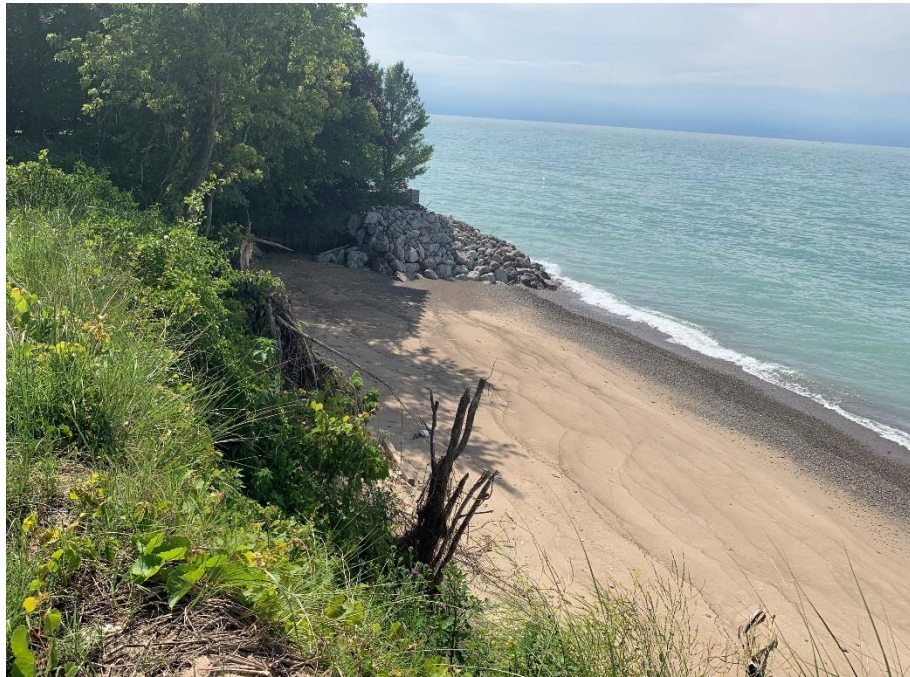
Figure 6: Photo of Stop 39 Beach Facing Southwest, 8/5/20

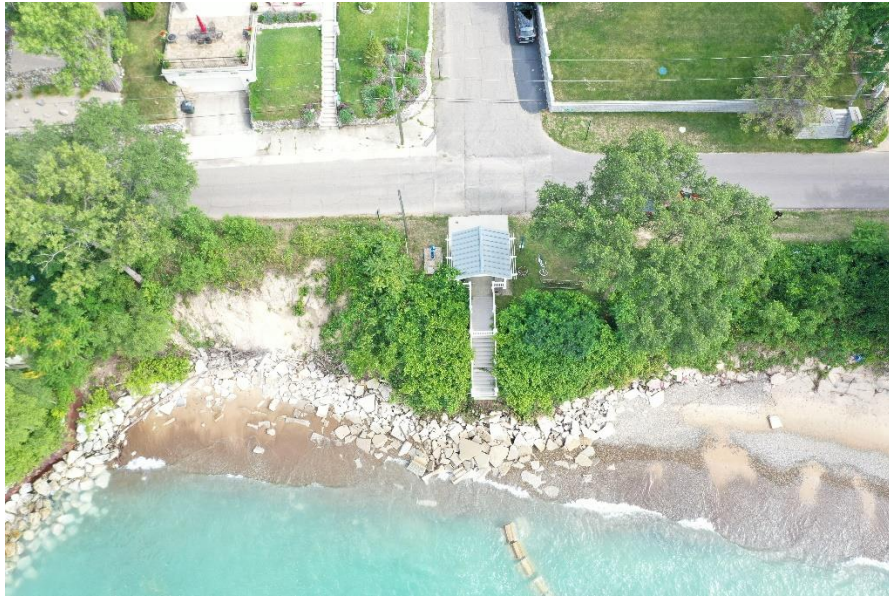
The bluff is experiencing erosion at the toe of the slope due to the lack of shoreline protection. The existing gentle beach slope allows the wave energy to run up the beach and erode the toe. The concrete riprap is providing some protection as shown in Figure 7, however, the waves are overtopping the riprap and removing material from the upland bluff. This results in the sloughing of the bluff and bring the active erosion closer to Lakeshore Drive. The south side of the 600 LF beach area is experiencing significant erosion and Lakeshore Drive is only 10' from the top of the bluff, which puts the existing utility infrastructure along the road in jeopardy.

Figure 7: Drone Photo Stop 38, 8/5/20

- A. Regrade the concrete riprap to provide an appropriate bed for the shore protection system
- B. Install a sandbag system along toe of slope. The sandbags would need to be placed to ensure they are at an appropriate elevation and have scour protection in the front. The sandbag system should be installed to achieve a crest elevation of 590' minimum (Low Water Datum +12.5'). The system would need to connect the system to the adjacent revetment projects to prevent any funneling of wave energy
- C. Construct an access stairway across the revetment with steel pile system

- A. Install an armor stone revetment system across the toe of the slope to prevent erosion. The armor stones should be installed to ensure positive interlock within the stones. The newly placed armor stone would be on top of geotextile fabric and mattress stone (8"-12" diameter).
  - B. An access stair system could be constructed with steel piles across the revetment to assist with public beach access
-

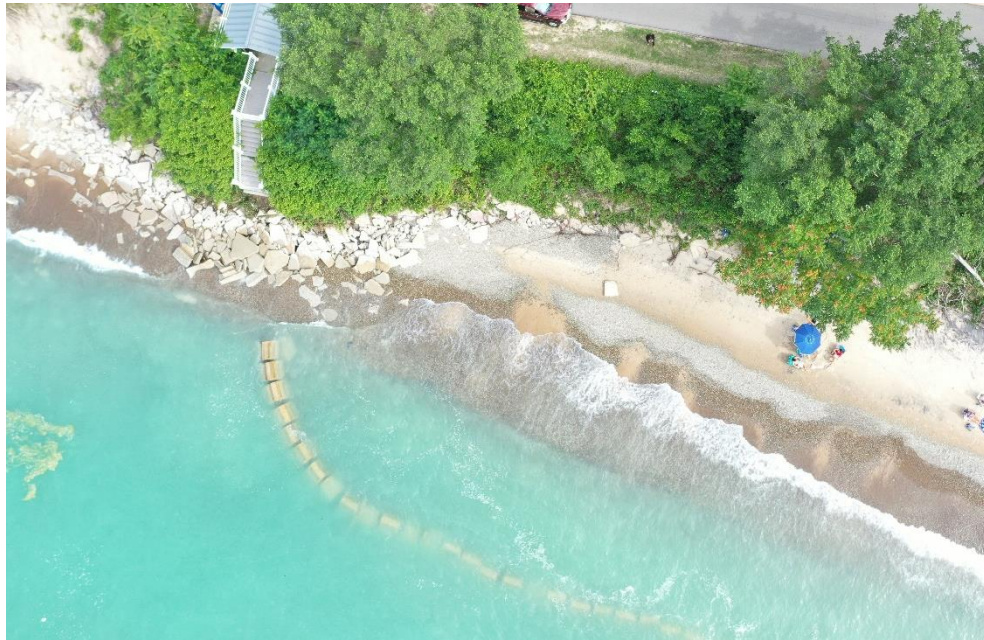
Figure 8: Photo of Wave Breaks at Stop 38, 8/5/20

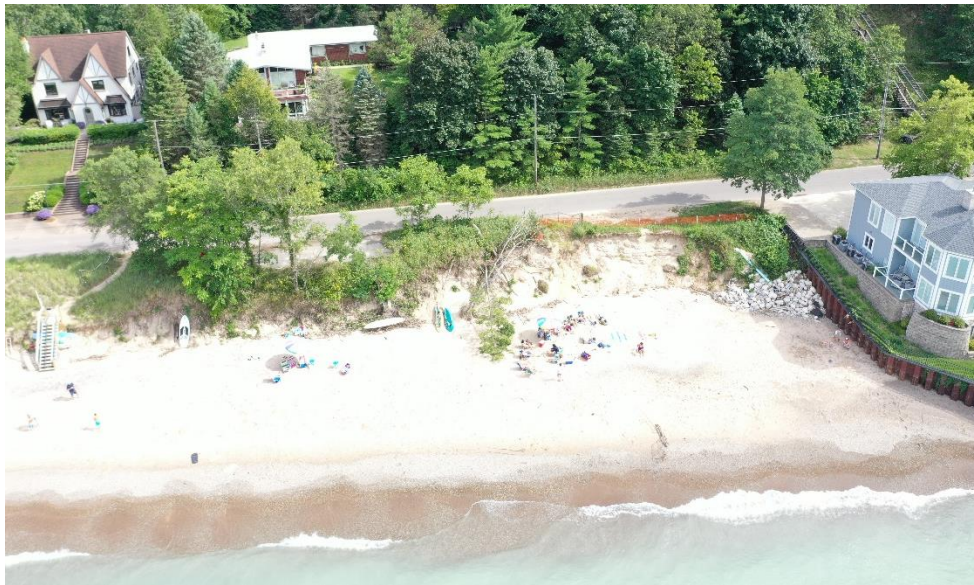
Figure 9: Photo of Erosion on Southern Beach Area, 8/5/20
