Your Home Inspection Report

2330 Bayview Pl, Everett, WA 98023

Z-Home Inspections

Residential Home Inspection

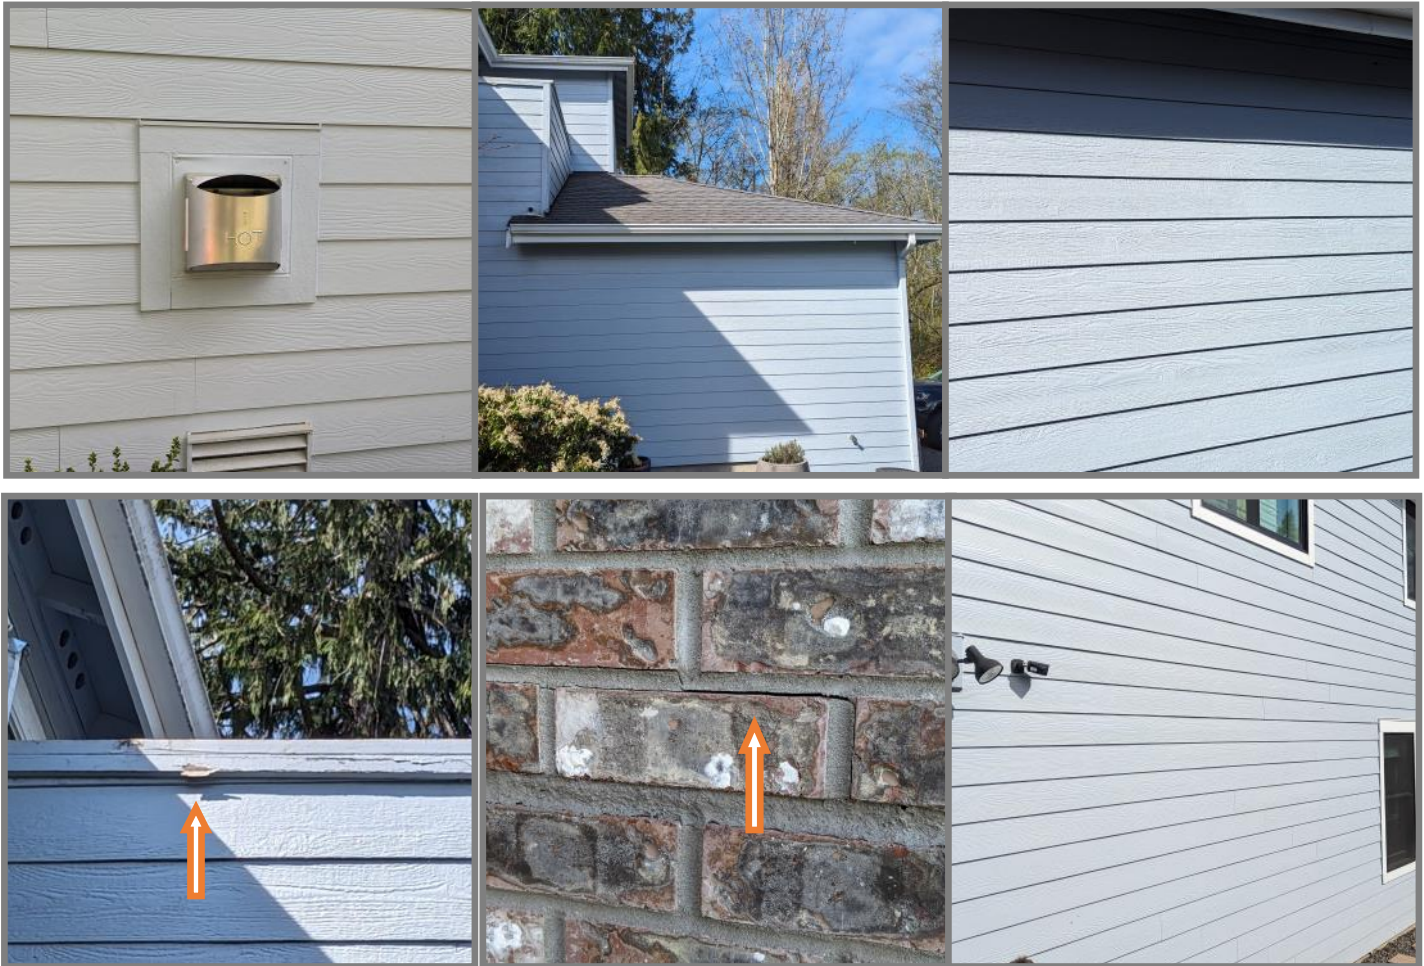
There was one area of trim in need of primer and paint on the front/left side of the home.

There was one area where the mortar is in need of repair on the veneer brick on the front of the home.

Recommend a licensed contractor remedy.

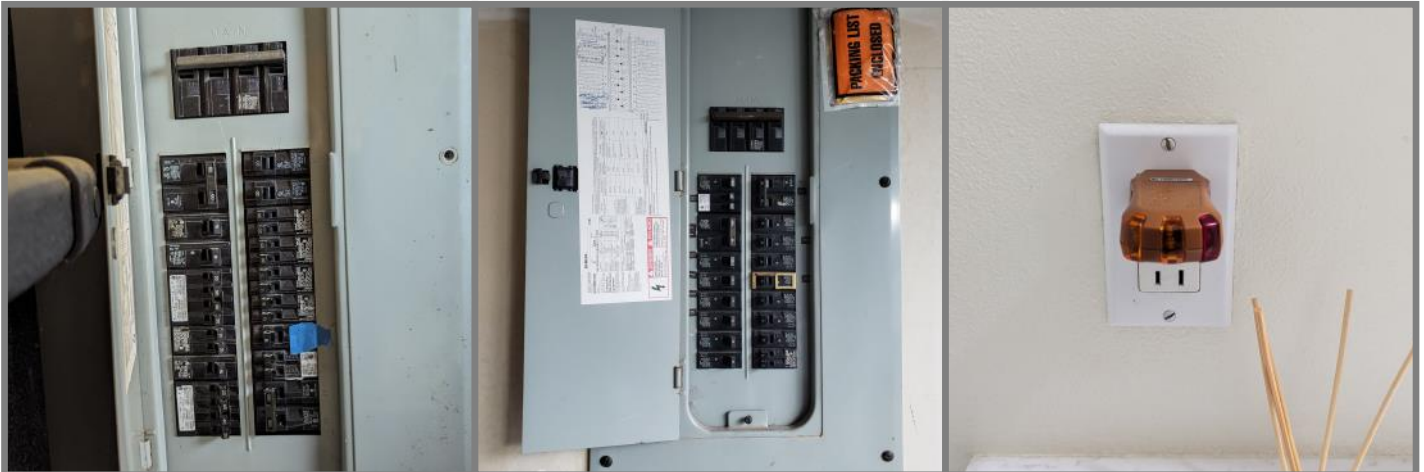
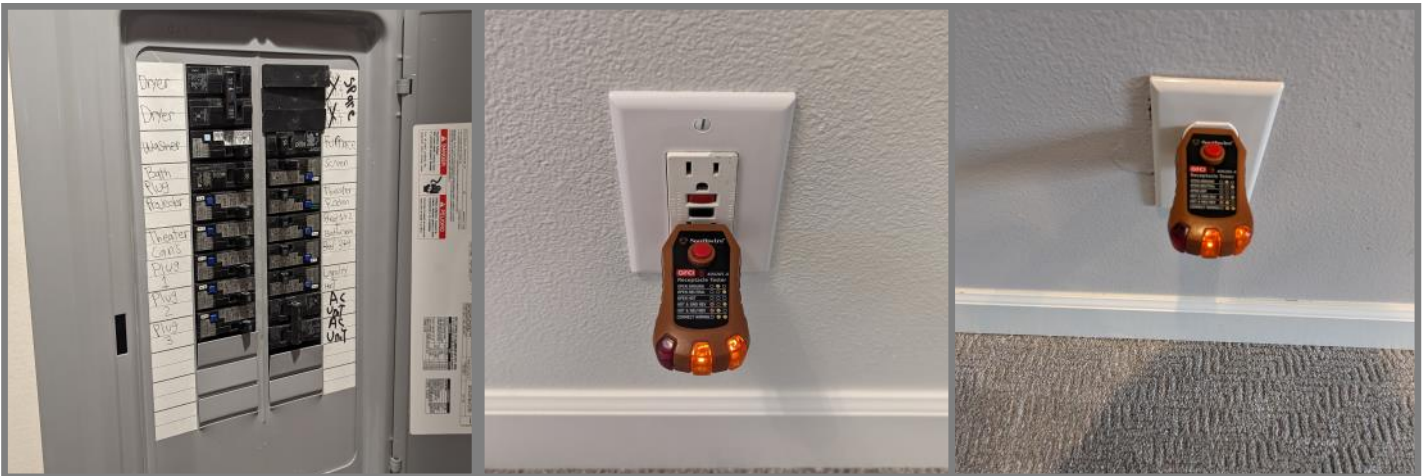
The electrical GFCI outlet in downstairs bathroom did not appear to operate and is in need of replacement.

There were several electrical outlets in the home that appeared loose.

Recommend a licensed electrician remedy as needed.

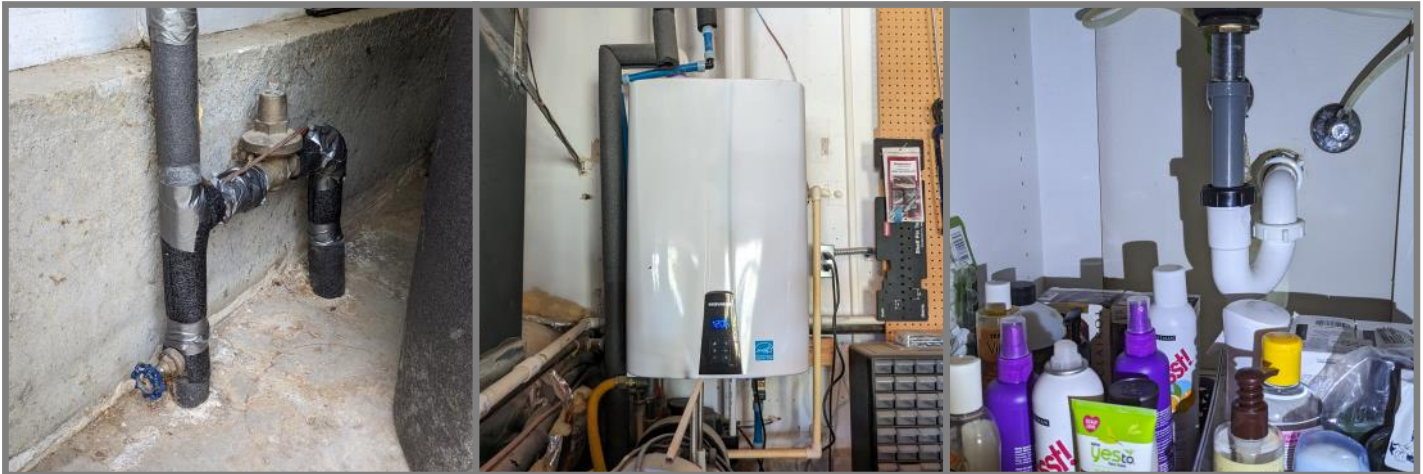
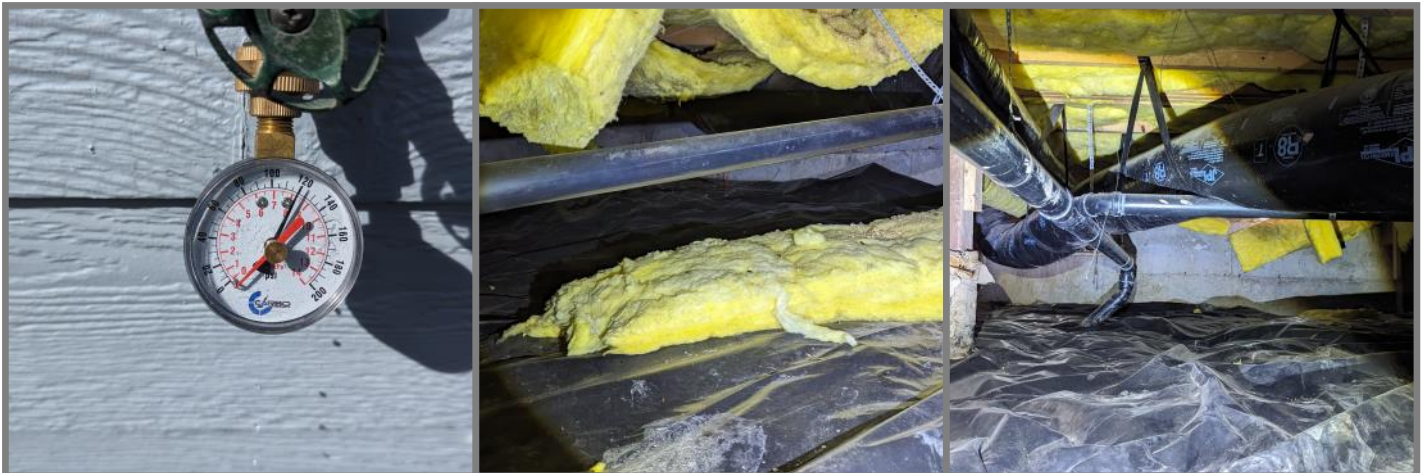
The water pressure to the home tested to be at 120 psi. Recommended psi range is 40-80.

The home is equipped with a water pressure reducer valve located near the water shut-off valve.

Recommend reducing the water pressure down to 80 psi.

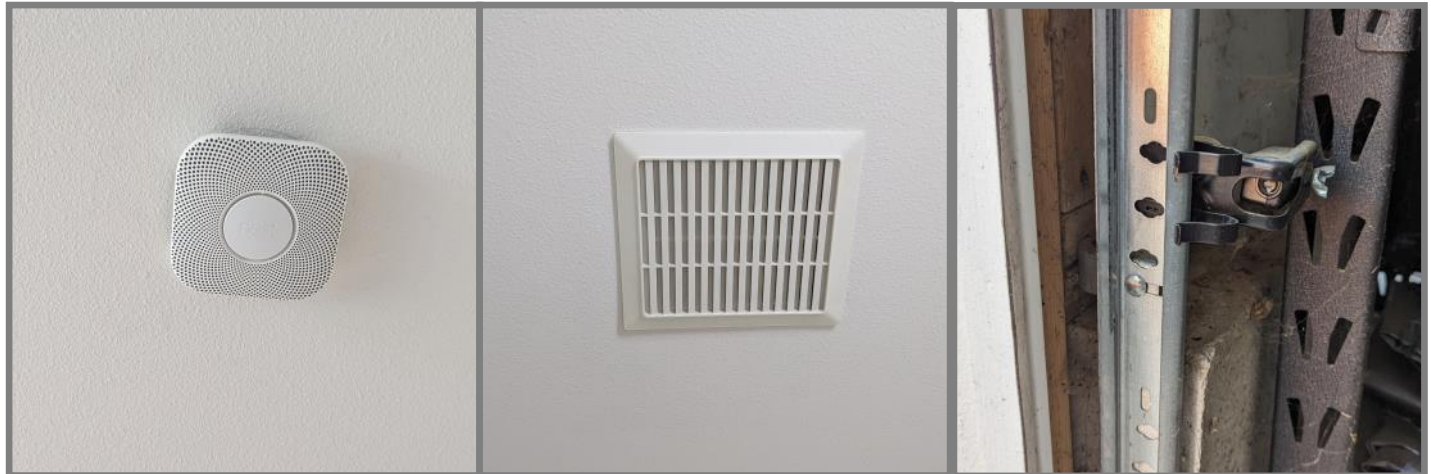
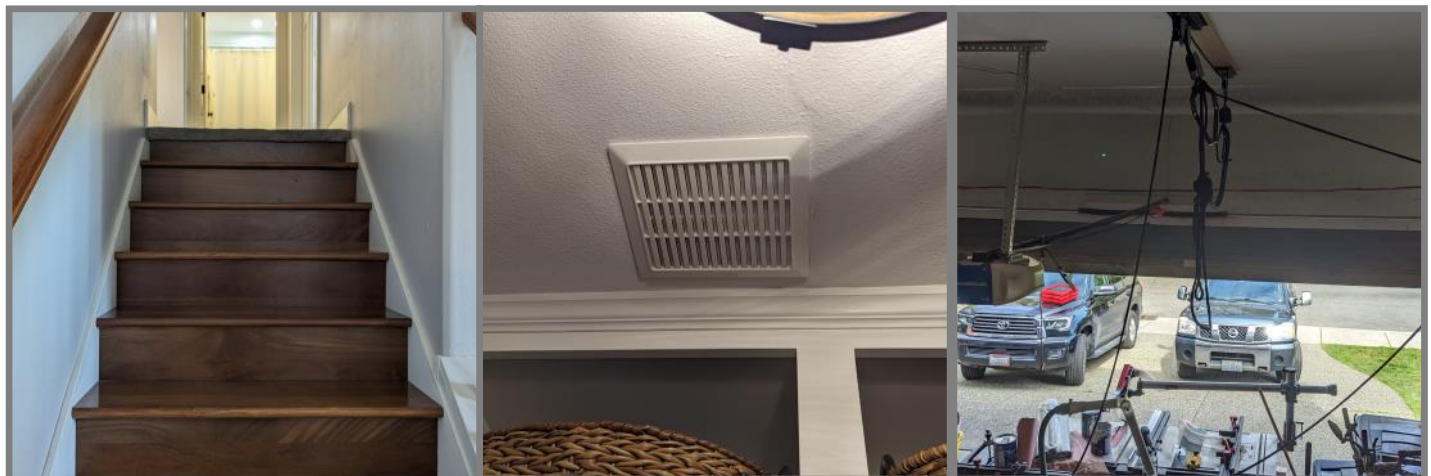
Both automatic garage doors did activate during the inspection.

Recommend the garage doors safety photo eyes be lowered.

Recommend a licensed contractor remedy as needed.

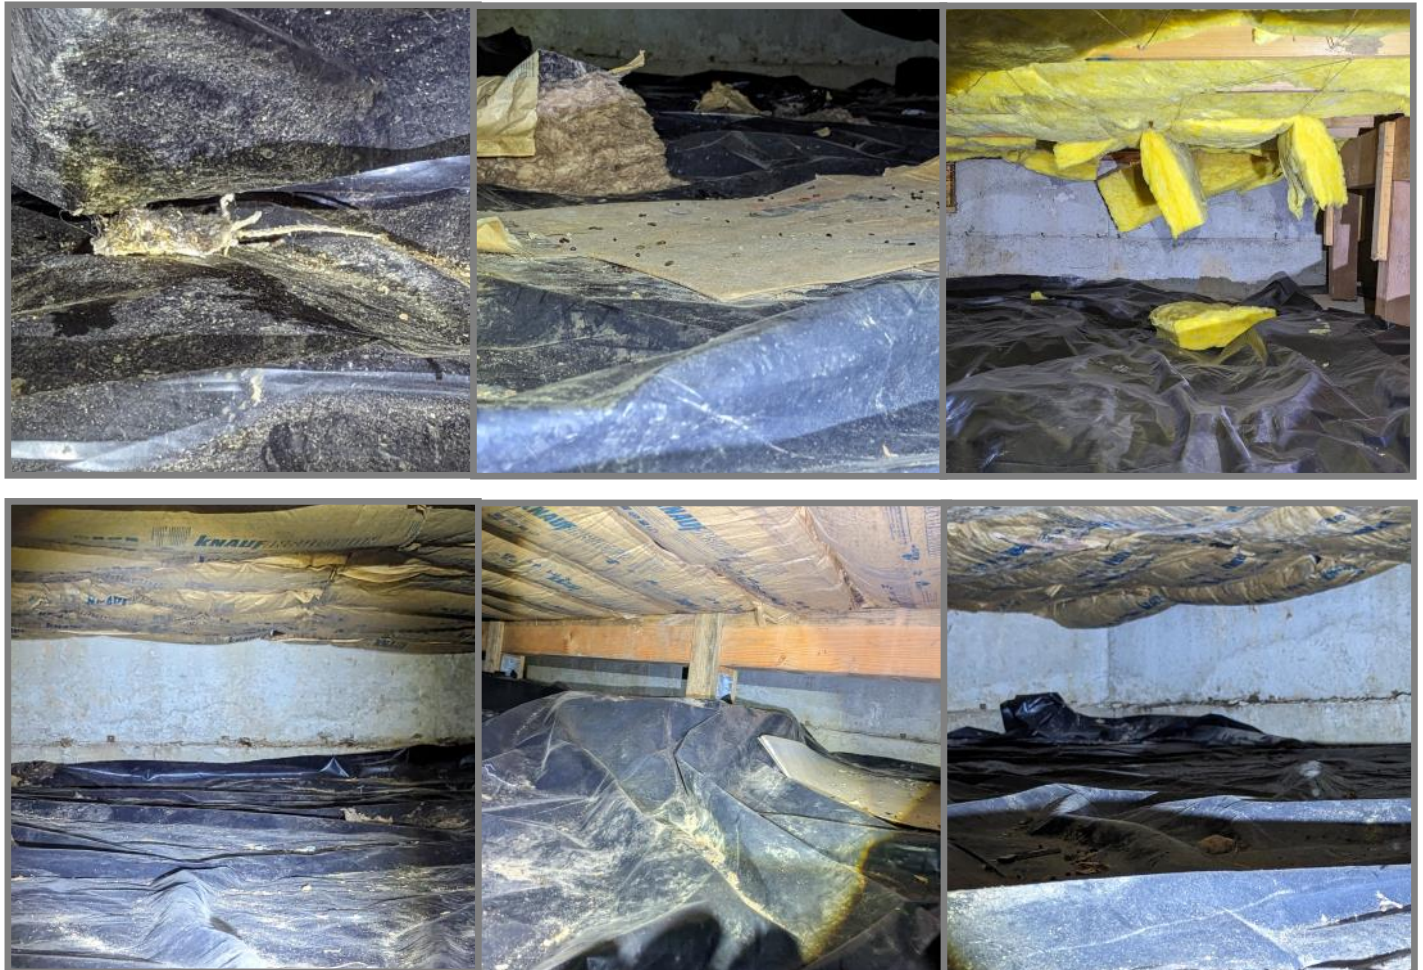
There were many areas where the floor insulation was not well attached and/or not attached at all.

There did appear to have been an active pest issue in the crawlspace during the time of the inspection.

Recommend a licensed contractor/exterminator remedy and monitor the issue.
