Your Home Inspection Report

4433 75th St. SW, Mukilteo, WA 98275

3/28/2023 2:00pm – 4:00pm

Residential Home Inspection

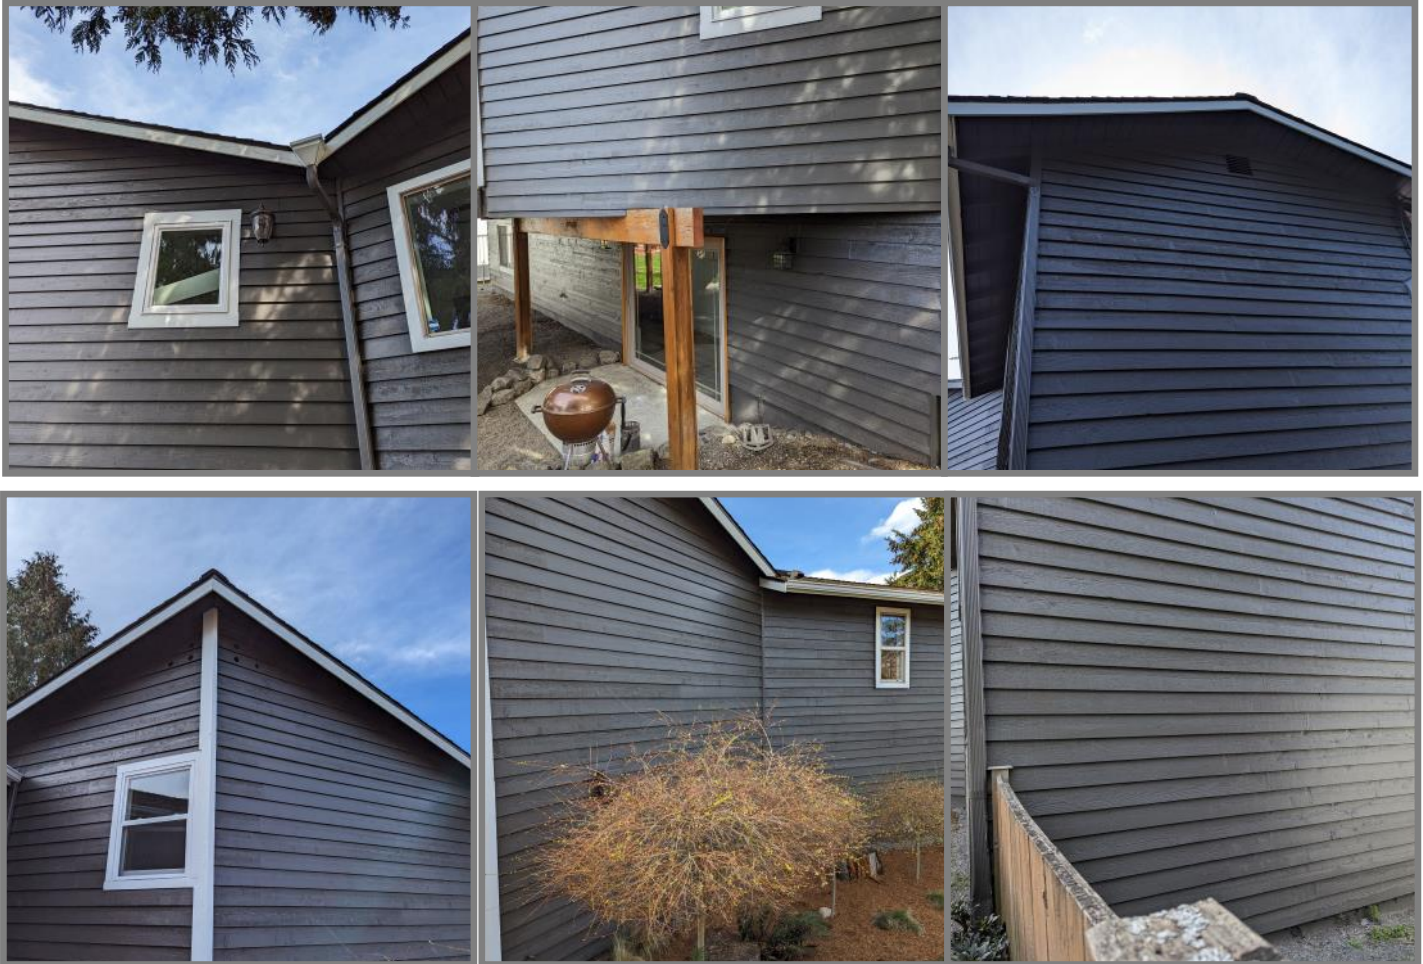
2. Siding and Trim

The exterior siding is a natural wood clap type siding and on all sides of the home. The siding on the home appeared to be in good condition on all sides of the home.

The paint to the exterior of the home appeared to be in good condition on all sides of the home.

The exterior trim is a natural wood, most likely cedar or fir and in good condition on all sides of the home.

The eaves and fascia boards in good condition on most sides of the home.

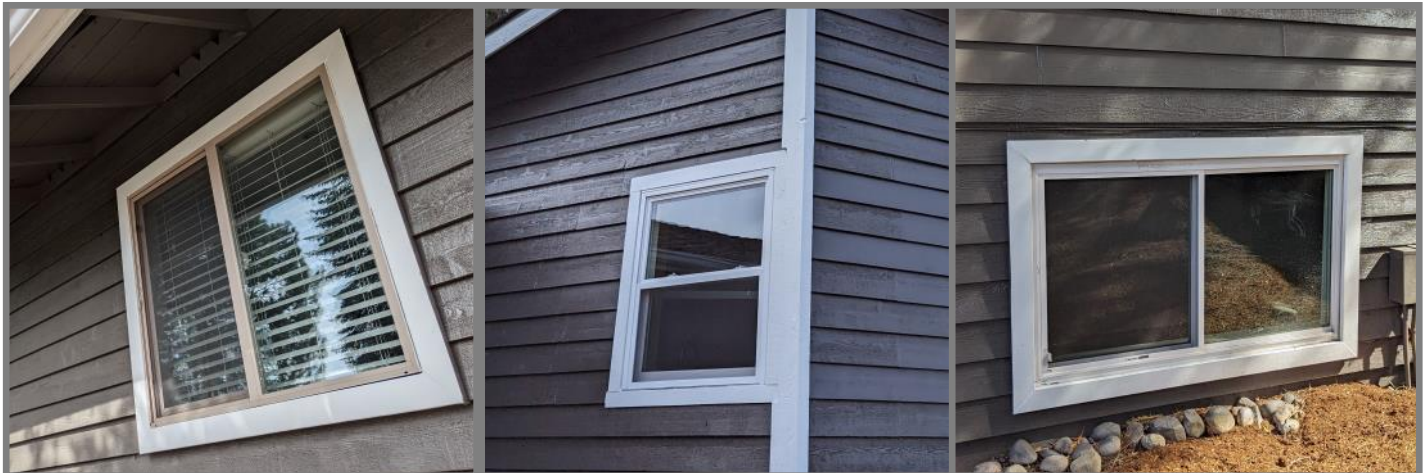
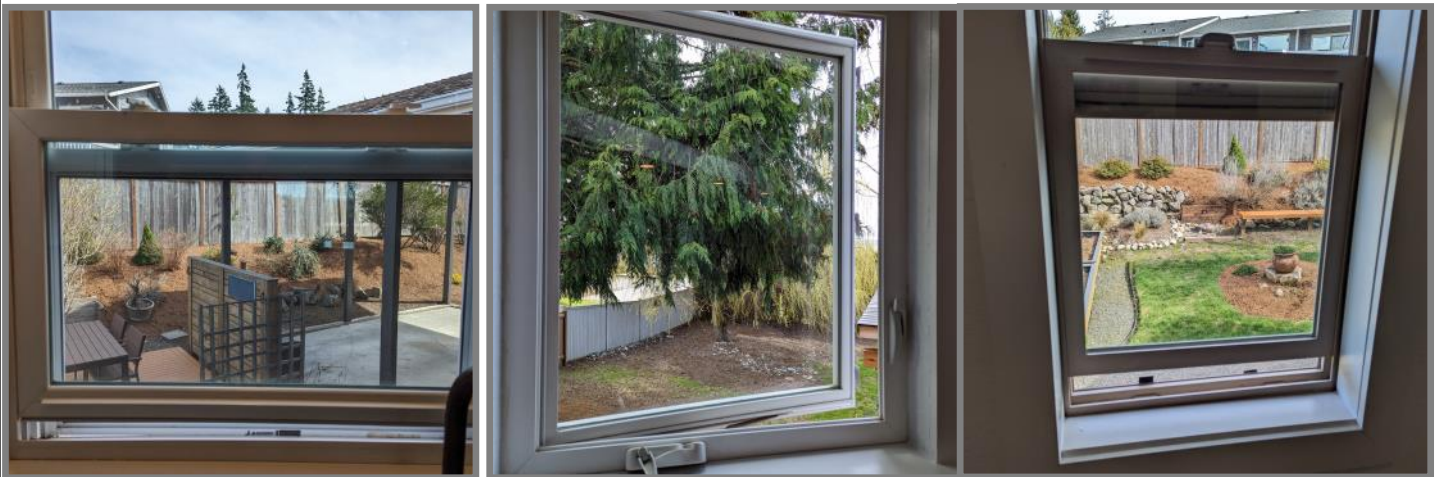
3. Windows

The home appears to have all updated double pane vinyl framed windows. All windows tested did operate as they should.

No jamming or loose window panels were detected at the time of the inspection.

There were no signs of failed window seals or broken glazing or glass.

All operable windows tested did lock properly at the time of the inspection.

Most screens appeared to be in place and in good condition.

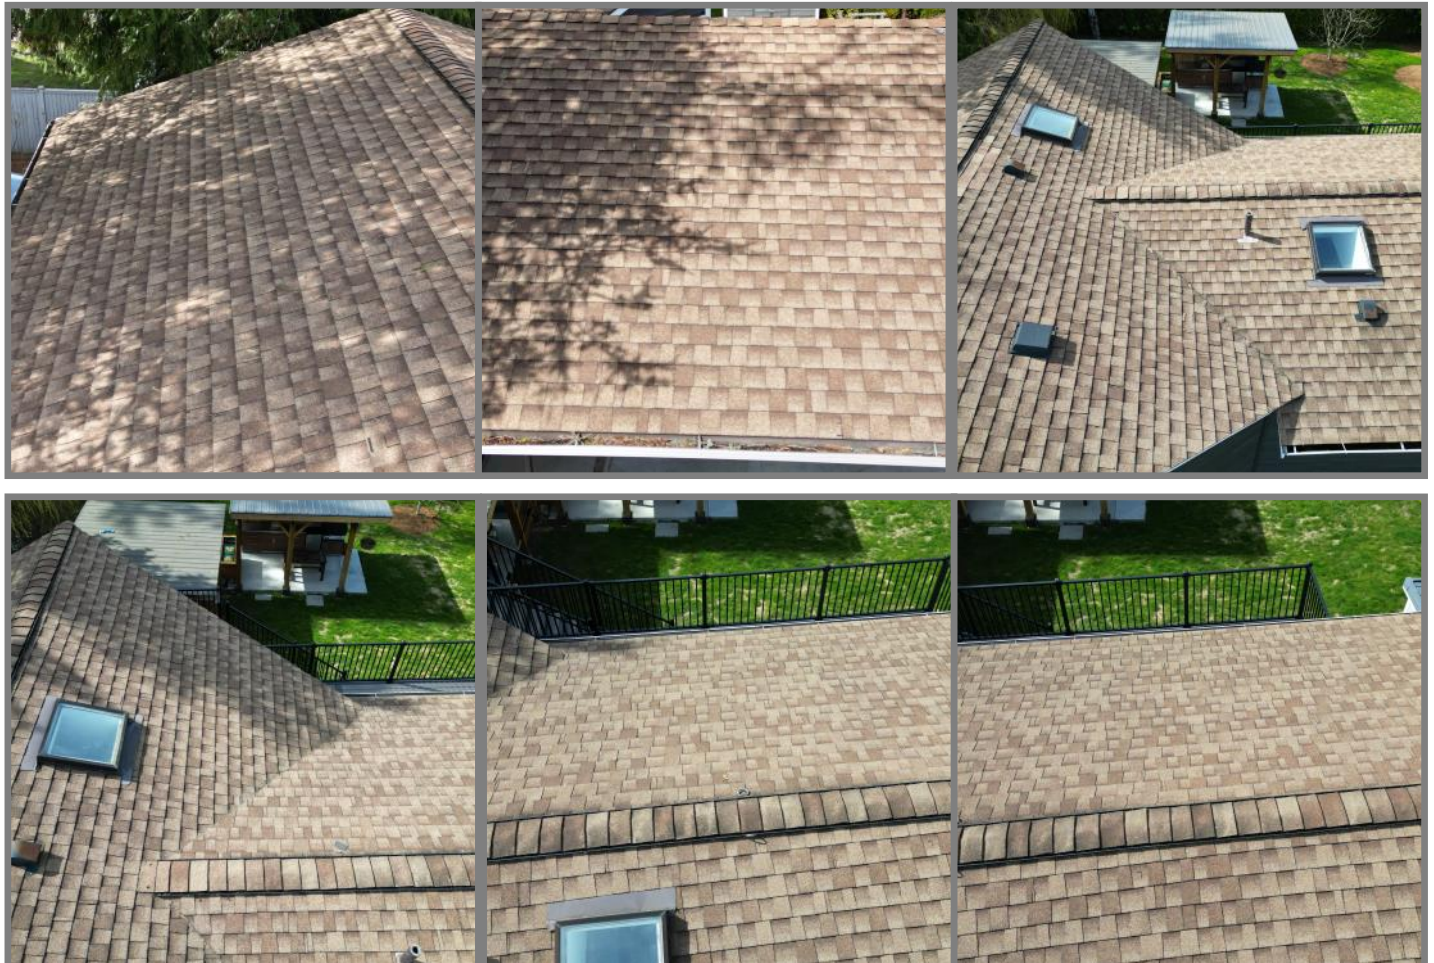
4. Roof

There was the updated architectural composite asphalt type roofing material.

All materials looked to be intact and in good condition during the time of the inspection.

This roof covering should protect the home for at least 10+ more years under normal weather conditions and regular maintenance.

Note: As the home owner, take the time to take occasional ground surveys of the roof for moss build-up and/or trees limbs getting too close to the roofline (no closer than ten feet is recommended).

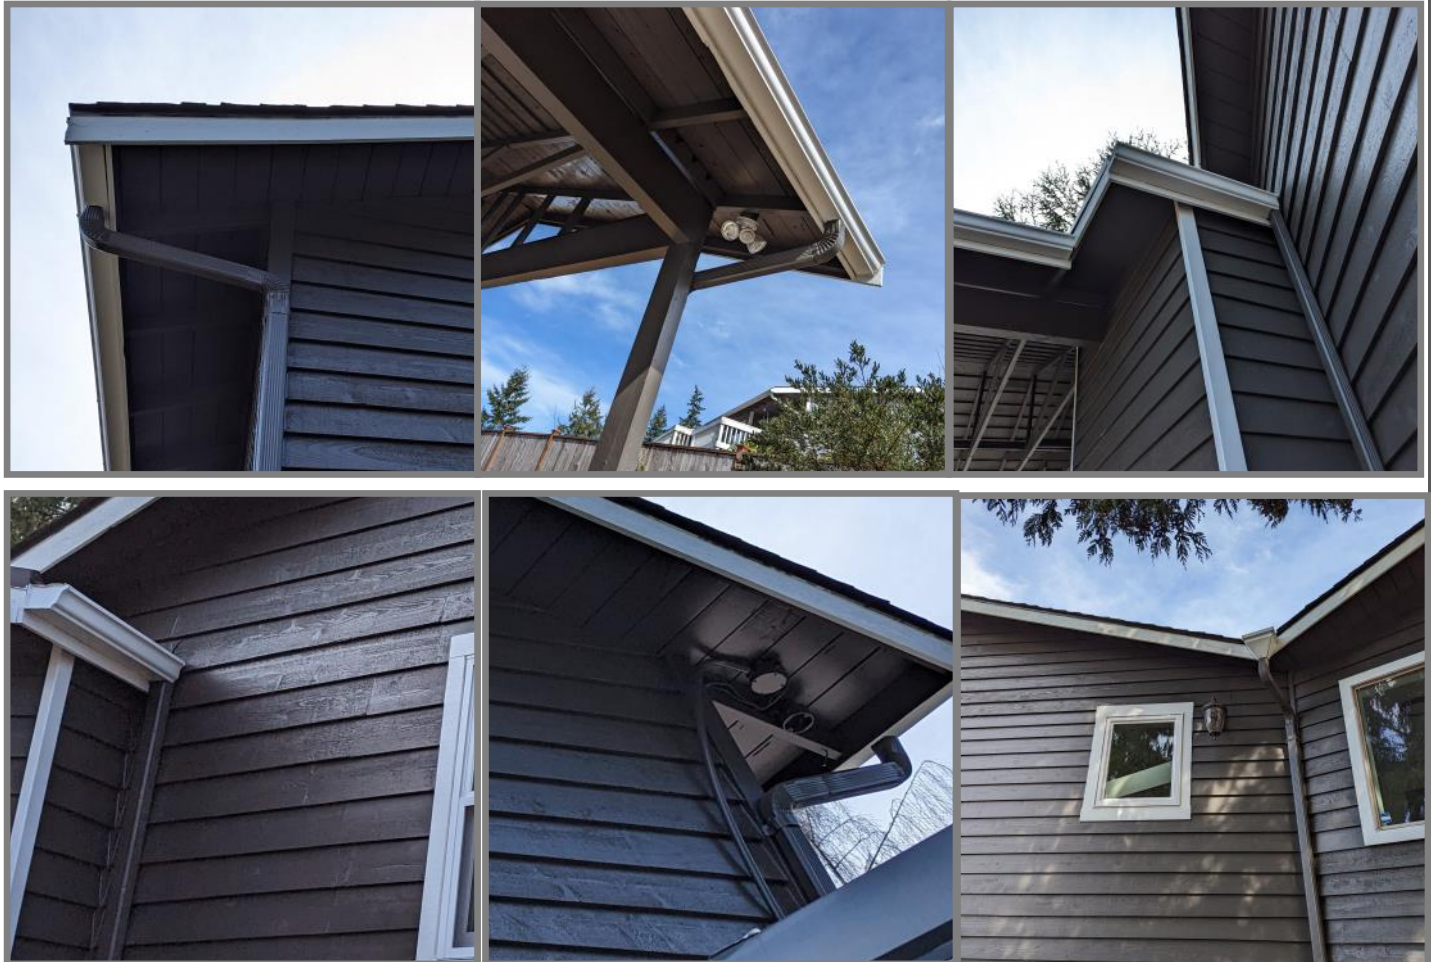
5. Gutters and Downspouts

The gutters and downspouts are of aluminum material.

The gutters appear to be in good condition and well attached to the home.

The gutters appear to have an adequate number of downspouts to help keep rainwater flowing away from the home on all sides.

Note: **Recommend establishing a regular maintenance schedule for having the gutter system cleaned and maintained to ensure the gutters are effectively protecting the home.**

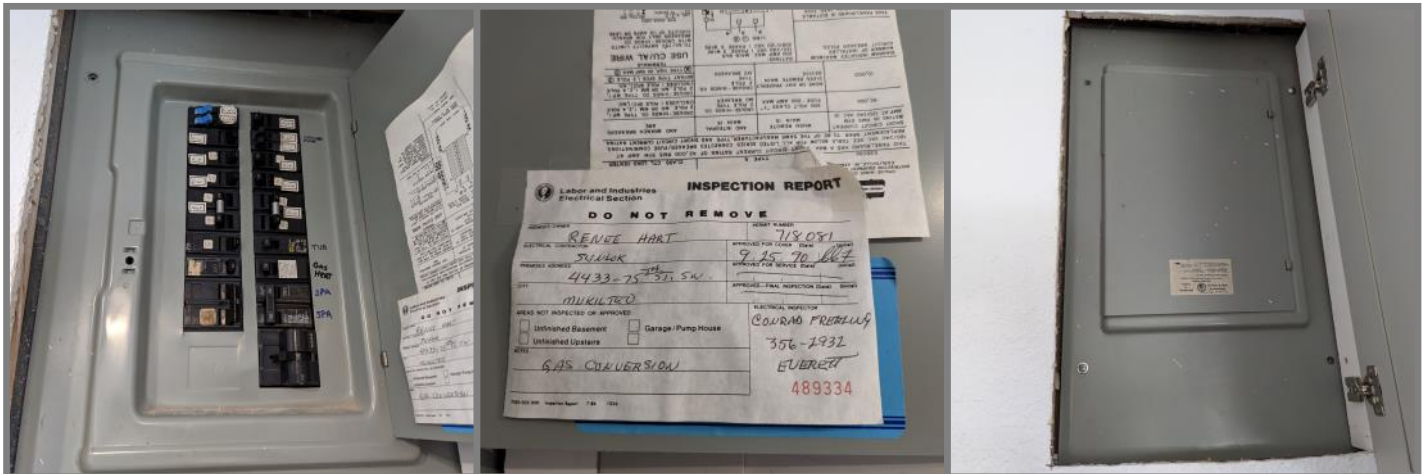
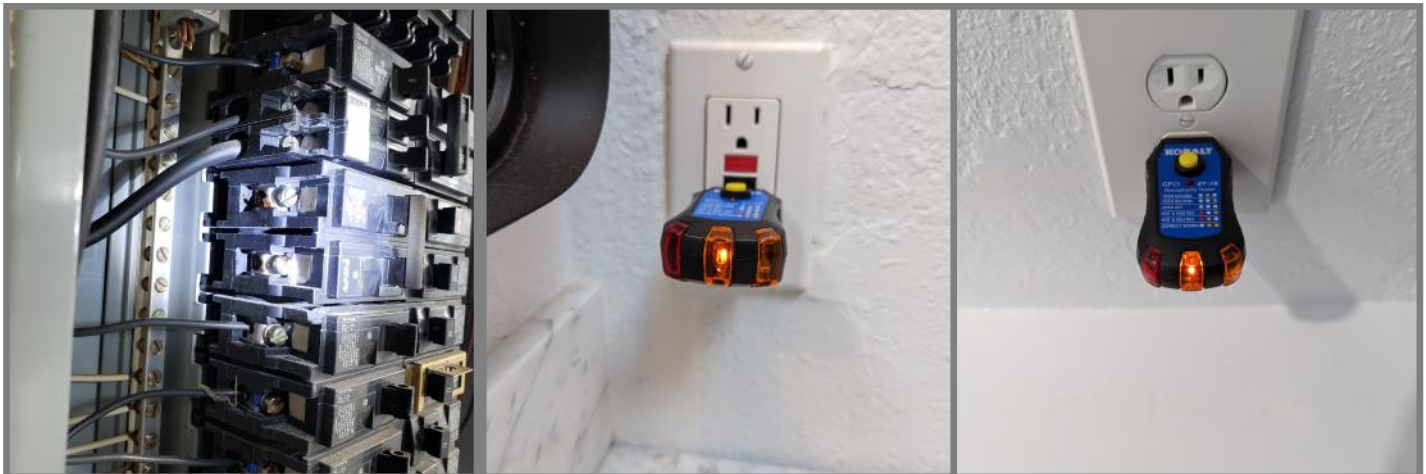
6. Electrical

The home's electrical service panel is located in the basement of the home.

The panel appeared to be the original panel and in good condition.

There was no sign of thermal activity or faulty breakers at the time of the inspection.

The breaker legend appeared to be well marked.

A small amount of the electrical outlets tested as being not properly wired (no ground/reversed wired).

Recommend a licensed electrician evaluate and remedy as needed.

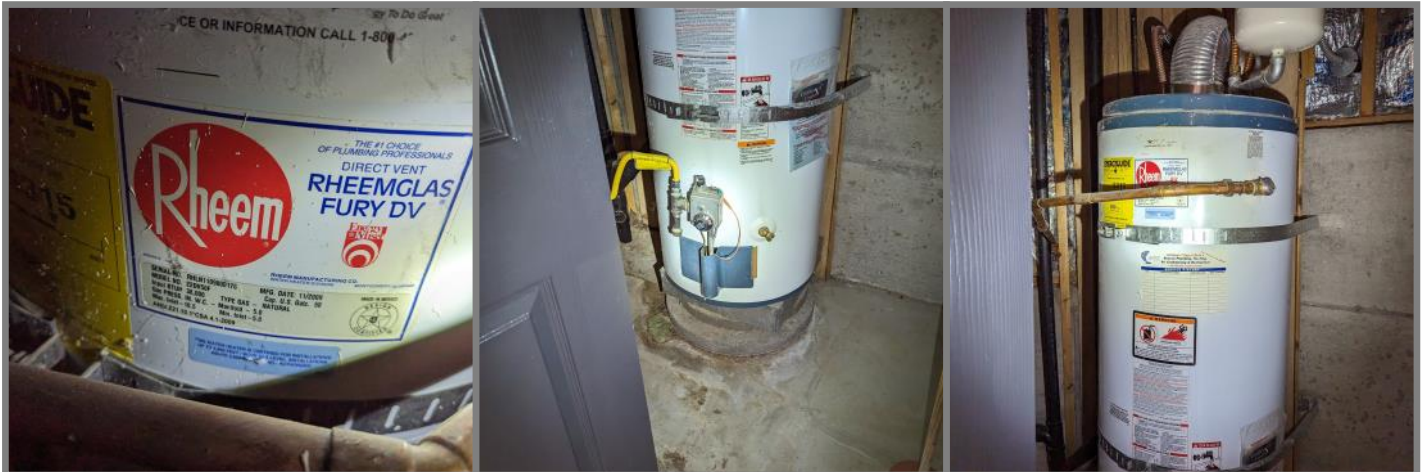
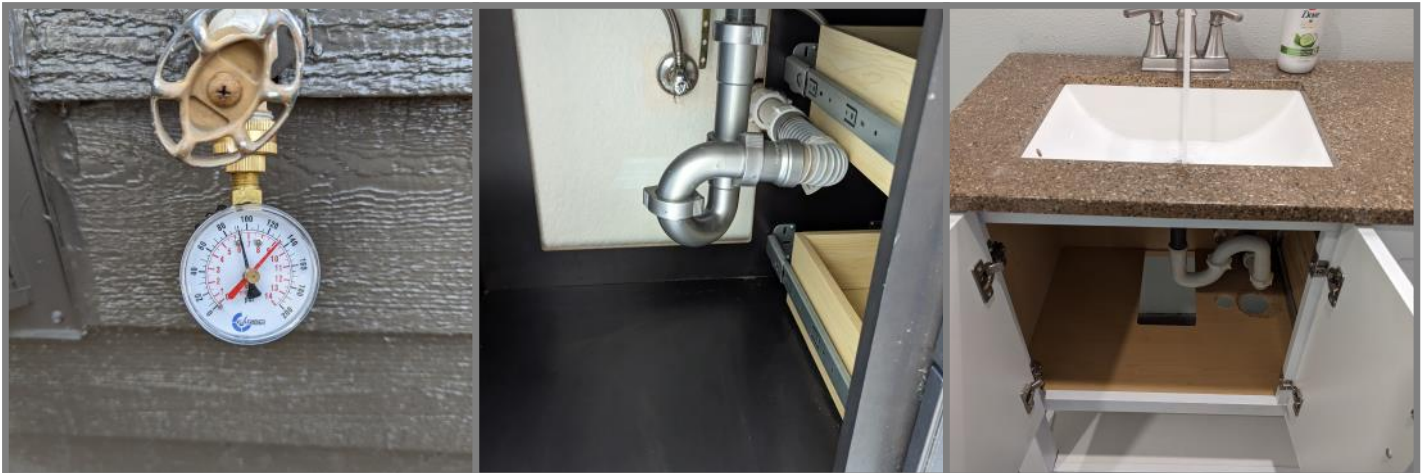
7. Plumbing

This home is served by a public water source and sewer systems.

The gas Rheem hot water heater appeared to be installed and manufactured in 2009 and nearing the end of it's life expectancy.

There were no apparent live leaks in the plumbing supply and/or waste systems.

The water pressure to the home tested to be at 90 psi. Recommended psi range is 40-80.

The water shut-off valve can be found at the water meter near the street.

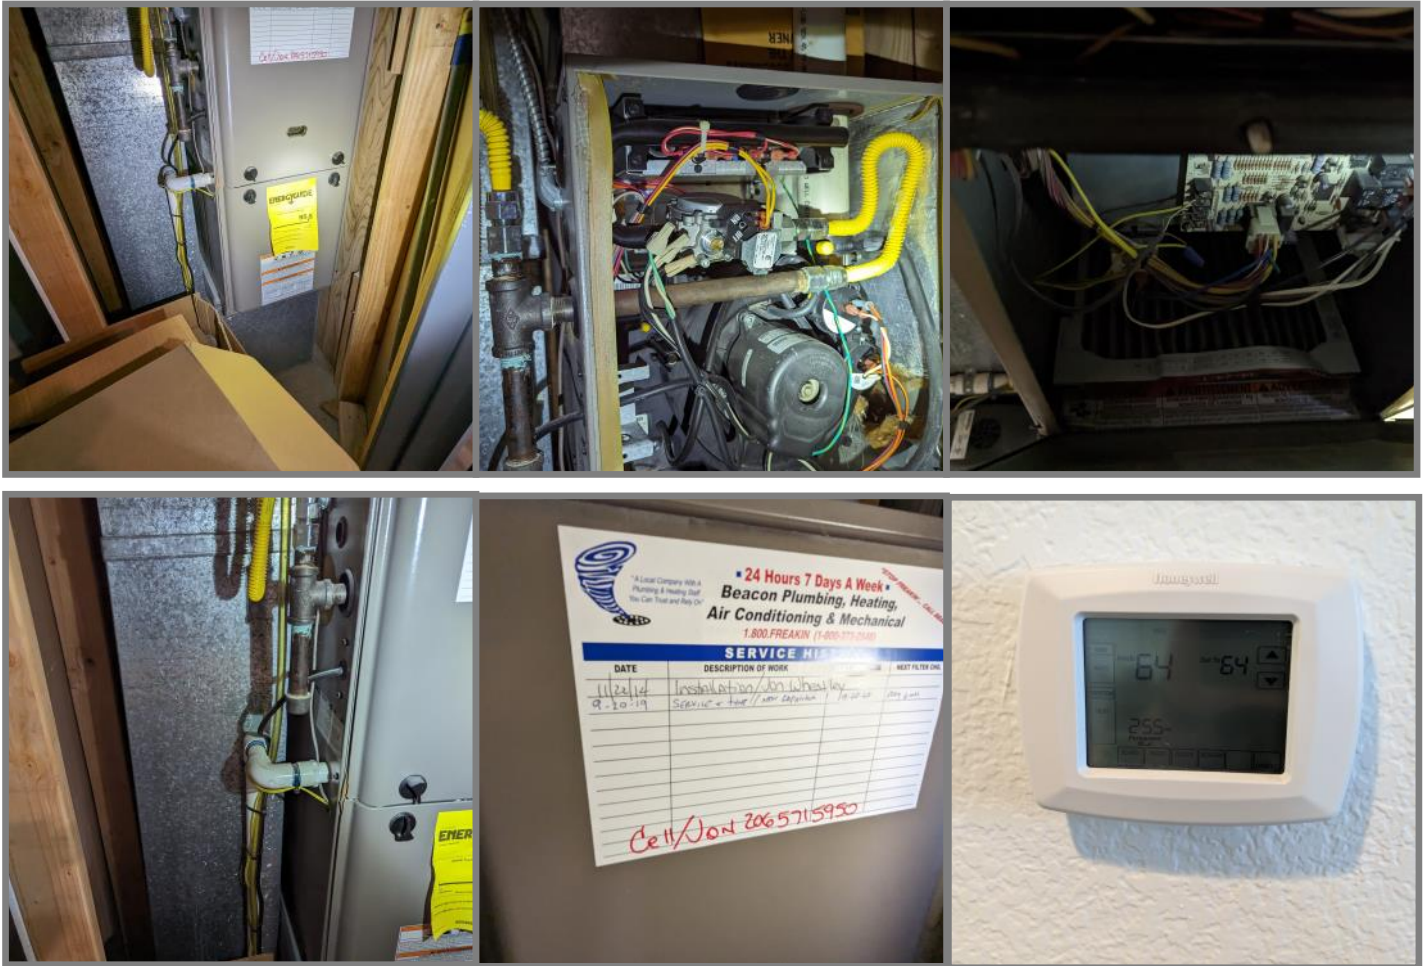
8. Heating

The main heat source to the home is derived from a gas forced air unit located in the basement of the home.

The programmable thermostat did activate the gas furnace during the time of the inspection.

Due to the fact that the furnace is a gas furnace, it is recommended to have the gas unit be serviced by a licensed HVAC contractor on an annual basis.

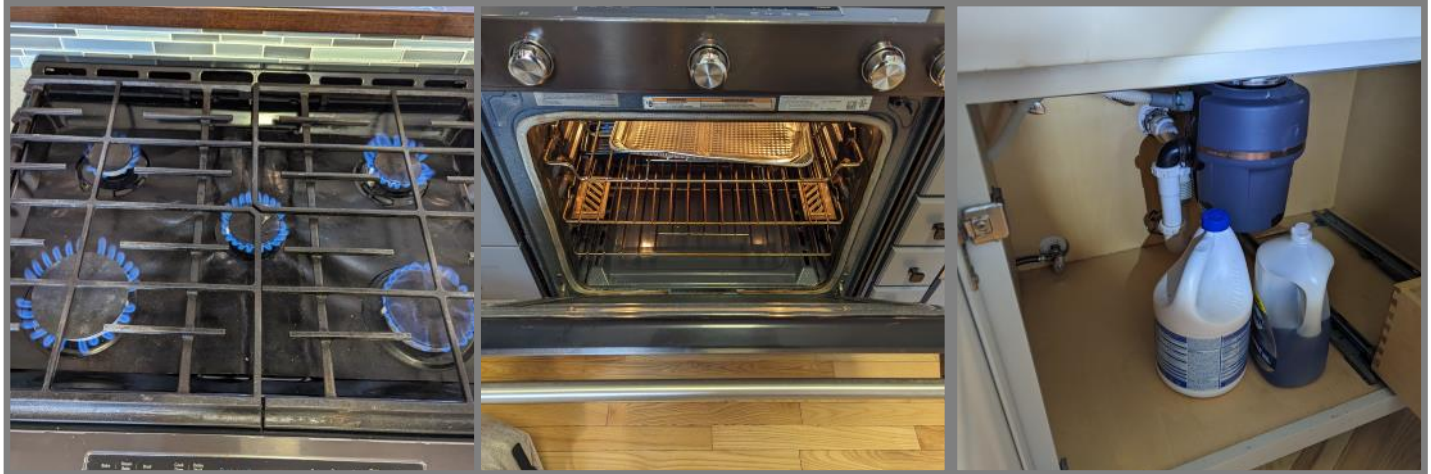
9. Kitchen

The oven, stove top, garbage disposal, exhaust fan and dishwasher were operational during the time of the inspection.

All kitchen built-in cabinets doors and drawers were tested and operated as designed.

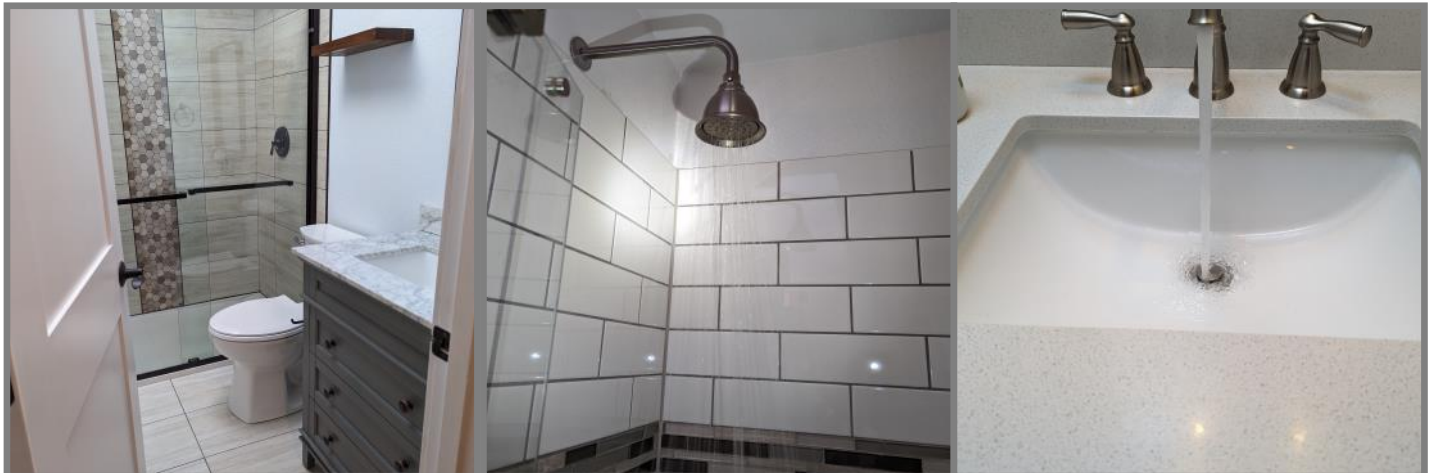
10. Bathroom

All faucets, toilets, showers and exhaust fans were tested and operated as they should.

All bathroom built-in cabinets doors and drawers were tested and operated as designed.

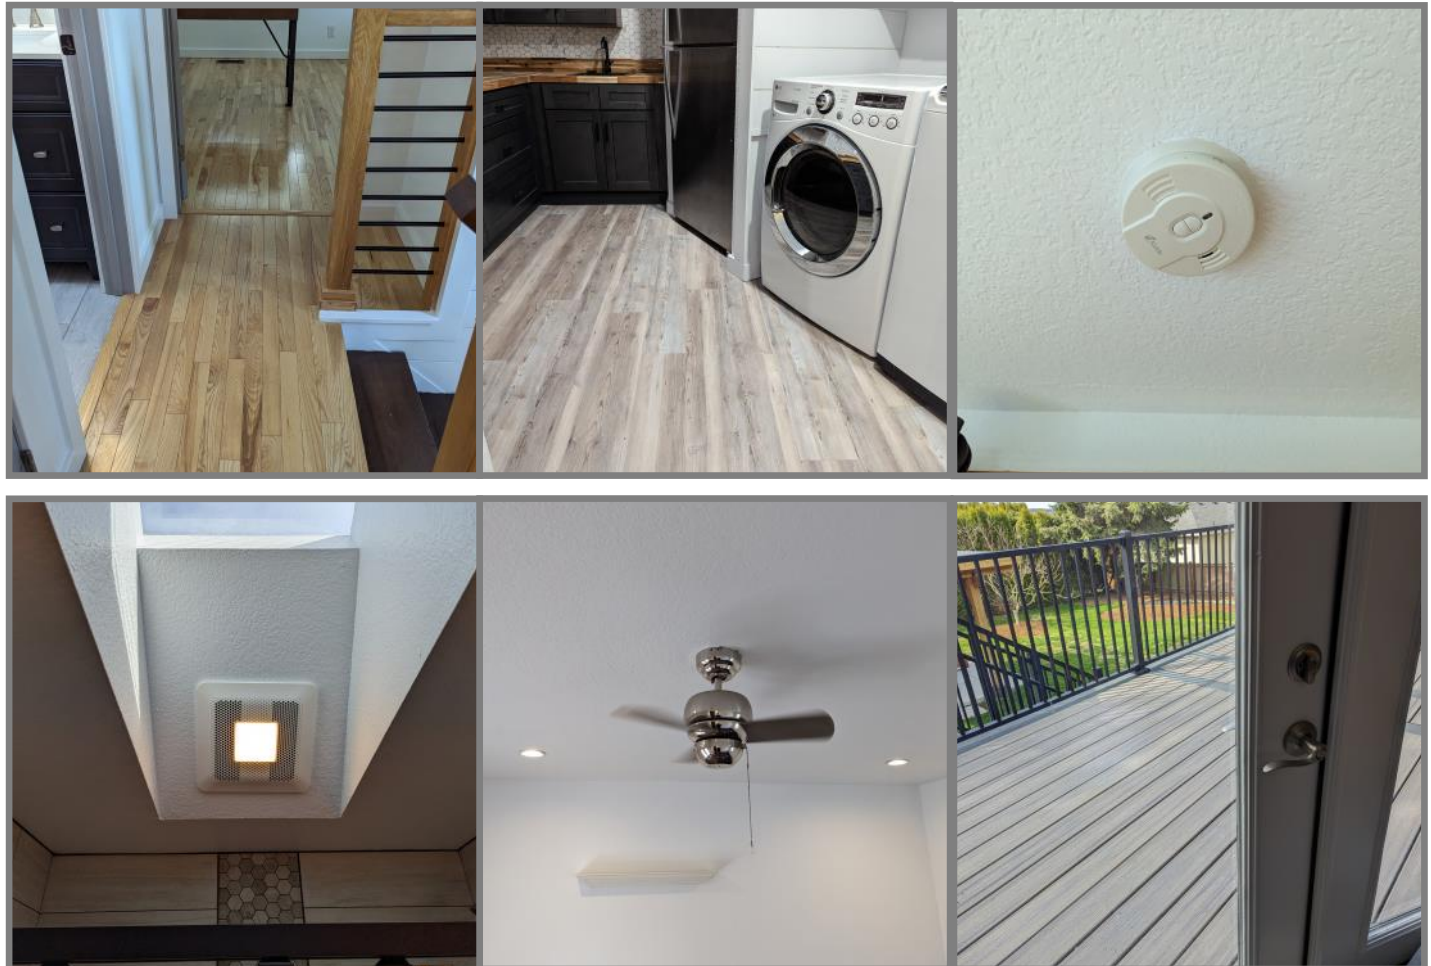
11. Entrance, Doors, and Interior

All the various flooring coverings are in good condition.

All light fixtures, exhaust fans, ceiling fans, doors, door locks and handrails were tested and operated as designed.

The home has all the required smoke and carbon monoxide detectors in the home.

Recommend all detectors are supplied with fresh batteries and tested for proper operation.

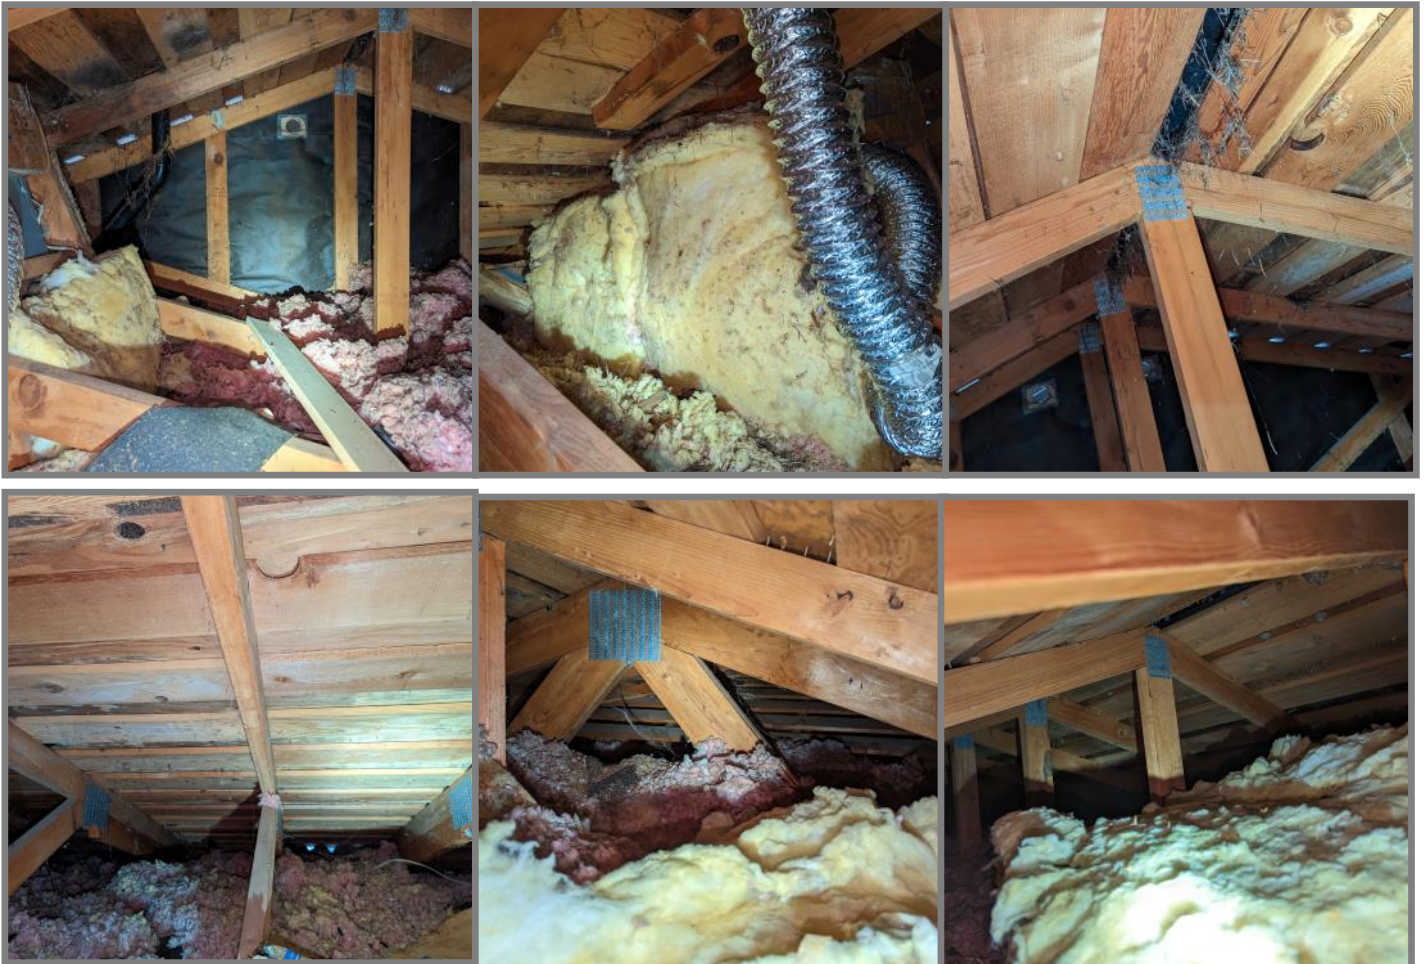
12. Attic

The ceiling is well insulated with blown in type insulation.

All rafter/ roof trusses, sheathing, other materials appeared to be in good condition, properly constructed

All materials showed no signs of any water intrusion/ damage during the time of the inspection.

The attic space did appear to have the appropriate amount of ventilation.

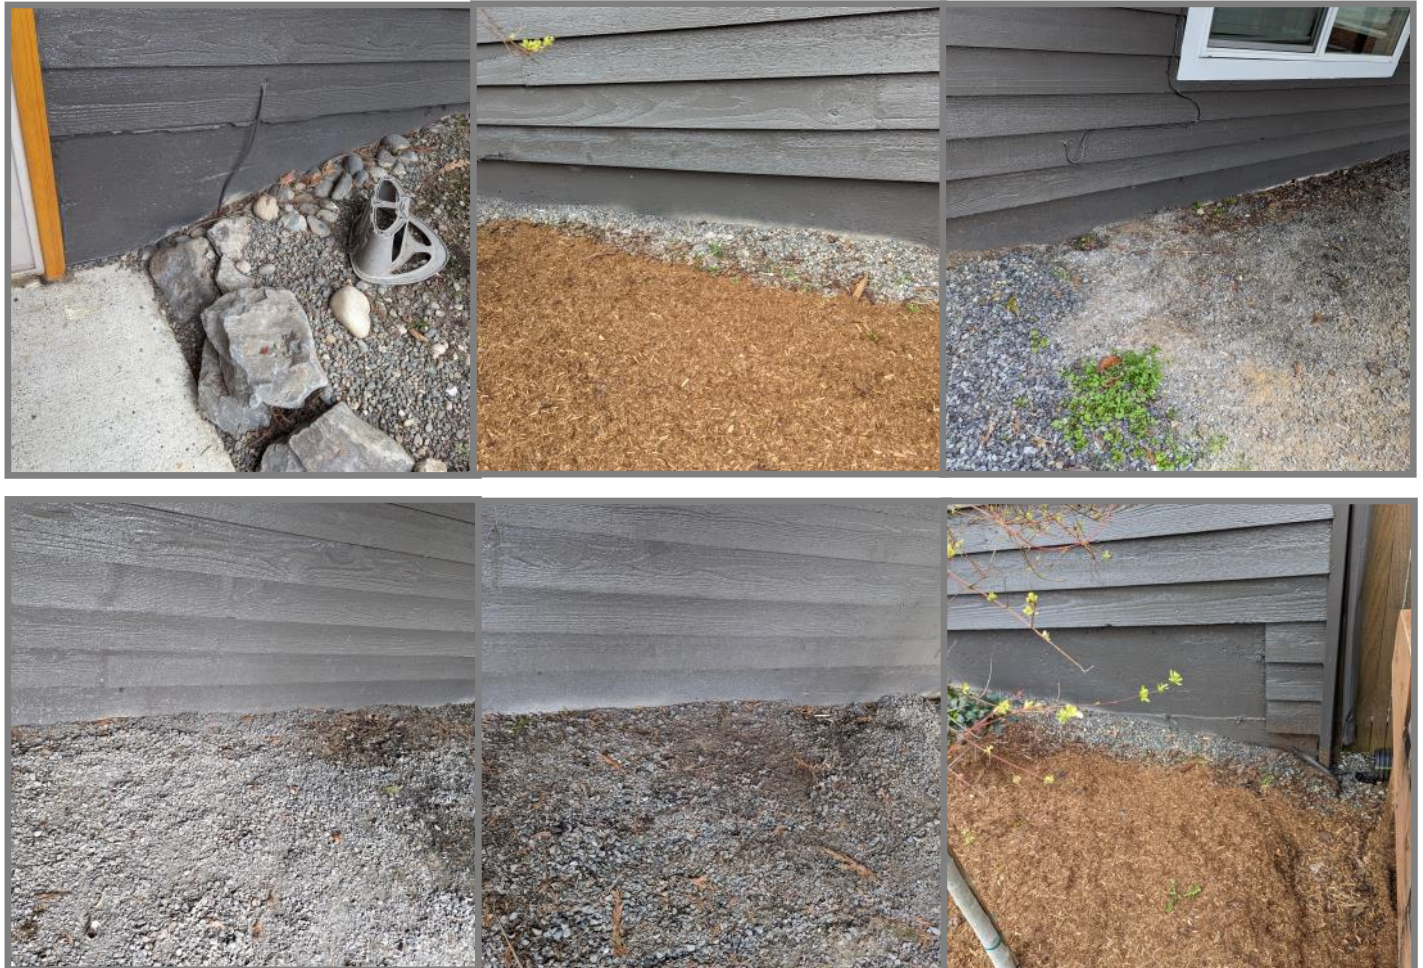
13. Foundation— Concrete Slab

The home’s concrete slab foundation appeared to be in good condition.

There were no signs of excessive movement in the foundation as there were no major cracks observed during the time of the inspection.

There were no major cracks in the ceilings and walls of the home during the time of the inspection.

There were no problems with windows and doors jamming when tested during the time of the inspection.
