Your Home Inspection Report

6751 Waterton Cir. Mukilteo, WA 98275

4/13/2023 3:00pm – 5:00pm

Residential Home Inspection

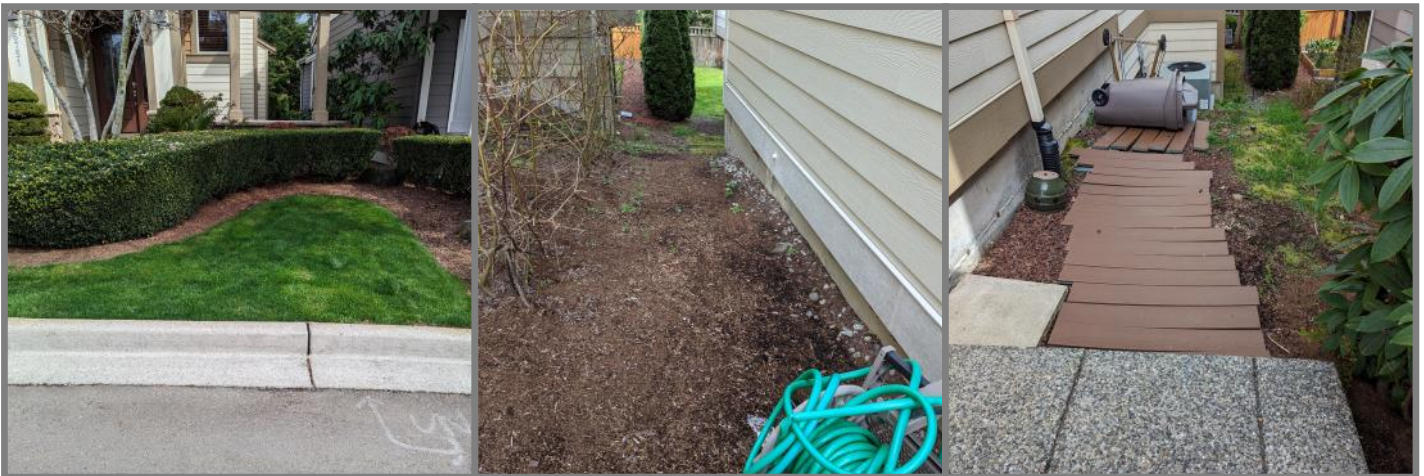
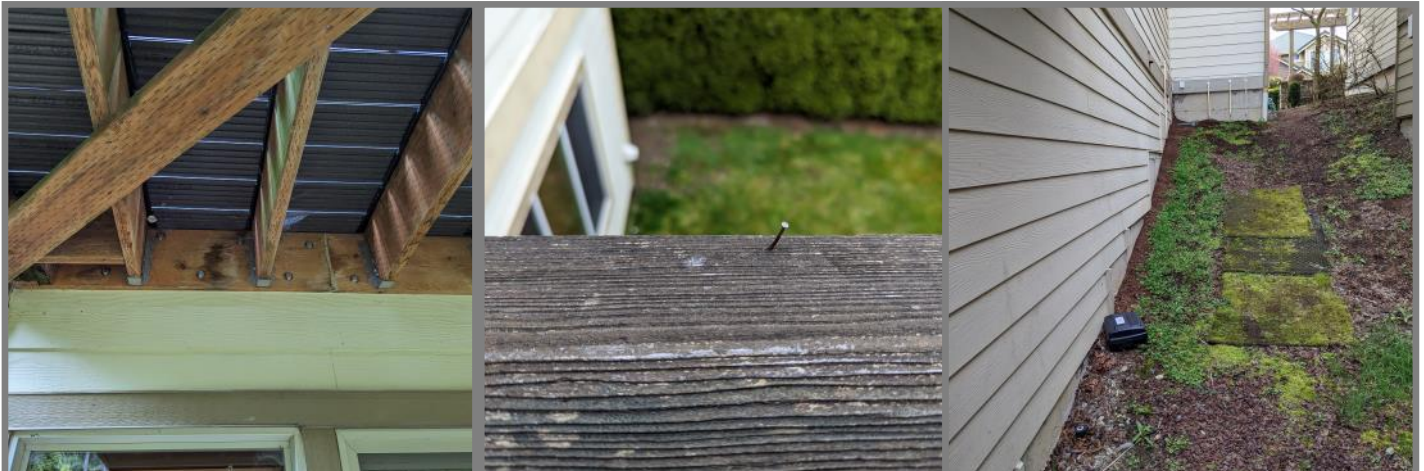
- 1. Site**— The yard, front porch and driveway were in good condition and appeared they should for a home 18 years old. The suspended composite/wood deck appeared to well constructed and attached to the home. **Recommend removing or nailing down the wood nails sticking up on the guardrails.**

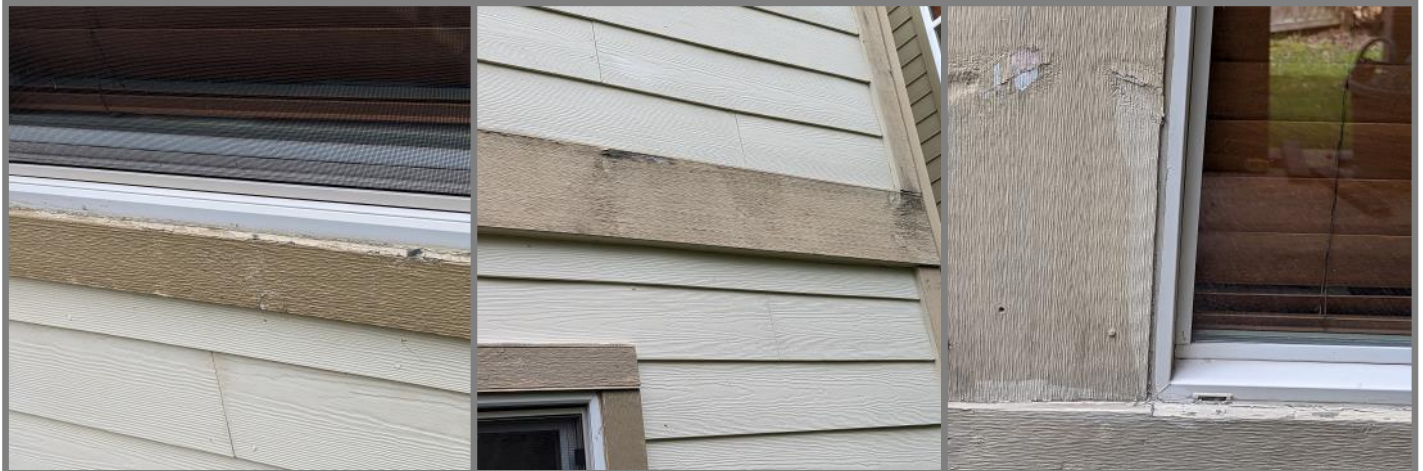
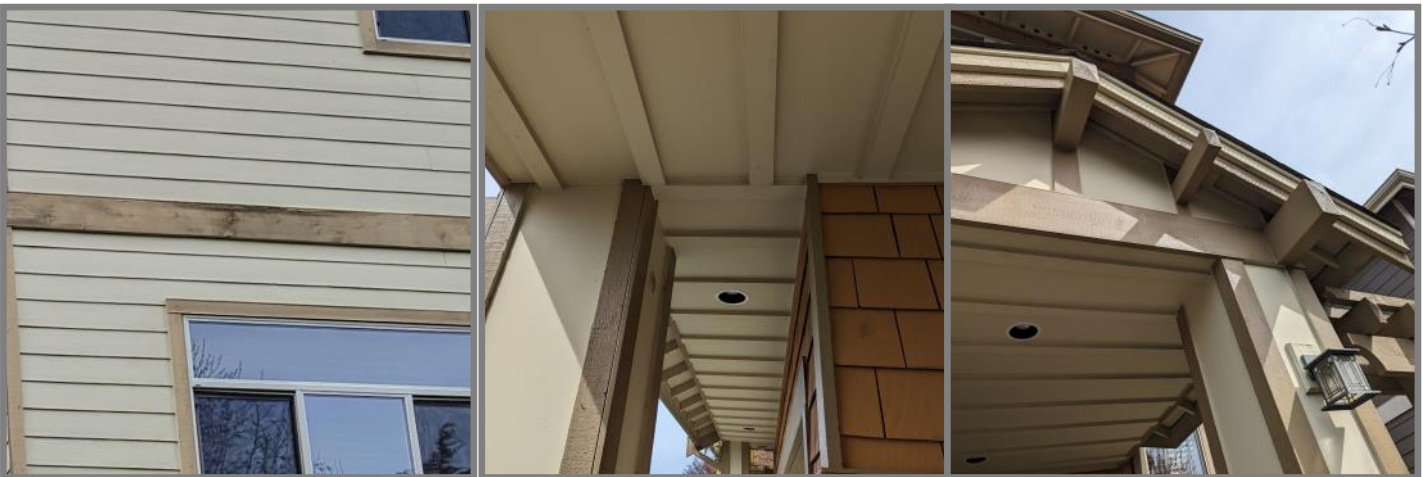
The wood trim on the rear of the home appears to be in need of fresh caulking, primer and paint. This is the side of the home that naturally receives most of the sun, wind and weather and is common to occur on this side.

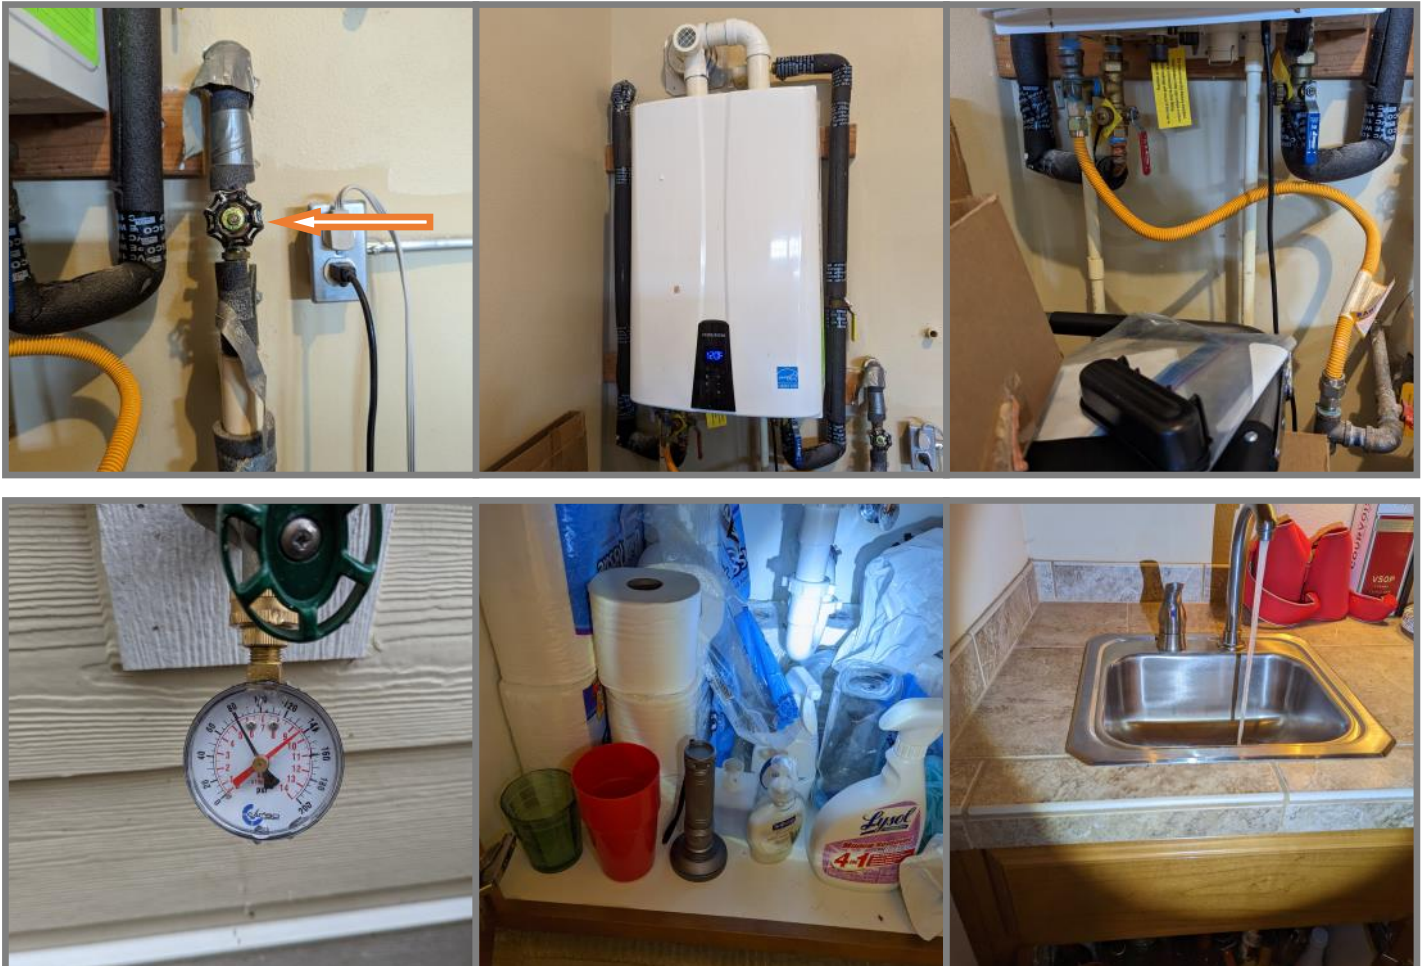
The water pressure to the home tested to be at 80 psi. Recommended psi range is 40-80. The main water shut-off valve was located near the hot water heater and pointed out below.

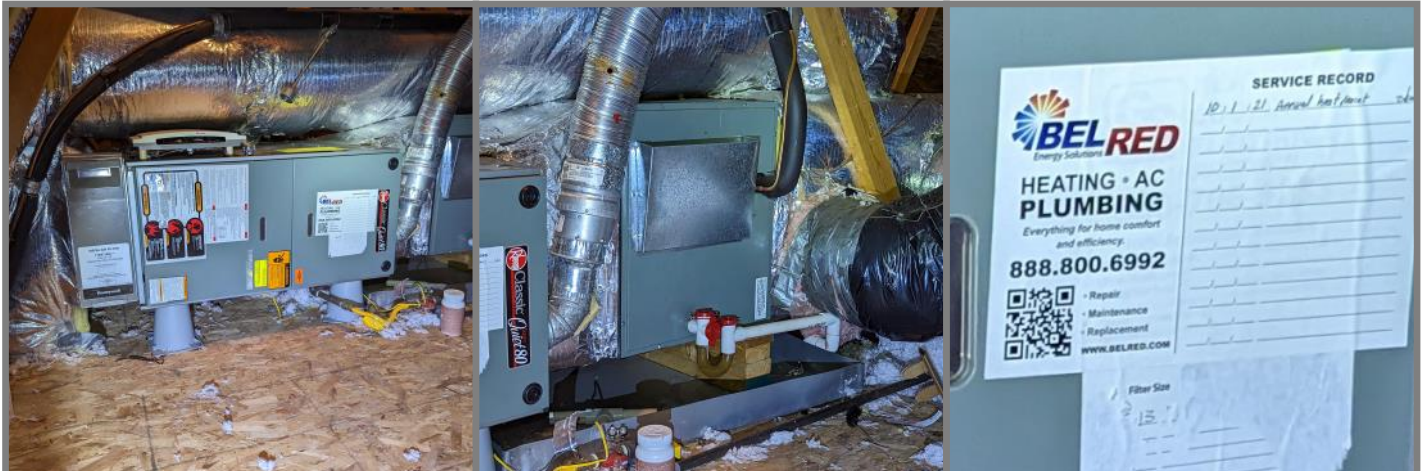
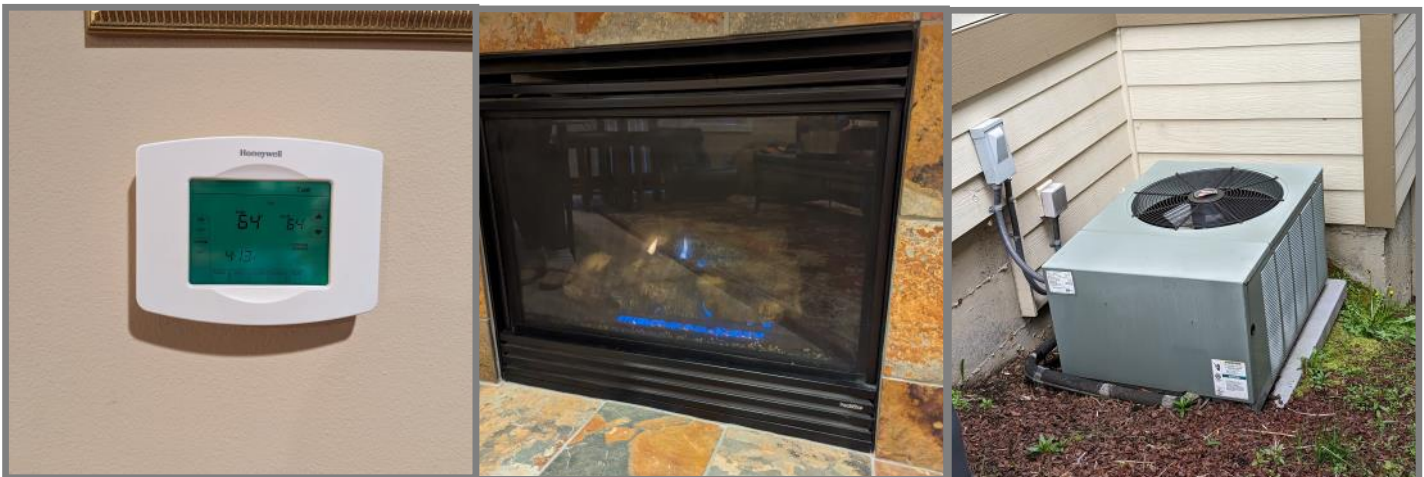
The furnace appeared to have it's last annual service in 2021.

Recommend a licensed HVAC contractor conduct an annual service on the Lennox unit and service the gas fireplace as well.

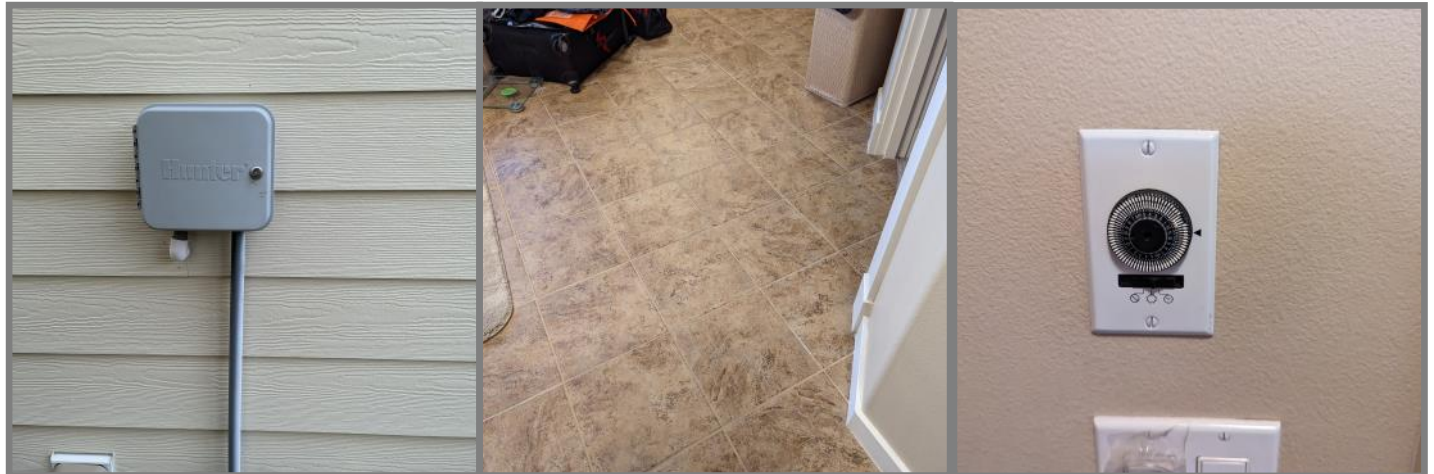
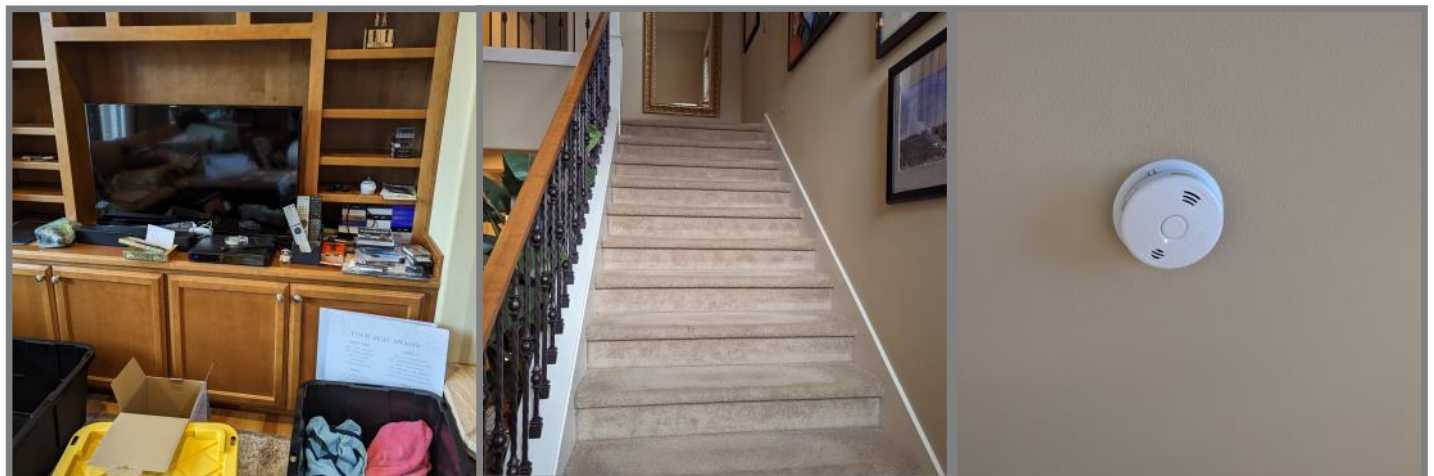
The home has all the required smoke and carbon monoxide detectors in the home.

Recommend all detectors are supplied with fresh batteries (back-up) and tested for proper operation.
