Your Home Inspection Report

5518 148th PL SW, Edmonds, WA 98026

Residential Home Inspection

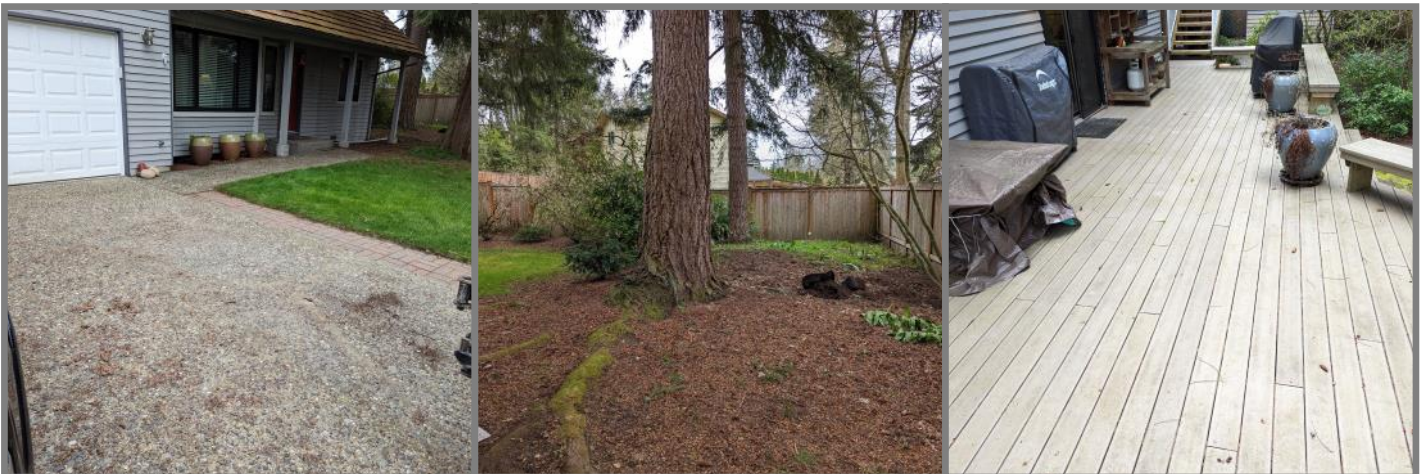
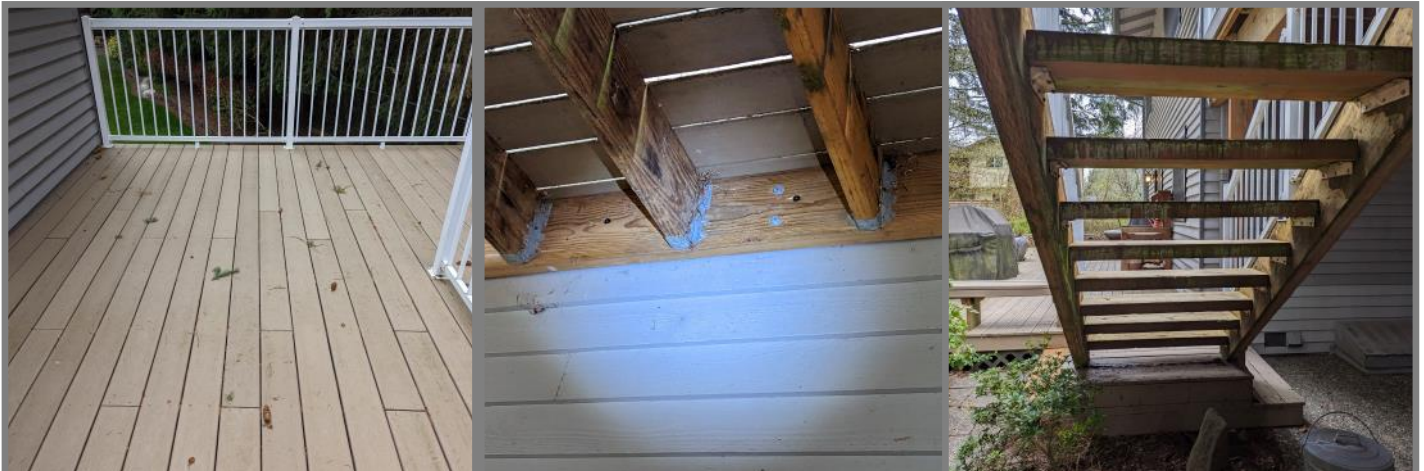
- 1. Site**— The yard, sidewalk, and driveway were in good condition and appeared they should for a home 40 years old. The composite/wood decks appeared to be properly constructed. The suspended deck did appear to be properly attached to the home and all handrails properly supported.

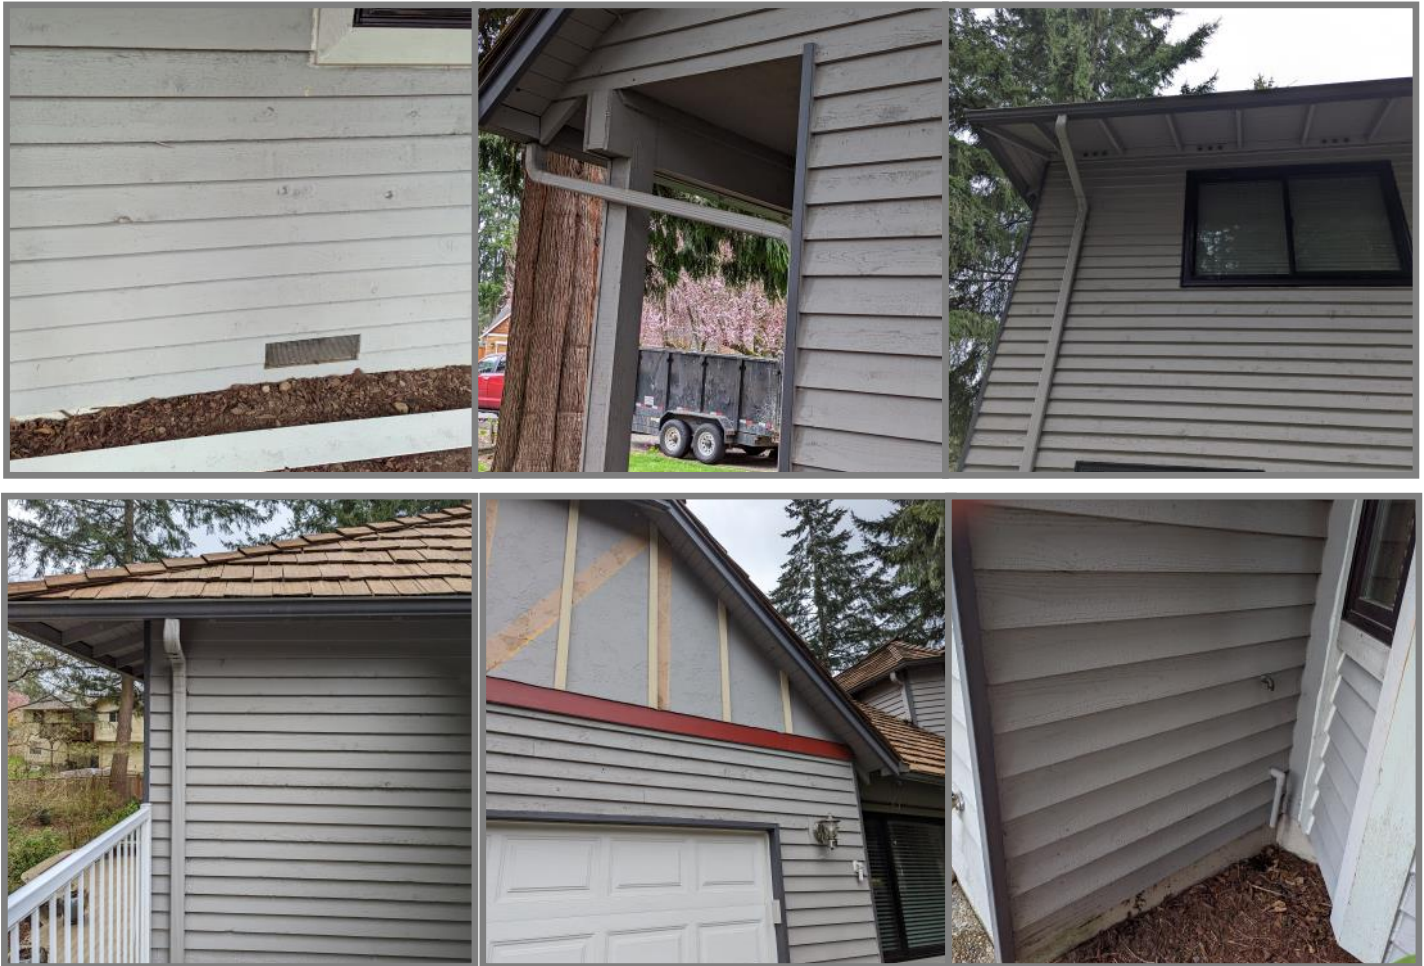
2. Siding and Trim

The exterior siding is a natural wood clap type siding on all sides of the home. The siding on the home appeared to be in good condition on all sides of the home.

The paint of the home's exterior siding and trim appeared to be in good condition with **no** signs of peeling, cracking and/or damage.

The front Tudor style of the home has been converted to board and batter. The is not considered a defect as the wood is still protected by primer/paint.

This wood trim and exterior were updated and painted since inspection.

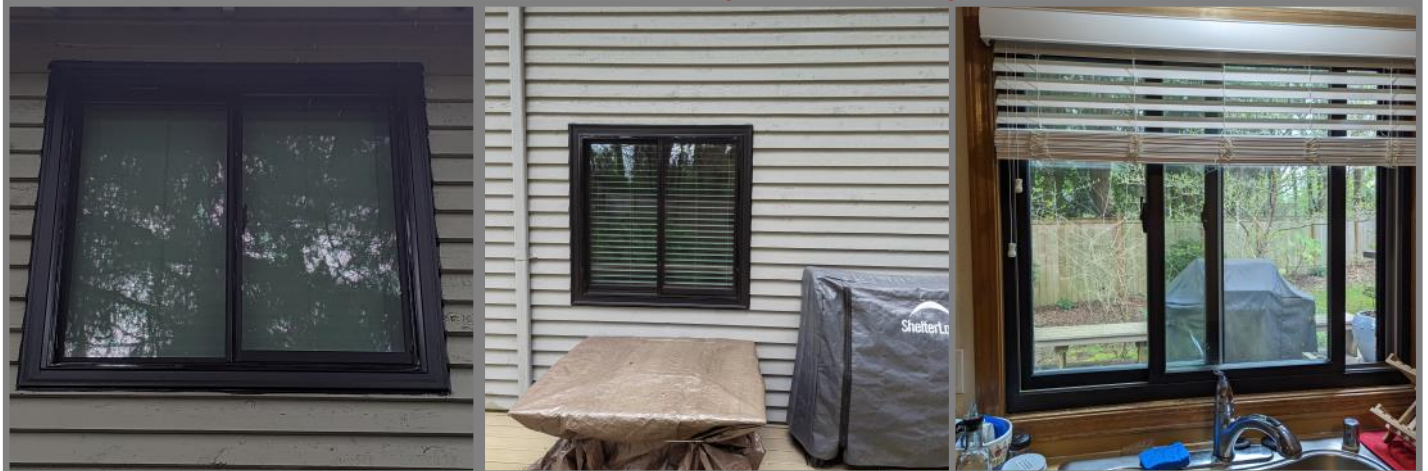
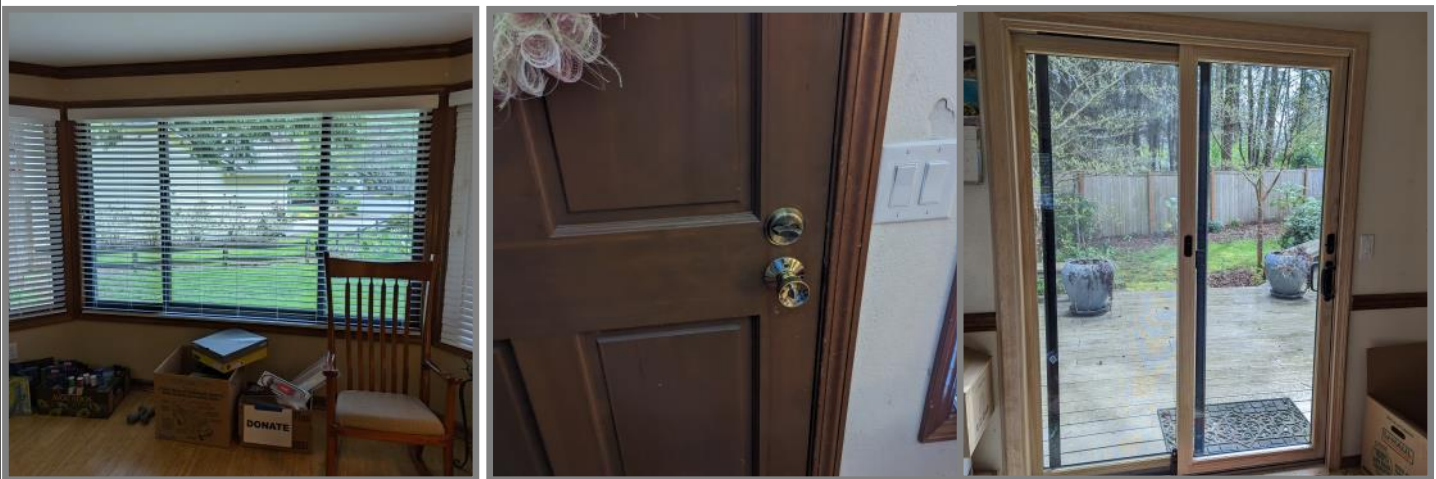
3. Windows/Doors

The home appears to have updated double pane vinyl framed windows. All windows tested did operate as they should.

There were no signs of failed window seals or broken glazing or glass.

**All interior doors and all windows have been updated!
Windows alone were \$58,000, see receipt at end of report.**

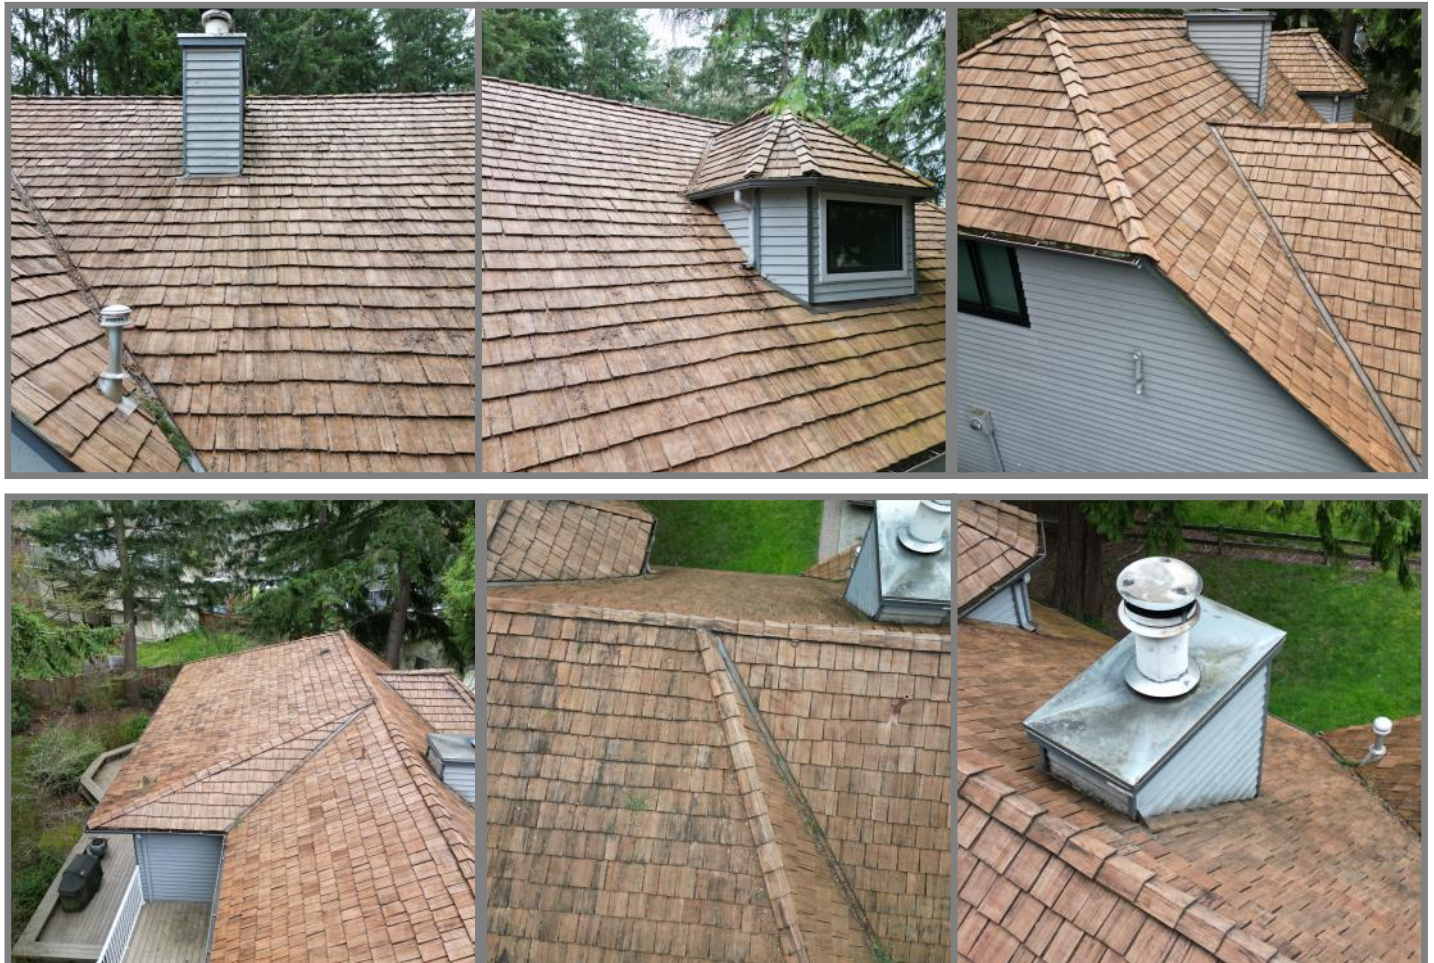
4. Roof

There was the updated red cedar shingle type roofing material.

All materials looked to be intact and in good condition during the time of the inspection. There were no signs of significant granule loss, curling and/or damaged materials. There were no signs of excessive moss build-up.

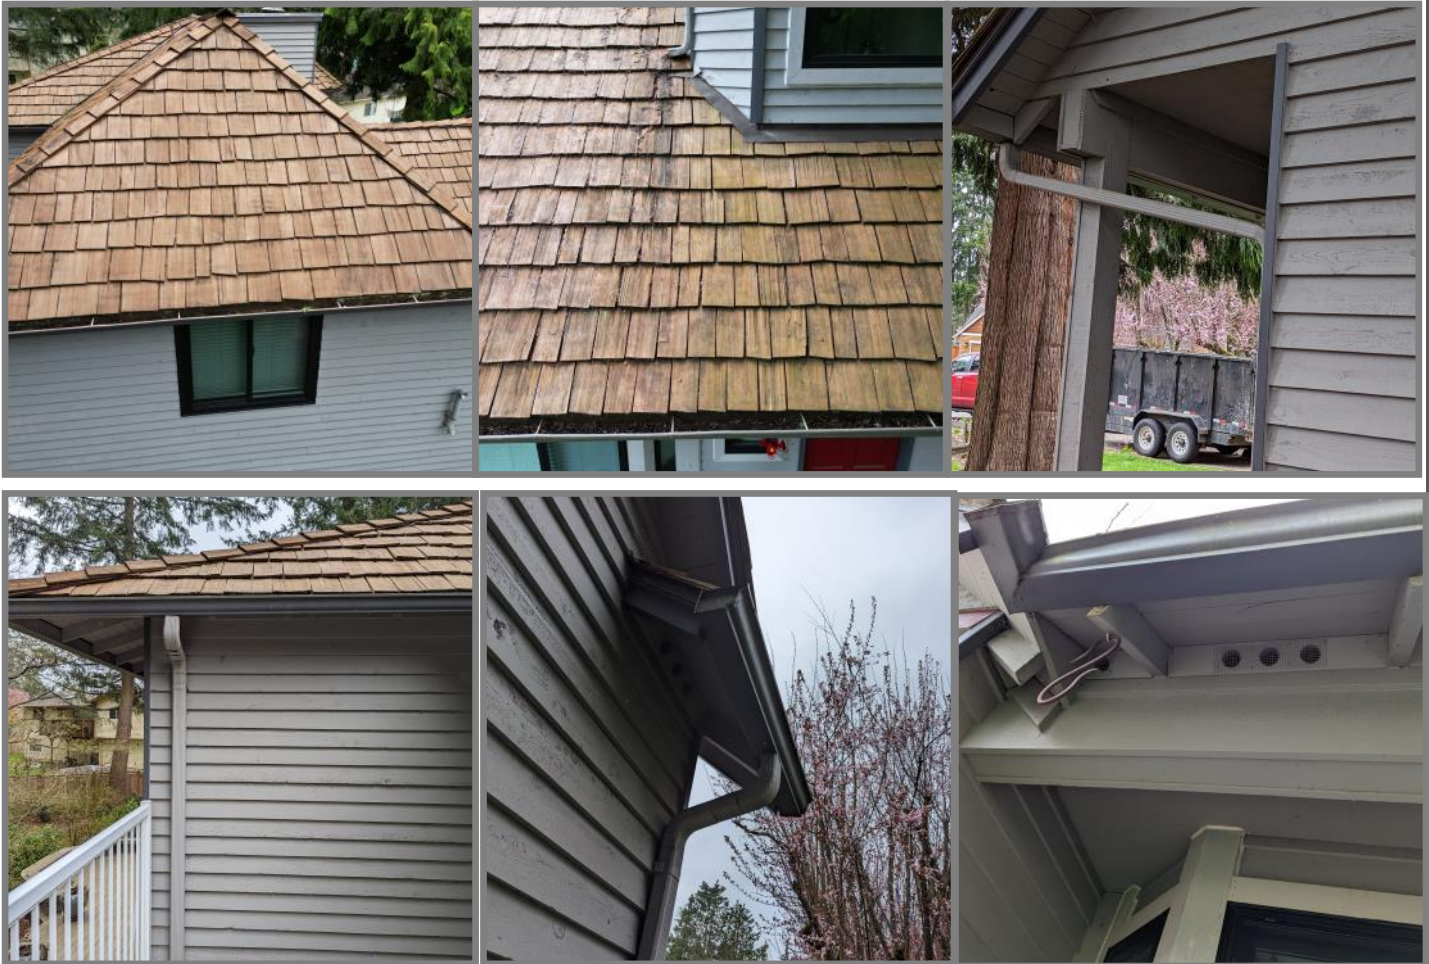
5. Gutters and Downspouts

The gutters did appear to be in need of a cleaning as there did appear to be trees debris build-up in the gutters during the time of the inspection.

Recommend a licensed contracted clean gutters.

Roof and gutter cleaned.

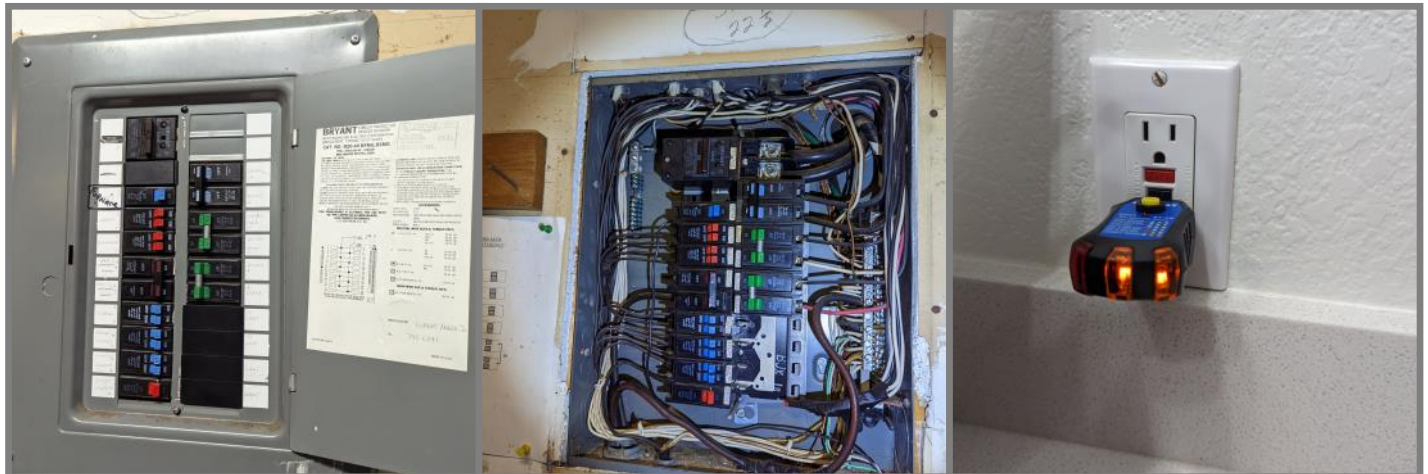
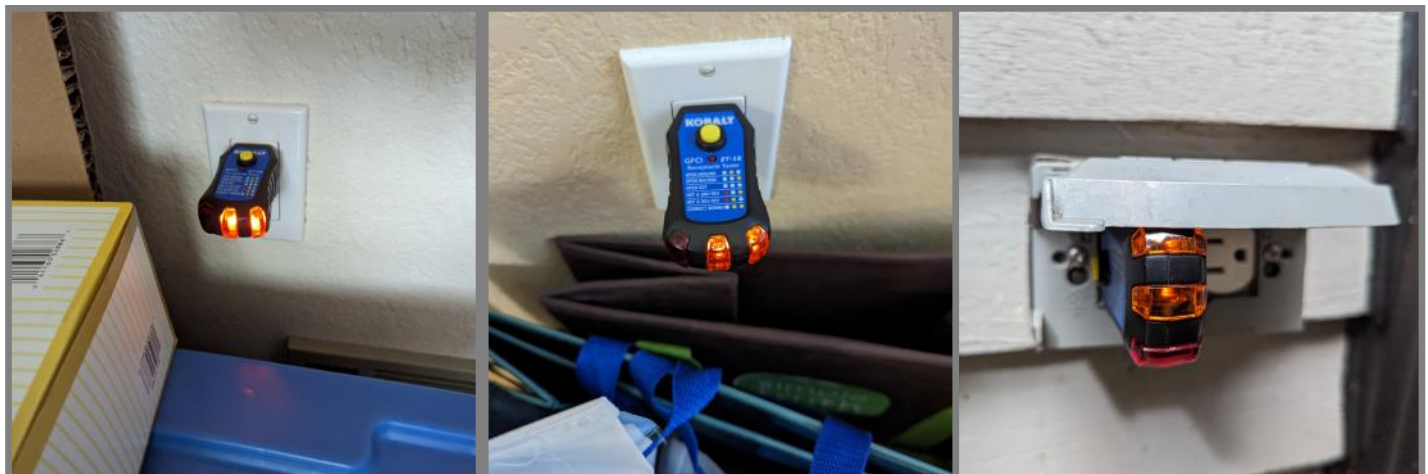
6. Electrical

The Westinghouse electrical service panel is located in the garage of the home.

The panel appeared to be the original panel and in good condition.

The garage and kitchen appeared to be without GFCI protection.

Recommend a licensed electrician evaluate and remedy. **Repaired. Inspection occurred before completion of Kitchen remodeling.**

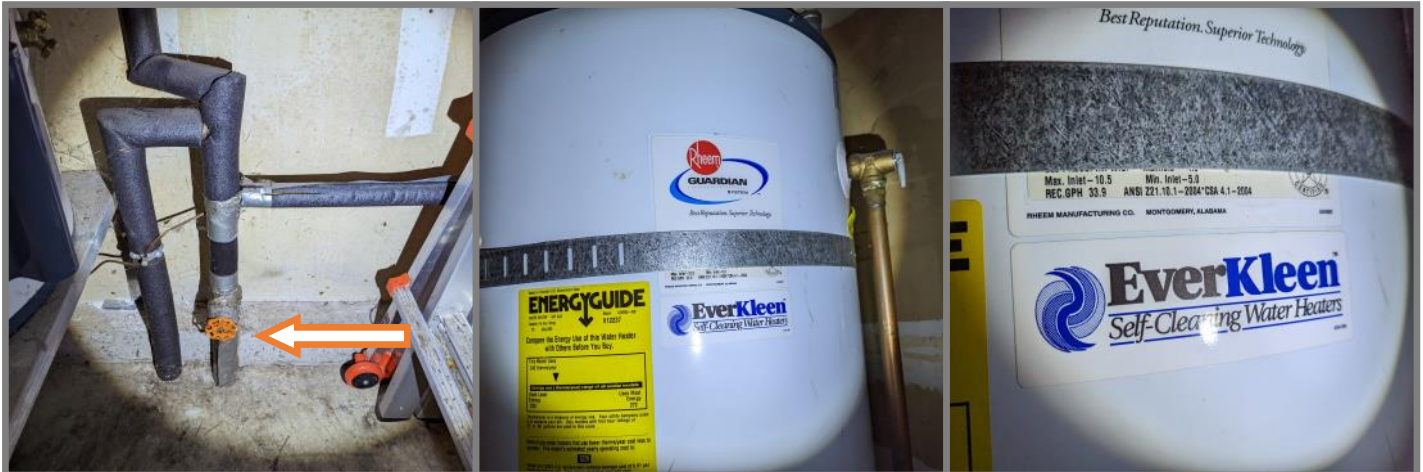
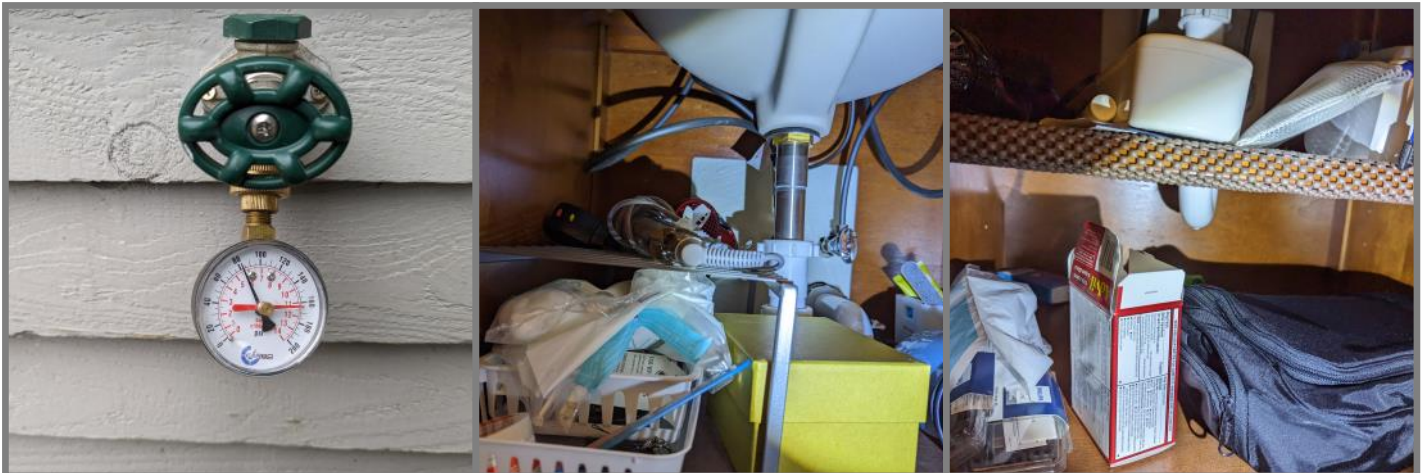
7. Plumbing

The gas Rheem hot water heater appeared to be installed and manufactured in 2004 and at the end of it's life expectancy.

The water pressure to the home tested to be at 80 psi. Recommended psi range is 40-80.

Recommend a licensed contractor replace the hot water tank as soon as possible.

**Brand new water heater installed in June.
See receipt at end of report**

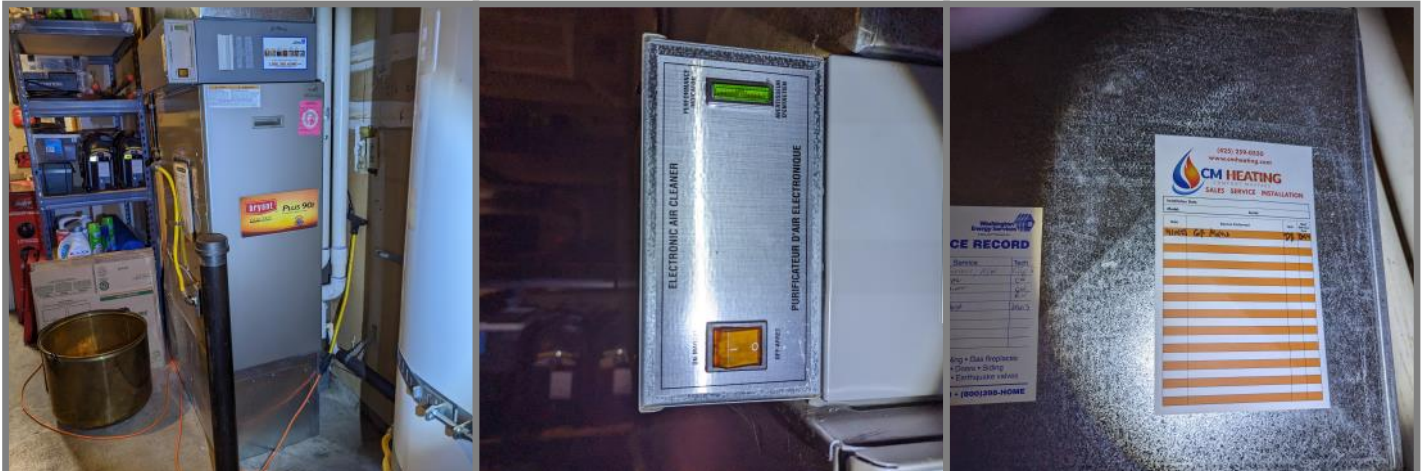
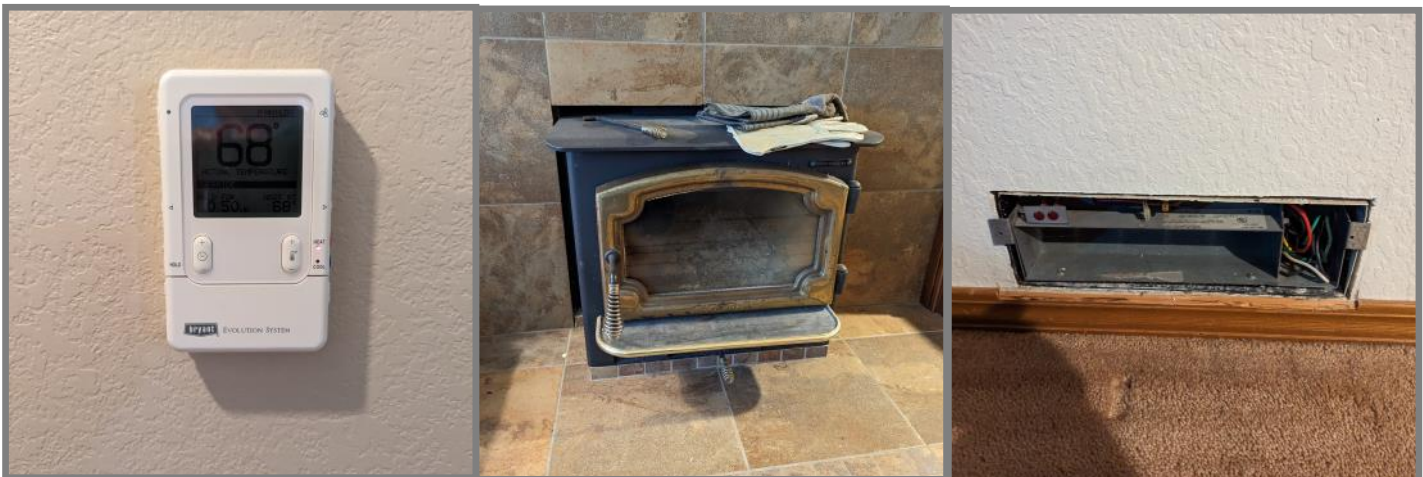
8. Heating

The main heat source to the home is derived from a gas Bryant forced air unit located in the garage of the home. The thermostat did activate the furnace during the time of the inspection.

The wood burning insert fireplace located in the living room of the home did appear to be in good condition, but in need of cleaning. Recommend a chimney sweep service before use.

Insert serviced, see report attached.

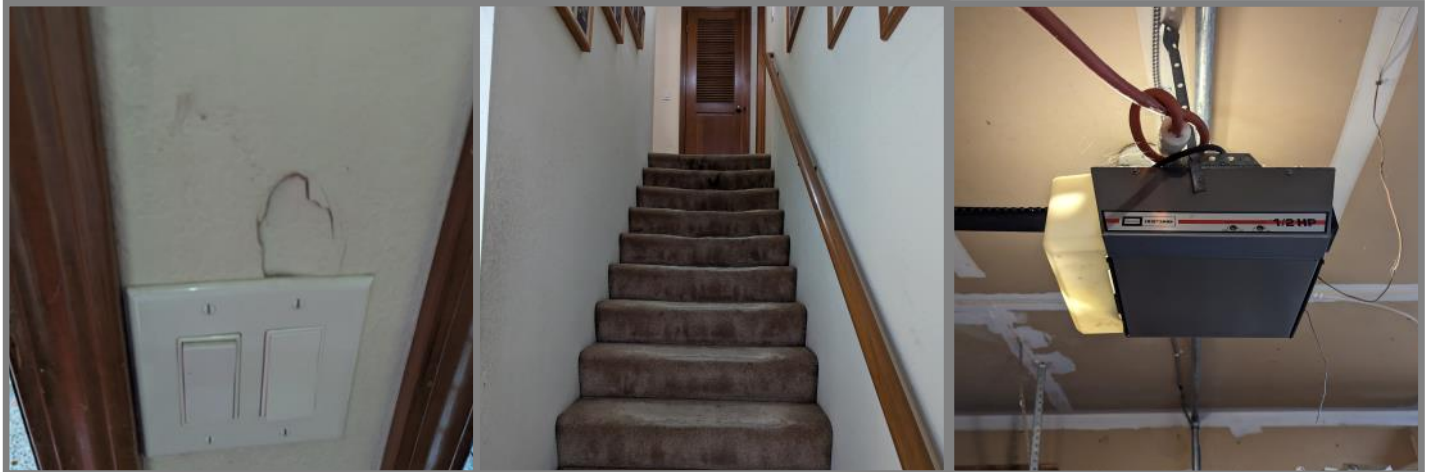
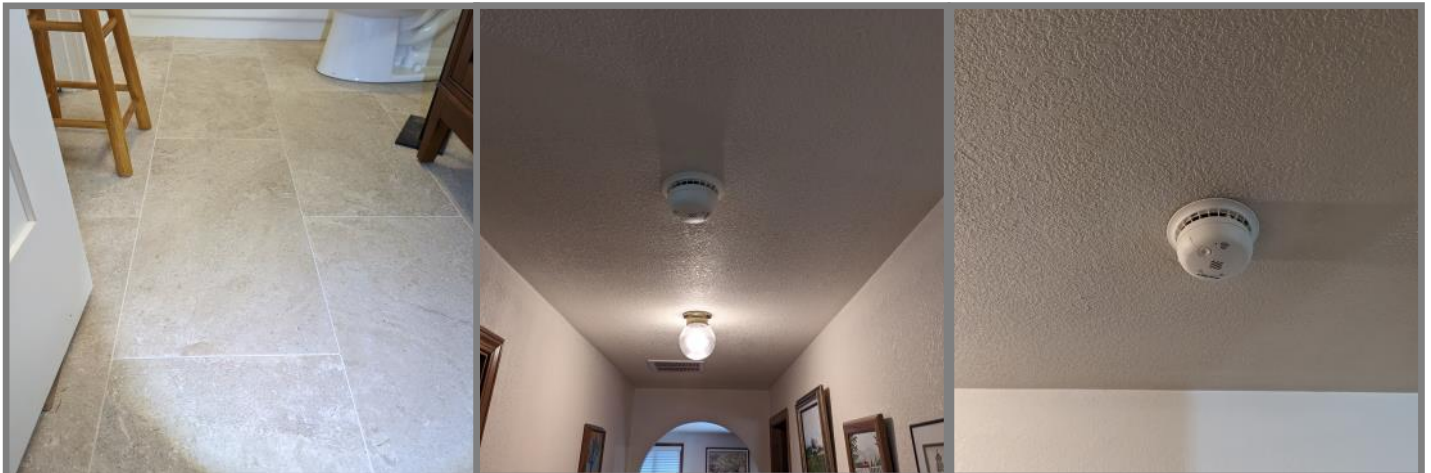
11. Entrance, Doors, and Interior

The floor carpeting in the home was worn and in need of replacement.

The older Sears automatic garage door opener was missing the required safety photo eyes. However, the garage door did activate as designed.

Recommend a licensed contractor remedy these issues.

1. Detectors have fresh batteries.
2. All carpet removed and replaced, except in primary where it was in good condition.

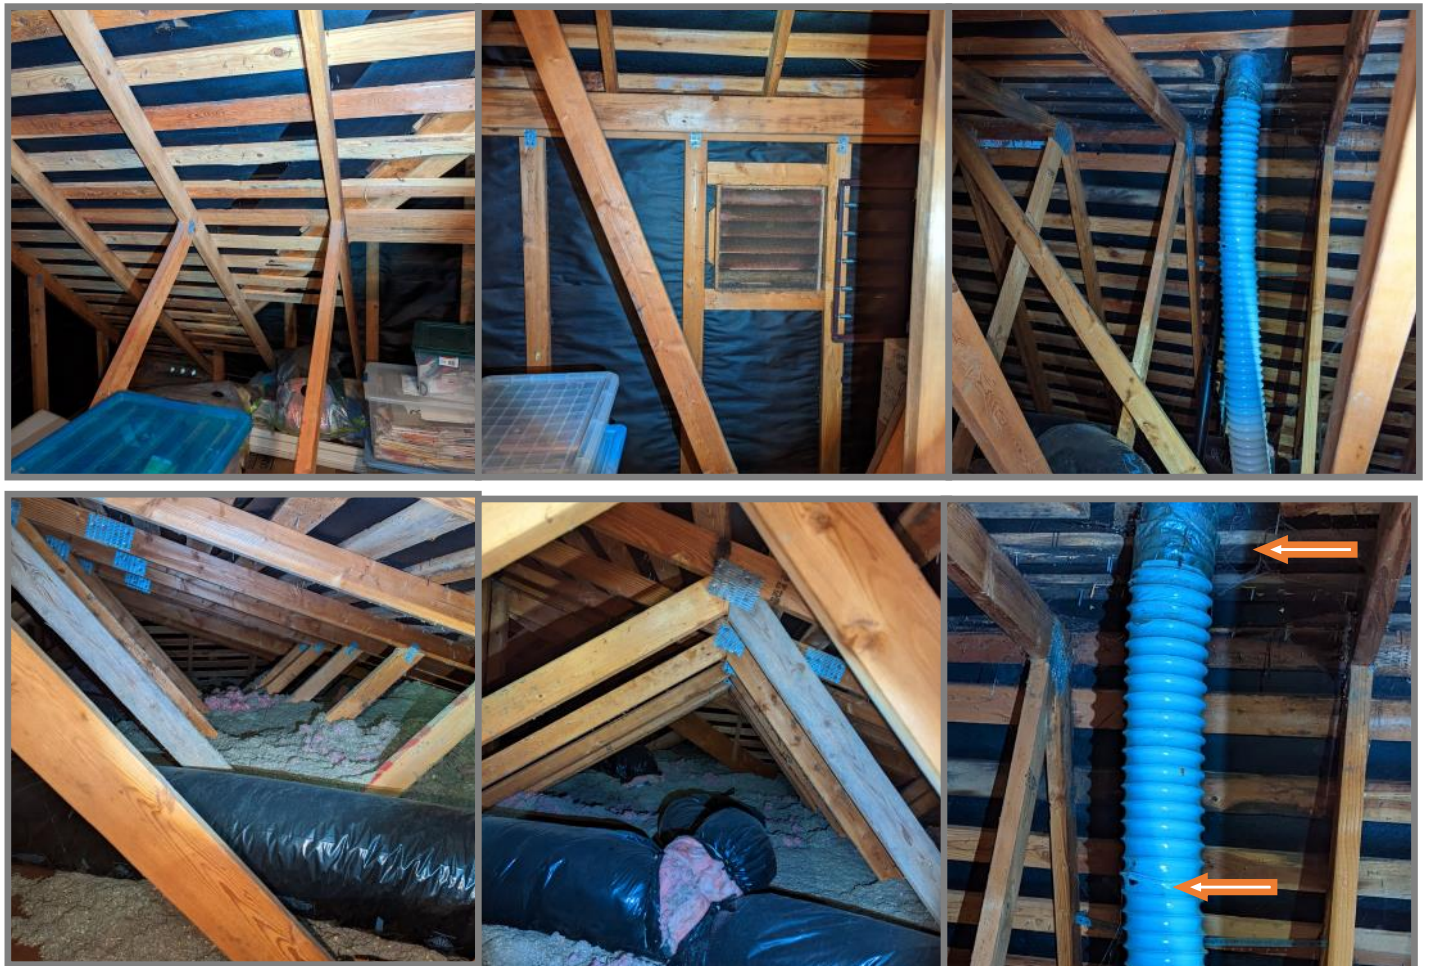
12. Attic

There was one exhaust flue flex hose in the attic in need of replacement as it appeared to have a small hole and was improperly attached at the top.

Recommend a licensed contractor remedy as needed.

Exhaust hose re-attached by contractor.

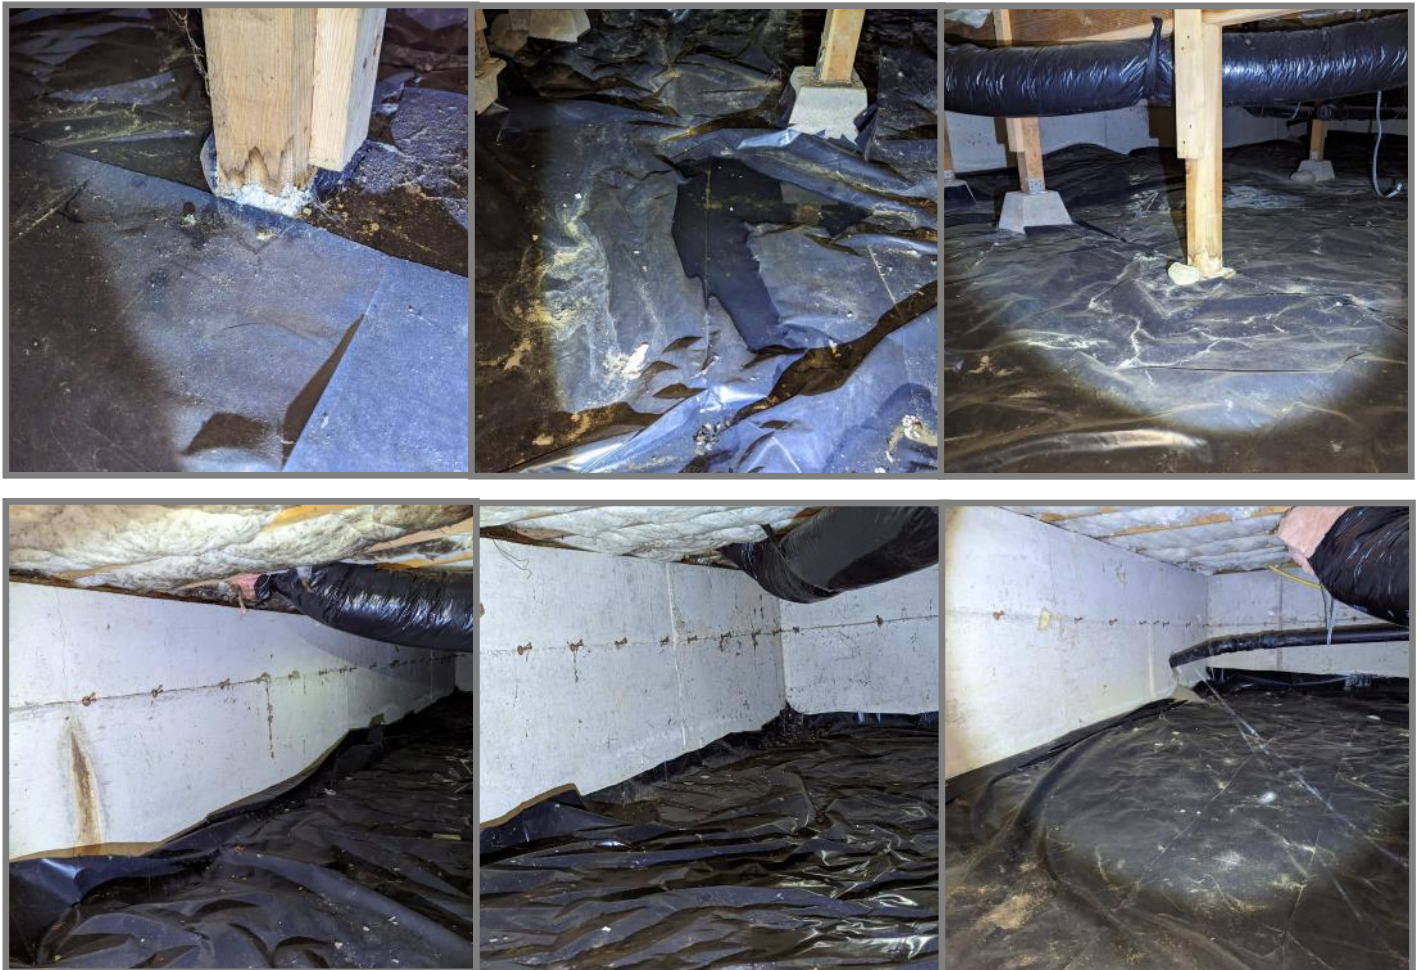
13. Foundation—Crawlspace

There did appear to be 2 to 3 posts/footings in need of repair as the crawlspaces seasonal water line has caused some efflorescence and water stains and possible support post movement. This observation while it does need to be addressed, appears to not have affected the home adversely in the floors, walls, windows and doors.

Recommend a licensed contractor evaluate and remedy the issue.

3 posts identified and secured with Simpson ties, see photos attached.
