# Inspection Notes

## 10701 62nd Pl W. Mukilteo

## **Inspection Report**

**Property Address:**  
10701 62nd PL W  
Mukilteo WA 98275

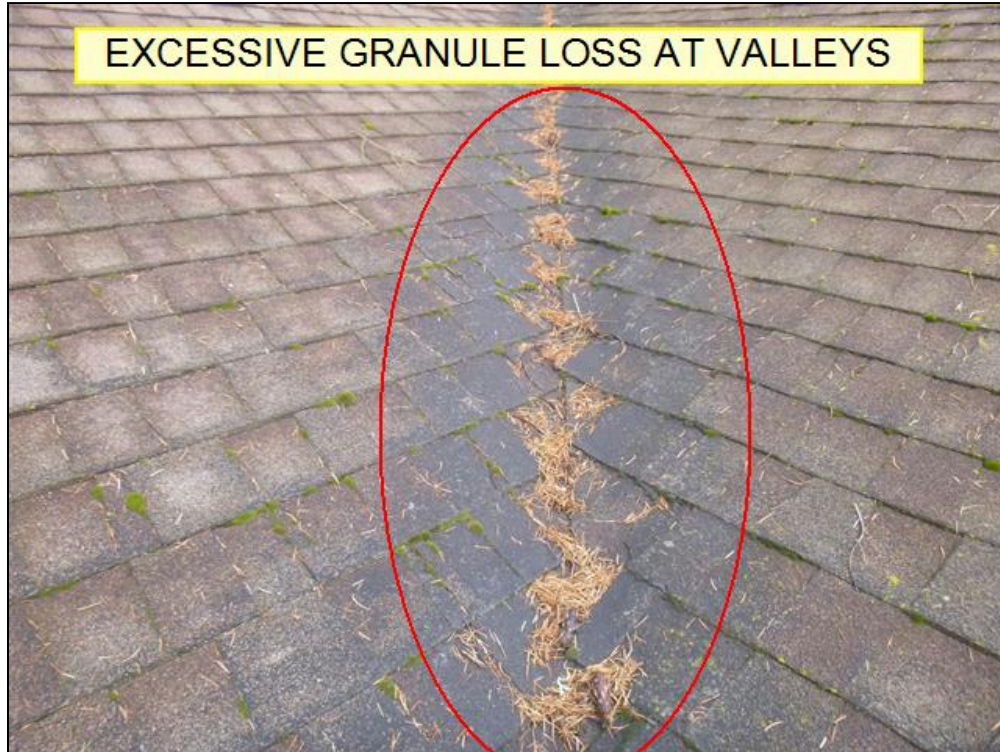
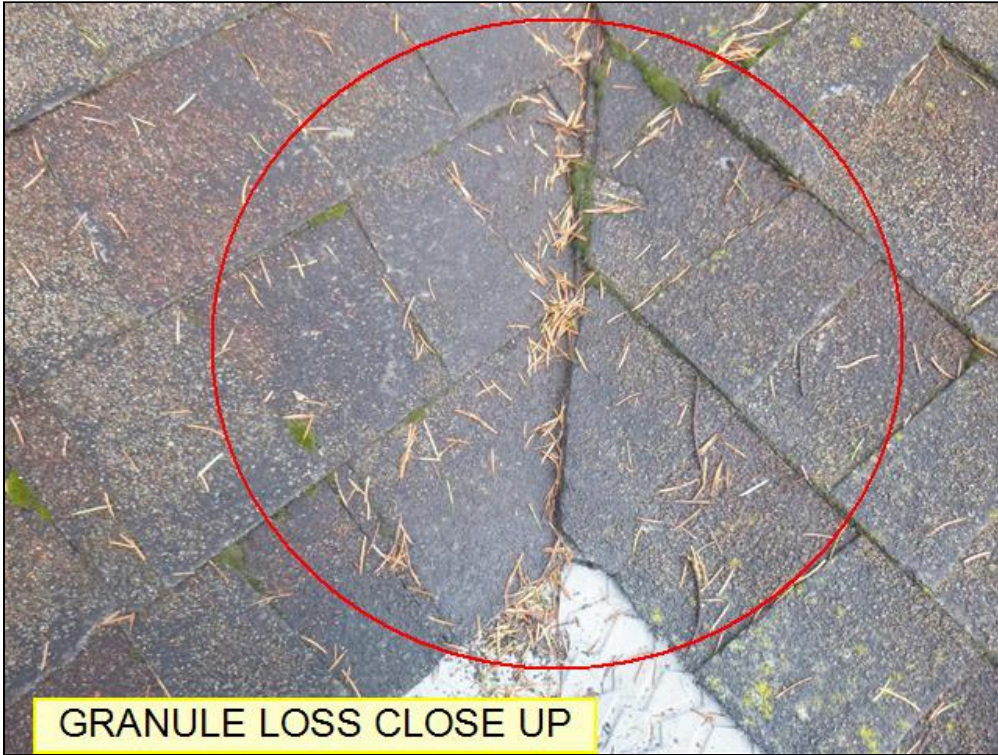
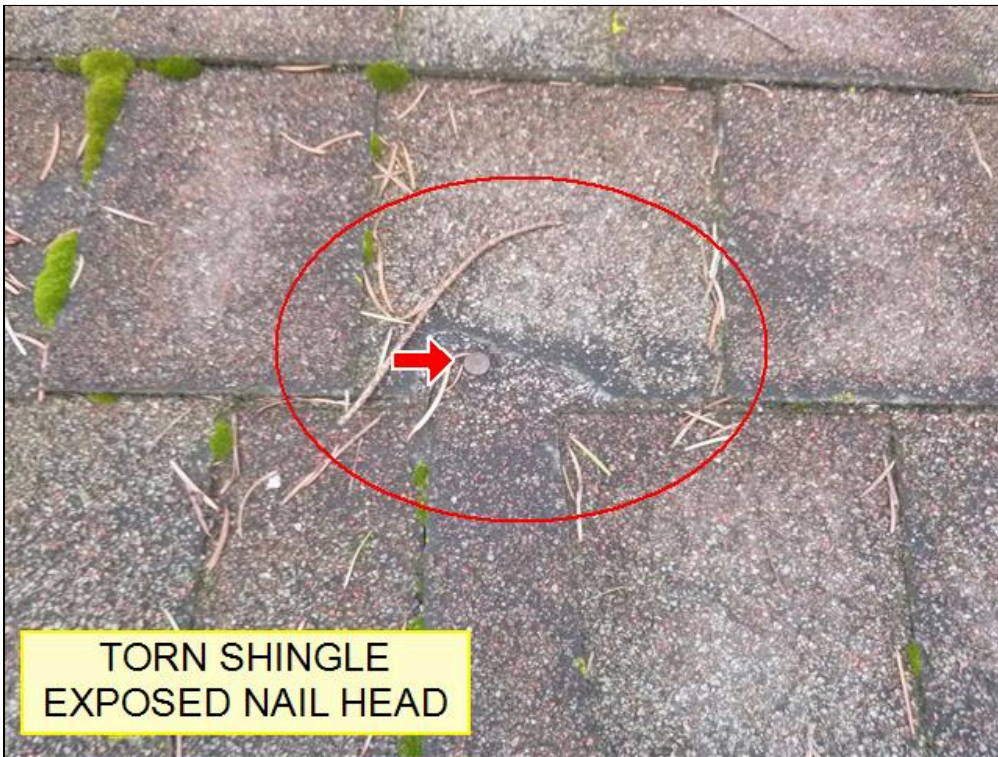
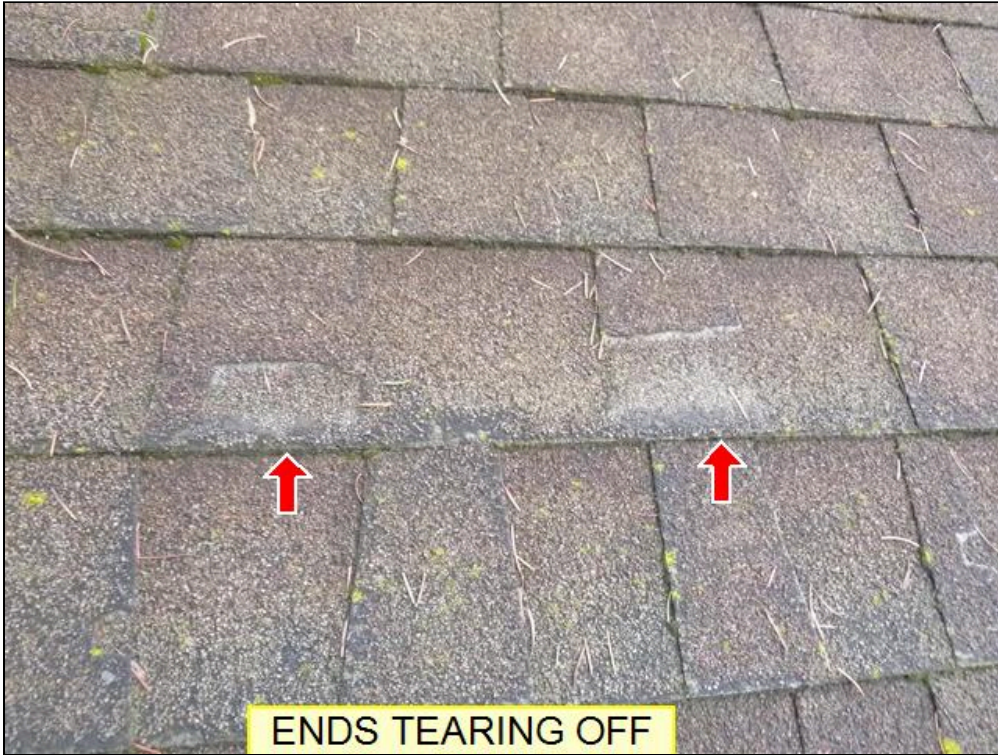
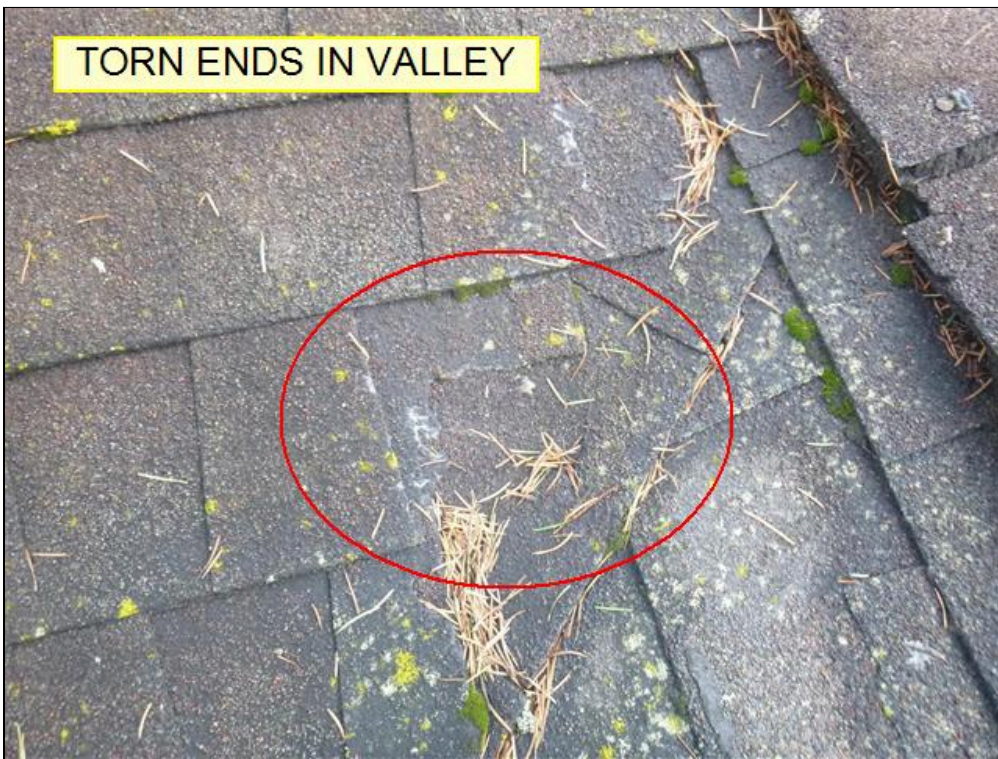
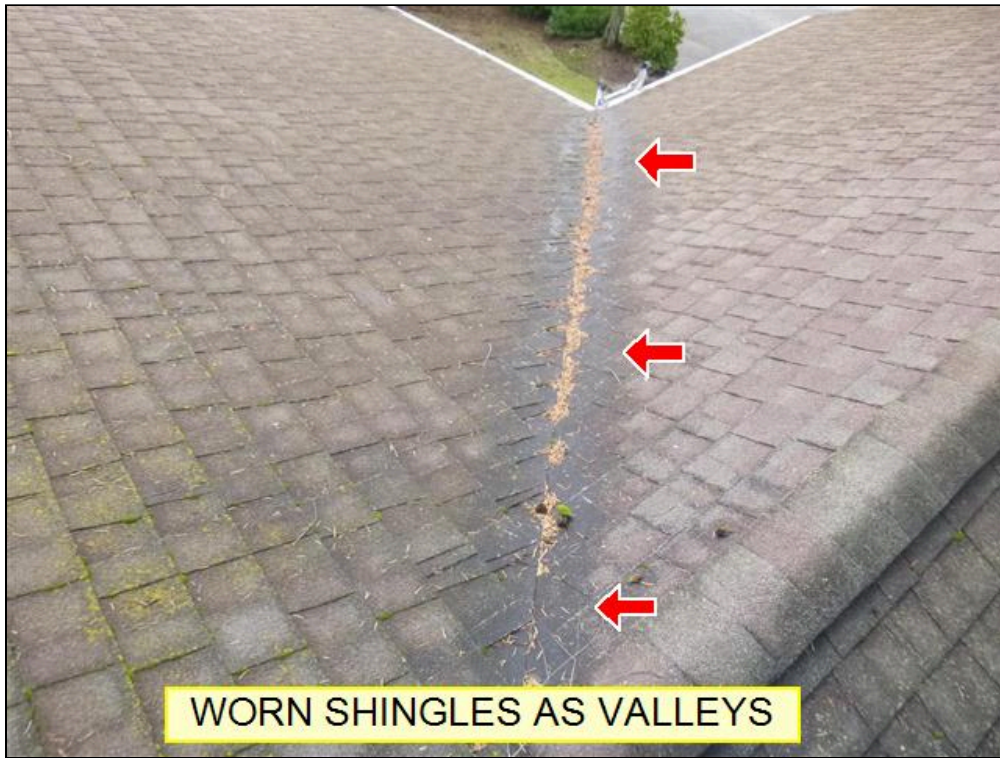
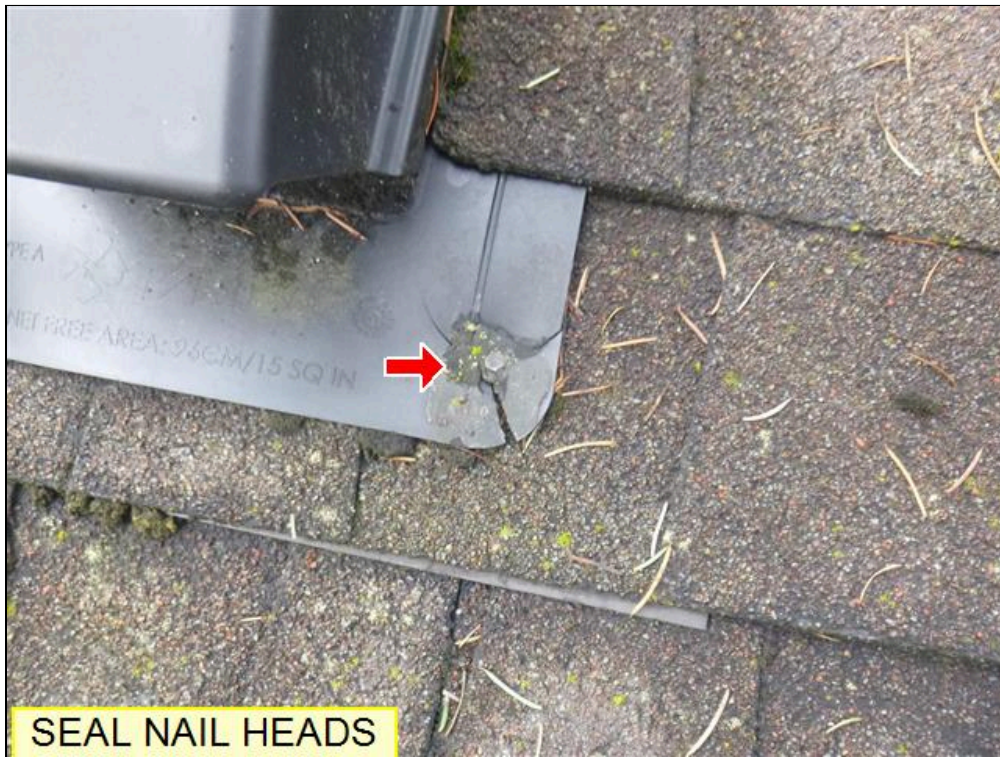
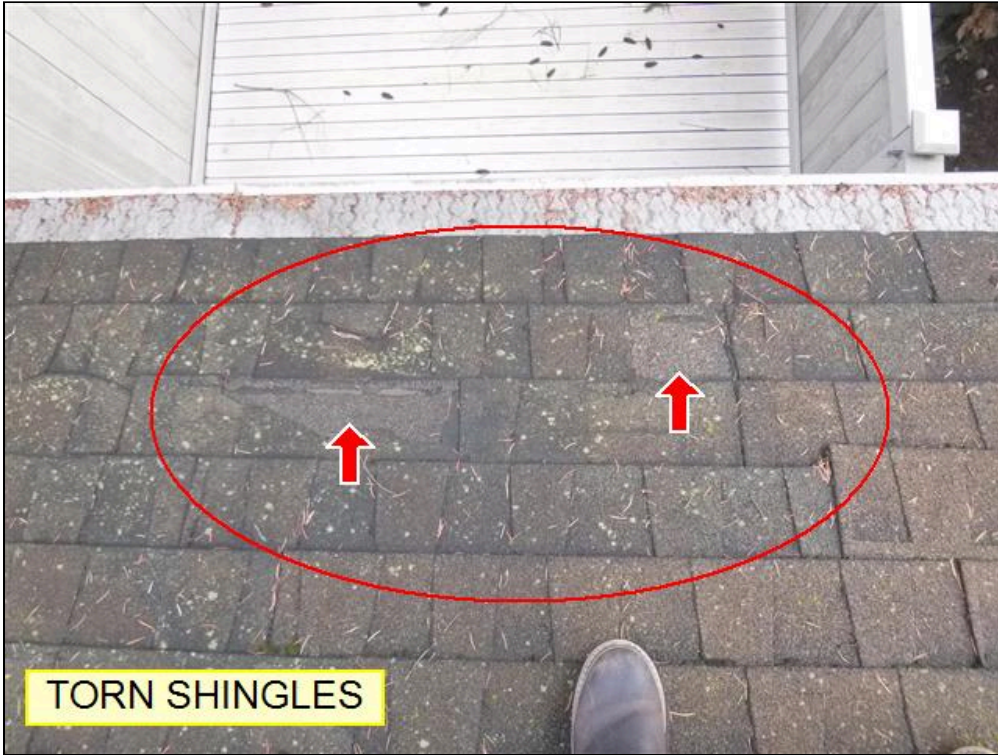
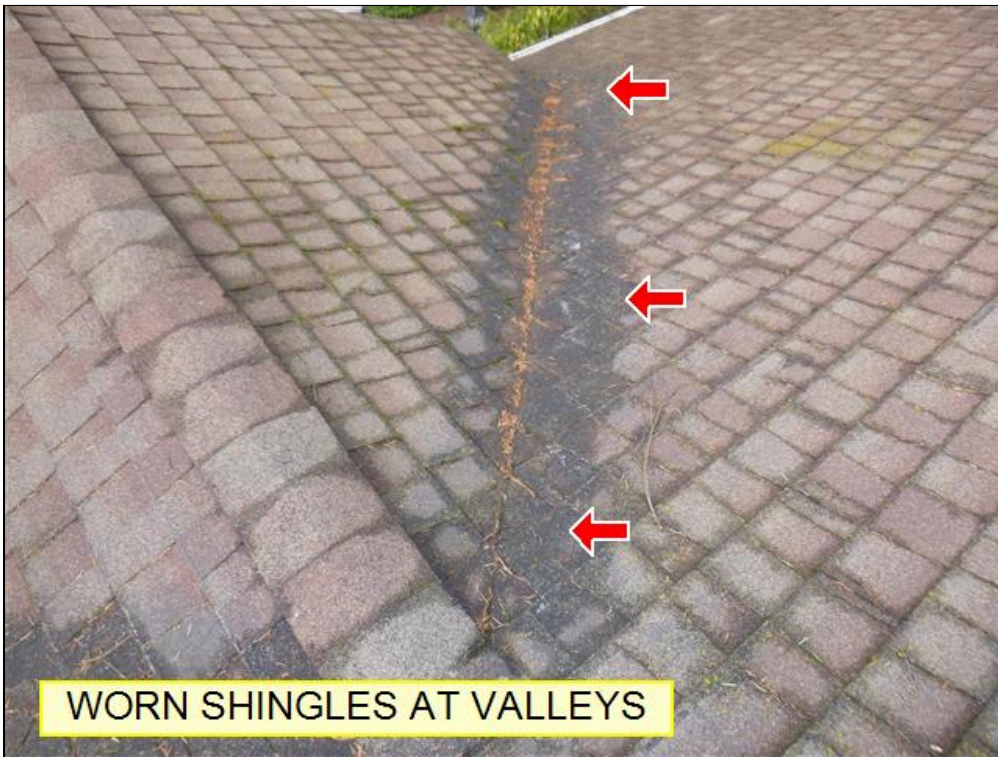
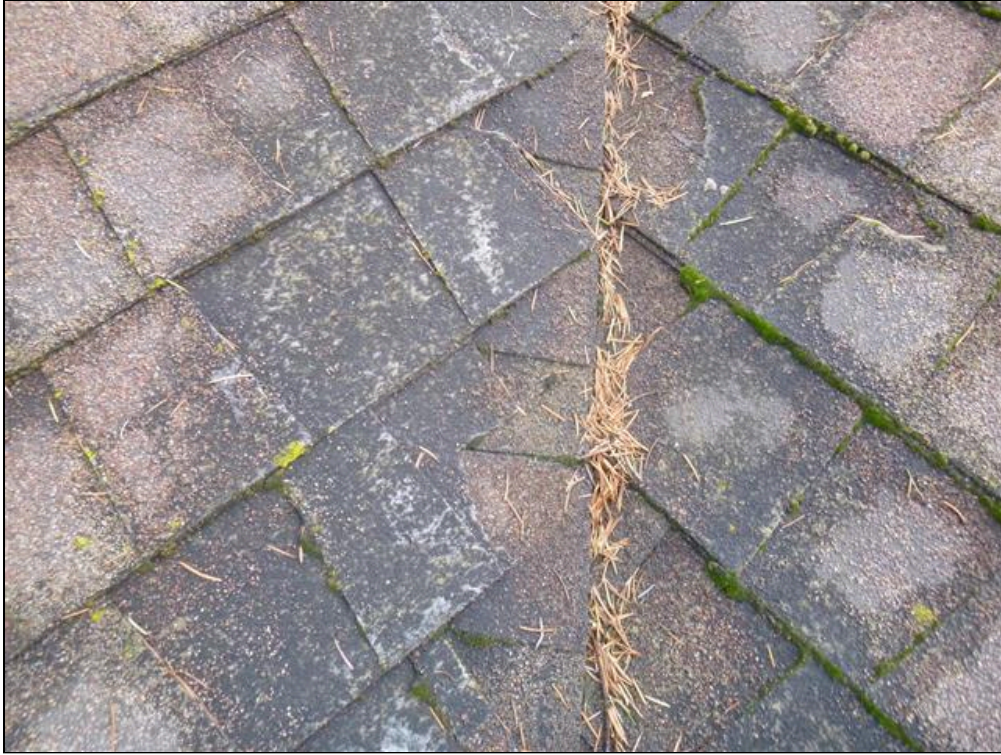
**1.0** ROOF COVERING IN OVERALL FAIR CONDITION. GRANULE LOSS ALONG WITH THE TORN TOPS OF SHINGLES FOUND IN MANY AREAS. EXCESSIVE GRANULE LOSS NOTED IN VALLEYS. UNKNOWN EXACT AGE OF THE ROOF, BUT I WOULD ESTIMATE AROUND 20 YEARS OLD. EXPOSED NAIL HEAD NOTED OVER THE FRONT PORCH AREA. ALL EXPOSED NAIL HEADS SHOULD BE SEALED WITH ROOFING MASTIC. **RECOMMEND HIRING A LICENSED ROOFING CONTRACTOR FOR FURTHER EVALUATION OF THE ROOF COVERING. REPLACE ANY WORN VALLEYS IF NEEDED OR ANY OTHER REPAIRS OR REPLACEMENT THAT ROOFING CONTRACTOR RECOMMENDS.**

ROOF COVERING IN OVERALL FAIR CONDITION. GRANULE LOSS ALONG WITH THE TORN TOPS OF SHINGLES FOUND IN MANY AREAS. EXCESSIVE GRANULE LOSS NOTED IN VALLEYS. UNKNOWN EXACT AGE OF THE ROOF, BUT I WOULD ESTIMATE AROUND 20 YEARS OLD. EXPOSED NAIL HEAD NOTED OVER THE FRONT PORCH AREA. ALL EXPOSED NAIL HEADS SHOULD BE SEALED WITH ROOFING MASTIC. **RECOMMEND HIRING A LICENSED ROOFING CONTRACTOR FOR FURTHER**

**EVALUATION OF THE ROOF COVERING. REPLACE ANY WORN VALLEYS IF NEEDED OR ANY OTHER REPAIRS OR REPLACEMENT THAT ROOFING CONTRACTOR RECOMMENDS.**

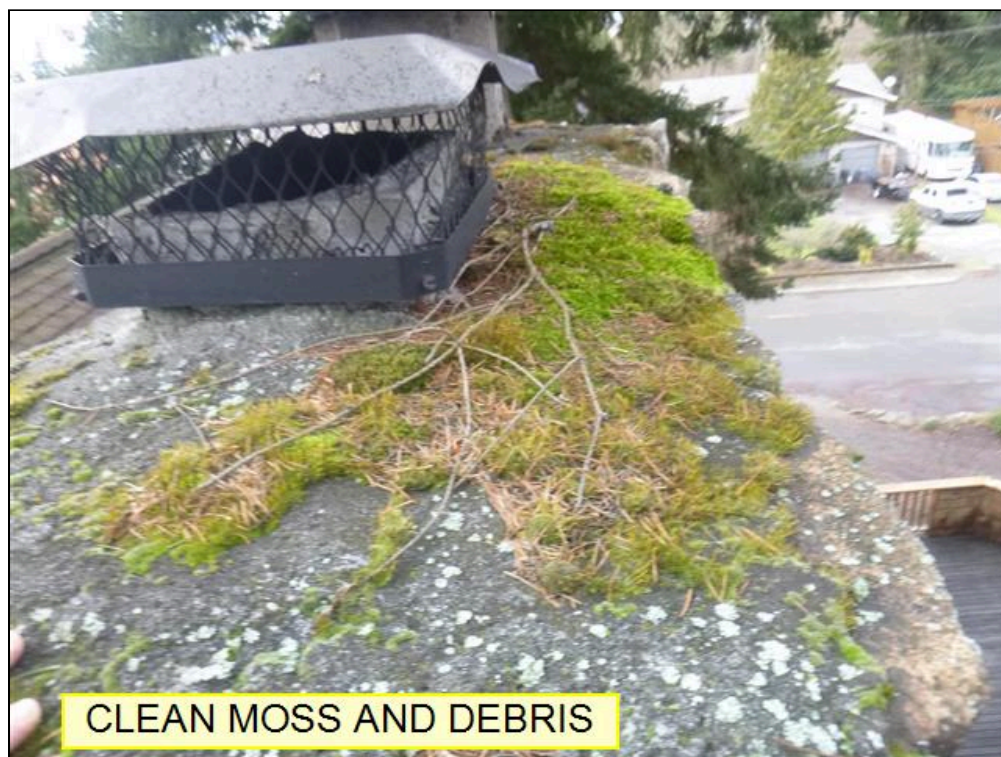
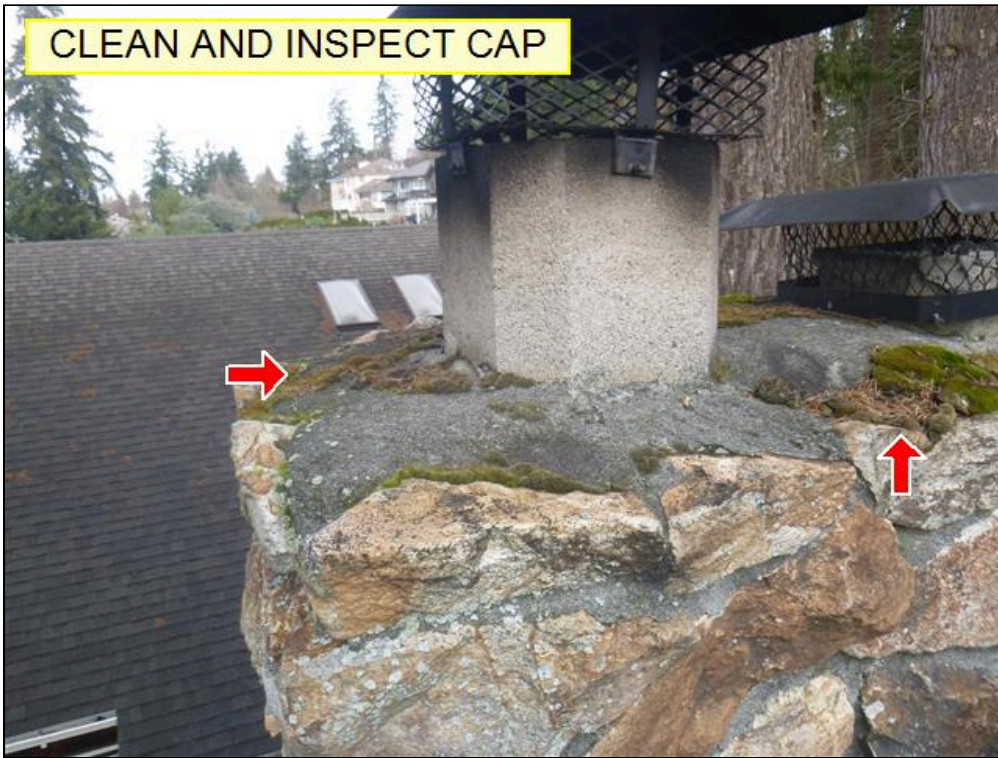
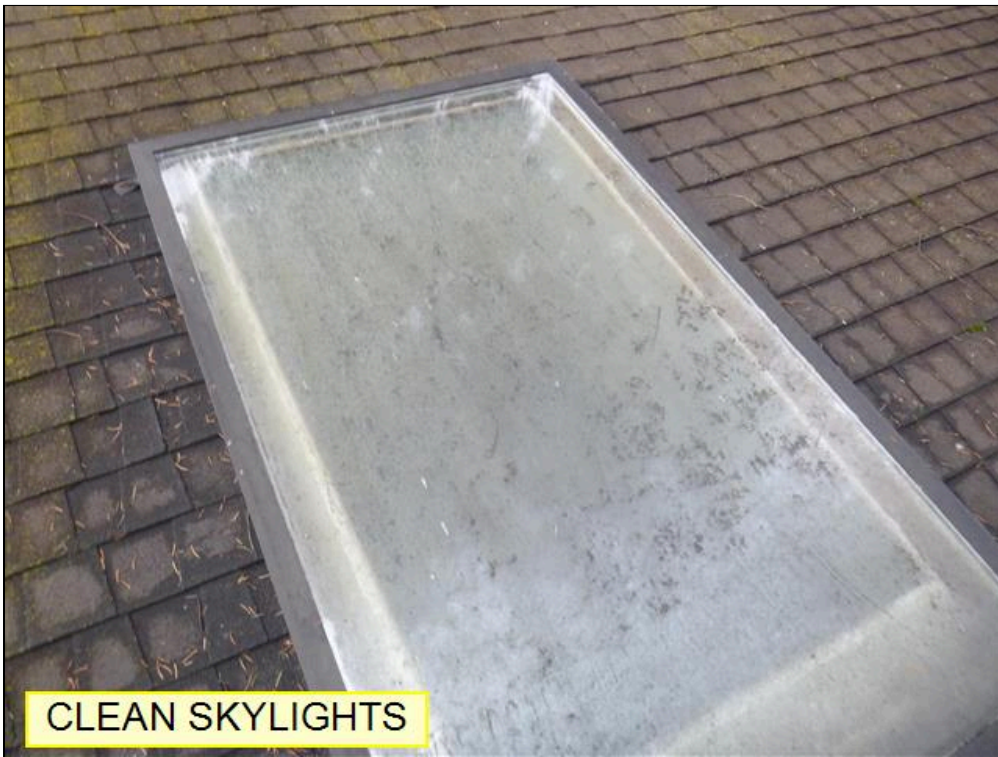
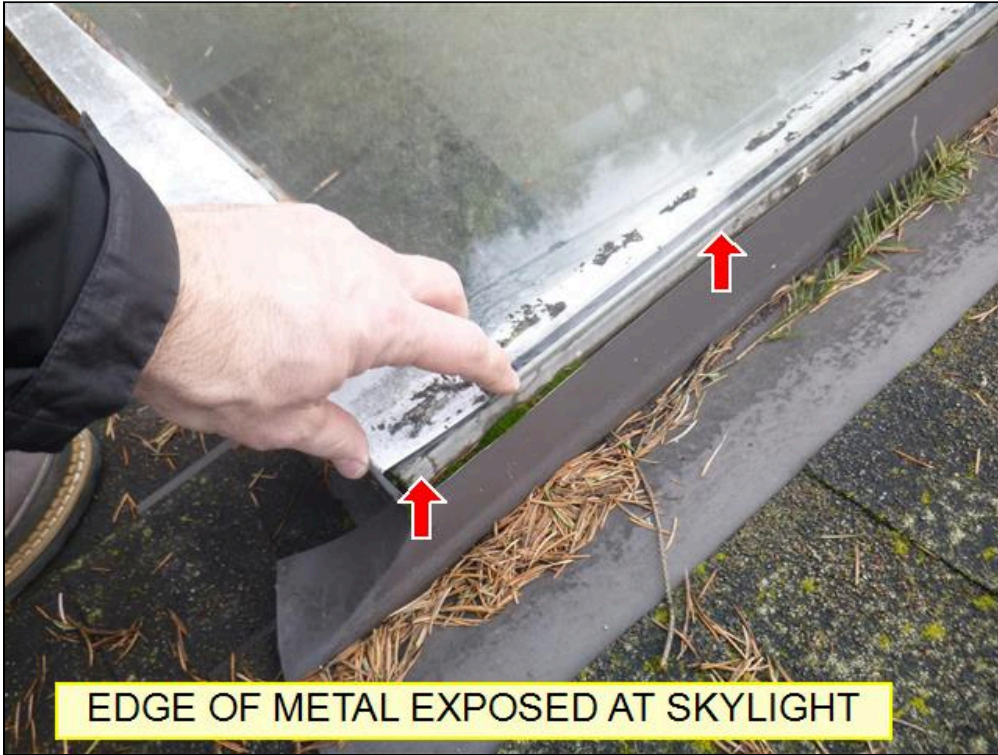
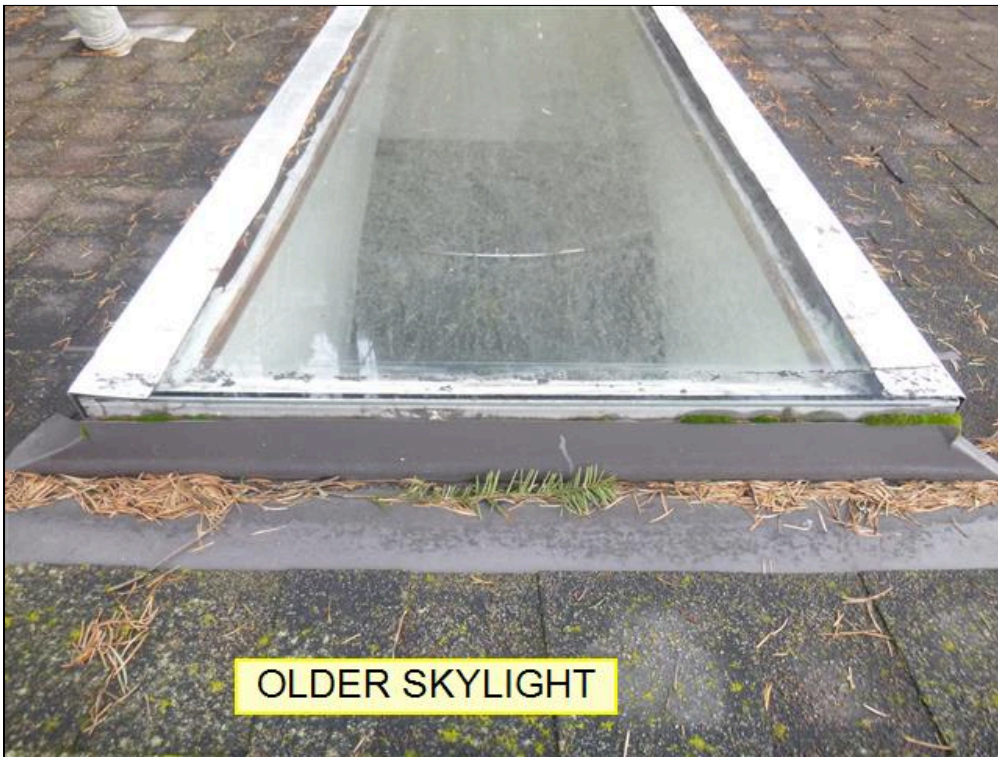
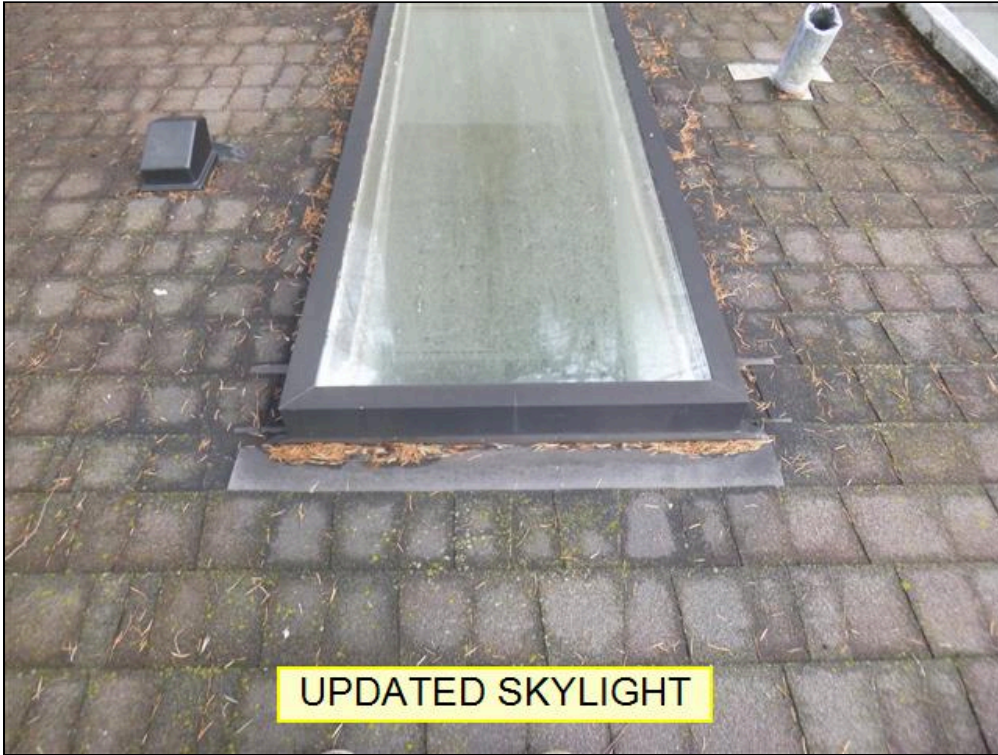
**1.2** THERE ARE THREE SKYLIGHT ON THE EAST SIDE OF THE ROOF. ONE OF THE SKYLIGHT HAS MISSING UPPER SEAL/CAP. THIS SKYLIGHT APPEARS OLDER AND NOT LIKE THE OTHER TWO UPDATED ONES. THE METAL FLASHING IS EXPOSED AND WILL ALLOW WATER TO SEEP DOWN BEHIND THE FLASHING. THIS SKYLIGHT IS A LEAK CONCERN. **RECOMMEND HIRING A LICENSED ROOFING CONTRACTOR FOR FURTHER EVALUATION AND REPAIRS/REPLACEMENT IF NEEDED.** **SKYLIGHTS NEED TO BE CLEANED.**

MOSS GROWTH NOTED ON CONCRETE CHIMNEY CAP. **RECOMMEND REMOVING AND CLEANING THE CONCRETE CAP. CHECK FOR ANY CRACKING/DETERIORATION AND MAKE REPAIRS OR CAP REPLACEMENT AS NEEDED.**

THERE ARE THREE SKYLIGHT ON THE EAST SIDE OF THE ROOF. ONE OF THE SKYLIGHT HAS MISSING UPPER SEAL/CAP. THIS SKYLIGHT APPEARS OLDER AND NOT LIKE THE OTHER TWO UPDATED ONES. THE METAL FLASHING IS EXPOSED AND WILL ALLOW WATER TO SEEP DOWN BEHIND THE FLASHING. THIS SKYLIGHT IS A LEAK CONCERN. **RECOMMEND HIRING A LICENSED ROOFING CONTRACTOR FOR FURTHER EVALUATION AND REPAIRS/REPLACEMENT IF NEEDED. SKYLIGHTS NEED TO BE CLEANED.**

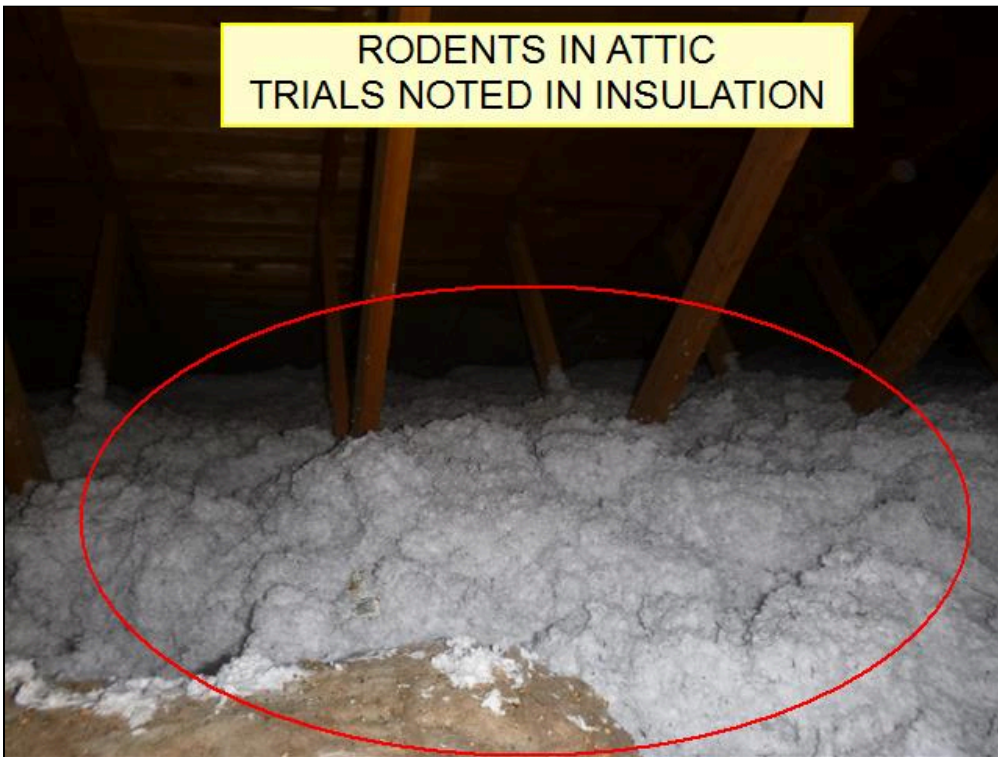
1.4 Picture 1

**1.4 EVIDENCE OF RODENT ACTIVITY IN THE ATTIC SPACE. UNKNOWN IF THIS ACTIVITY IS RECENT OR WAS DONE A WHILE BACK. RECOMMEND FURTHER EVALUATION BY A LICENSED RODENT CONTRACTOR. TREAT AS NEEDED.**

EVIDENCE OF RODENT ACTIVITY IN THE ATTIC SPACE. UNKNOWN IF THIS ACTIVITY IS RECENT OR WAS DONE A WHILE BACK. **RECOMMEND FURTHER EVALUATION BY A LICENSED RODENT CONTRACTOR. TREAT AS NEEDED.**

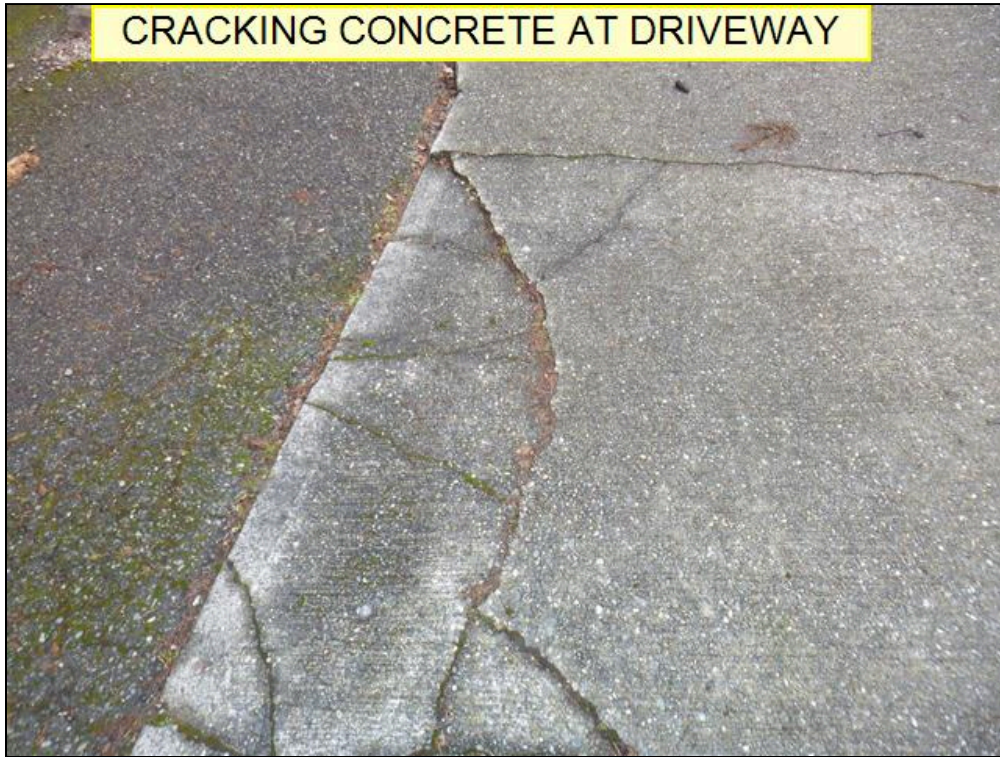
2.3 Picture 1

**2.3** CONCRETE CRACKING NOTED AT THE FRONT PORCH. CONCRETE CRACKING IS COMMONLY FOUND AT OLDER DRIVEWAYS. NOT NOTABLE TRIP HAZARDS PRESENT AT TIME OF INSPECTION. THIS IS FOR YOUR INFORMATION. REPAIR OR REPLACEMENT MAY BE WARRANTED IN THE FUTURE.

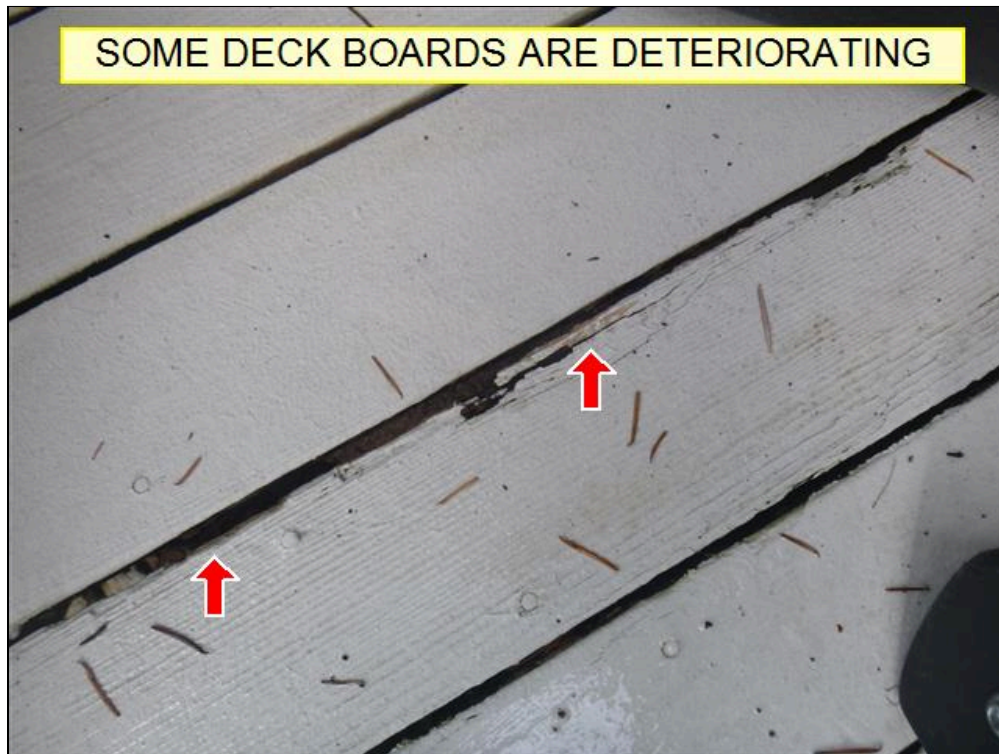
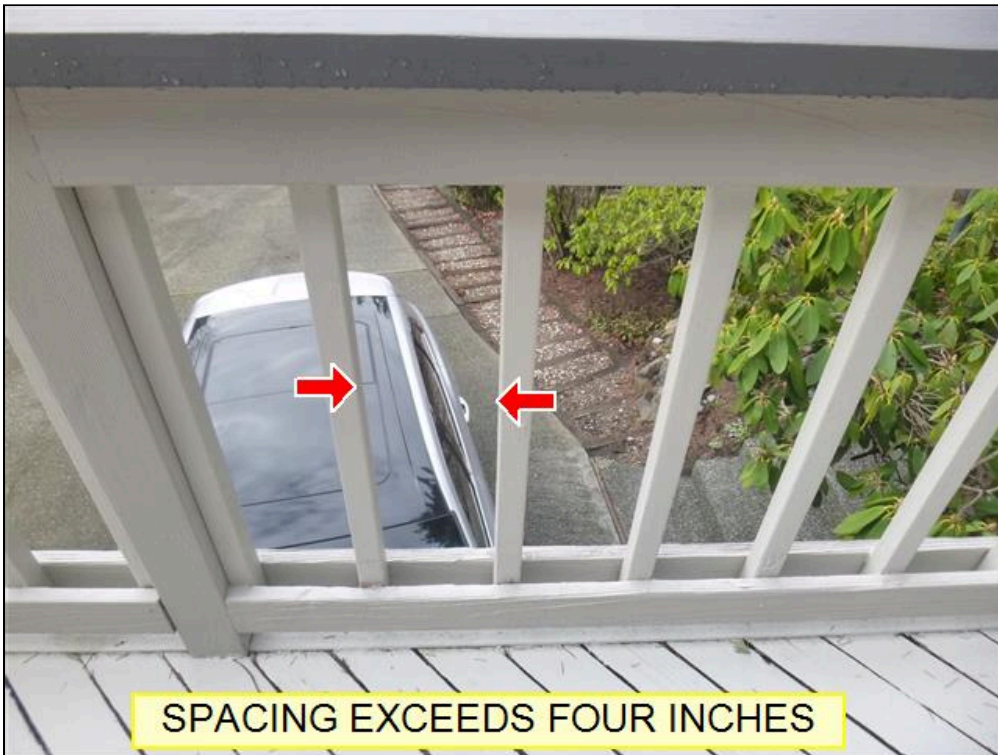
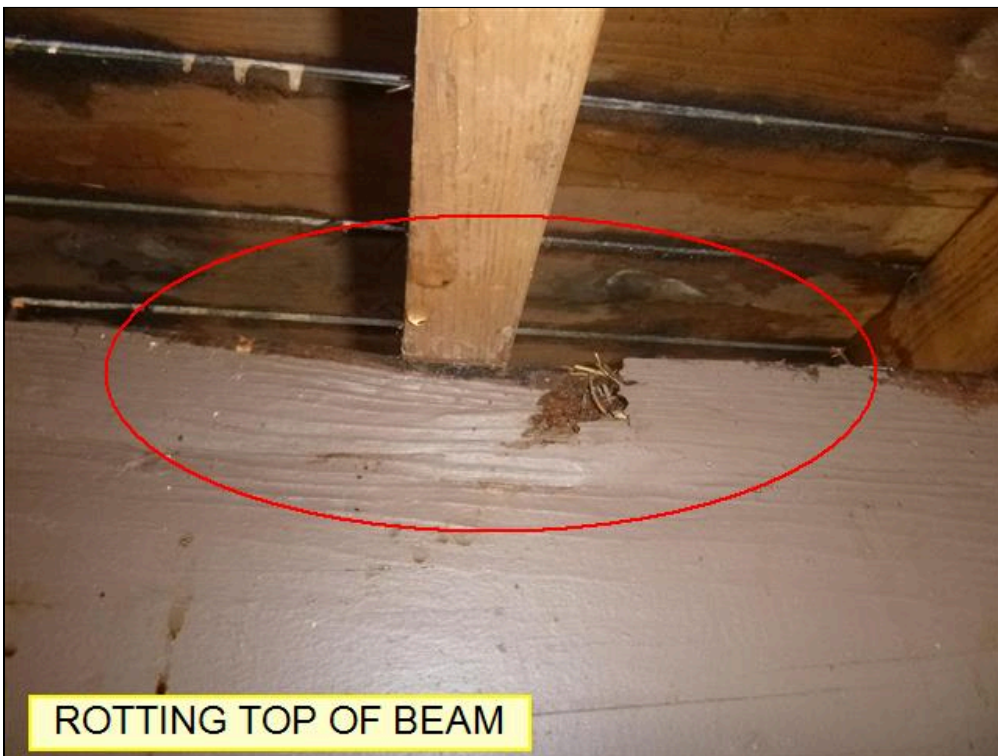
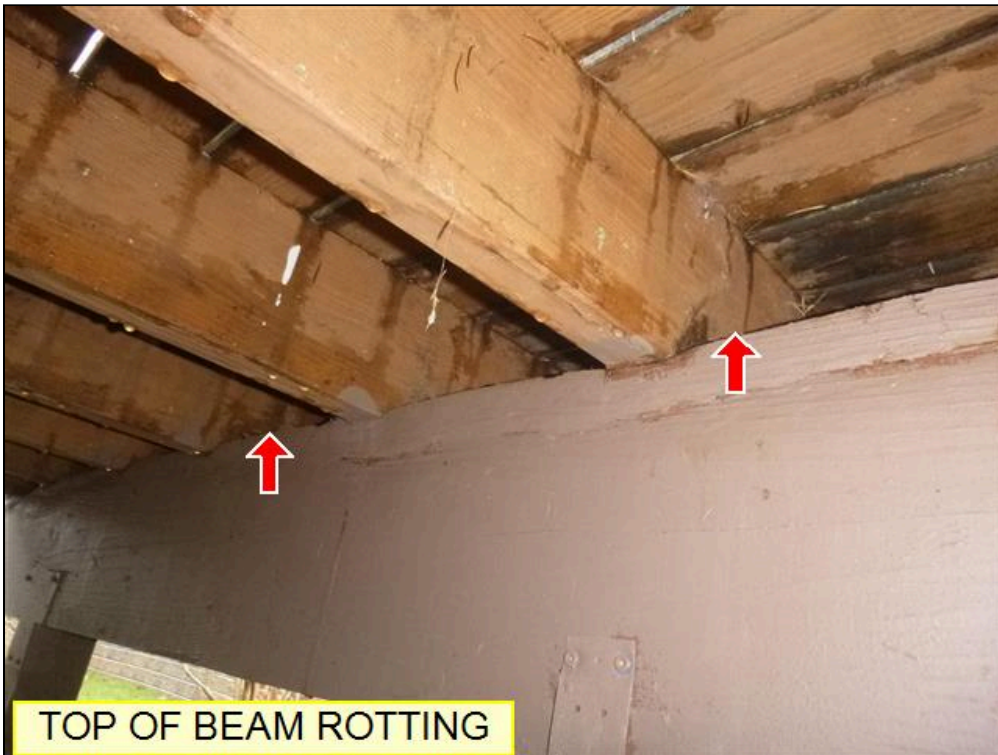
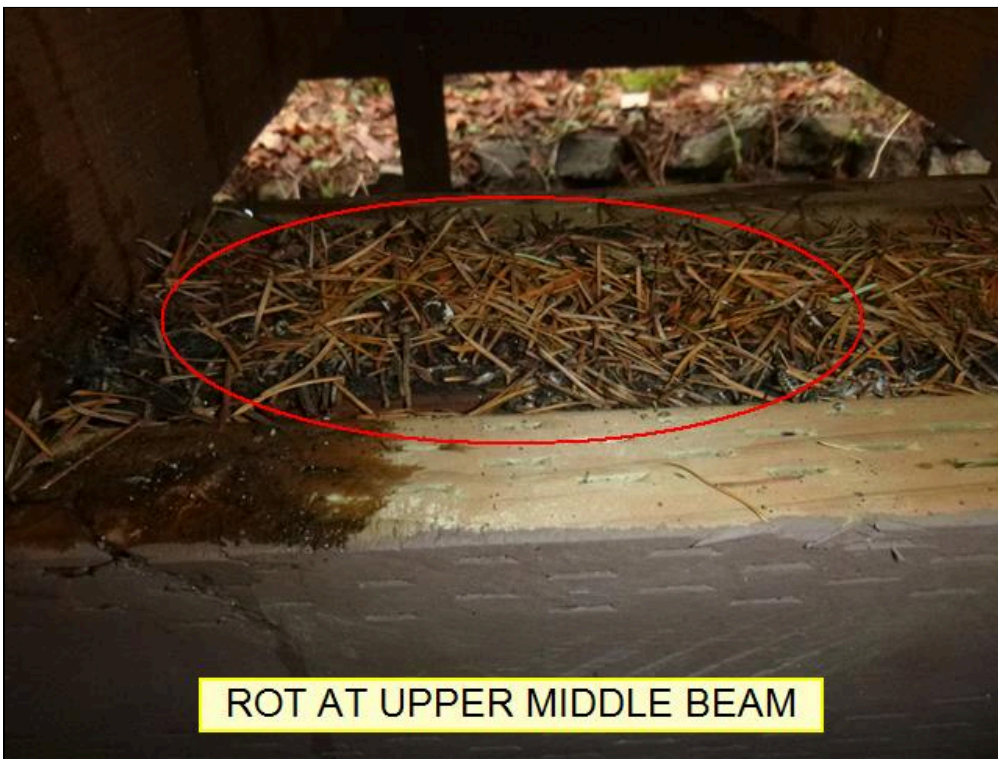
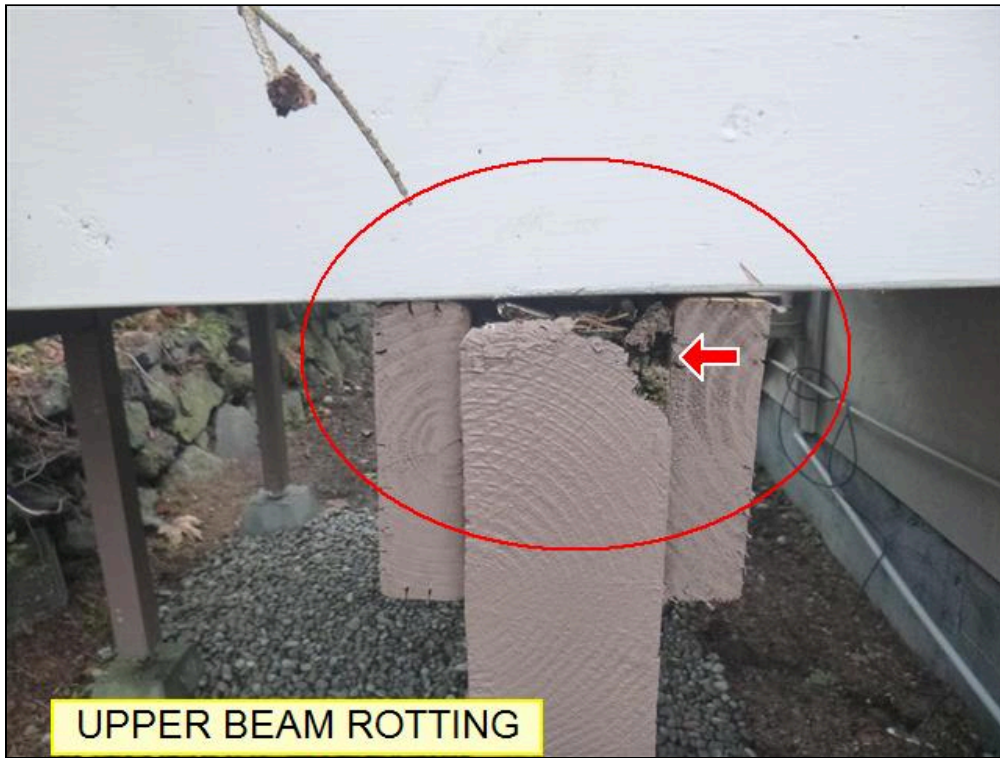
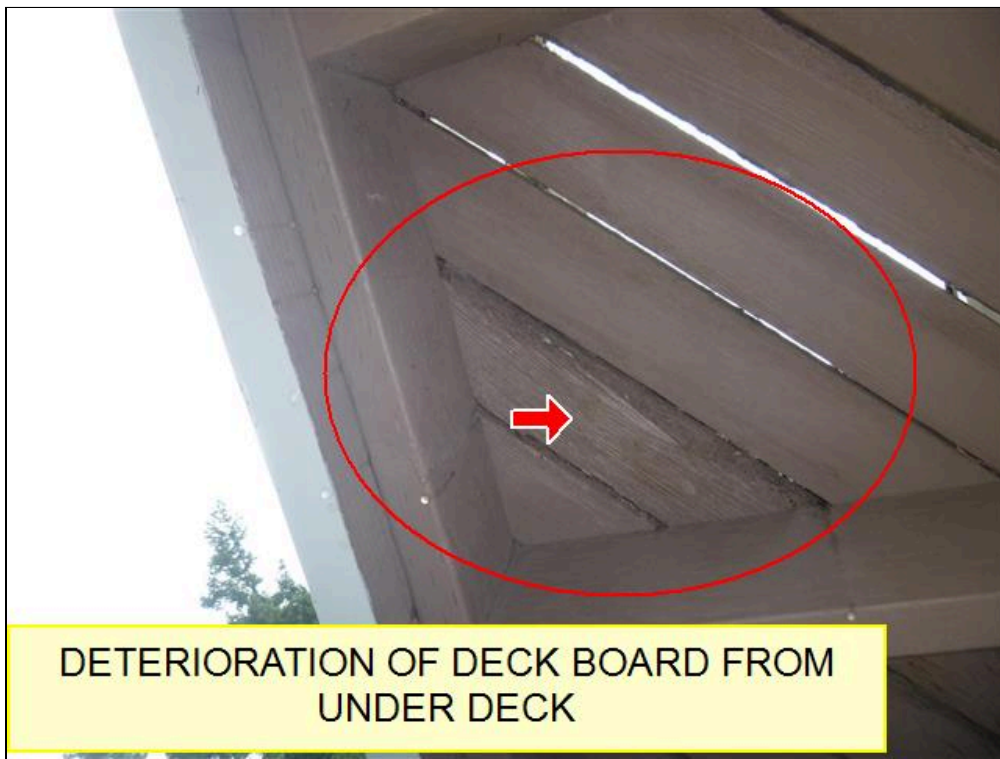
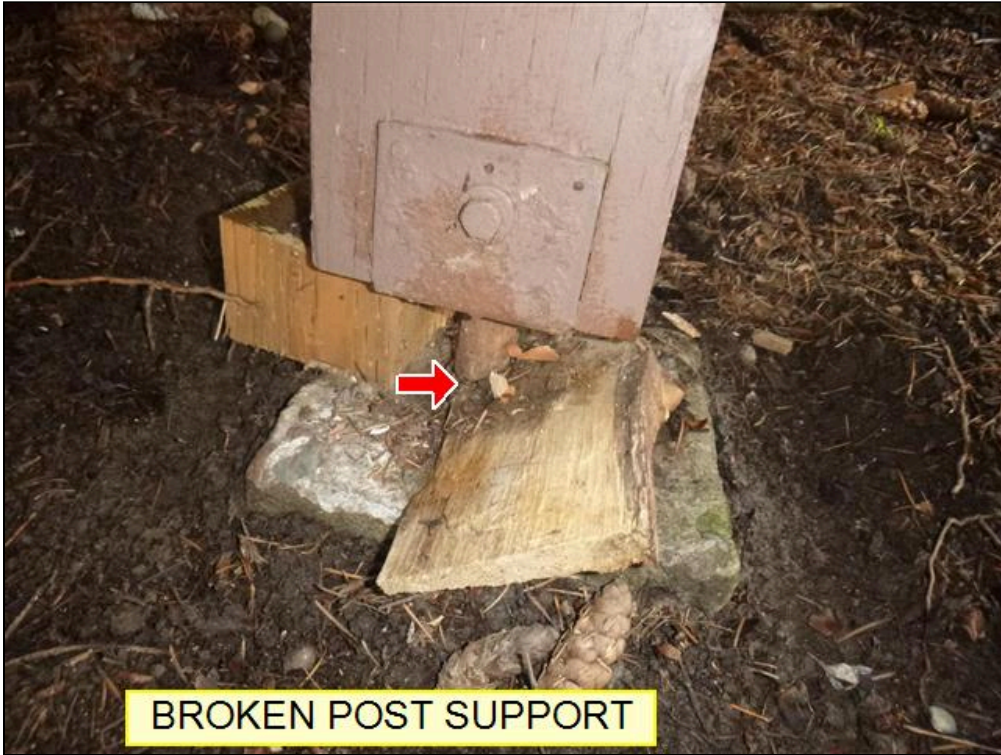
**2.4** SEVERAL OF THE WOOD DECKING BOARDS AT THE FRONT DECK ARE DETERIORATING. SOME OF THE DECKING BOARDS HAVE BEEN REPLACED. EVENTUAL REPLACEMENT OF ALL THE DECKING BOARDS WILL BE NEEDED AS IT AGES. DECK IS STILL FUNCTIONAL AND FELT SECURE. REPLACE ANY SEVERELY ROTTING DECKING BOARDS AS NEEDED.

BALUSTER SPACING FOR THE DECK EXCEEDS THE INDUSTRY STANDARD OF FOUR INCHES. THIS FOUR INCHES SPACING IS TO PREVENT SMALL CHILDREN FROM GETTING STUCK BETWEEN THE RAILING. THIS IS FOR YOUR INFORMATION. USE CAUTION IF SMALL CHILDREN ARE ON THE DECK.

ROTTING SUPPORT BEAMS NOTED AT THE REAR DECK OFF THE MASTER BEDROOM. THE TOP EDGE OF THE BEAM IS SOFT. THE MIDDLE SUPPORT BEAM HAS BEEN RETROFITTED WITH PRESSURE TREATED LUMBER. EVENTUAL REPLACEMENT OF BOTH BEAMS WILL BE NEEDED.

ONE OF THE CENTER FRONT DECK POSTS METAL BRACKET HAS BROKEN OFF. IT APPEARS WOOD PIECES ARE HOLDING THE POST IN PLACE. RECOMMEND REPLACEMENT OF THE SUPPORT POST AS NEEDED.

SEVERAL OF THE WOOD DECKING BOARDS AT THE FRONT DECK ARE DETERIORATING. SOME OF THE DECKING BOARDS HAVE BEEN REPLACED. EVENTUAL REPLACEMENT OF ALL THE DECKING BOARDS WILL BE NEEDED AS IT AGES. DECK IS STILL FUNCTIONAL AND FELT SECURE. REPLACE ANY SEVERELY ROTTING DECKING BOARDS AS NEEDED.

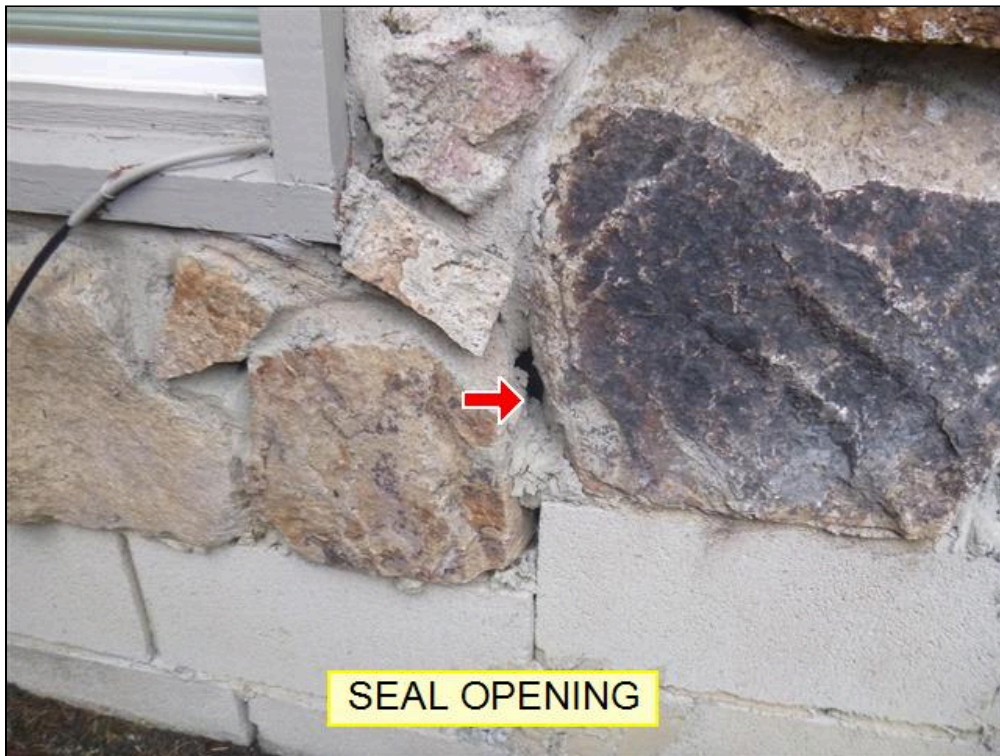
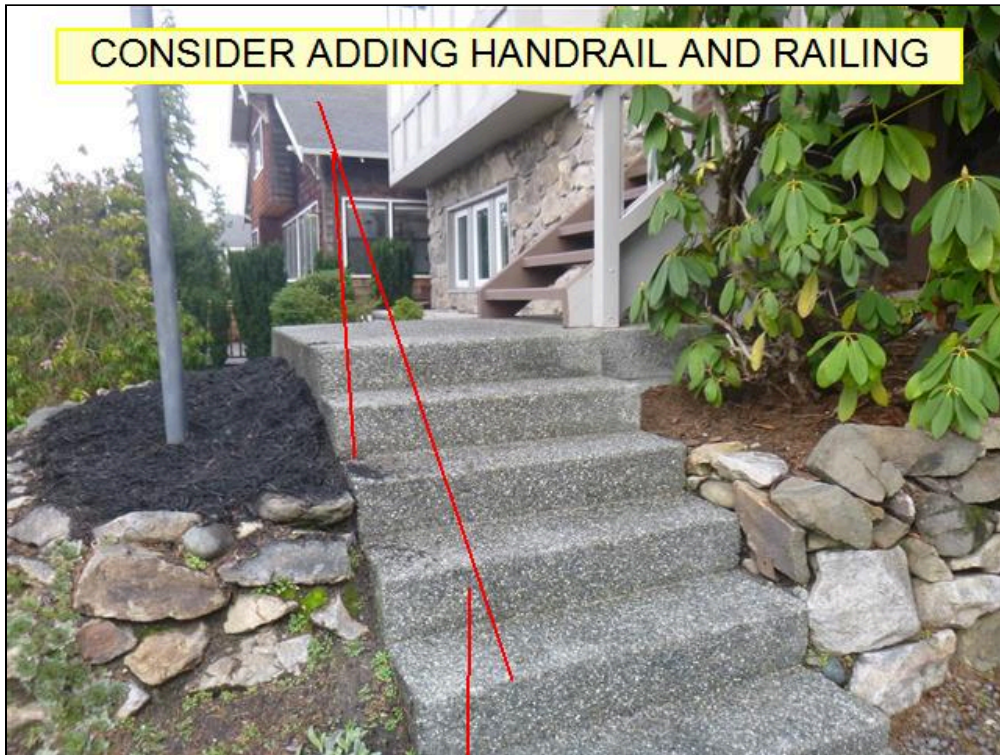
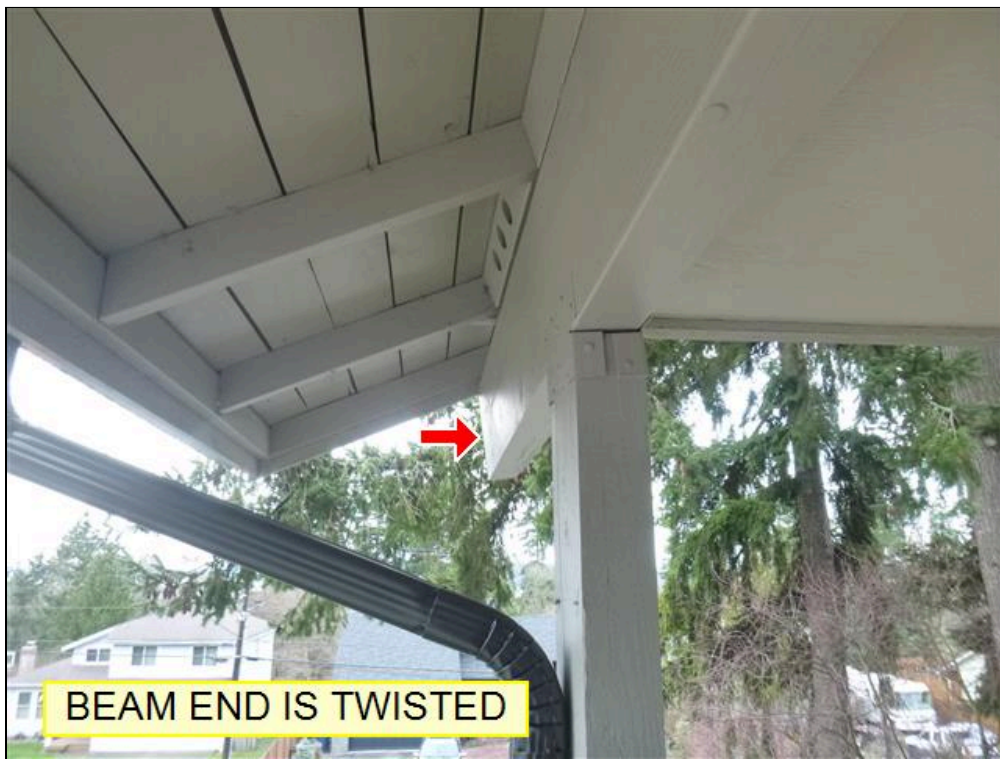
**2.7** SEAL HOLE IN FRONT MASONRY BLOCKS TO PREVENT MOISTURE AND RODENTS FROM ENTERING INTO THIS AREA.

CONSIDER ADDING A RAILING AND HANDRAIL FOR STEPS AND LANDING LEADING UP TO THE FRONT PORCH.

FRONT PORCH BEAM IS TWISTED AT THE END. POST AND BEAM CONNECTED IS STILL SOLID. THIS IS FOR YOUR INFORMATION.
