# Inspection Notes

## 10701 62nd Pl W. Mukilteo

## **Inspection Report**

**Property Address:**  
10701 62nd PL W  
Mukilteo WA 98275

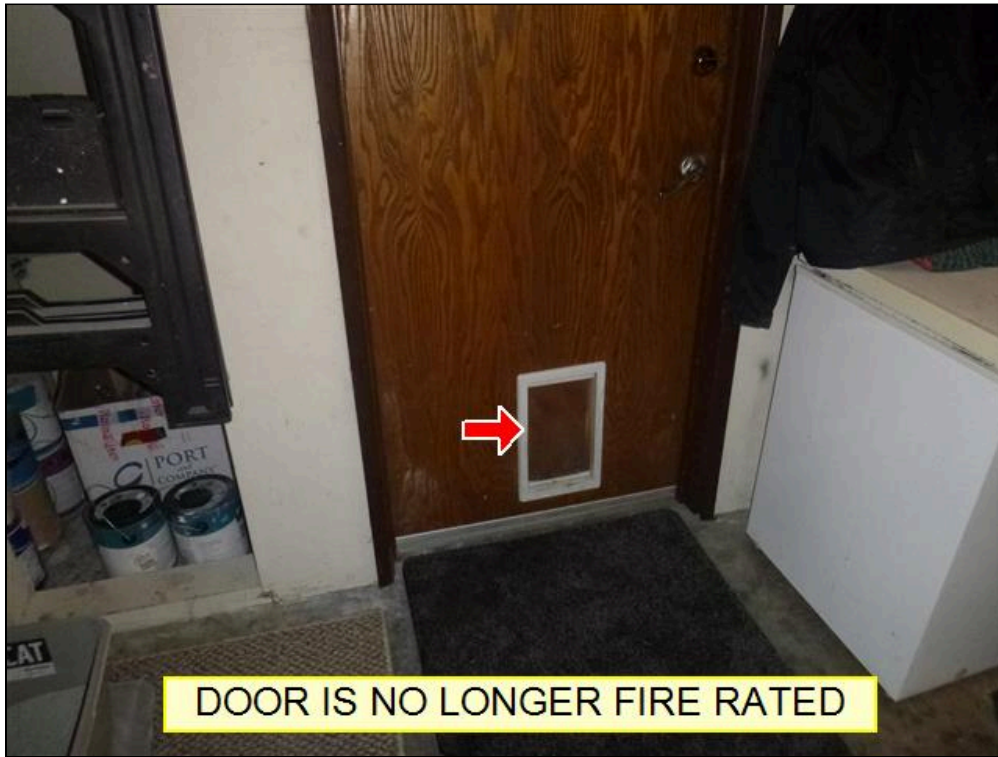
3.4 Picture 1

**3.4** A SMALL DOG DOOR WAS INSERTED INTO THE GARAGE DOOR LEADING INTO THE HOUSE. THIS DOOR IS NO LONGER A FIRE RATED DOOR. **RECOMMEND INSTALLING A 20 MINUTE FIRE RATED DOOR LEADING INTO THE HOUSE FROM THE GARAGE.**

A SMALL DOG DOOR WAS INSERTED INTO THE GARAGE DOOR LEADING INTO THE HOUSE. THIS DOOR IS NO LONGER A FIRE RATED DOOR. **RECOMMEND INSTALLING A 20 MINUTE FIRE RATED DOOR LEADING INTO THE HOUSE FROM THE GARAGE.**

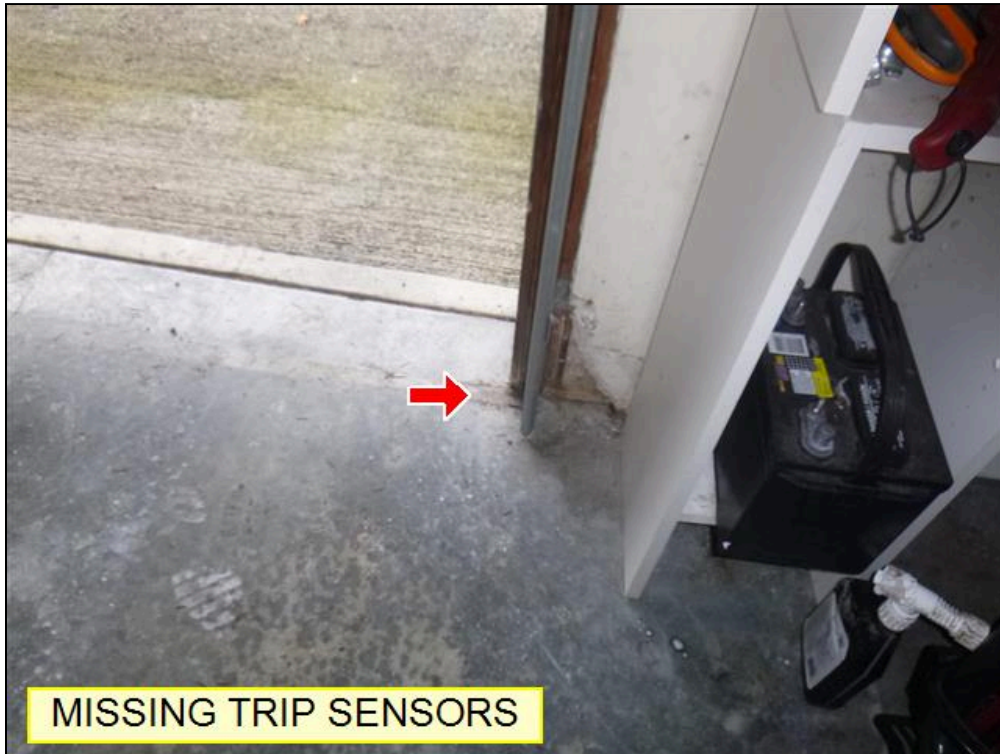
3.5 Picture 1

**3.5** GARAGE DOOR OPENERS ARE MOST LIKELY THE ORIGINALS. MISSING SAFETY TRIP SENSORS. RECOMMEND INSTALLING SAFETY TRIP SENSORS AT THE LOWER PORTION OF THE DOORS. CONSIDER OPENER REPLACEMENT IN THE NEAR FUTURE.

GARAGE DOOR OPENERS ARE MOST LIKELY THE ORIGINALS. MISSING SAFETY TRIP SENSORS. RECOMMEND INSTALLING SAFETY TRIP SENSORS AT THE LOWER PORTION OF THE DOORS. CONSIDER OPENER REPLACEMENT IN THE NEAR FUTURE.

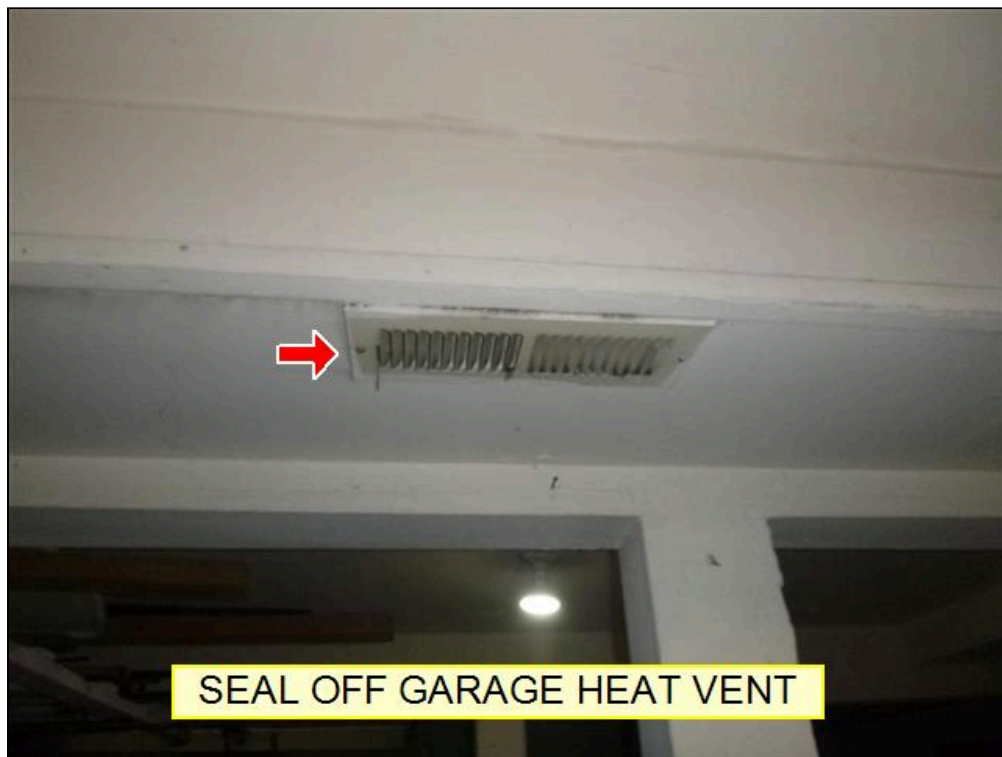
3.8 Picture 1

**3.8** A HEAT REGISTER(SUPPLY) VENT WAS FOUND IN THE GARAGE. THIS IS NO LONGER ALLOWED PER CURRENT BUILDING CODES. THIS HEAT VENT IS AN AVENUE FOR SMOKE (PRODUCTS OF COMBUSTION) CARBON MONOXIDE TO ENTER THE HOME. RECOMMEND SEALING OFF THIS HEAT VENT IN THE GARAGE CEILING. USE OTHER SOURCES OF HEAT IF NEEDED.

A HEAT REGISTER(SUPPLY) VENT WAS FOUND IN THE GARAGE. THIS IS NO LONGER ALLOWED PER CURRENT BUILDING CODES. THIS HEAT VENT IS AN AVENUE FOR SMOKE (PRODUCTS OF COMBUSTION) CARBON MONOXIDE TO ENTER THE HOME. RECOMMEND SEALING OFF THIS HEAT VENT IN THE GARAGE CEILING. USE OTHER SOURCES OF HEAT IF NEEDED.

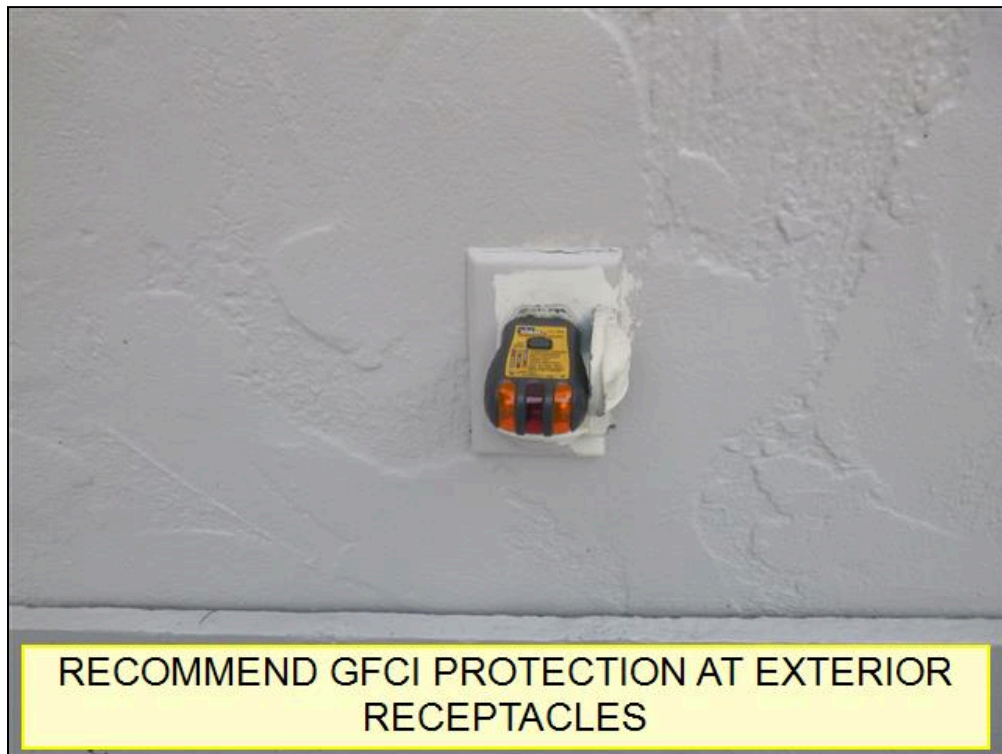
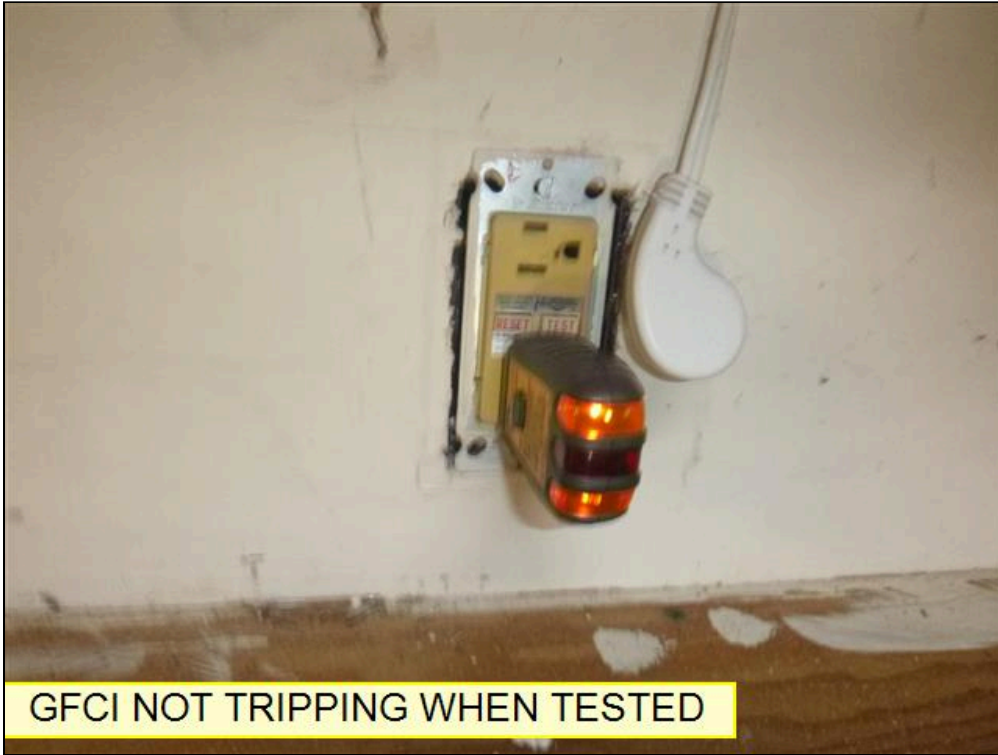
**7.5** RECOMMEND GFCI PROTECTION FOR ALL EXTERIOR AND GARAGE RECEPTACLES. THIS IS CURRENT ELECTRICAL STANDARDS AND FOR OCCUPANT SAFETY..

GARAGE GFCI RECEPTACLE WOULD NOT TRIP WHEN TESTED. RECOMMEND REPLACEMENT TO ENSURE PROPER OPERATION.

RECOMMEND GFCI PROTECTION FOR ALL EXTERIOR AND GARAGE RECEPTACLES. THIS IS CURRENT ELECTRICAL STANDARDS AND FOR OCCUPANT SAFETY.

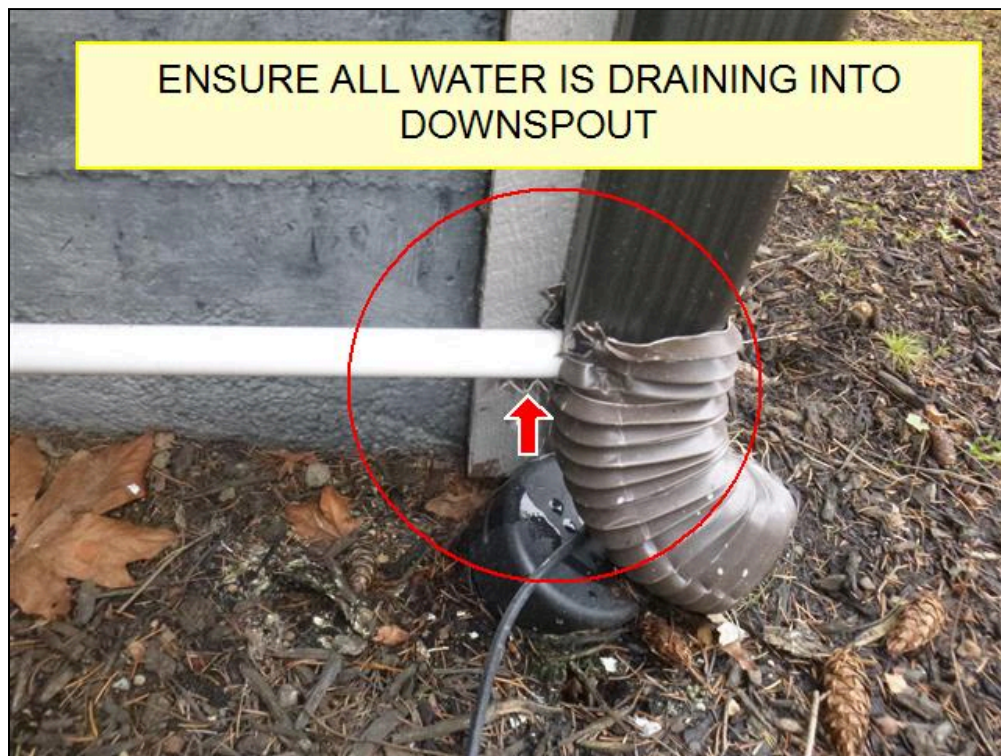
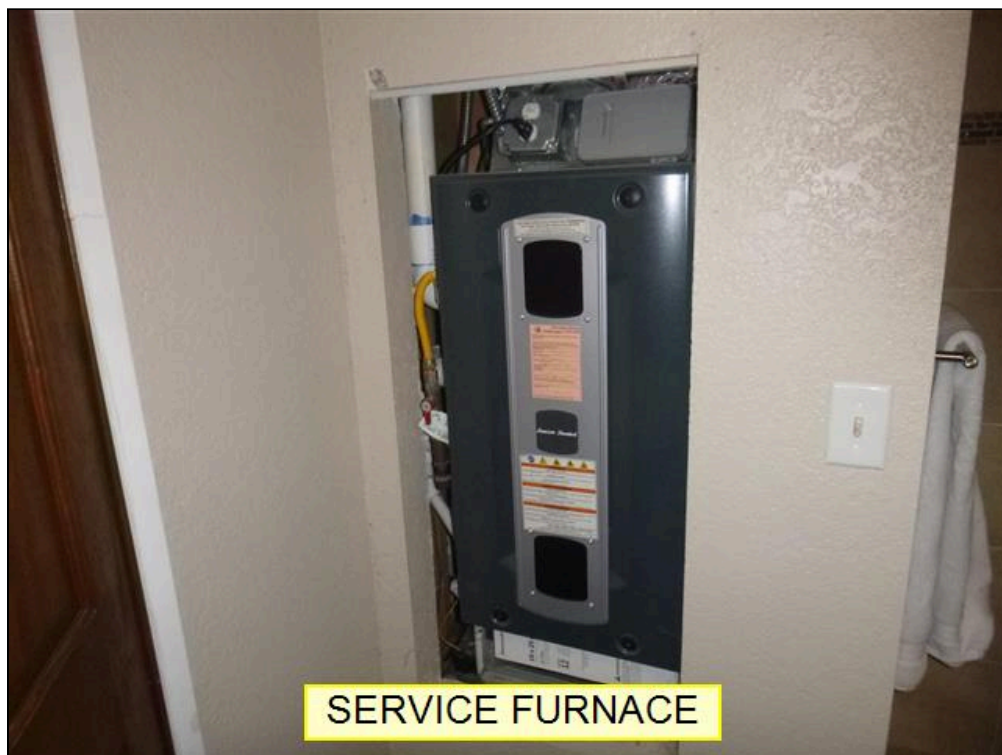
**8.0 FURNACE WAS INSTALLED IN 2017. NO SERVICE TAGS NOTED. RECOMMEND HIRING A LICENSED HVAC CONTRACTOR TO SERVICE THE FURNACE.**

CONDENSATE LINE FOR THE FURNACE IS NOT FULLY DRAINING INTO THE DOWNSPOUT. LEAKING WATER NOTED. ENSURE WATER IS FULLY DRAINING INTO THE DOWNSPOUT.

FURNACE WAS INSTALLED IN 2017. NO SERVICE TAGS NOTED. **RECOMMEND HIRING A LICENSED HVAC CONTRACTOR TO SERVICE THE FURNACE.**

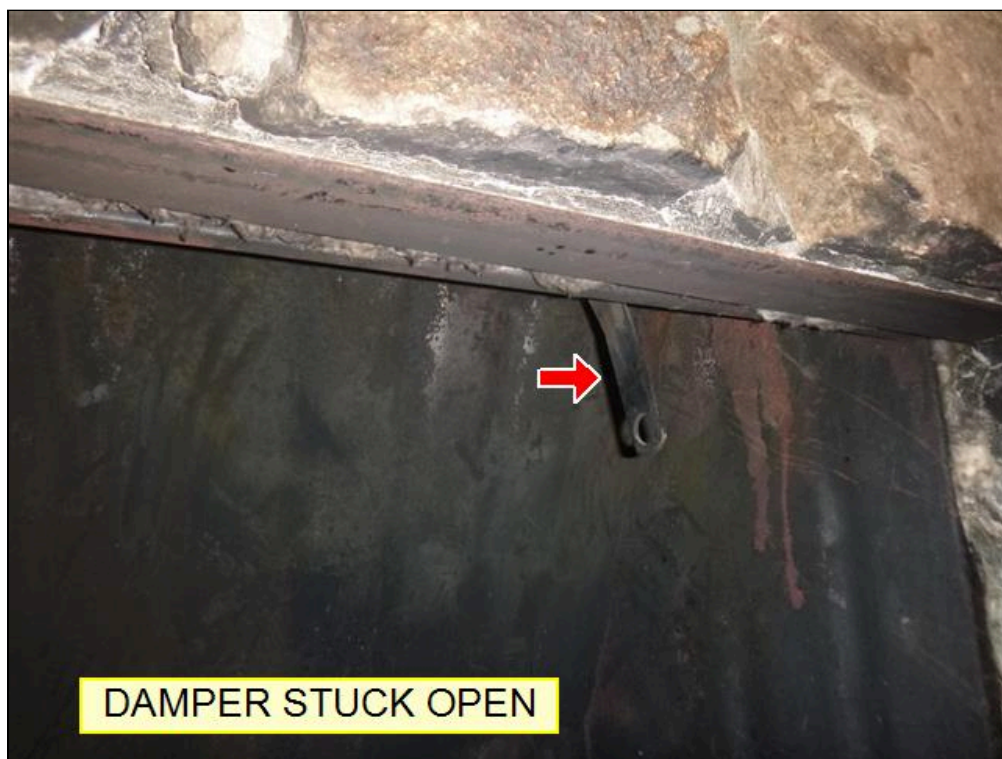
8.5 Picture 1

**8.5 UPPER FIREPLACE DAMPER DOES NOT OPEN OR CLOSE. DAMPER MAY HAVE CORRODED. UNKNOWN CONDITION OF THE INNER FIREPLACE FLUES. RECOMMEND HIRING A LICENSED FIREPLACE CHIMNEY SWEEP CONTRACTOR TO INSPECT AND CLEAN THE FLUES IF NEEDED.**

UPPER FIREPLACE DAMPER DOES NOT OPEN OR CLOSE. DAMPER MAY HAVE CORRODED. UNKNOWN CONDITION OF THE INNER FIREPLACE FLUES. **RECOMMEND HIRING A LICENSED FIREPLACE CHIMNEY SWEEP CONTRACTOR TO INSPECT AND CLEAN THE FLUES IF NEEDED.**

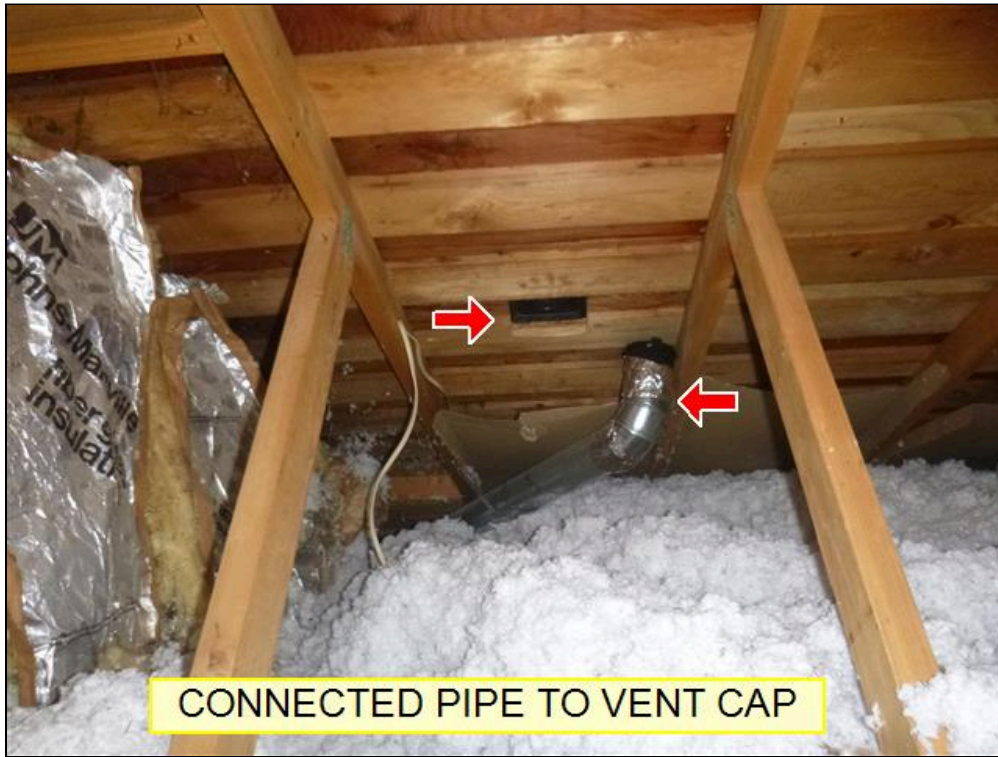
9.3 Picture 1

**9.3** BATHROOM CEILING VENT PIPING HAS BECOME DISCONNECTED IN THE ATTIC. RECOMMEND RECONNECTING VENT PIPING TO ENSURE BATHROOM AIR IS VENTING TO THE EXTERIOR OF THE HOUSE.

BATHROOM CEILING VENT PIPING HAS BECOME DISCONNECTED IN THE ATTIC. RECOMMEND RECONNECTING VENT PIPING TO ENSURE BATHROOM AIR IS VENTING TO THE EXTERIOR OF THE HOUSE.
