Inspected By: Timothy Moreau, P.E.

Home Inspection Report

45 Oak Run Drive

Inspected on Fri, Sep 6 2019 at 2:00 PM

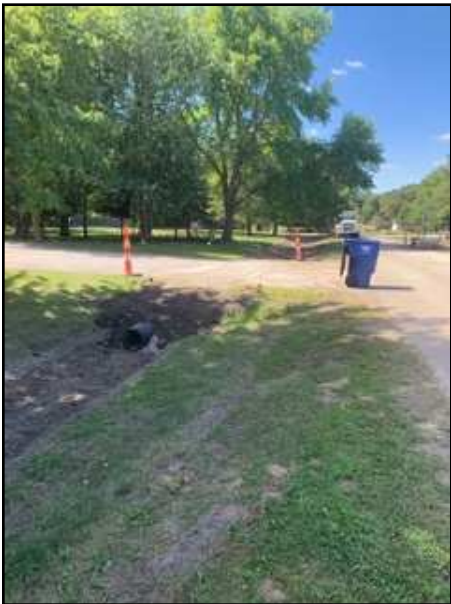
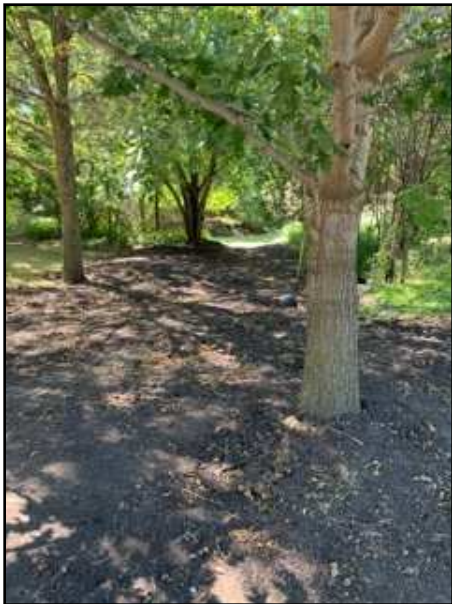
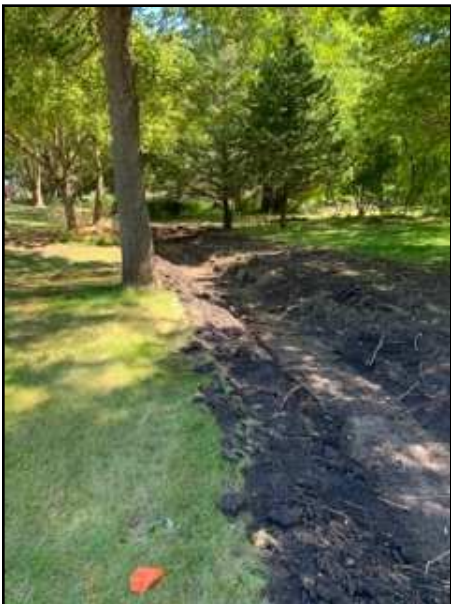
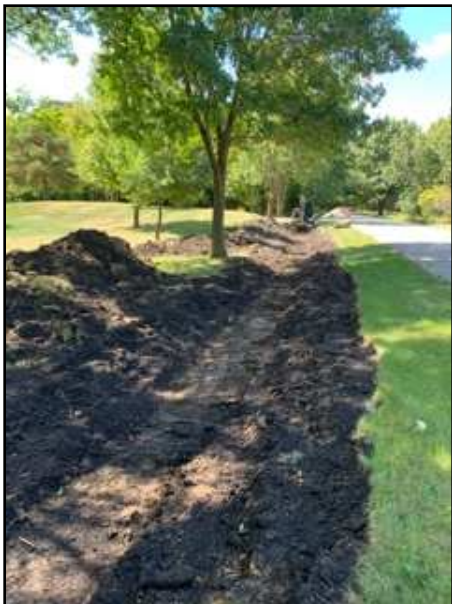
Comment 2:
Drainage Ditch Grading & Driveway Culvert Improvements along Oak Run Drive.

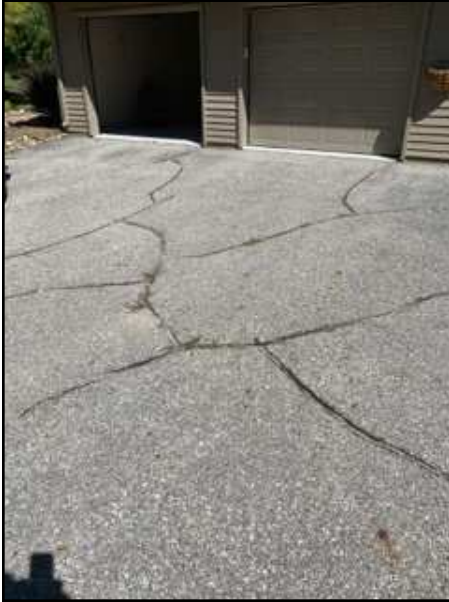
Figure 3-1

Minor Cracking & Surface Spalling in Asphalt Driveway which has been Sealed Previously; Typical for 27 year old pavement.

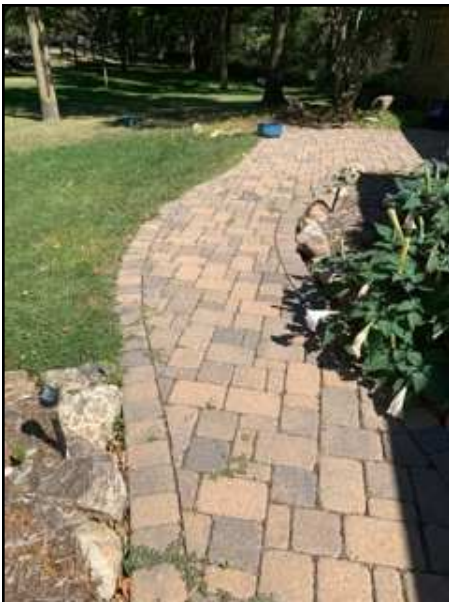
Figure 4-1

Minor Weed Growth in Paver Joints; Maintenance Recommended.

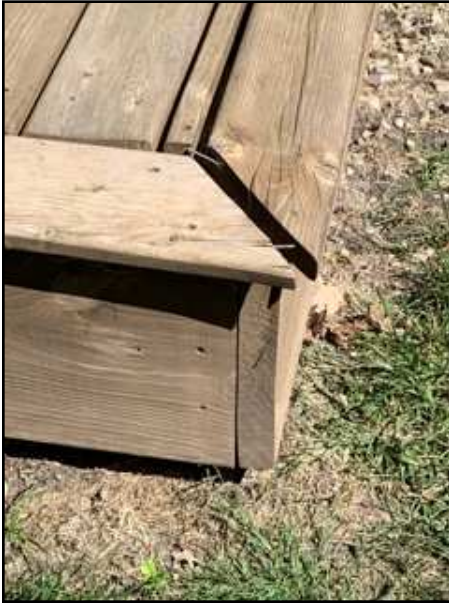
Figure 5-1

Edge Board on Lower Level Deck S.W. corner separating; Repairs Recommended

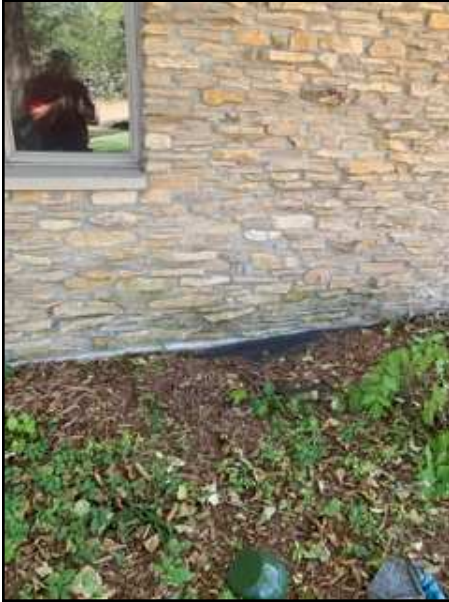
Figure 8-1

Low Area Adjacent to Foundation Wall North Side East of Entry; Potential Entry Point for Water to Enter Crawl Space.

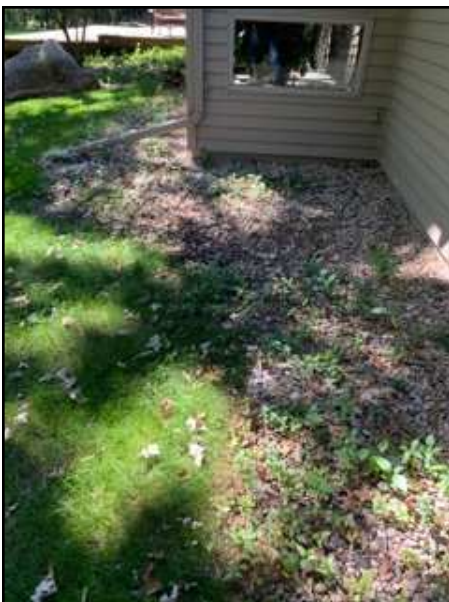
Figure 9-1

Low Area Adjacent to Foundation Wall South Side East of Living Room; Potential Entry Point for Water to Enter Crawl Space.

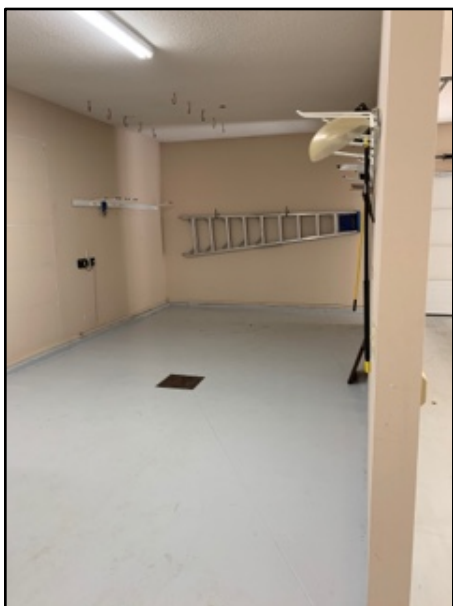
Figure 13-1

Extra Storage Stall - No Overhead Door.

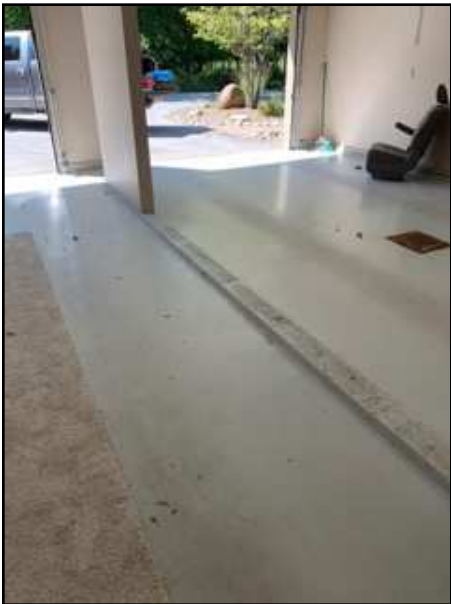
Figure 14-1

Comment 14:
Protruding Foundation - Potential Tripping Hazard.

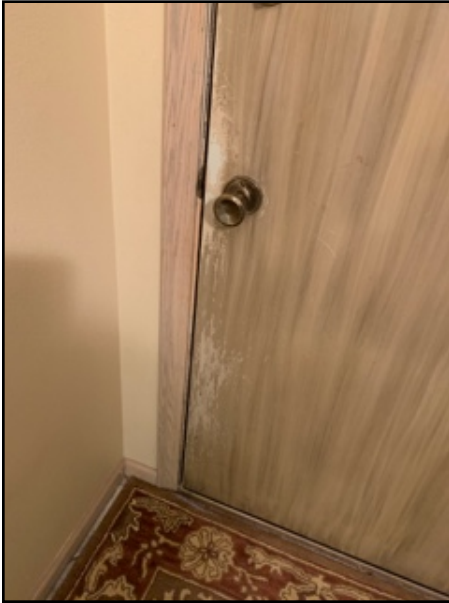
Figure 18-1

Door to Garage - Finish Worn on Inside; Appears to be Due to Dog Scratching Door .

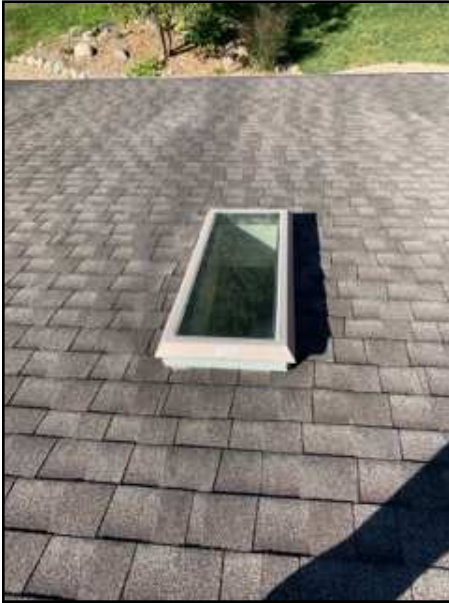
Figure 20-1

Comment 20:
Sky Light - Good Condition.

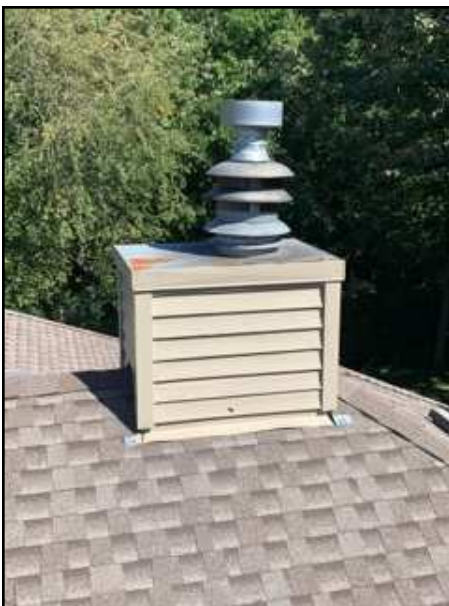
Figure 21-1

Comment 21:
Chimney - Metal Cap showing signs of Rust; Recommend Rust Preventive Coating.

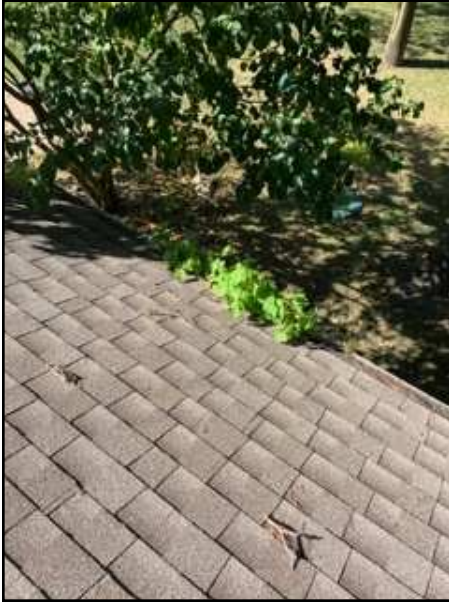
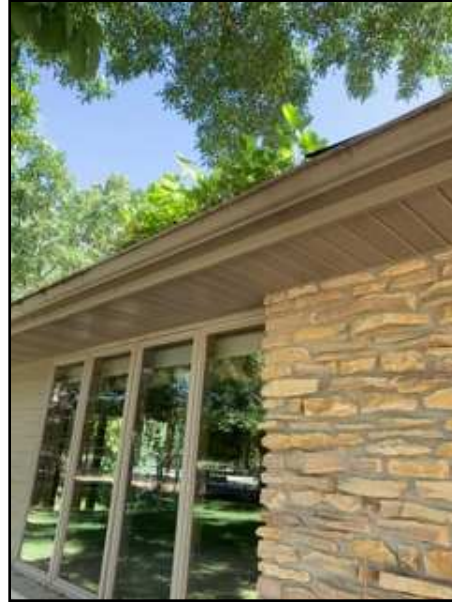
Vegetation Growing Gutter - North Side; Damage to Gutter Guard Apparent; Serious Cleaning of Gutters and Repairs to Gutter Guard Recommended.

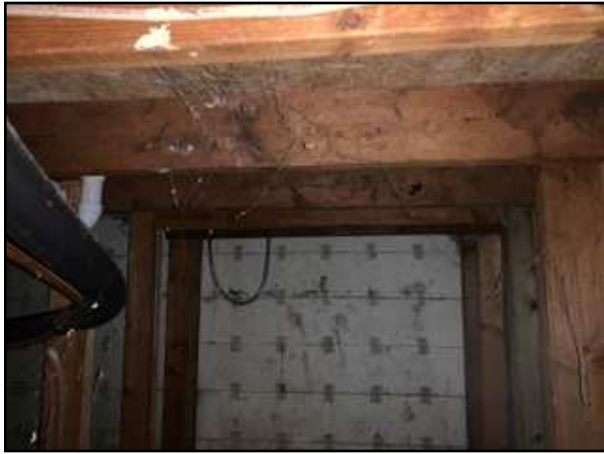
Figure 30-1

No Rotting Structural Members Observed Under Hot Tub.

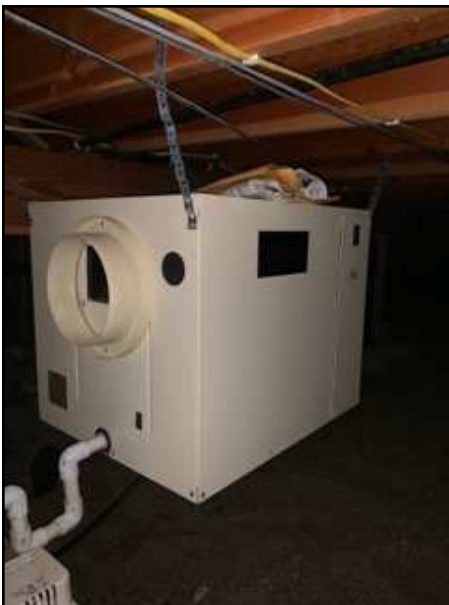
Figure 31-1

AprilAire Dehumidifier with Condensate Pump Located in Crawl Space; Did Operate when Switch was turned on; Recommend further Evaluation.

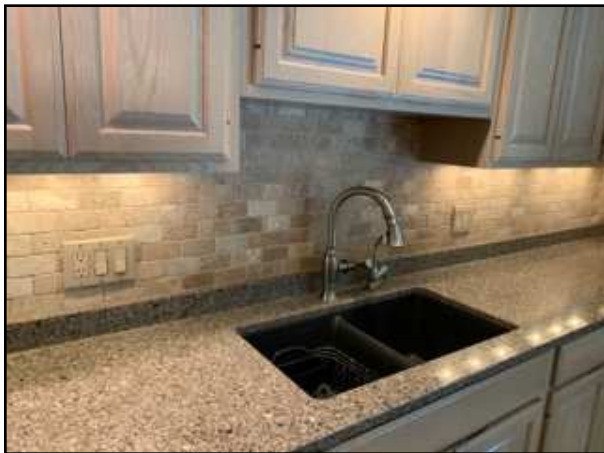
Figure 35-1

Comment 35:
No GFCI Receptacles by Kitchen Sink.

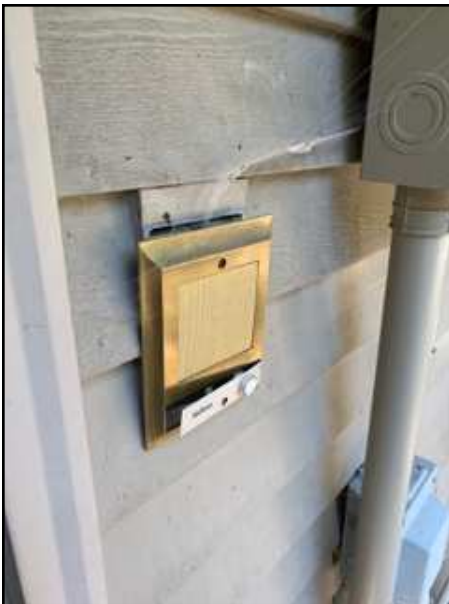
Figure 37-1

**Comment 37:**
NuTone Speaker / Call Button in Need of Repair by Door No. 3

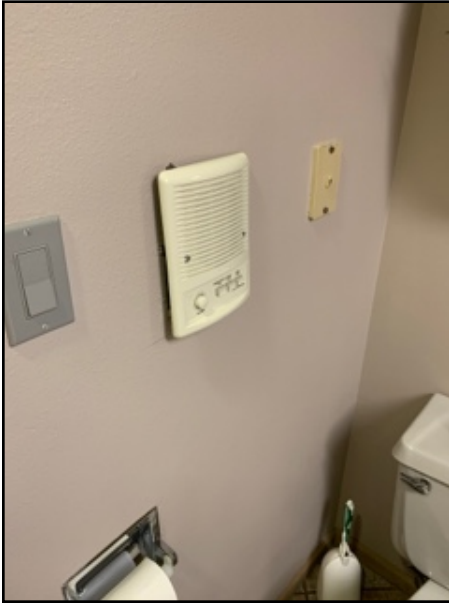
Figure 38-1

Comment 38:
NuTone Speaker in Laundry Room in Need of Repair.

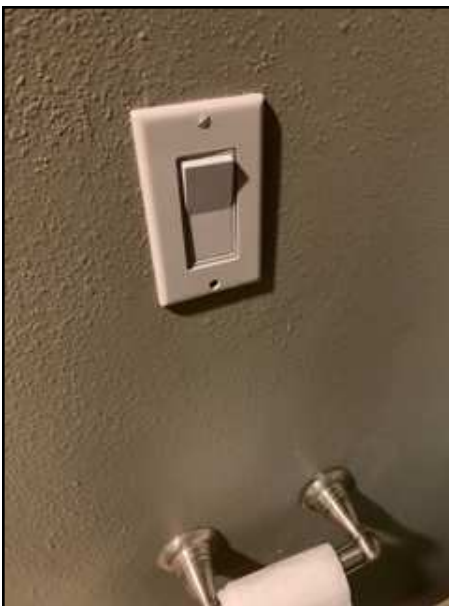
Figure 39-1

Comment 39:
Bottom Screw Missing on Switch Plate.

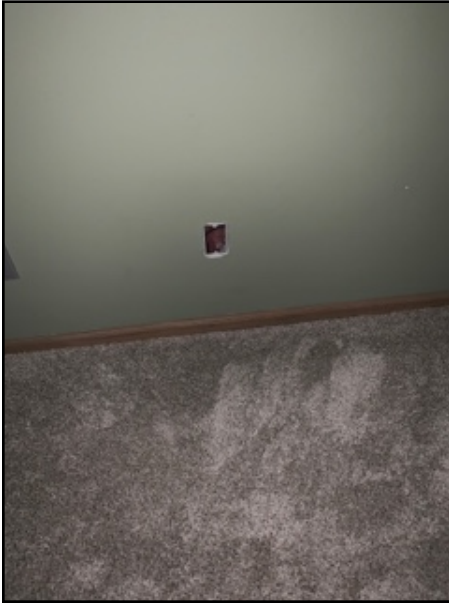
Figure 40-1

Comment 40:
Wall Plate Missing on East Wall.

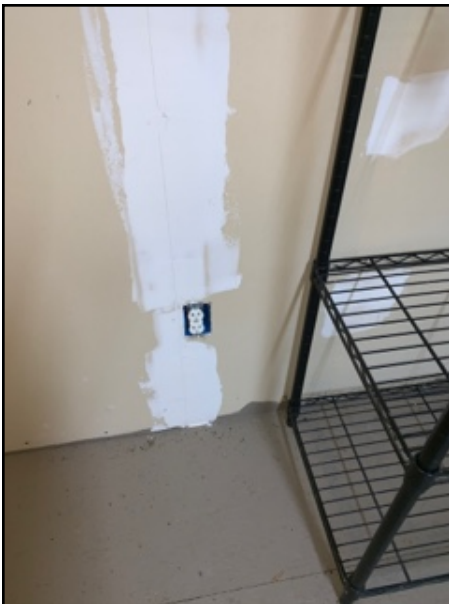
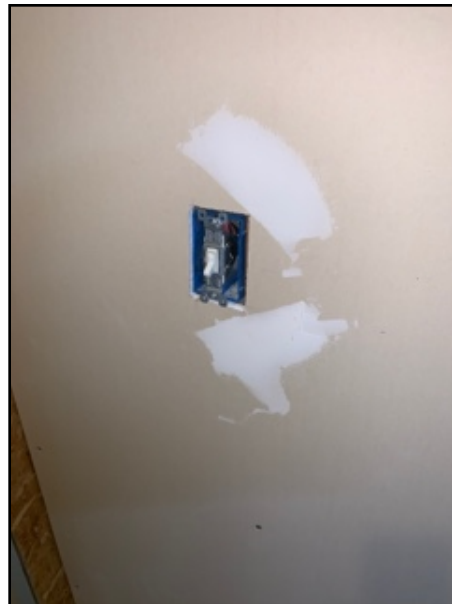
Comment 41:
Cover Plates Missing in Unfinished Area I'm Upper Level.

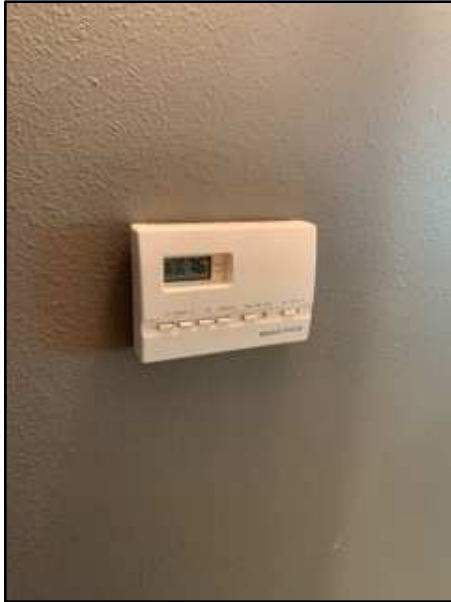
Figure 42-1

Thermostat Loose on Hallway Wall.

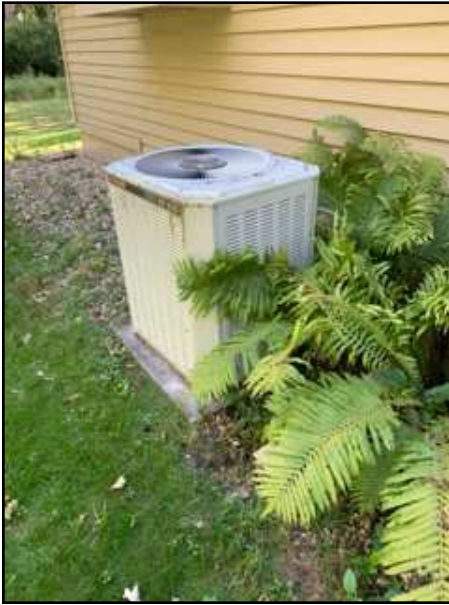
Figure 43-1

AC Condenser on East Side of Dwelling; Ferns adjacent Unit Clogging Air Flow;
Recommend Keeping Ferns Trimmed back to Maintain 12" Clearance.

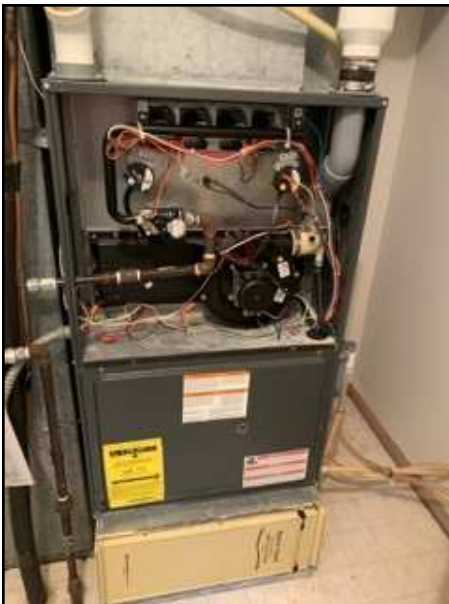
Figure 44-1

Comment 44:
High Efficiency 2 Stage Condensing Furnace with AprilAire Humidifier.

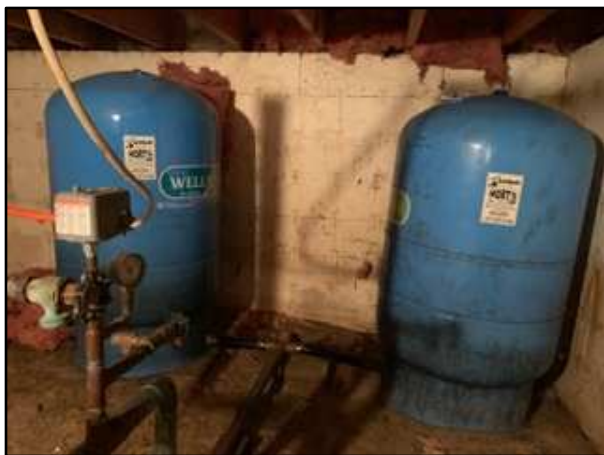
Figure 48-1

Pressure Tanks in Crawl Space - 50 Gallon Capacity per Tank Estimated;
Pressure Switch Set at 40 psi On / 60 psi Off.

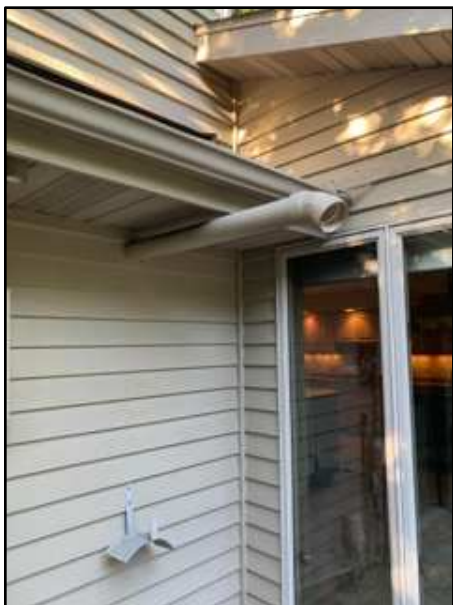
Figure 53-1

Comment 53:
Water Vent - Awkward Location.

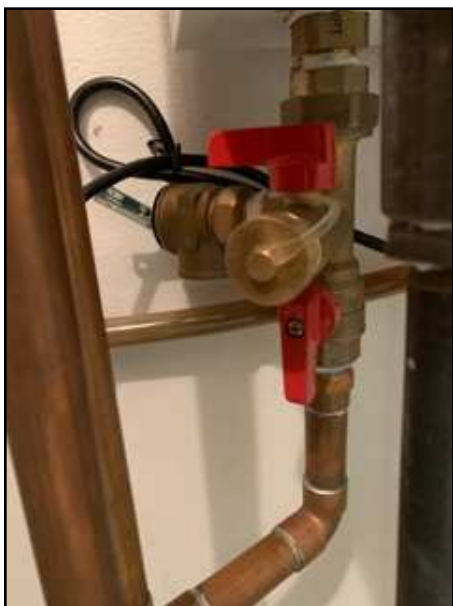
Figure 54-1

Comment 54:
Pressure Relief Valve - No Discharge Piping.

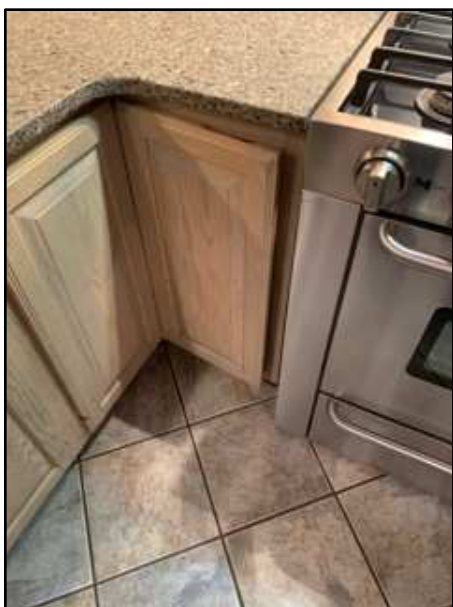
Figure 56-1

Comment 56:
Catch on Corner Cabinet Missing.

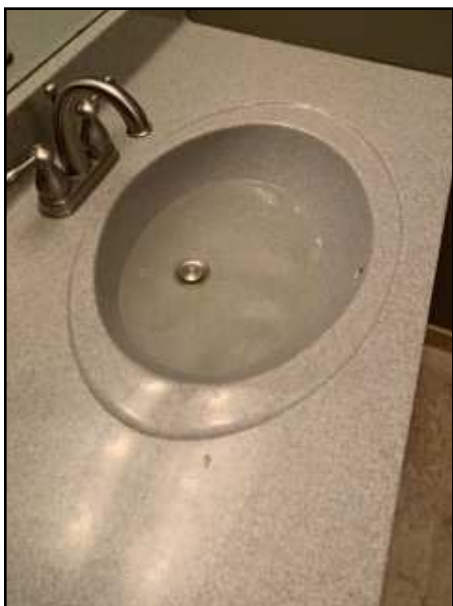
Figure 58-1

Sink Slow to Drain / Ran Hot Water for 3 - 4 minutes and water never got warm.

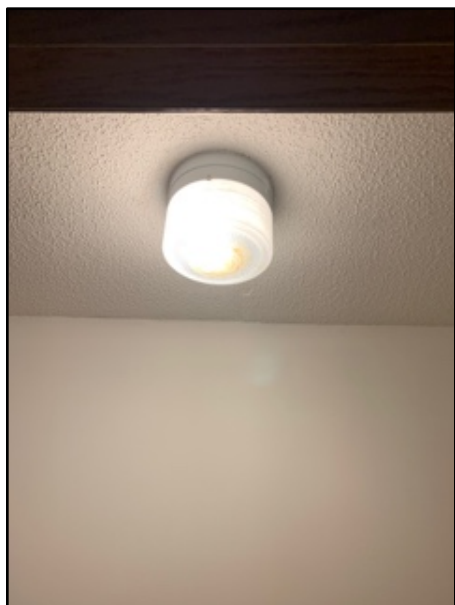
Figure 59-1

Comment 59:
No piping by fixture Observed.

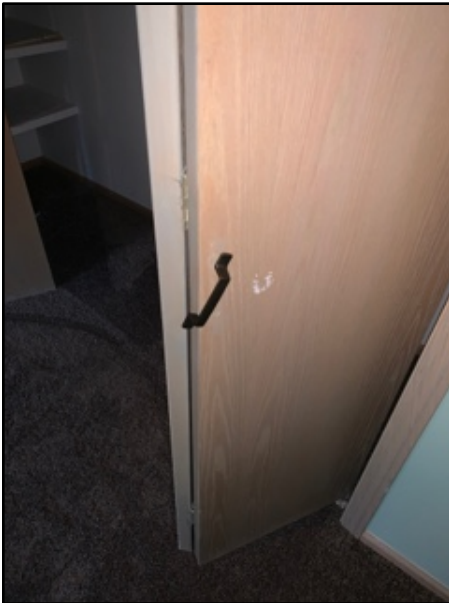
Figure 60-1

Comment 60:
Closet Door Handles in Need of Repair.

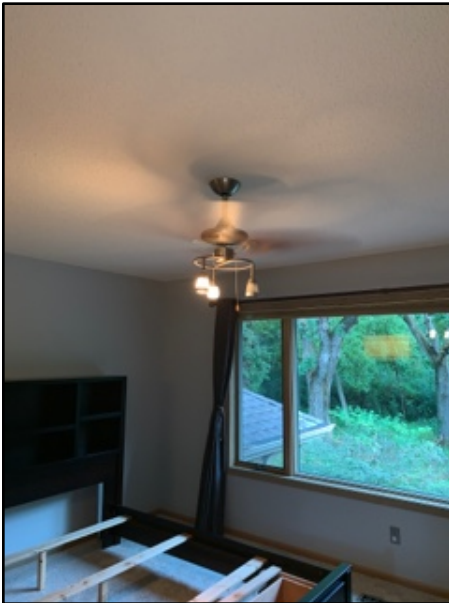
Figure 62-1

Comment 62:
Ceiling Fan out of Balance; Bulb Burnt Out.

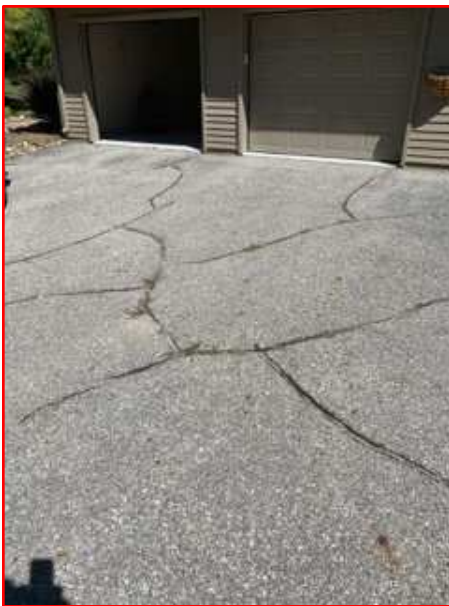
Figure 3-1

1) Comment 3: Minor Cracking & Surface Spalling in Asphalt Driveway which has been Sealed Previously; Typical for 27 year old pavement.

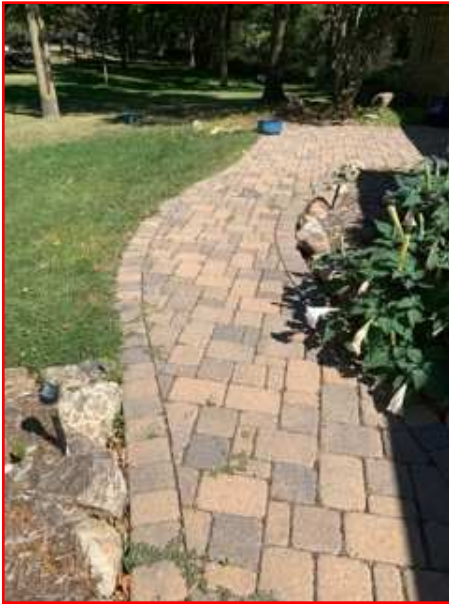
Figure 4-1

2) Comment 4: Minor Weed Growth in Paver Joints; Maintenance Recommended.

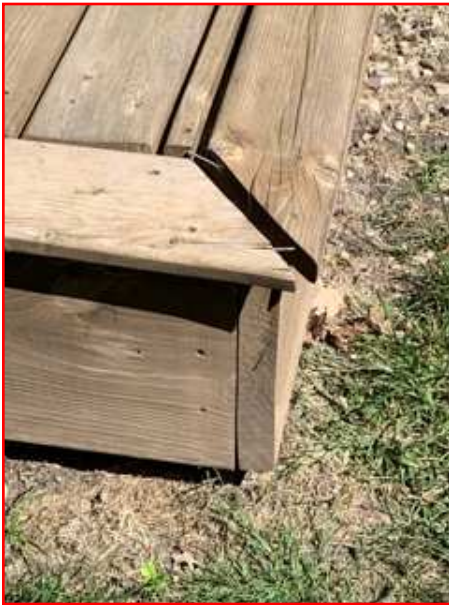
Figure 5-1

3) Comment 5: Edge Board on Lower Level Deck S.W. corner separating; Repairs Recommended

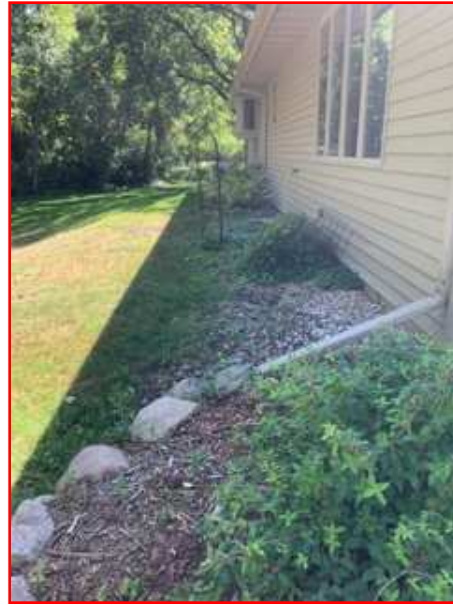
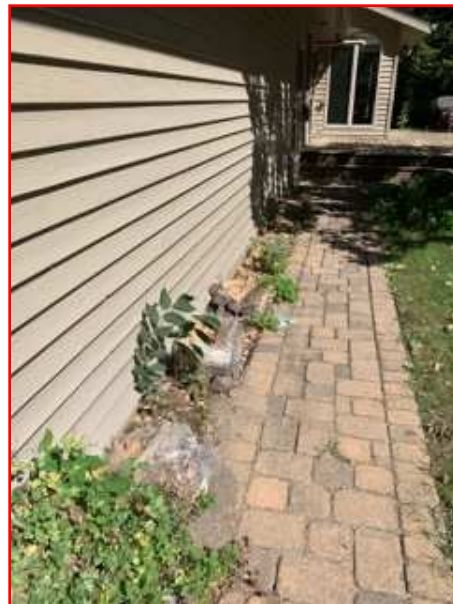
4) Comment 7: Planting Area Overgrown with Weeds.

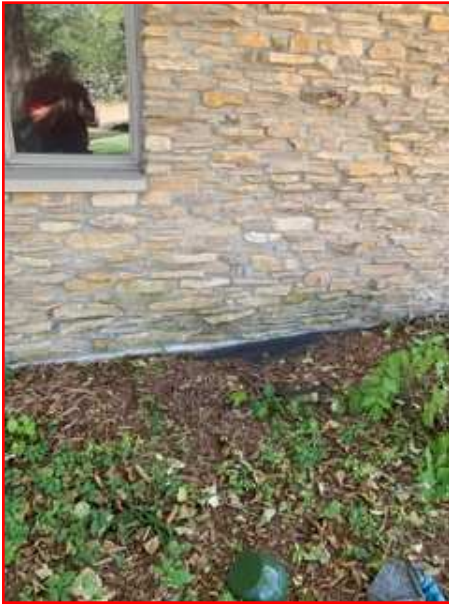
Figure 8-1

5) Comment 8: Low Area Adjacent to Foundation Wall North Side East of Entry; Potential Entry Point for Water to Enter Crawl Space.

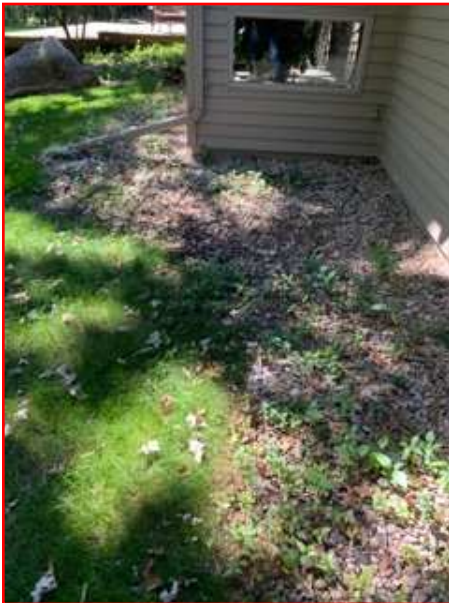
Figure 9-1

6) Comment 9: Low Area Adjacent to Foundation Wall South Side East of Living Room; Potential Entry Point for Water to Enter Crawl Space.

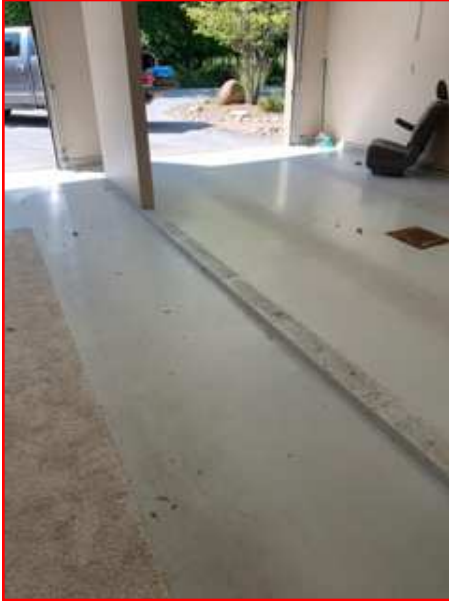
Figure 14-1

8) Comment 14: Protruding Foundation - Potential Tripping Hazard.

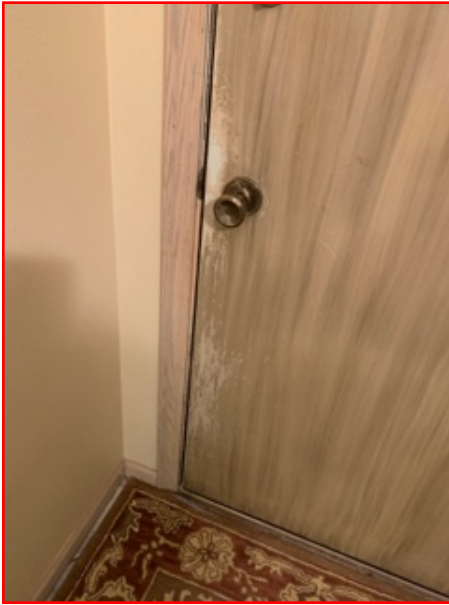
Figure 18-1

10) Comment 18: Door to Garage - Finish Worn on Inside; Appears to be Due to Dog Scratching Door .

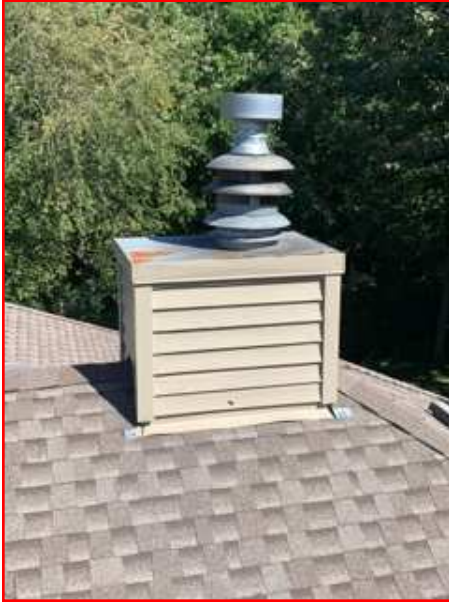
Figure 21-1

12) Comment 21: Chimney - Metal Cap showing signs of Rust; Recommend Rust Preventive Coating.

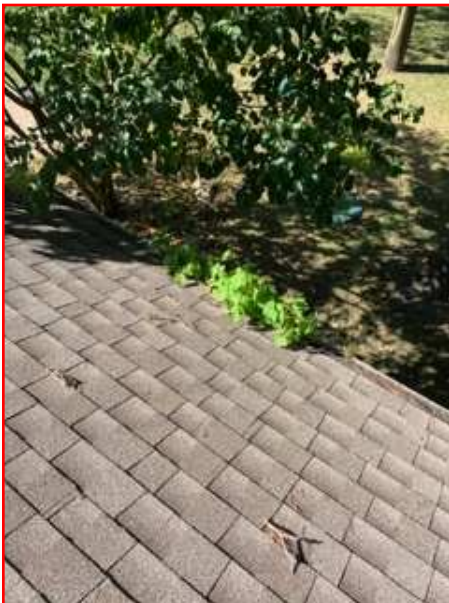
Figure 24-1

13) Comment 24: Vegetation Growing Gutter - North Side; Damage to Gutter Guard Apparent; Serious Cleaning of Gutters and Repairs to Gutter Guard Recommended.

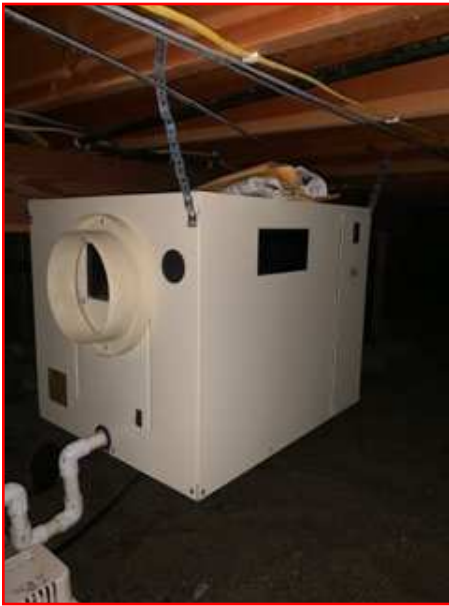
Figure 31-1

15) Comment 31: AprilAire Dehumidifier with Condensate Pump Located in Crawl Space; Did Operate when Switch was turned on; Recommend further Evaluation.

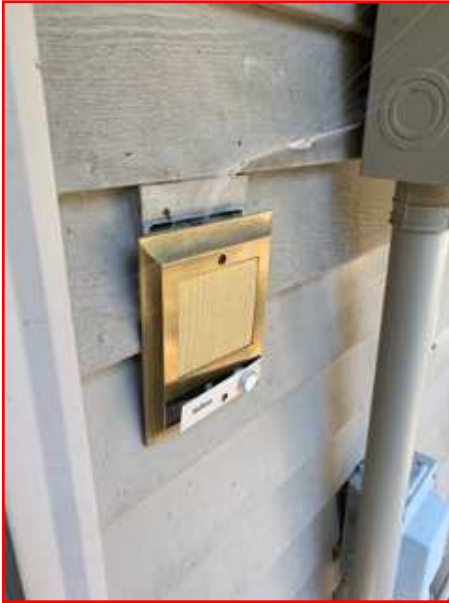
Figure 37-1

16) Comment 37: NuTone Speaker / Call Button in Need of Repair by Door No. 3

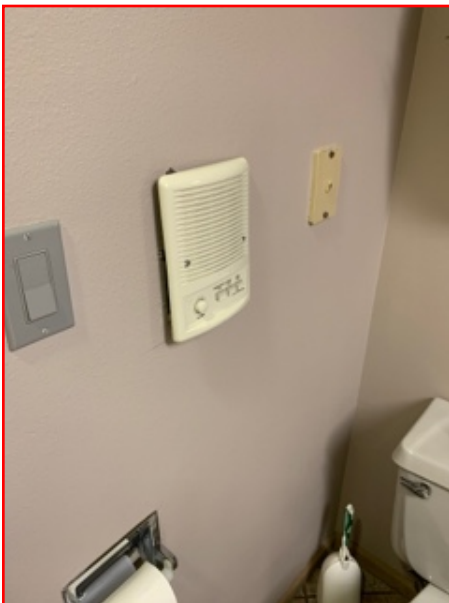
Figure 38-1

17) Comment 38: NuTone Speaker in Laundry Room in Need of Repair.

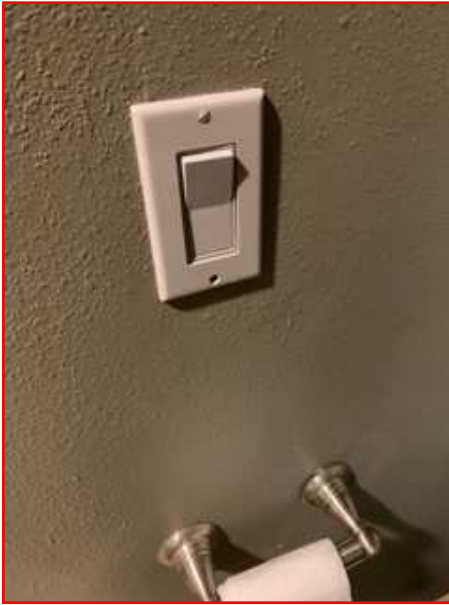
Figure 39-1

18) Comment 39: Bottom Screw Missing on Switch Plate.

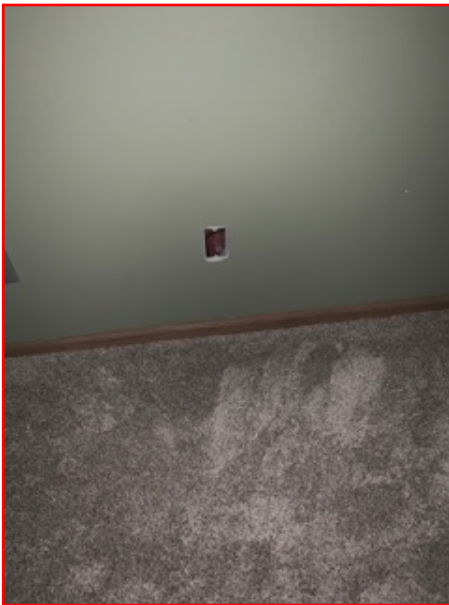
Figure 40-1

19) Comment 40: Wall Plate Missing on East Wall.

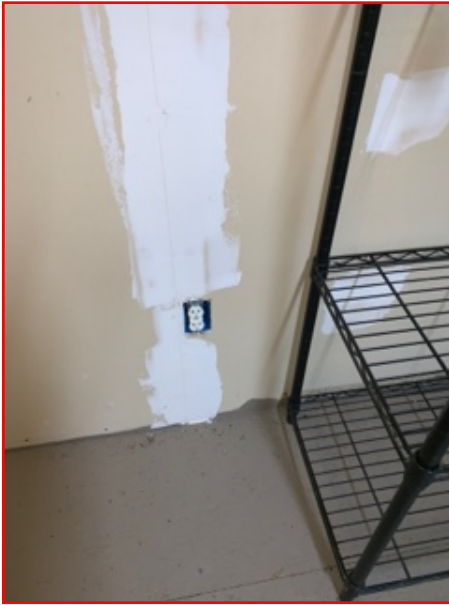
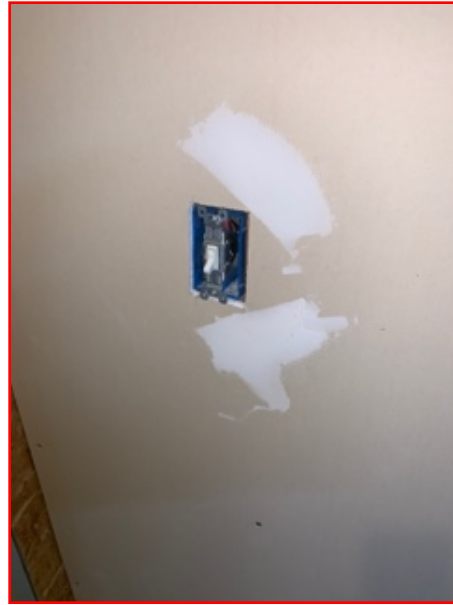
20) Comment 41: Cover Plates Missing in Unfinished Area l'm Upper Level.

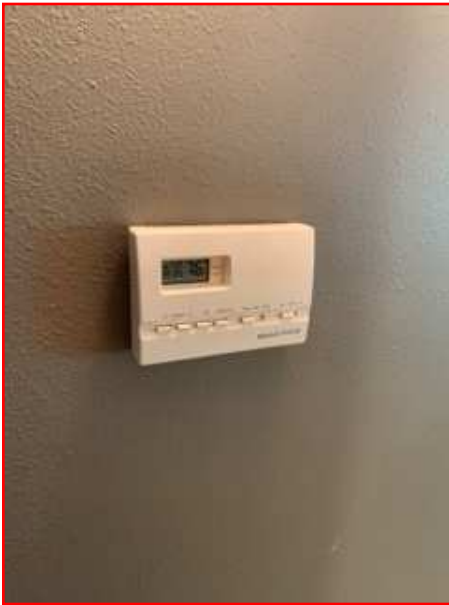
Figure 42-1

21) Comment 42: Thermostat Loose on Hallway Wall.

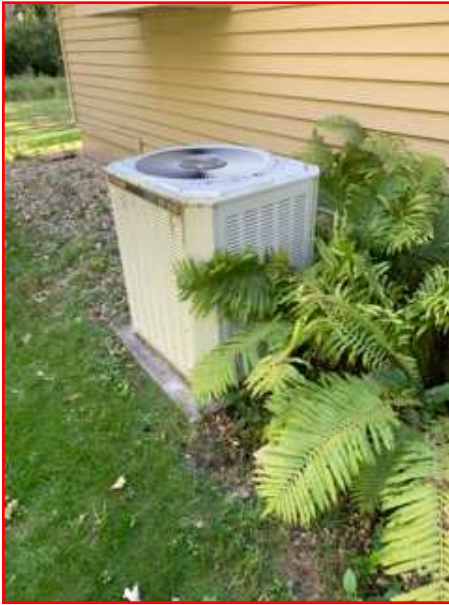
Figure 43-1

22) Comment 43: AC Condenser on East Side of Dwelling; Ferns adjacent Unit Clogging Air Flow; Recommend Keeping Ferns Trimmed back to Maintain 12" Clearance.

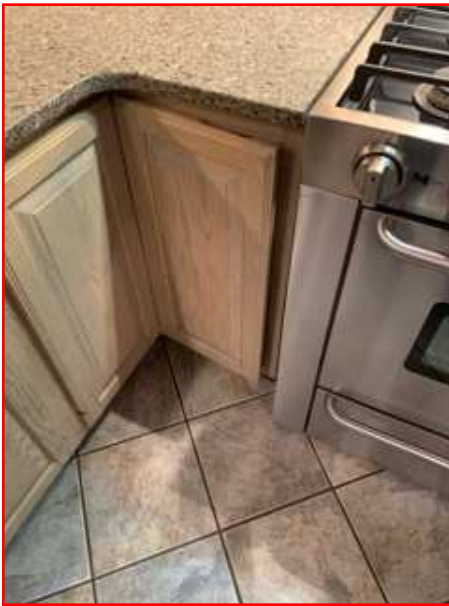
Figure 56-1

27) Comment 56: Catch on Corner Cabinet Missing.

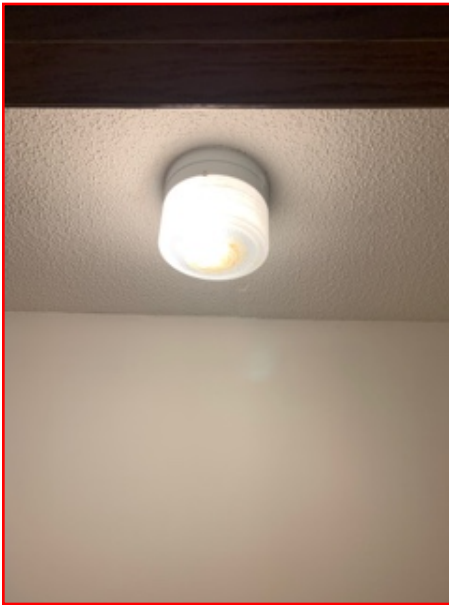
Figure 59-1

30) Comment 59: No piping by fixture Observed.

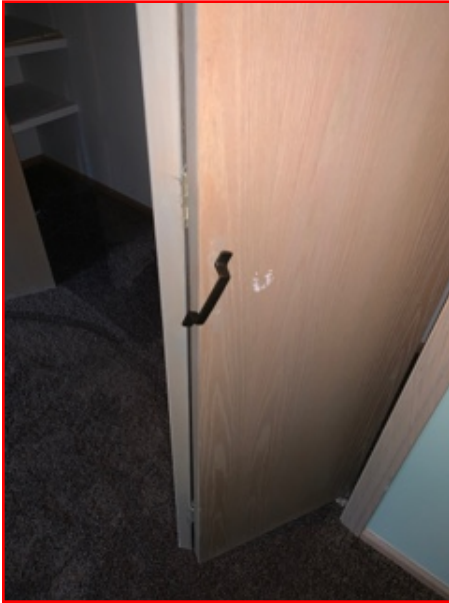
Figure 60-1

31) Comment 60: Closet Door Handles in Need of Repair.

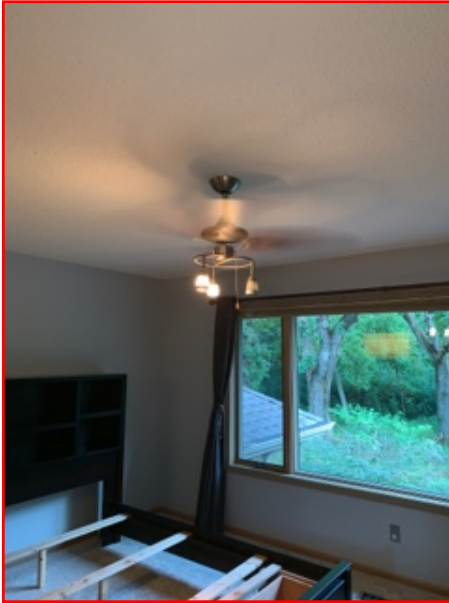
Figure 62-1

33) Comment 62: Ceiling Fan out of Balance; Bulb Burnt Out.
