FULL RESERVE STUDY

Victorian Condominium Association

Cleveland Heights, Ohio
August 23, 2018

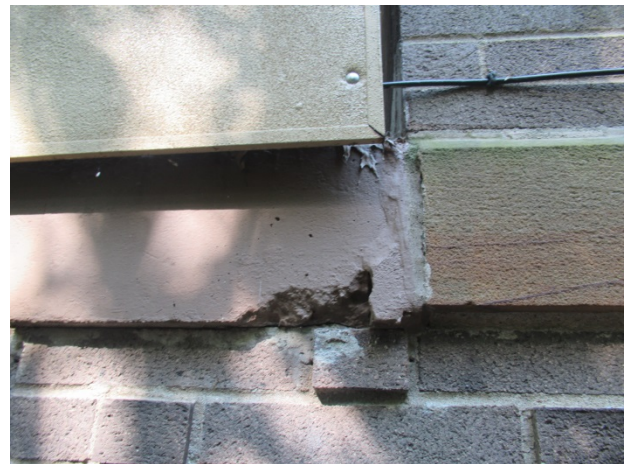
Condition: Good to fair with areas of spalled concrete and minor efflorescence present

Spalled balcony concrete

Useful Life: Capital repairs including a close-up visual inspection, patching of delaminated concrete, routing and filling of cracked concrete, and waterproof coating applications every 8- to 12-years.

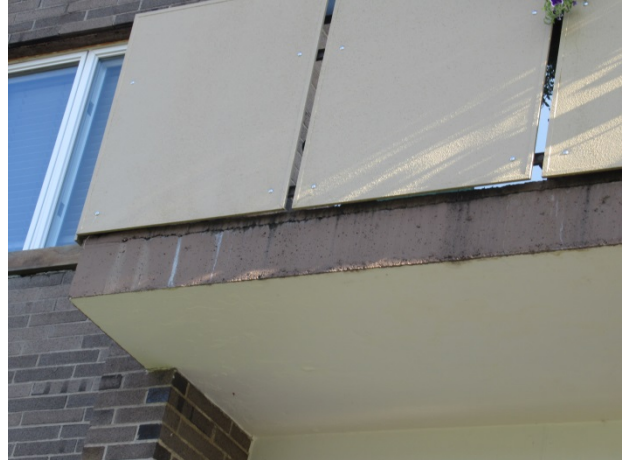
Efflorescence

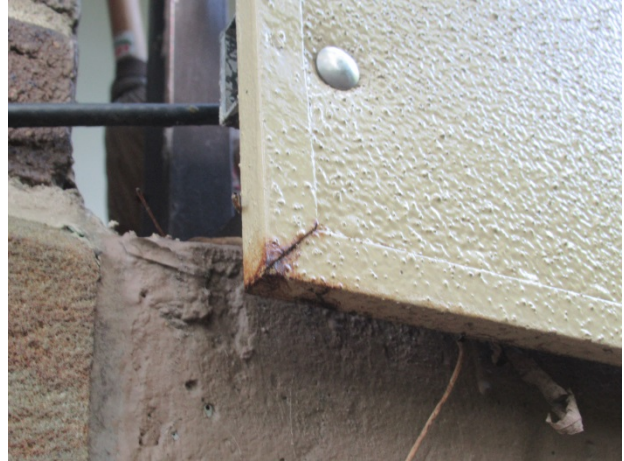
Minor panel rust

Useful Life: Railings of this type have a useful life of up to 50 years with the benefit of periodic maintenance. Periodic maintenance should include applications of a protective paint finish and partial replacement of deteriorated steel every six- to eight-years.

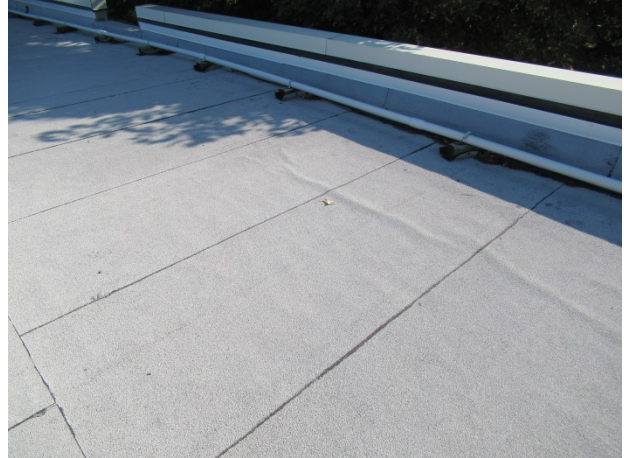
Isolated loose membrane

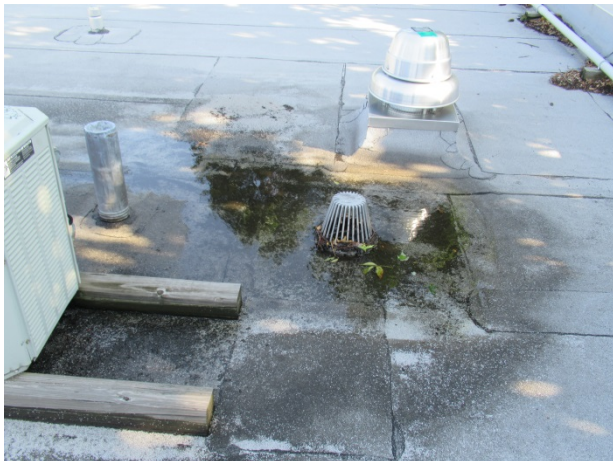
Ponding water and build-up at drain

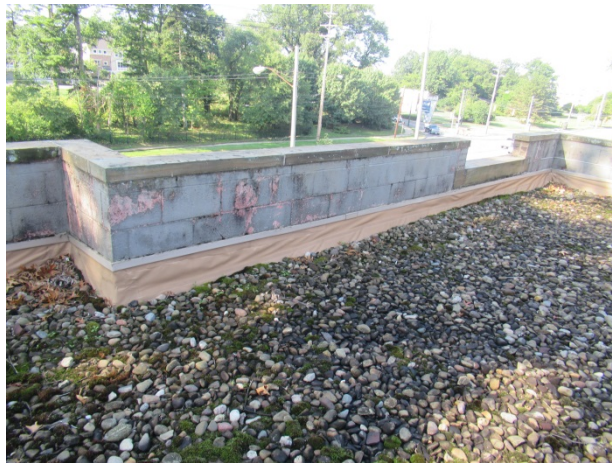
Loose membrane at built-up roof section

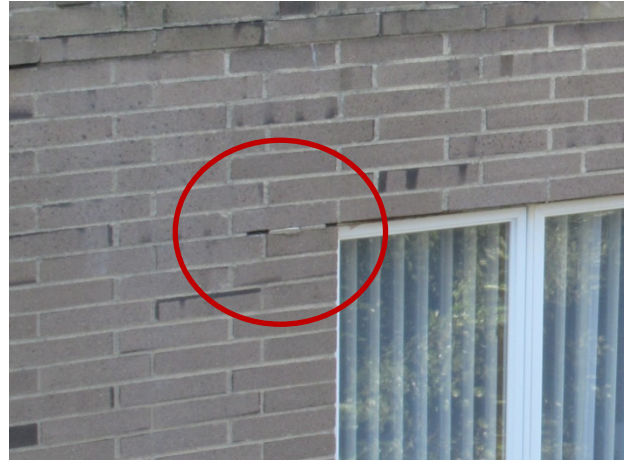
Mortar loss at lintel

Useful Life: We advise a complete inspection of the masonry and related masonry repairs 8- to 12-years to forestall deterioration.

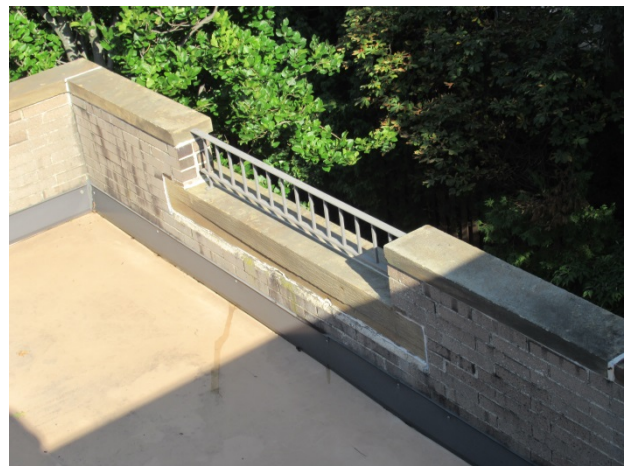
Repairs at balcony stone sill

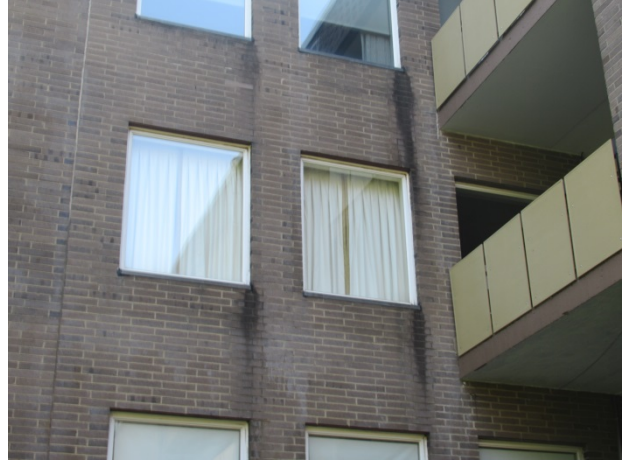
Masonry stains

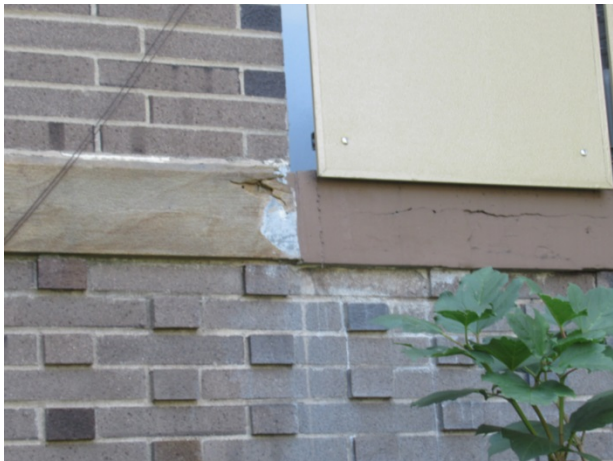
Damaged stone masonry and repairs

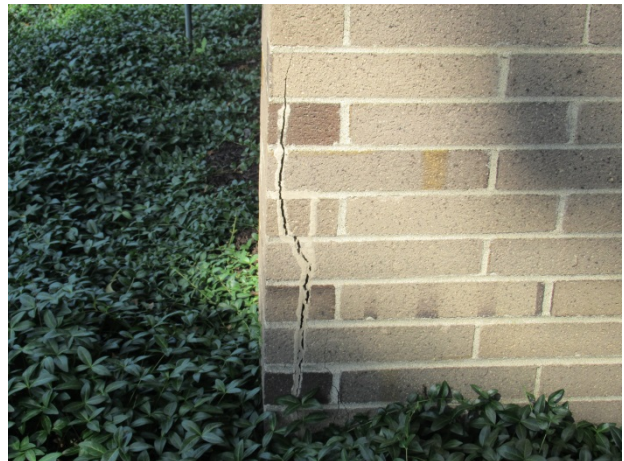
Masonry cracks and previous repair

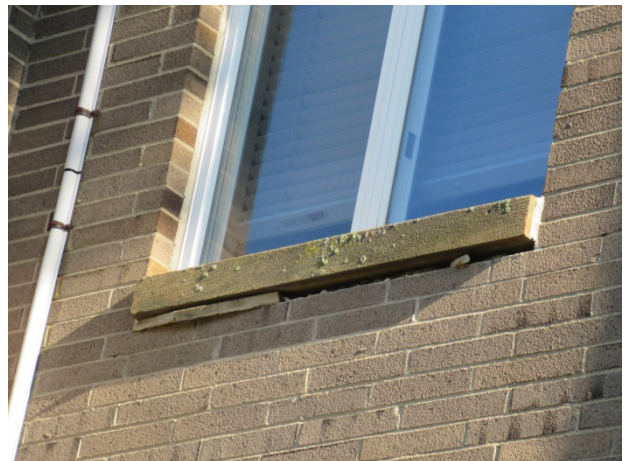
Mortar loss below window sill

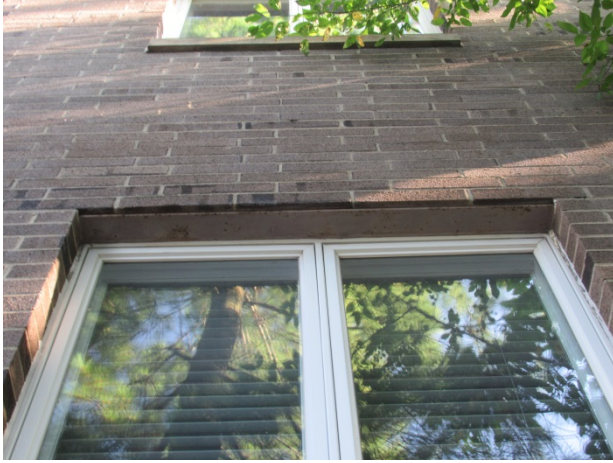
Lintel rust

Component Detail Notes: We recommend an inspection, repair and replacement of the steel lintels. Lintels are structural supports or beams above windows and doors. Fatigued lintels also allow the direct penetration of storm water into the wall assembly. These inspections should locate areas of rust on the lintels and cracks or other structural damage to the walls around lintels. The contractor should remove any areas of rust, prime and paint these lintels. Paint protects and maximizes the remaining useful life of the lintels and therefore the exterior wall systems. Structural damage can eventually lead to costly replacements of lintels and surrounding wall systems. The following diagram details a typical metal lintel and weep system and may not reflect the actual configuration at Victorian:

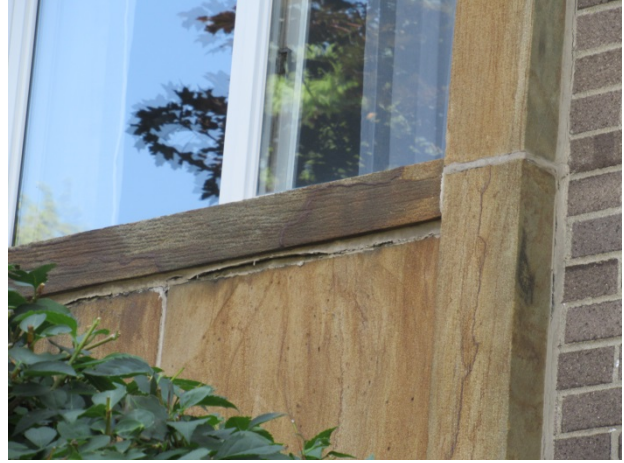
Failed sealants

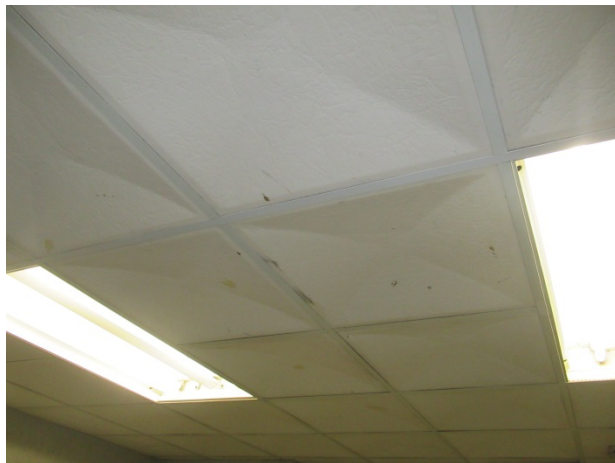
Damaged ceiling tiles in billiards room

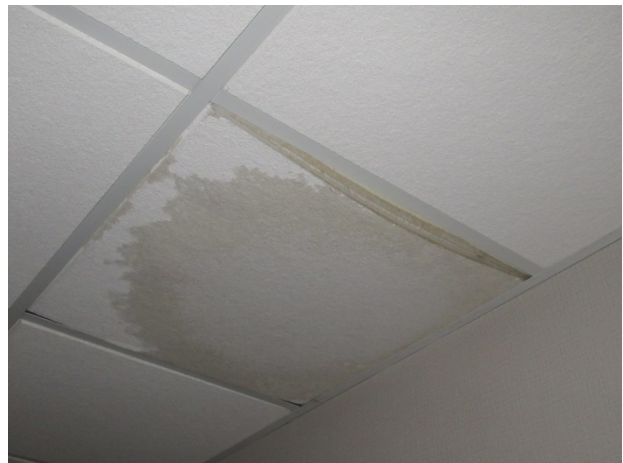
Stained hallway acoustical ceiling tiles, located near Unit 205

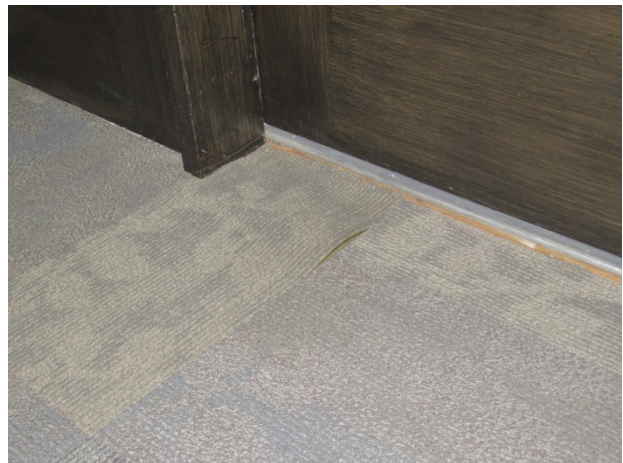
Loose carpet square

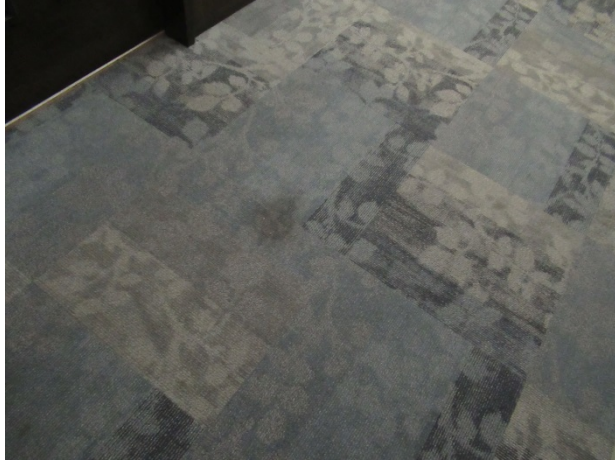
Hallway carpet stain

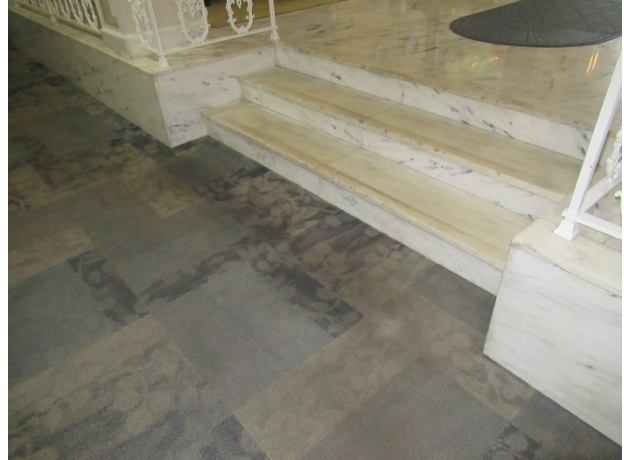
Carpet discoloration near lobby

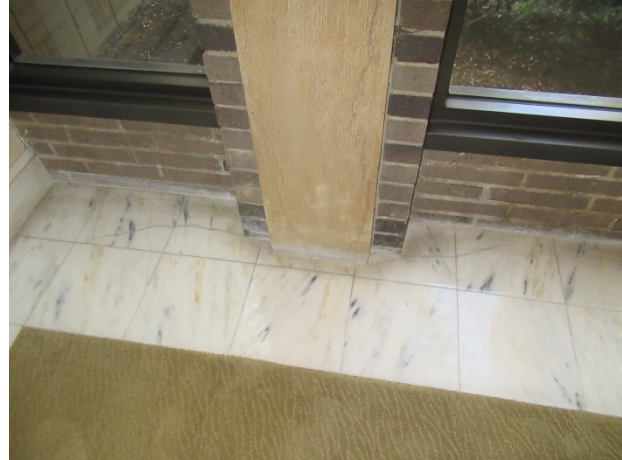
Tile crack

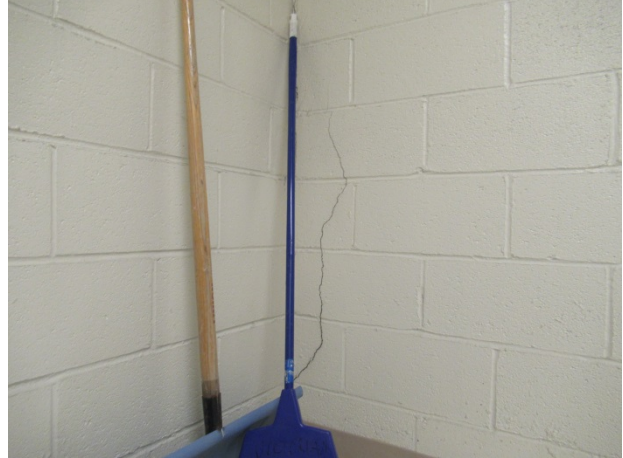
Masonry wall and finish crack

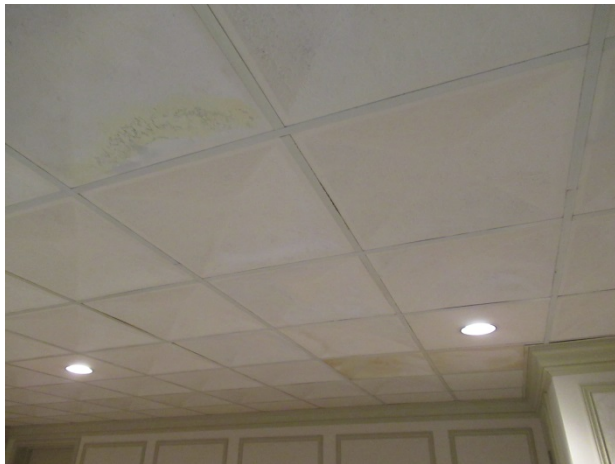
Stained ceiling tiles

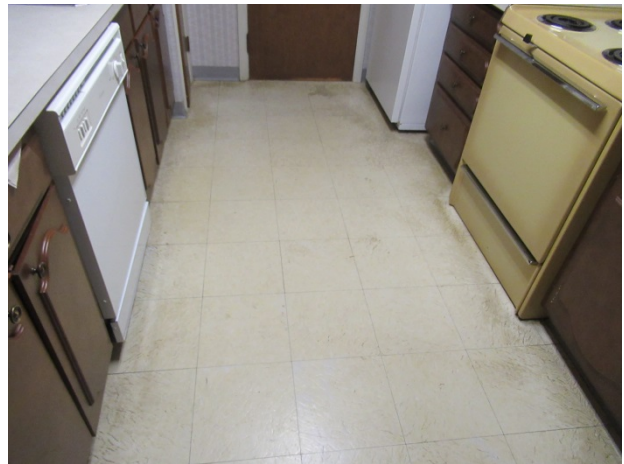
Worn tile

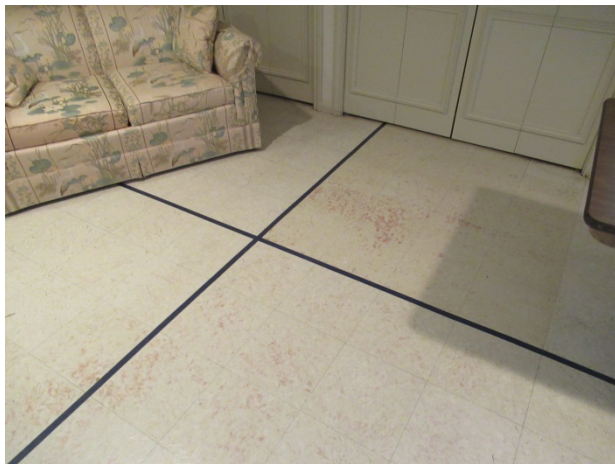
Worn tile

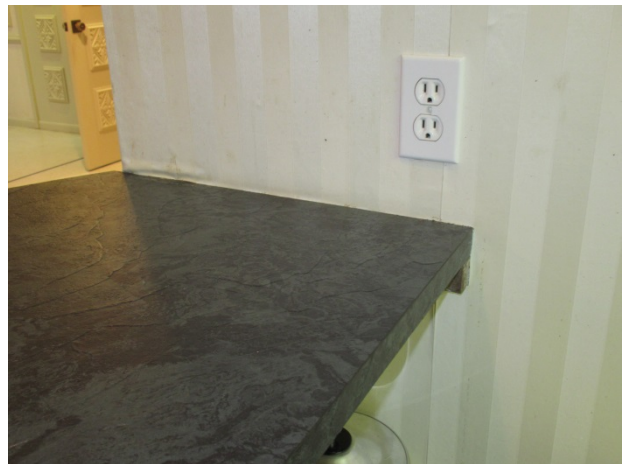
Loose wall paper

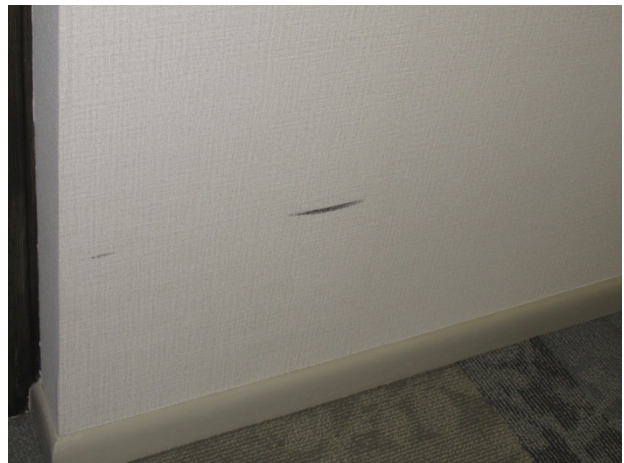
Scuffed wall coverings

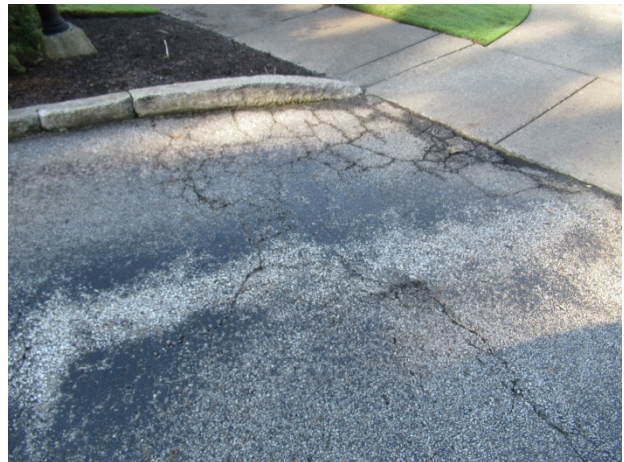
Front pavement cracks and settlement

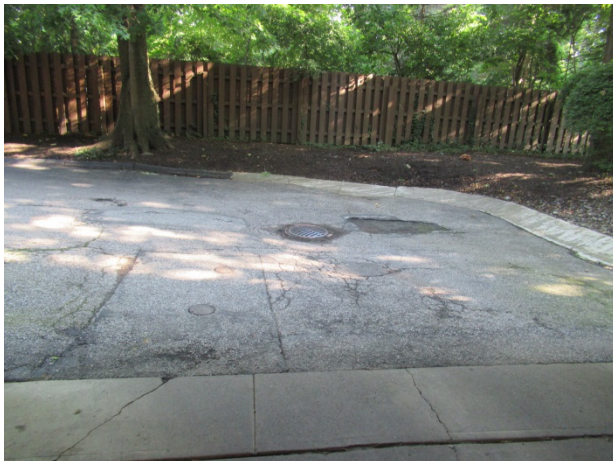
Rear pavement potholes and deterioration

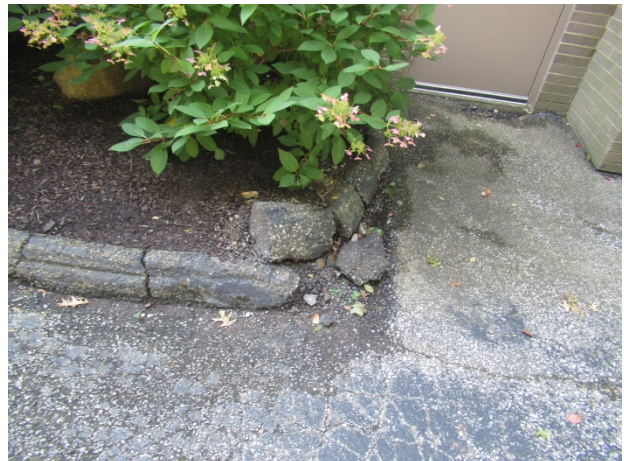
Rear pavement and curb deterioration

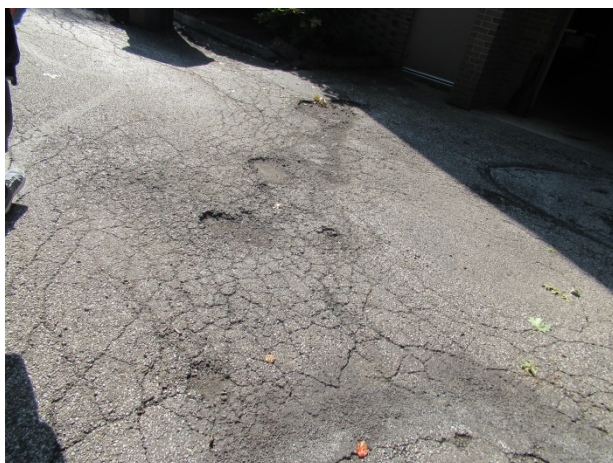
Rear pavement potholes, cracks and deterioration

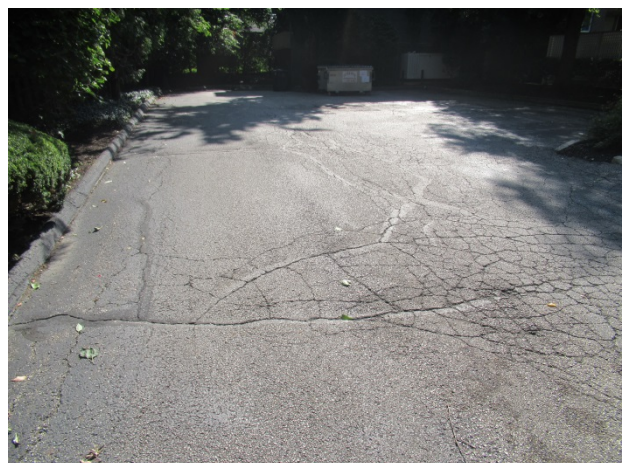
Rear pavement alligator cracks

The manner of repaving is either a mill and overlay or total replacement. A mill and overlay is a method of repaving where cracked, worn and failed pavement is mechanically removed or milled until sound pavement is found. A new layer of asphalt is overlaid atop the remaining base course of pavement. Total replacement includes the removal of all existing asphalt down to the base course of aggregate and native soil followed by the application of two or more new lifts of asphalt. We recommend mill and overlayment on asphalt pavement that exhibits normal deterioration and wear. We recommend total replacement of asphalt pavement that exhibits severe deterioration, inadequate drainage, pavement that has been overlaid multiple times in the past or where the configuration makes overlayment not possible. Based on the apparent visual condition and configuration of the asphalt pavement, we recommend the mill and overlay method for initial repaving followed by the total replacement method for subsequent repaving at Victorian.

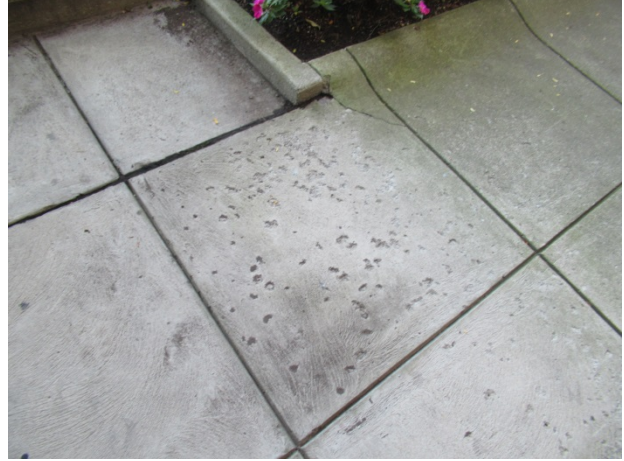
Concrete spall

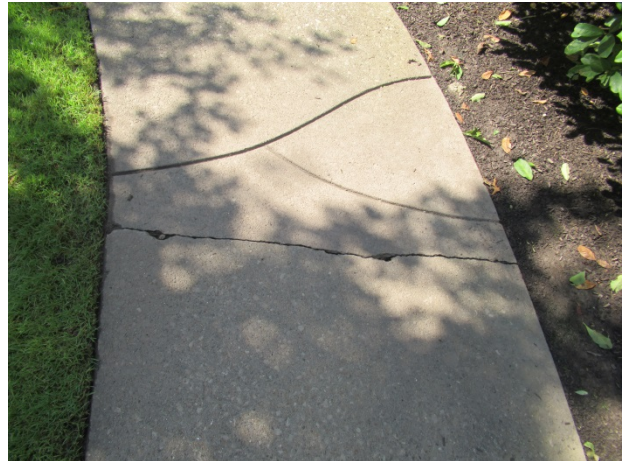
Rear courtyard crack

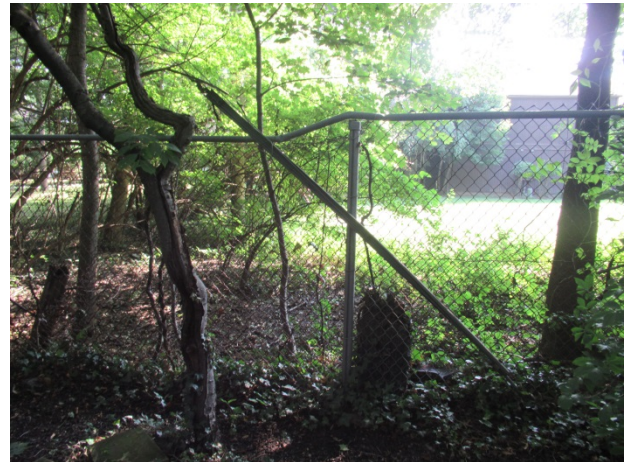
Damaged section of chain-link fence

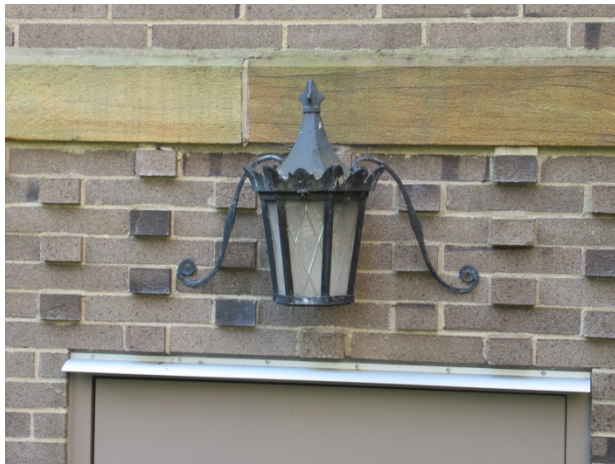
Exterior light fixture, note finish deterioration

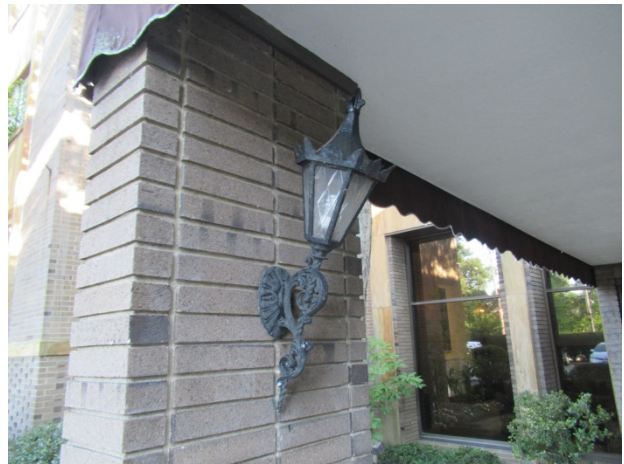
Exterior light fixture, note finish deterioration

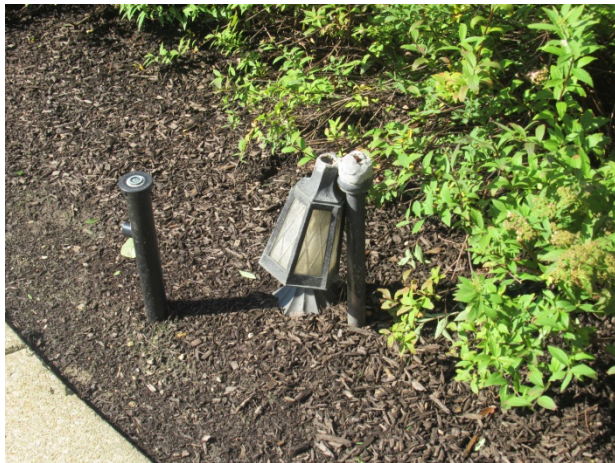
Bollard in poor condition

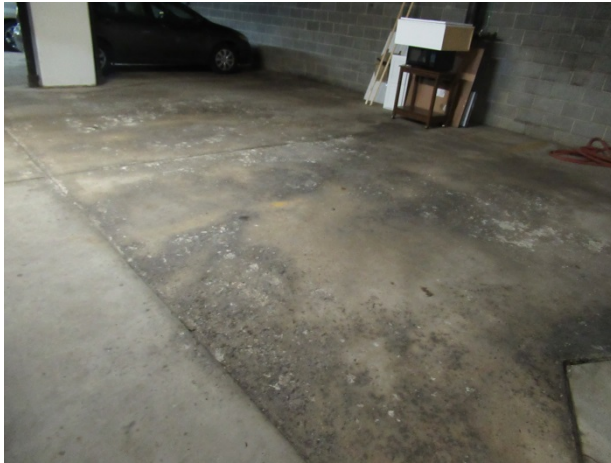
Spalled on-grade concrete

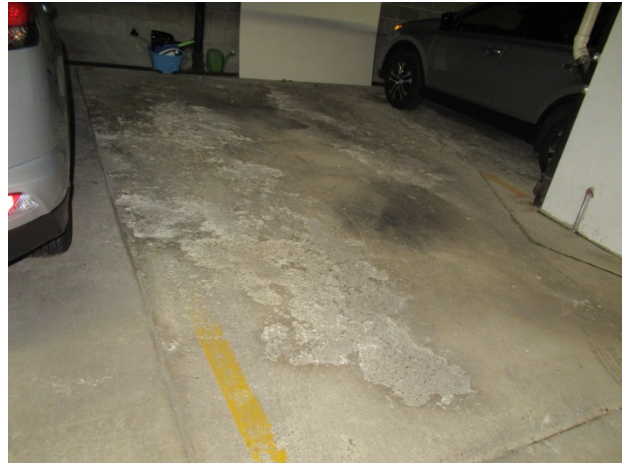
Spalled on-grade concrete

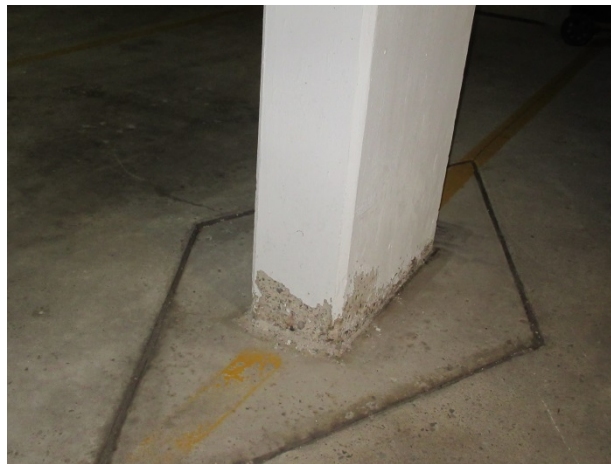
Spalled concrete column
