Case Study

Arena Concourse Floor Raising & Void Fill

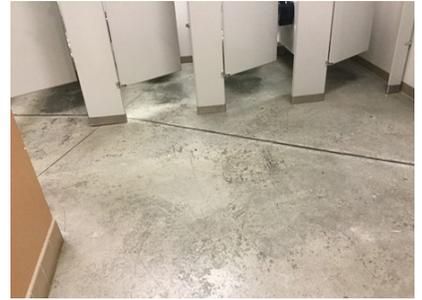
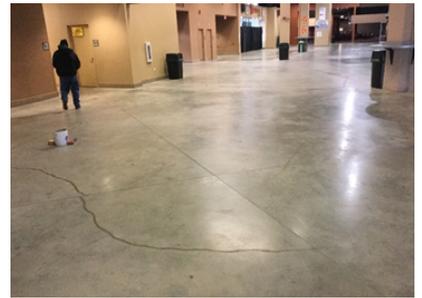
RaiseRite met with the municipality who own the Arena on site to verify the areas they wanted tested out with HMI TracFoam in accordance with the radar map that had been provided by a scanning company. There was an area in the bathrooms that actually needed to be raised as the floor has been settling for many years along with an area outside of the bathrooms that had voids. The mudjacking process had been tried numerous times on the concourse floor, but due to the weight of the mudjacking material, the floor kept settling so TracFoam, and its lightweight properties, were a perfect fit for the project.

Using the radar map as a guide, RaiseRite began raising the bathroom floor slab that had settled back to its original height and then void filled an area of the concourse using HMI TracFoam. Three hundred pounds of material were used during the lift and void fill of the arena concourse floor. After the work was complete, the municipality had the radar mapping company return to map the areas of the floor that TracFoam had been injected under. The bathroom area and the area done outside on the concourse both came up with negative void assessments. Overall, a resounding success for RaiseRite and HMI TracFoam! Standard polyurethane foam if used would have shown up as a void and you could not tell the difference between the foam and a void. Had we not used Trac foam, we would not have been able to verify the areas that had been filled. Because the municipality said that they would be analyzing with GPR in the future with other repairs that would be required. Because of this, it was necessary to be able to identify the difference between foam and a void.
