Assetivo

Case Studies

Case Study: Empty Keg Turner Bearing Failure.

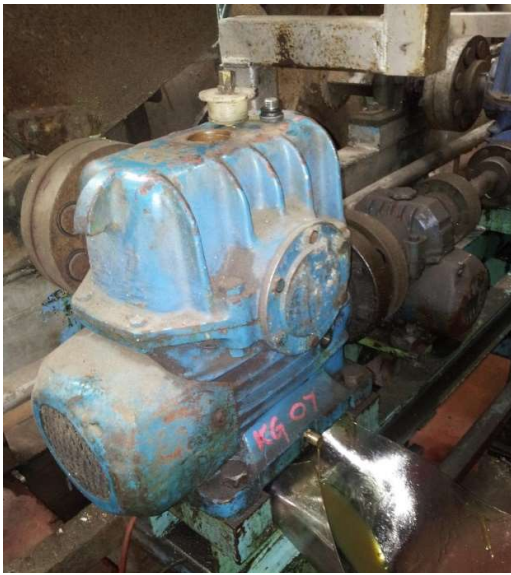
Figure 1: Empty Keg Turner KG-07

wash area. They consist of a motor and belt driven central gearbox with twin output shafts driving two keg turner gearboxes via a series of couplings (see Figure 1). The keg turning gearboxes were added to the CBM database and were monitored solely via visual inspections and oil sampling. Vibration analysis was not carried out due to difficult access as well as the equipment being slow-moving with partial rotation and intermittent operation.

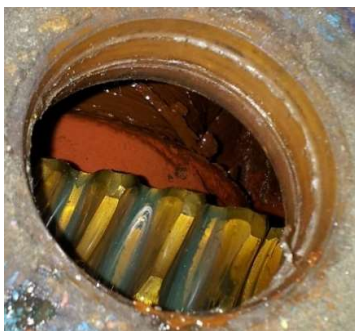
condition. A simple visual inspection revealed that there appeared to be damage to the drive end bearing cage (see Figure 3) in the form of a fracture which suggested that it was highly likely that the rolling elements were no longer contained in the bearing's structure. The bronze gear wheel teeth appeared to be in reasonable condition with some signs of wear. The other worm gear and helical gears could not be inspected accurately to determine condition. A borescope inspection via the oil fill hole revealed several rolling elements strewn on the gearbox casing floor (see Figure 4). The rolling elements appeared to show some evidence of corrosion - likely from long-term ingress of water into the gearbox.

Figure 3: Damaged roller bearing cage

The oil sample and report revealed wear internal to the gearbox components and using a borescope inspection it was found that drive-end rolling element bearing was catastrophically failed. Though it is unknown how long the gearbox had been operating with a failed drive end bearing, the next logical failure due to the significant dynamic and geometric changes would have been the non-drive end bearing and or gear teeth. And if the bearing had failed and all load-bearing capacity lost, and structural integrity and geometry lost, then the gearbox would no longer have been functional. With respect to the findings, the brewery was informed immediately of the issue, and given that a direct replacement spare was not held for this obsolete gearbox, it was sent out for repair to a local supplier and was returned for use before the end of the shutdown week to ensure continued, reliable operation.

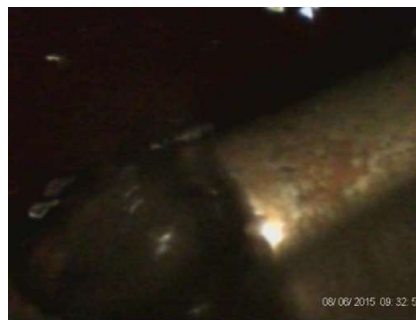
Figure 4: Rolling element on the gearbox floor
