Assetivo

Case Study: RCA on Fryer Bearing Failures.

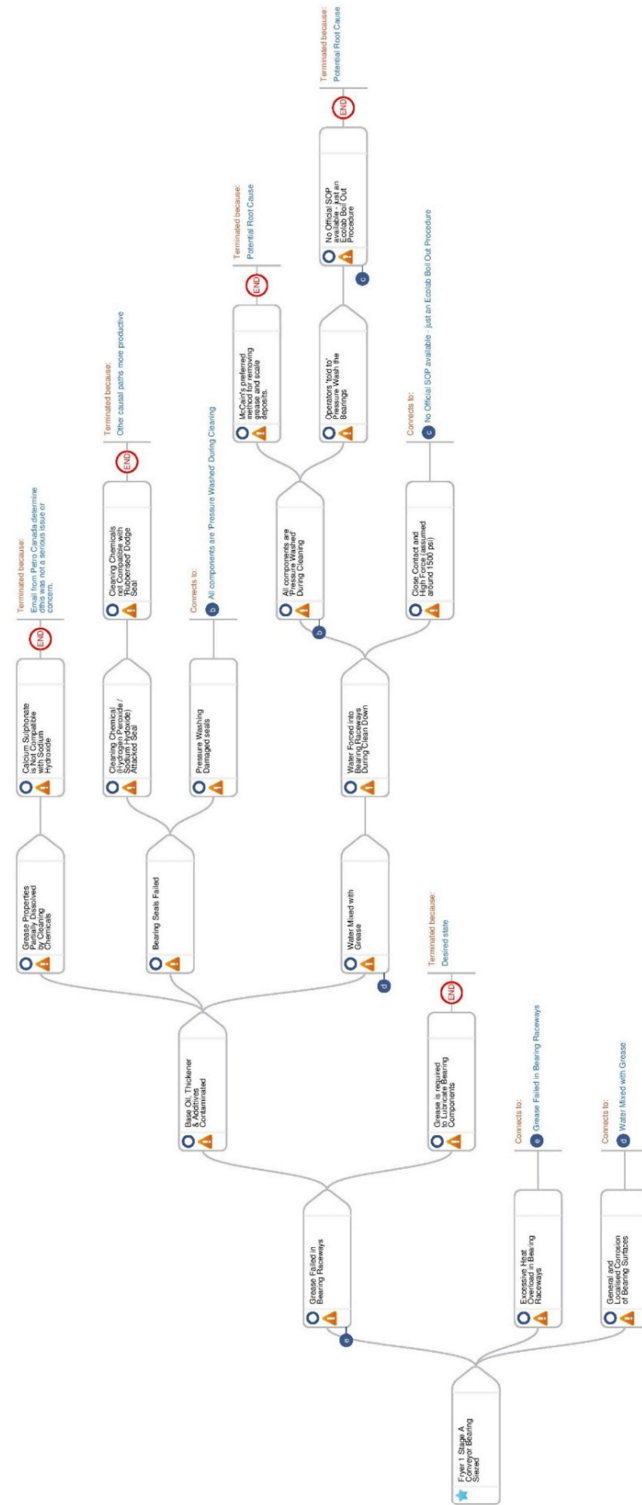
Appendix 1: RCA Cause & Effect Chart

The cause and effect chart determined that the principal physical causes of the failure were bearing grease functional failure, corrosion of bearing surfaces, and subsequent heat overload in the bearing raceways. Refer to Appendix 1 for the full chart. The reason for functional failure was determined to be contamination of the base oil, thickener, and additives. The three driving forces that co-existed to cause the grease functional failure were the failure of the bearing seals, water contamination of the grease, and chemical contamination of the grease. The latter, however, was not thought to be a strong contributor to grease functional failure. However, chemical attack of the ‘rubberised’ seals in conjunction with close contact pressure washing was thought to contribute more strongly – again as physical root causes. Doubts – unconfirmed - were also raised regarding the temperature resistance of the bearings seals. From a systemic cause perspective, the cause effect chart revealed that there is no Standard Operating Procedure (SOP) available for guidance on power washing Fryer 1 - especially in terms of how to deal with mechanical, electrical and instrumentation assets and components. Evidence collection also revealed that Fryer 1 is being run at 33% above asset nameplate capacity where the Food Manufacturer line rate is 20,000 Kgs/Hour as opposed to OEM stated capacity of 15,000 Kgs/Hour.

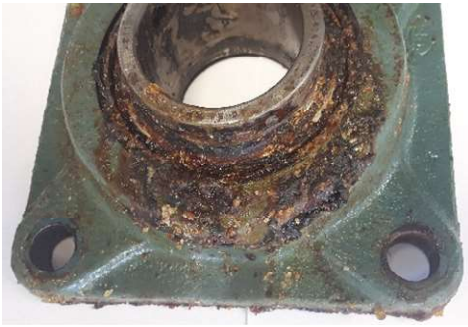
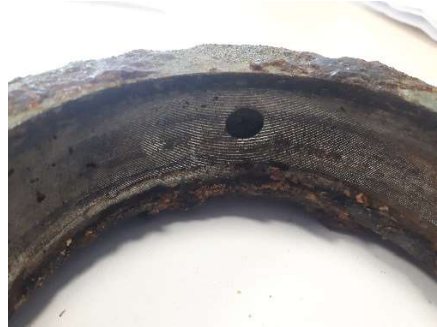
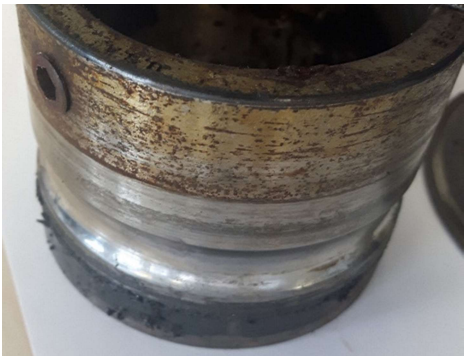
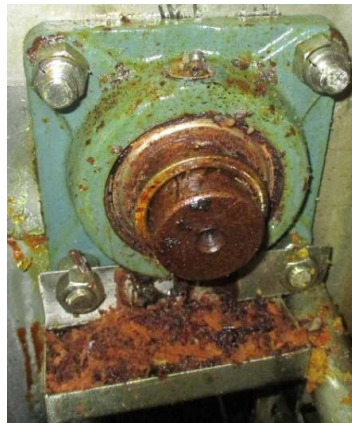
Appendix 2: Selection of Bearing Failure Photographs (corrosion & contamination)

It must be noted that the investigation and analysis indicated that the failed bearings are not genuine wear out failures. They are not reaching their natural wear out phase or anywhere near their L_{10} life (the statistical time at which 10% of these bearings would have failed under the same operating conditions). The bearings appear to be a mixture of infant mortality and random failures. This means that time-based replacements will have no effect on reliability and is not a valid strategy in this instance.

4. Remove time-based replacements on Fryer 1 Tail End 4 bolt flange bearings - see comments in Appendix 2.

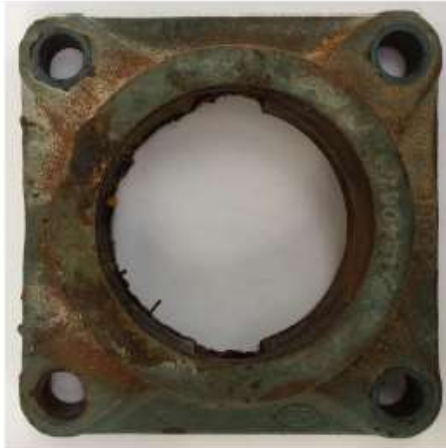
Bearing type:	Insert Bearing
Bearing designation:	DODGE SC-55-MM 211
Housing designation:	DODGE F4BC
Bearing reference name:	BRG A
Manufactured:	USA
Visual investigation summary:	The bearing suffered mostly from moisture contamination leading to corrosion found on the housing and bearing components. Photos below are a visual summary of the findings.
Disposition	To be Scrapped 21-05-2019

Fig.1 Housing Front: Corrosion

- Prevent corrosion by improving protection of bearing from moisture contamination
- Ensure the bearing solution can cope with temperatures around 190°C
- Ensure correct lubrication type, quantity and relubrication intervals are employed

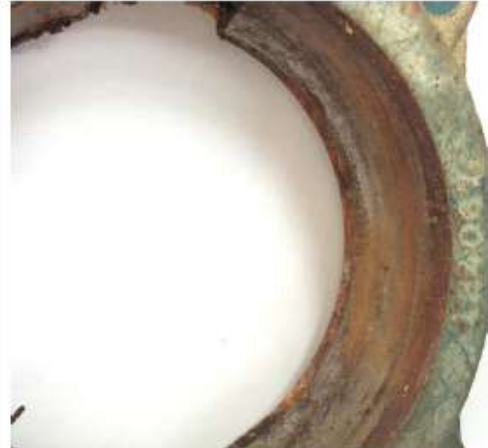
Fig.2 Housing Bore: product contamination & corrosion

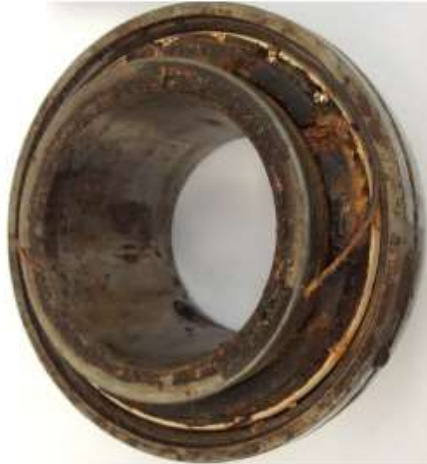
Fig.3 Lubricant: Solid, hard & dry

All the lubricant found in the bearing was hard, solid and brittle, a combination of moisture contamination and high temperature being the most likely cause. Lubricant in this condition is unable to function correctly. Lubrication is a critical component in the proper functioning of a bearing. If there is insufficient lubrication or if the lubricant has lost its lubricating properties, an oil film cannot form between the bearing internal surfaces and metal-to-metal contact occurs leading to accelerated bearing damage.

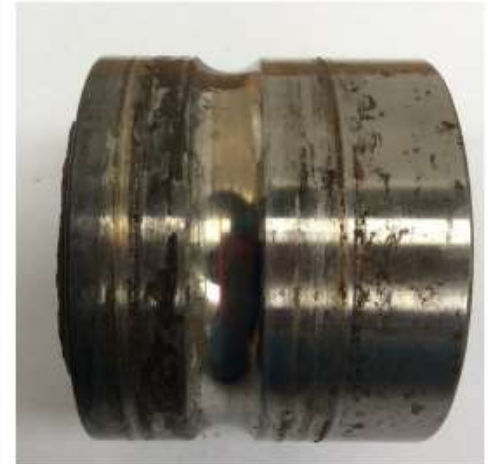
Fig.4 IR Raceway: Lubricant starv. & discolouration

On first reception of the bearing, it was unable to rotate due to the level of corrosion on the internal components. From the inspection, it is clear that the bearing was subject to high levels of moisture contamination, evident in most of the images in section 3 of this report. Figures 7 and 8 highlight the polished rolling contact path that is slightly biased to one side of the outer ring, this indicates that the bearing is subject to an axial load component. The “orange-brown” discolouration found on the inner ring, outer ring and rolling elements is indicative of a high temperature condition.

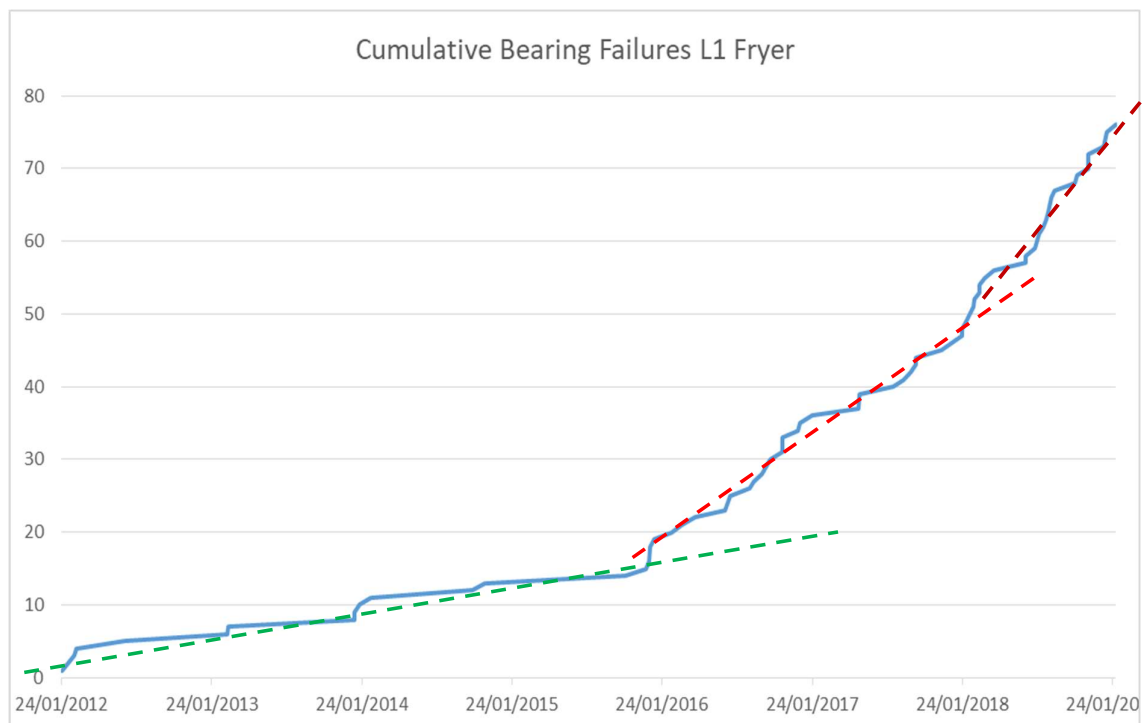
Appendix 5: Bearing Failure Trends

Analysis of historical work orders on Fryer 1, clearly show a significant, step-change increase in failures around late 2015/early 2016. The rate of failure was maintained from that date. It was then seen to increase once again around January 2018. Assetivo has been unable to retrieve any robust data/information from the Food Manufacturer regarding potential reasons for this significant change (i.e. product changes, process changes, cleaning changes, projects, upgrades, etc.). In terms of asset maintenance, the Dodge bearings used have been used since initial installation in 2000, and the lubricant type was changed in early 2013 approximately – two years prior to the step change. As a point of note, historically, Dodge bearings have arrived on site with no lubricating grease. It is believed that many have been installed on Fryer 1 with no grease and therefore have failed rapidly. There is now a process in place to stop this occurring. However, the larger, unresolved step change issue seen below is considered critical by Assetivo and needs further investigation by the Food Manufacturer as soon as possible.

1. Increased bearing failures on Fryer 1 since late 2015/2016 to present day - Internal company investigation required to determine trigger point for the dramatic, step change – see Appendix 5. This is deemed a high priority by Assetivo.
