## Case Study: Condition Monitoring Prevents Downtime - Skip Hoist Bearing Issue

### Executive Summary

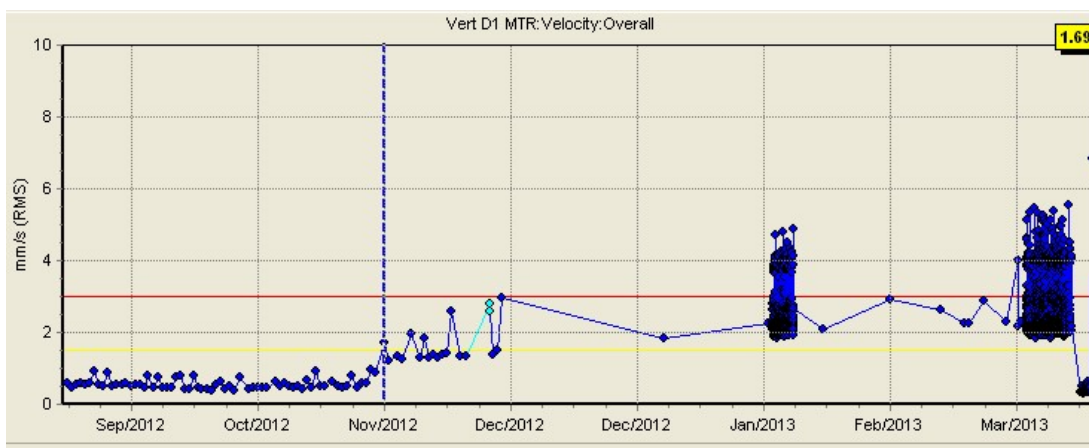
The Skip Hoist had been running smoothly for several years without any serious interruptions to production. In early November 2012, a step change in the overall velocity RMS reading (mm/s) was noticed on the drive motor 1 drive-end bearing via a vertically mounted accelerometer. The trend had always been under 1 mm/s RMS for several years. At first the trend oscillated between values of 1.6 to 3 mm/s between November and December 2012 – as seen in Figure 3. Then in early January 2013 the trend became more erratic with values oscillating between 2 and 5.5 mm/s – values considerably above historical trends and a clear sign of an anomaly in the system. The motor drive end bearing was greased in mid-November 2012 but it had little or no effect on vibration levels as shown in **Figure 3**.

**Figure 3:** Online system six-month trend

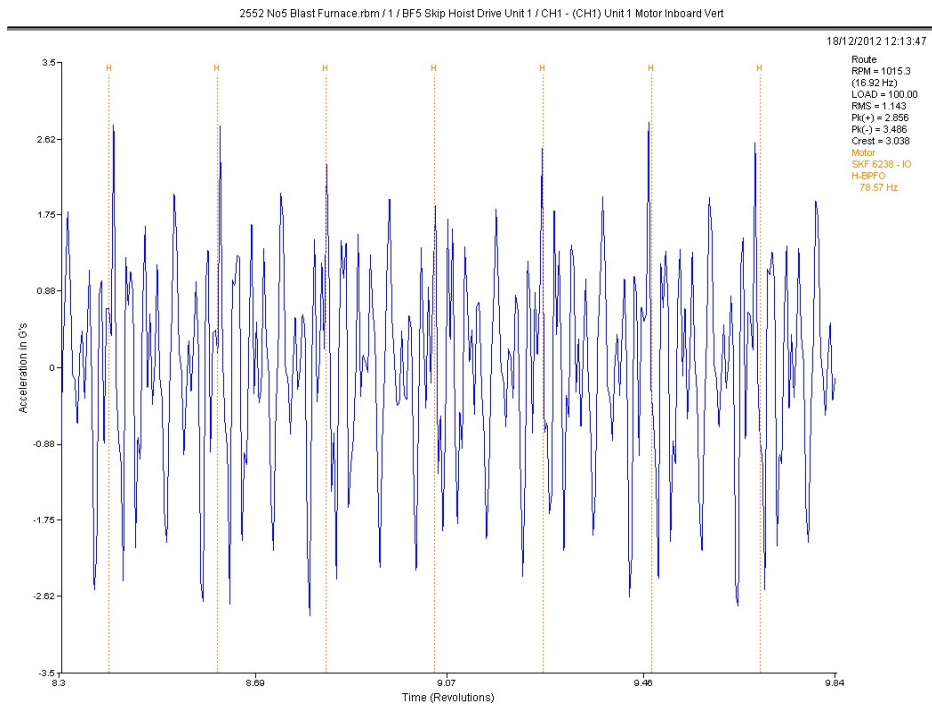
On closer inspection of the time waveform from hand-held data (see **Figure 4**) it was clear that impacting was present, and repetitive and periodic in nature. The analysis software allowed all fault frequencies (including running speeds, line frequencies, and fan blade and gear mesh frequencies) to be overlaid on the time waveform. After trying several bearing frequencies, a perfect match was found in the BPFO, i.e. an anomaly was present in the outer race of the bearing.

**Figure 4:** Acceleration time waveform taken on 18/12/2012

As further evidence that the anomaly is on the fixed outer race and *not* the rotating inner race, it is seen in **Figure 4** that the severity of the impacts is reasonably steady with no significant evidence of amplitude modulation that is common on inner race faults that move in and out of the load zone.

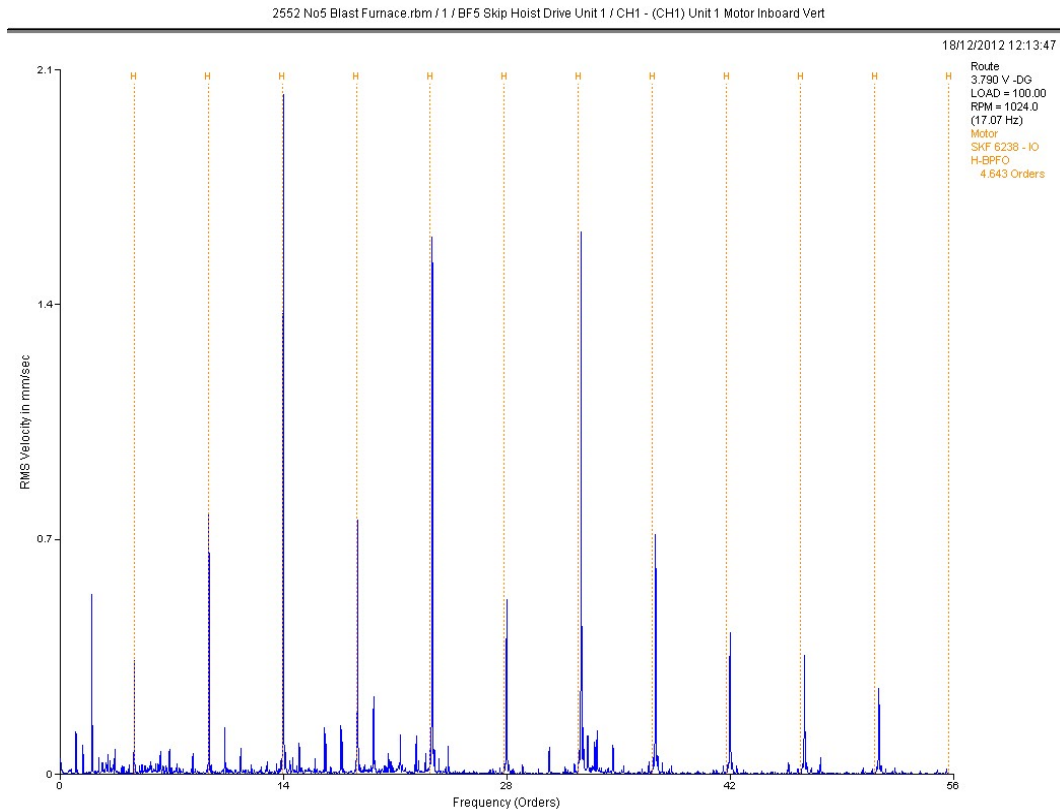
The analysis software carried out a Fast Fourier Transform to obtain a frequency spectrum as shown in **Figure 5**. In this instance it displayed the overall velocity RMS vibration levels in mm/s and the discrete frequency components that the overall level consisted of. Immediately it can be seen that there are several harmonics - a classic spectra symptom of impacting and non-linearities – dominating the spectrum up to an approximate frequency span (Fmax) of 1000Hz or 50 orders of running speed. On overlaying the known bearing fault frequencies again, the BPFO was a clear match for the impacting present starting from 4.6 orders of running speed up to eleven perfectly aligned harmonics. Again the lack of sidebands around the harmonics indicated that the fault probably was not an inner race fault.

**Figure 5:** Overall velocity spectrum taken on 18/12/2012

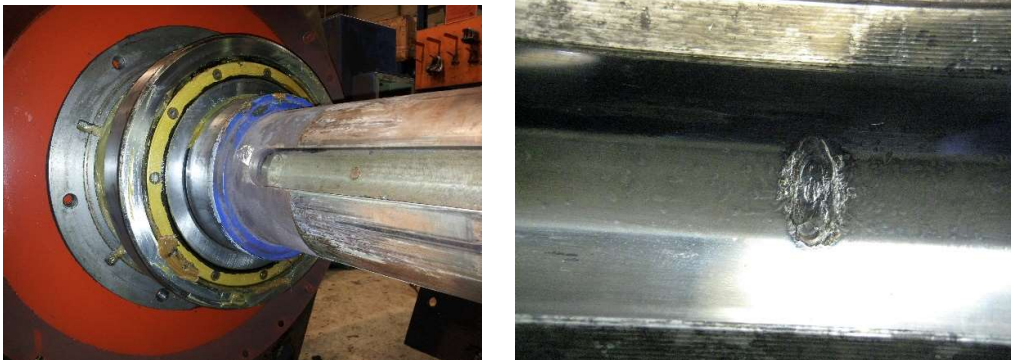
On inspection of the bearing it was found that the outer race had indeed suffered flaking damage (also known as spalling) as seen in **Figure 6**. This damage typically results from rolling fatigue of the smooth bearing raceway and causes metal to eventually break away from the surface. There is also evidence of randomly spaced denting which may come from the flakes being rolled and forced into the surface by the balls in motion. The running traces on the inner and outer races indicated normal radial loading with no indication of misalignment, bore ovality or thrust loading. To find the origin of the flaking would require testing of the grease and a study of the metallographic structure of the bearing materials – both of which were not possible in this case study.

**Figure 6:** Drive end bearing during strip & load zone damage on outer raceway

It is recommended that a new maintenance plan is developed (and old one reviewed) for the Skip Hoist to include lubrication routines, grease samples to be taken at fixed intervals for laboratory analysis, and a new procedure put in place to ensure motors in storage have their shafts rotated at fixed intervals to avoid any possibility of false brinelling.

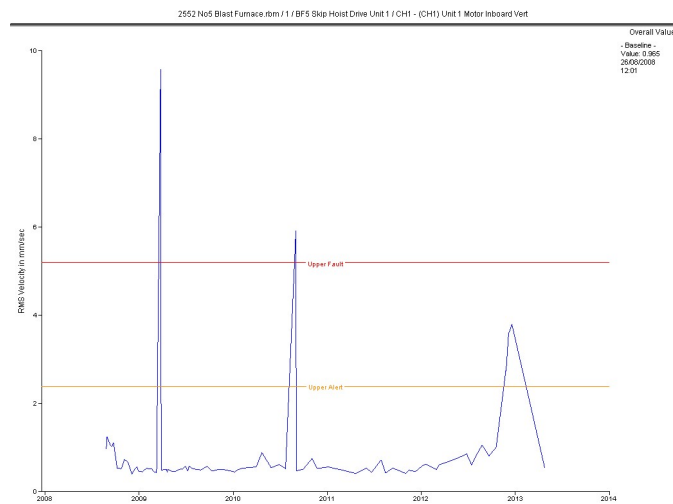
On a planned maintenance stop the replacement motor was installed, and then run up and put into full production. Vibration data was collected and analysed and as can be seen in **Figure 7**, overall vibration levels had dropped significantly to historical levels.

**Figure 7:** Trend of overall vibration levels showing drop in vibration

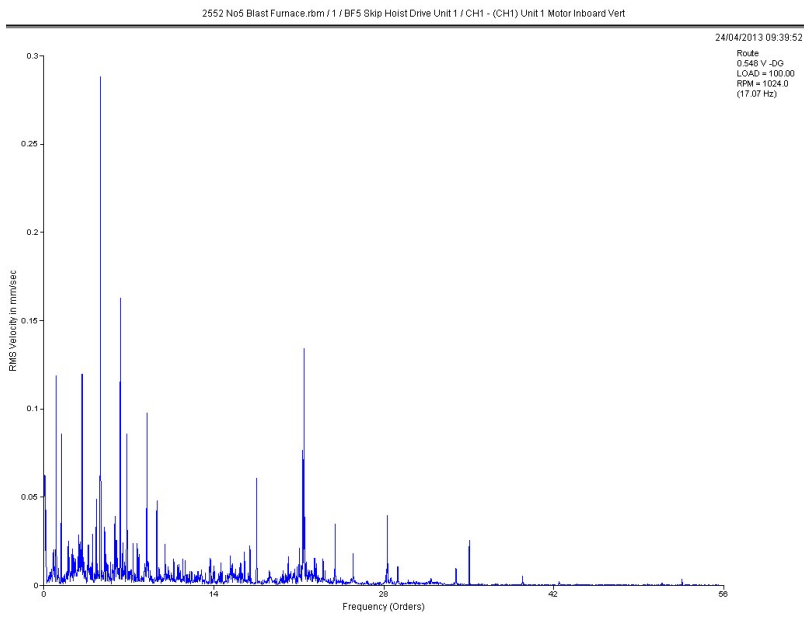
The time waveform and frequency spectra had also returned to stable, historical levels well within fault and alarm levels as shown in **Figures 8 and 9**.

**Figure 8:** Frequency spectrum of drive end bearing after motor change

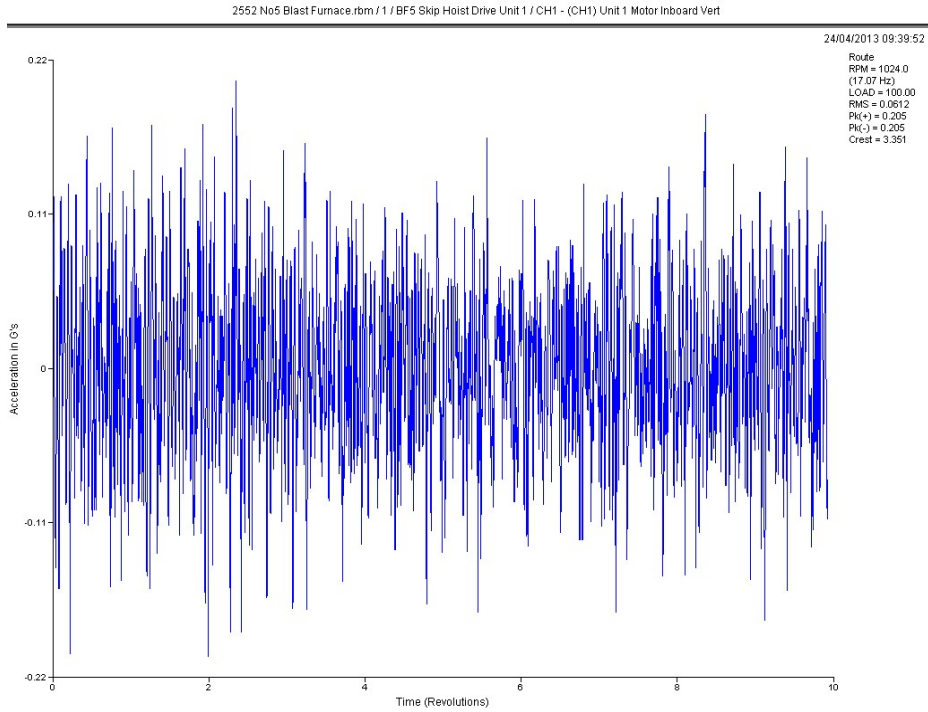
**Figure 9:** Acceleration time waveform of drive end bearing after motor change
