Inspection Report

123 Main St
Anytown CT 06000

Date of Inspection: 11/23/21

Welcome Home Inspections LLC

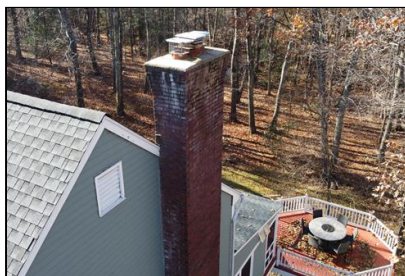
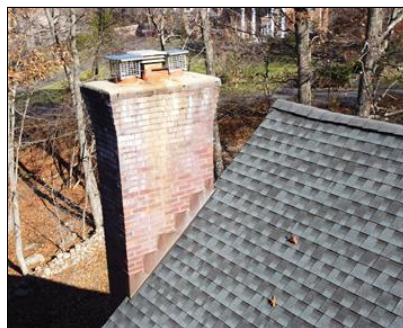
Observation: There appears to be a 3 flue chimney located on the left side of the home. I noted that all three flue appear to have caps. The flashing appears to be in good condition. I made the following notes about the chimney:

Cement Cap: Appears to have some cracking.

Condition of Chimney: The chimney is tight to the home, with no significant cracking noted.

Brick Damage? Where visible, i did not note any significant brick damage.

Recommendation: I do recommend you have the chimney cleaned and serviced if it has not been in the last year.

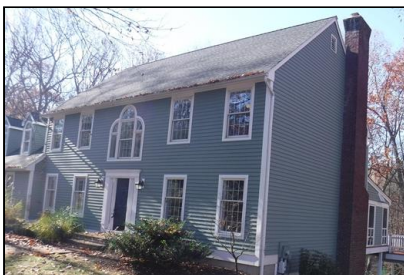
1.3 Siding

Observation: The siding seems to be wood, where visible and accessible the siding appears to be tight up against the house and the lines of the house are straight.

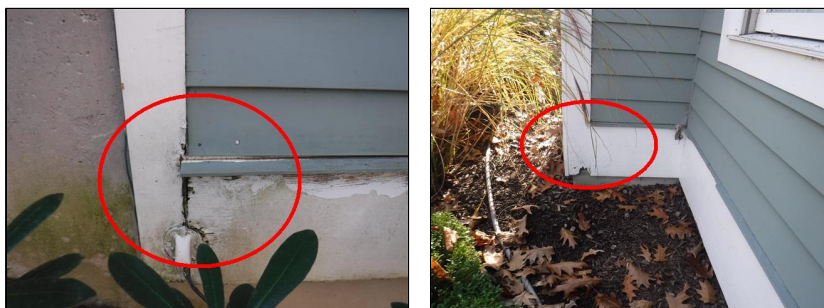
Observation: Portions of the wood trim throughout the house exhibit signs of deterioration, especially along the skirt board and drip cap located below the first course of siding.

Recommendation: Recommend having a licensed contractor evaluate the trim and at that time have them make recommendations.

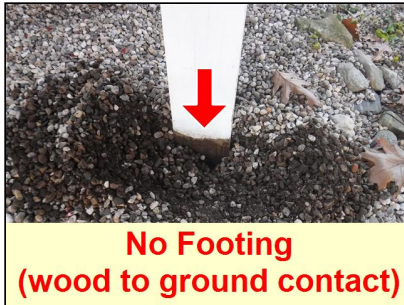
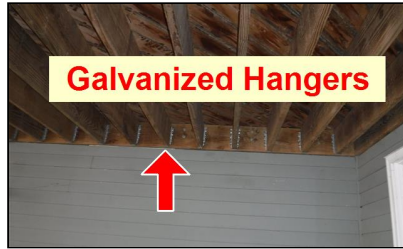
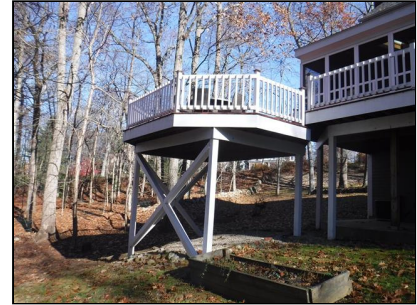
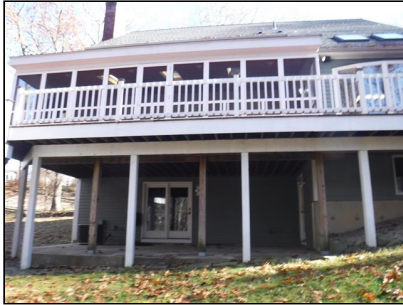
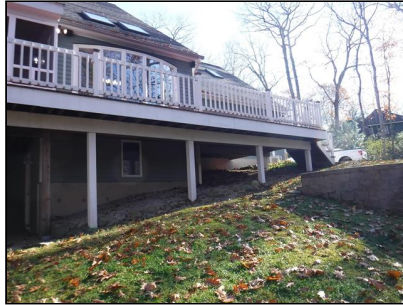
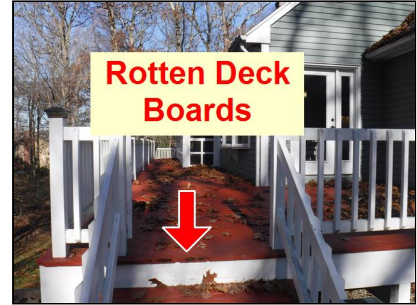
(1) **Observation:** There is a wood deck on the rear of the house. I inspected the deck and noted the following:

- There does not seem to be concrete piers for some sections of the deck.
- I noted wood rot. (decking at stairs, wood posts)
- I could not determine if there was flashing for the ledger board
- There appears to be galvanized hardware properly used in many locations.

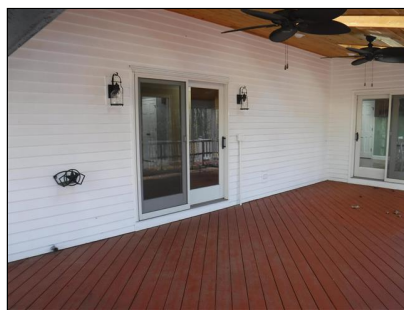
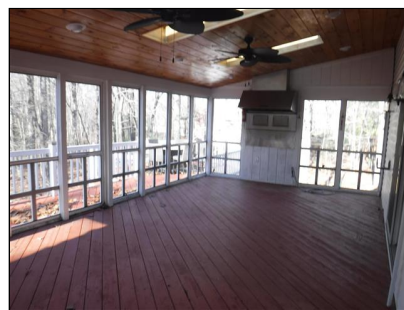
(3) **Observation:** There is a portion of the deck which has a roof and is closed in with screens. There also appears to be a hookup for a grill or stove. I noted that there is a hood for this cooking area but it was not tested during the time of inspection. The hood does appear to vent outside. There are two skylights in this section of roof and they appear in serviceable condition.

Recommendation: I highly recommend having the ducting unit thoroughly tested before using this screened in area for cooking. There may be special appliances required to be used in this area.

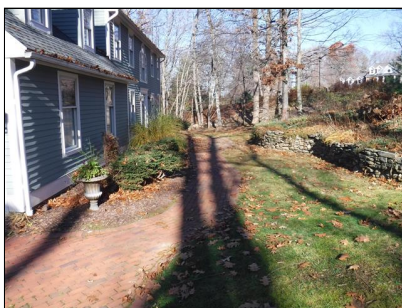
Observation: The front walkway appears to be pavers and is in good condition. I did not note any major cracking or depressions.

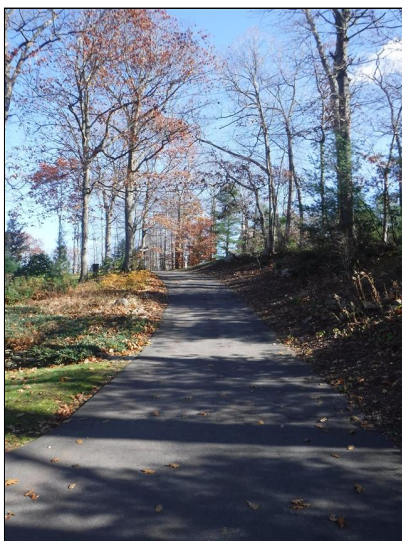
1.13 Driveway

Observation: The driveway for the most part is in good condition. I did not note any significant damage to the driveway. There was some minor cracking in several sections noted and they should be sealed to prevent anymore damage.

Recommendation: Recommend having a certified paving contractor evaluate and make necessary repairs.

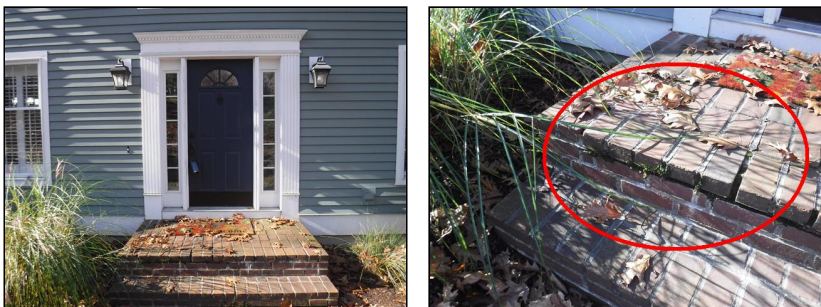
Observation: The brick steps at the front of the home are showing signs of damage. They appear to need some repointing.

Recommendation: Recommend you have the steps evaluated by a contractor and at that time have them make recommendations.

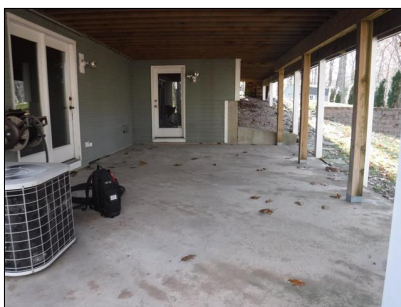
Observation: There is a concrete patio at the rear of the house and upon inspection seems to be in good condition. It was even and there was no standing water at the time of inspection.

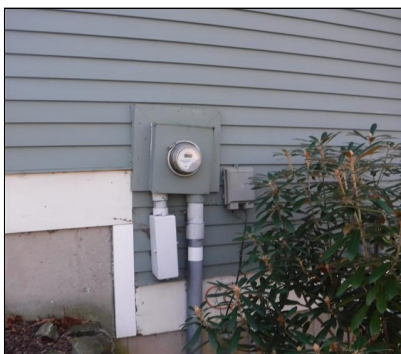
Observation: The electrical service entry is below ground and that section could not be inspected. The above ground section looked to be free of rust and seemed secure and tight to the home.

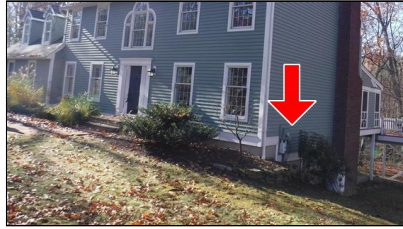
1.19 Oil fill and exhaust pipe location

Observation: The oil fill and exhaust pipes are located on the right side of the house when facing the front of the house. No significant issues were noted at the time of the inspection.

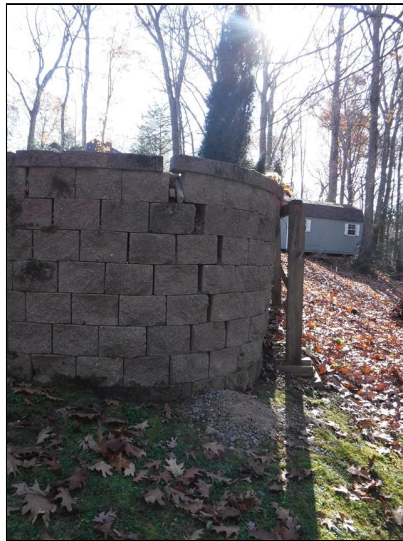
1.21 Retaining Wall(s)

Observation: I did note a retaining wall on the left side of the home. It appears to be tilting.

Recommendation: Recommend you have this retaining wall evaluated and necessary repairs made.

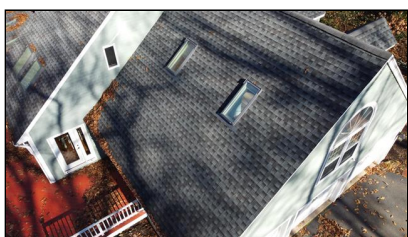
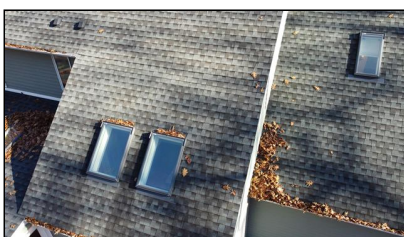
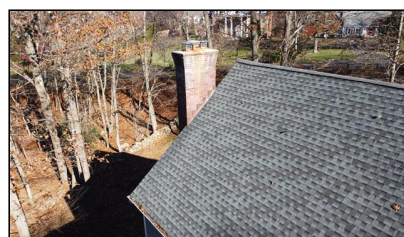
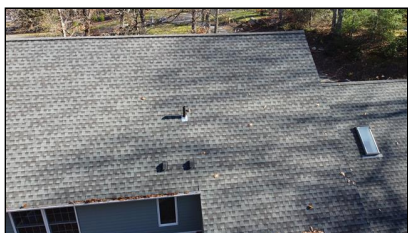
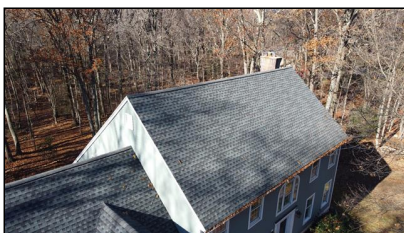
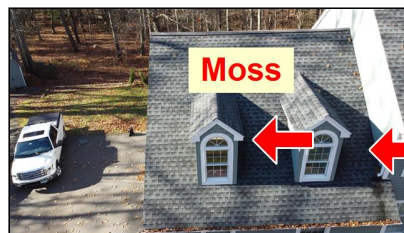
Observation: At the time of the inspection, the roof where visible and accessible seems to be performing its intended function of keeping out the rain and other related weather. The roof lines were straight. The shingles did not show any signs of lifting, thermal cracking or substantial particulate loss. No significant issues were noted with the shingles. The home appears to have architectural shingles and due to the age of the home, this appears, most likely, to be a replacement roof. Most architectural style shingles have a life expectancy of 25 - 30 years. I would place this roof statistically past the start of its expected life cycle.

Recommendation: Recommend you consult with a roofing company concerning the moss and dark spots. These can be cleaned off the roof.

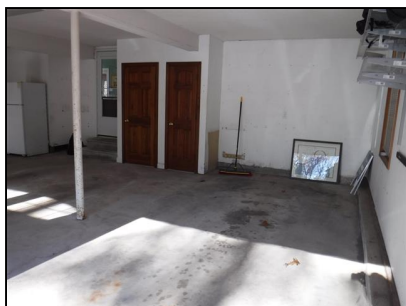
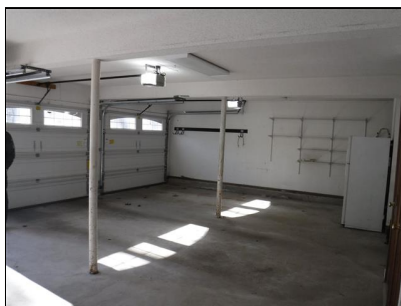
Observation: The garage floor appears to be poured concrete. No significant cracking was noted at the time of the inspection.

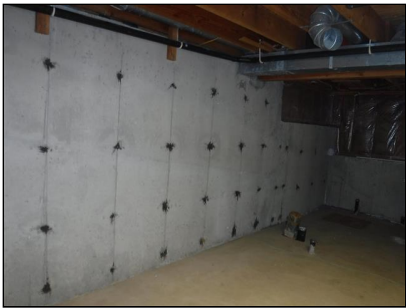
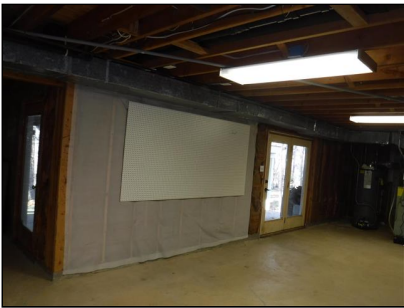
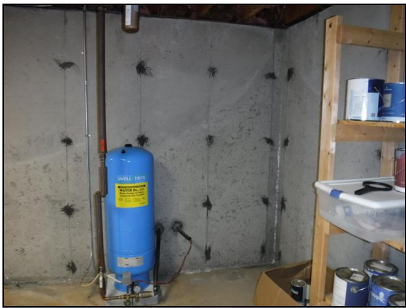
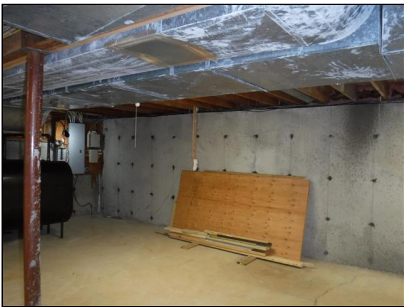
Observation: The interior basement foundation seems to be poured concrete. For the most part it appeared in good condition. I did note several vertical cracks. These cracks do not appear to have structural effect on the foundation. The foundation was even on either side of the cracks. The diameter of the cracks was less than the thickness of a quarter.

Recommendation: Consider filling these cracks and monitor for future movement. Consult with a contractor for further evaluation as needed.

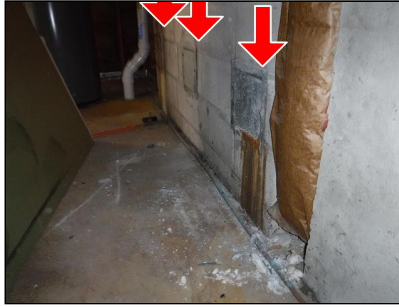
Observation: There seems to be three cleanout(s) in the basement. They were opened during the inspection and found not to be in need cleaning. I did not note any significant damage to the cleanout door(s).

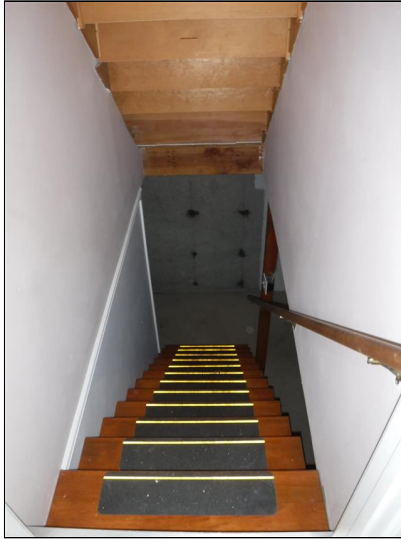
Observation: The basement stairs have railing(s) and appear to be solid with no movement noted at the time of my inspection.

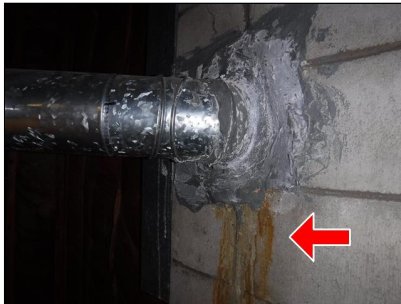
Observation: The chimney section in the basement appears to be in good condition, with no significant issues noted. There does appear to be possible water intrusion from both the flues and the cleanouts.

Recommendation: Consult a licensed contractor about ensuring flues are properly sealed and make repairs as necessary.

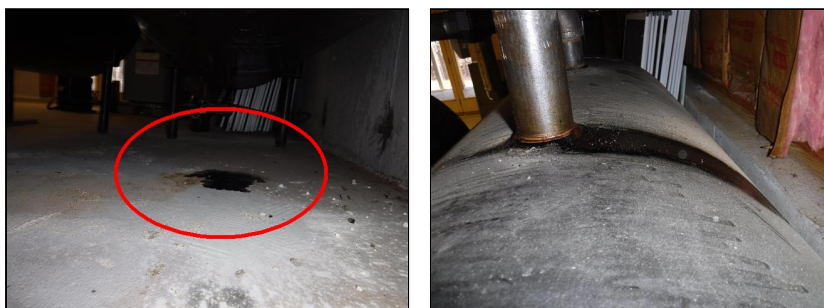
Observation: The oil tank did show signs of leaking. I did not note any patching of the tank. The leaking seemed to be coming from the top fill pipe. I would place this tank near the middle of its expected life cycle.

Recommendation: I recommend having a licensed heating company evaluate the tank.

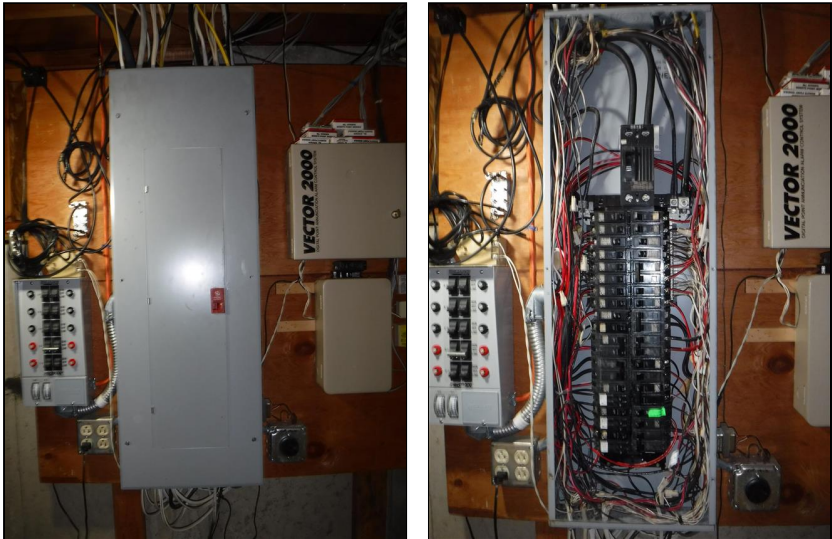
(1) **Observation:** The main panel box is located in the basement. The main disconnect breaker (basement) read 200 amps. The interior of the box looked clean and free of excessive rust or corrosion. I noted what looked like aluminum wiring coming into the home from the street. The branch wiring looked to be copper. The branch wires did look proportionally sized to their amperage. There was no significant corrosion noted on any of the wiring. The box appears to be properly grounded. I did note missing exterior box screws. **(replace screws as needed)** The panel appears to have good access. The electrical circuits appear to be in functioning condition and there appears to be no extra space for an additional circuit to be added.

Service Ground Location: The ground service location appears to be a grounding rod buried into the ground.

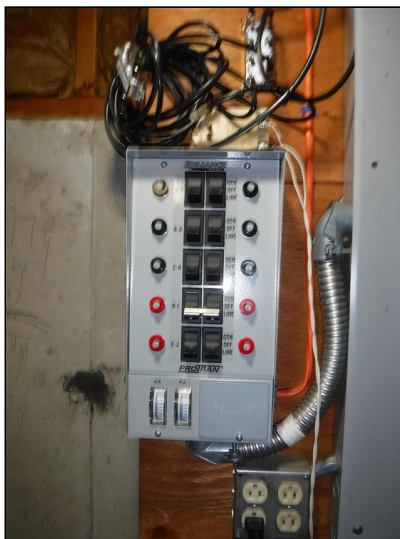
(2) **Observation:** There appears to be a generator for the home. This is outside the scope of a home inspection.

Recommendation: Recommend you have a licensed electrician come out evaluate the unit and show you how it functions.

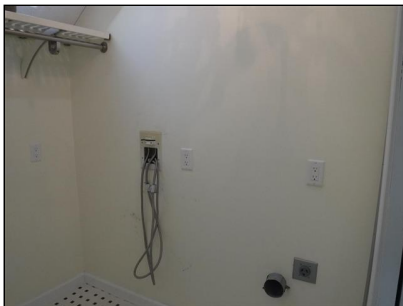
(1) **Observation:** I did note that the dryer is vented to the outside. The washing machine was not operated at the time of the inspection. Therefore, I was unable to test the washing machine drain. The standpipe was the correct size.

Recommendation: Recommend you check the dryer vent yearly for lint build-up and if necessary replace venting. I do recommend the installation of metal clad washing machine lines.

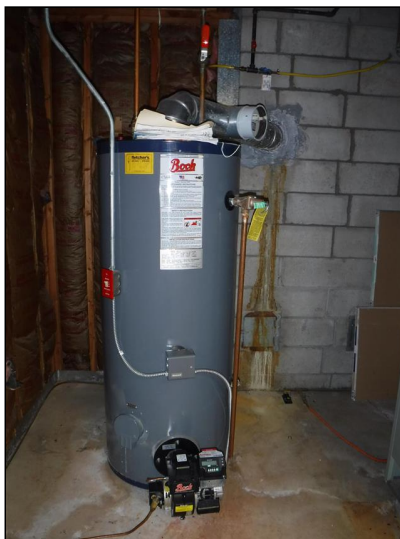
Observation: At the time of the inspection the water heater, which is located in the basement appears to be in good condition with no signs of leaks or physical damage. I did not note any rusting. The pressure relief valve extension is of adequate length. The expected life cycle of this type of unit is approximately 15 years. The water heater age, if noted will be listed in styles and materials.

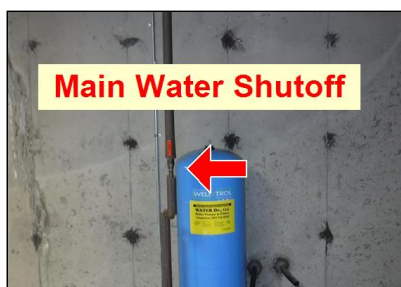
Observation: The main water shut off is located in the basement. Testing the operation of this valve is not within the scope of a home inspection. Operation of the valve from time to time will keep it functional and maximize its useful life. No significant rust or corrosion was noted on the shut off the day of the inspection.

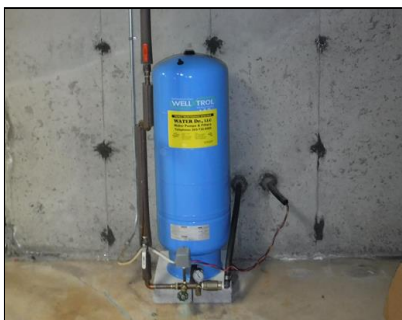
8.10 Pressurization tank

Observation: I noted a pressurization tank in the basement. It was not inspected during the home inspection. The pressure was acceptable in the home.

Recommendation: You may consider having a licensed plumber evaluate the tank.

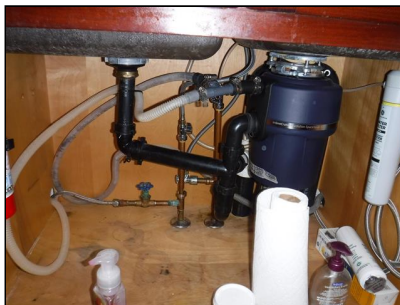
Observation: I ran the faucet water and the water volume appears adequate, I ran the hot and cold water and found no major defects. I did note shut offs under the sink. No leaking was noted from them at the time of the inspection. The drain pitch looked to be correct. The sink appeared to drain at a normal rate.

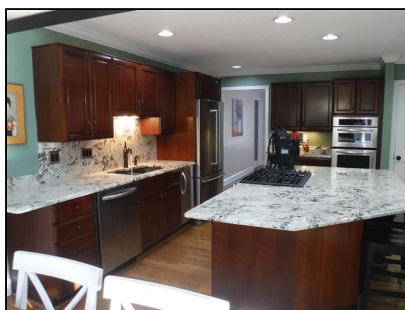
Observation: I opened and closed the majority of the cabinets and they appeared to operate adequately. Material: Wood

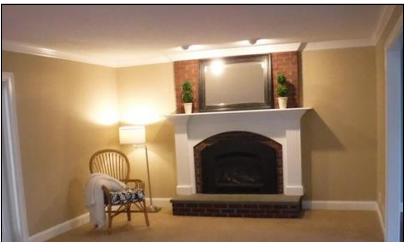
Observation: There is a LP fireplace in the living room. The unit was not tested during the inspection.
Recommendation: Recommend that you have a heating company clean and service the unit.

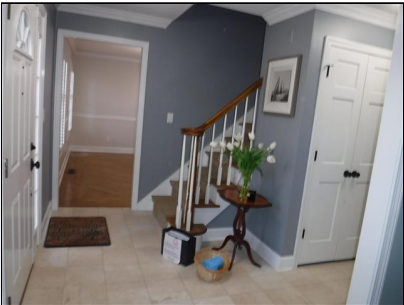
(1) **Observation:** The entryway in the home appears in good condition. The walls appear to be in good condition, with no significant issues noted. The ceilings look in good condition with no cracking or staining noted at the time of the inspection. The interior stairs appear to be in good condition. They felt solid under foot and no major deterioration was noted. Handrails appear to be solid to the touch.

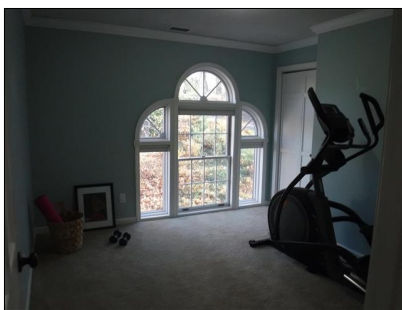
Observation: I did note windows that appear to be too low. The window should be tempered (not required) for safety reasons. They make special safety equipment for windows installed low to the ground.

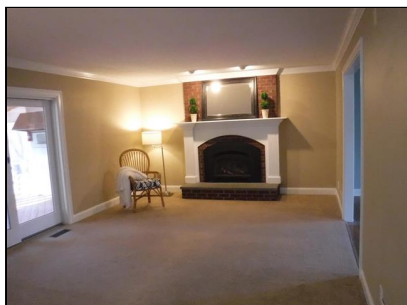
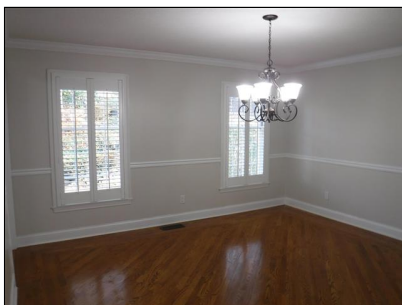
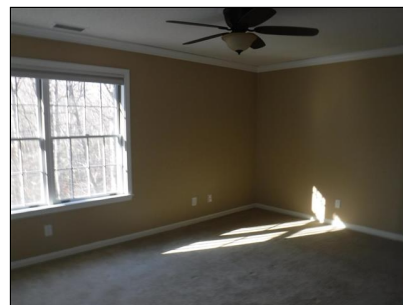
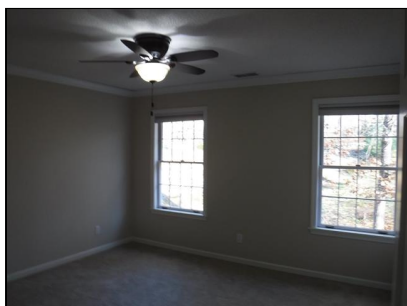
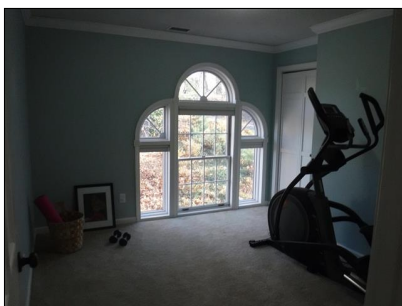
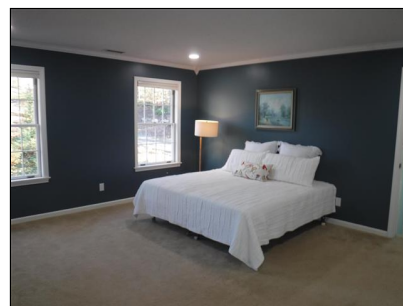
Observation: At the time of the inspection, there were no major cracks on the ceilings or walls and I did not note any significant staining.

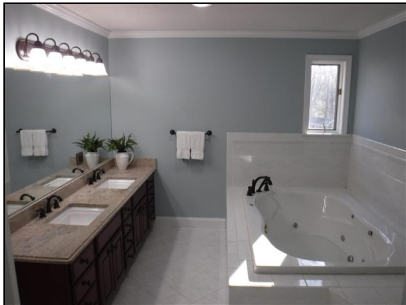
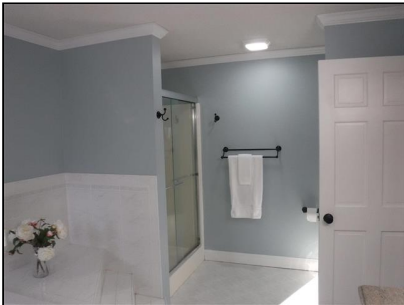
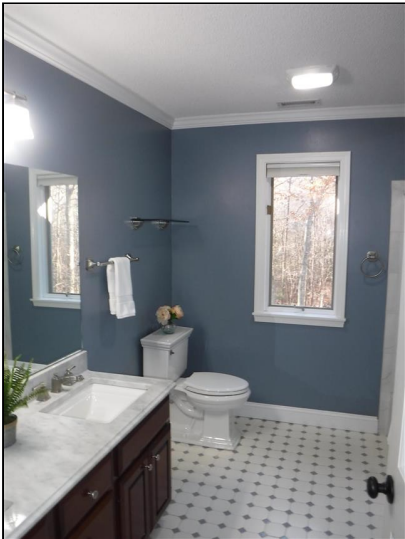
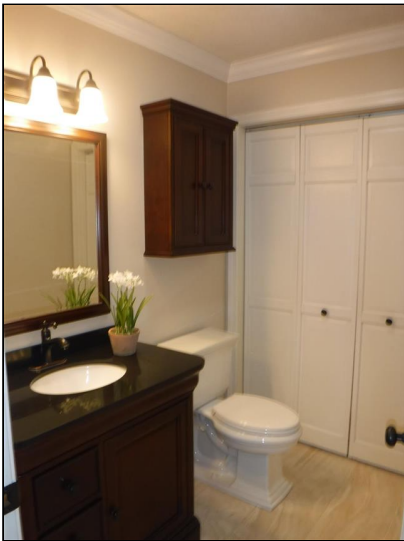
(1) **Observation:** No leaks were noted at the time of the inspection.

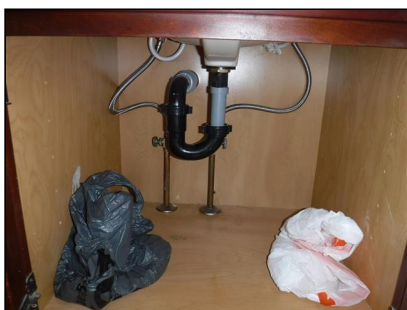
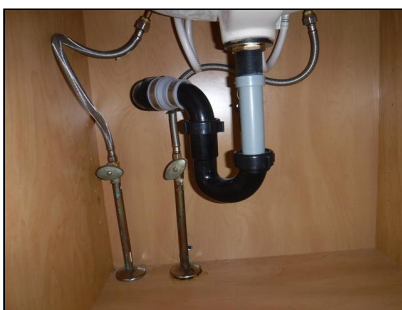
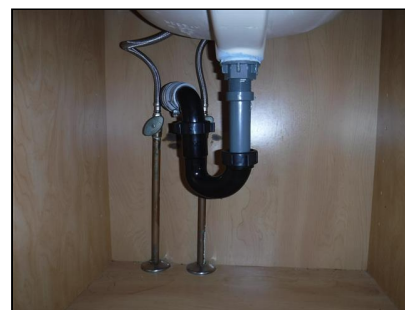
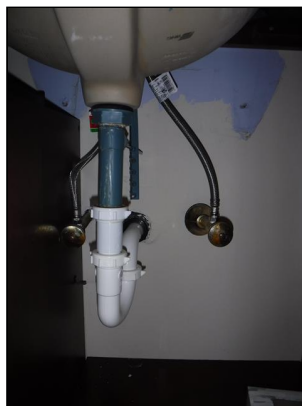
Observation: Water Volume appears adequate; I ran the hot and cold water and found no major defects. I did note shut offs under the sink. The sink stopper was functional the day of the inspection. I did not note any leaking from the sink at the time of the inspection.

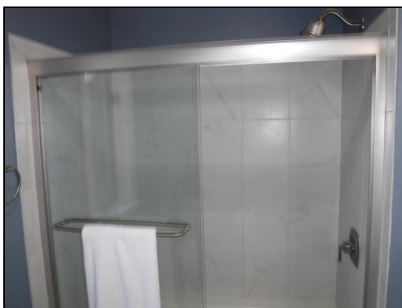
(1) **Observation:** The bathroom walls around the tub are tile, no major defects were found and the caulking appears to be in good condition. **Location:** Second floor full bathroom

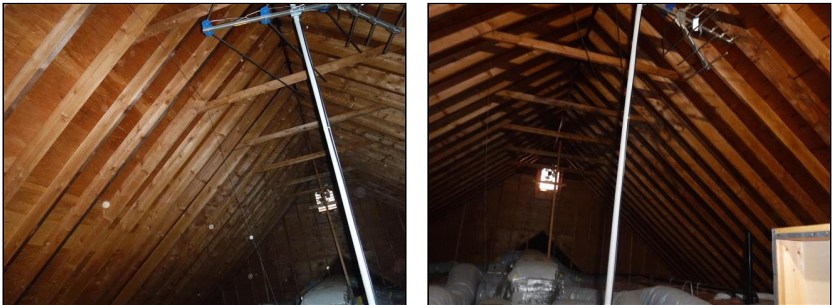
Observation: From inside the attic where visible and accessible the framing for the roof looks to be in good condition. The framing appears to be straight and even and there appears to be no major gaps between the joints.

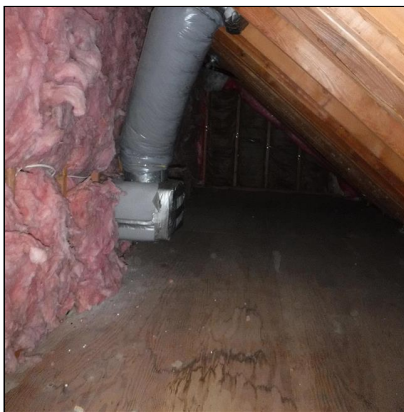
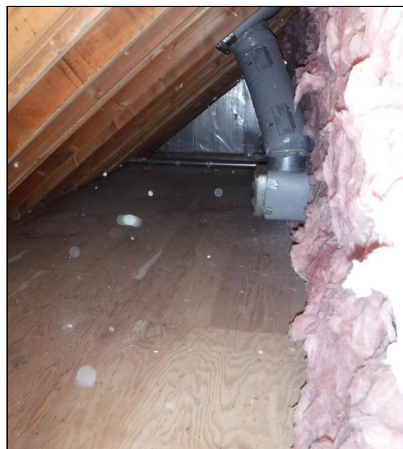
Observation: The main attic currently has very little flooring so there is no real storage space. There is a small attic area located in the bonus room above the garage. This area appears to be fully floored and may be better suited for storage.

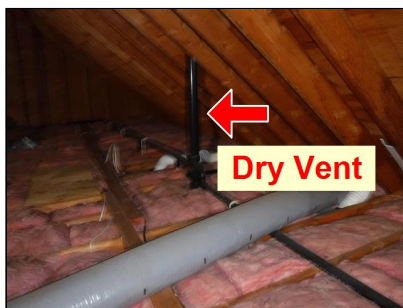
Observation: I noted the wood around the dry vent was clean and clear. No past water staining was noted. I also could not see any light coming from the outside.

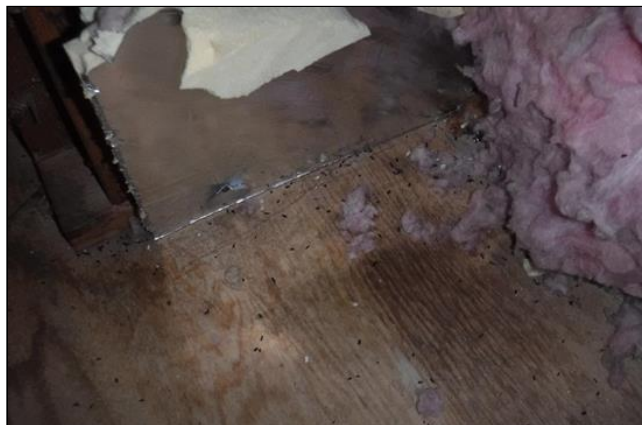
Observation: I noted mouse droppings in the attic.
