SAFETY BRIEF

The Pepcon Plant Fire/Explosion: A Rare Opportunity in Fire/Explosion Investigation *

by K. R. Mniszewski**

Abstract

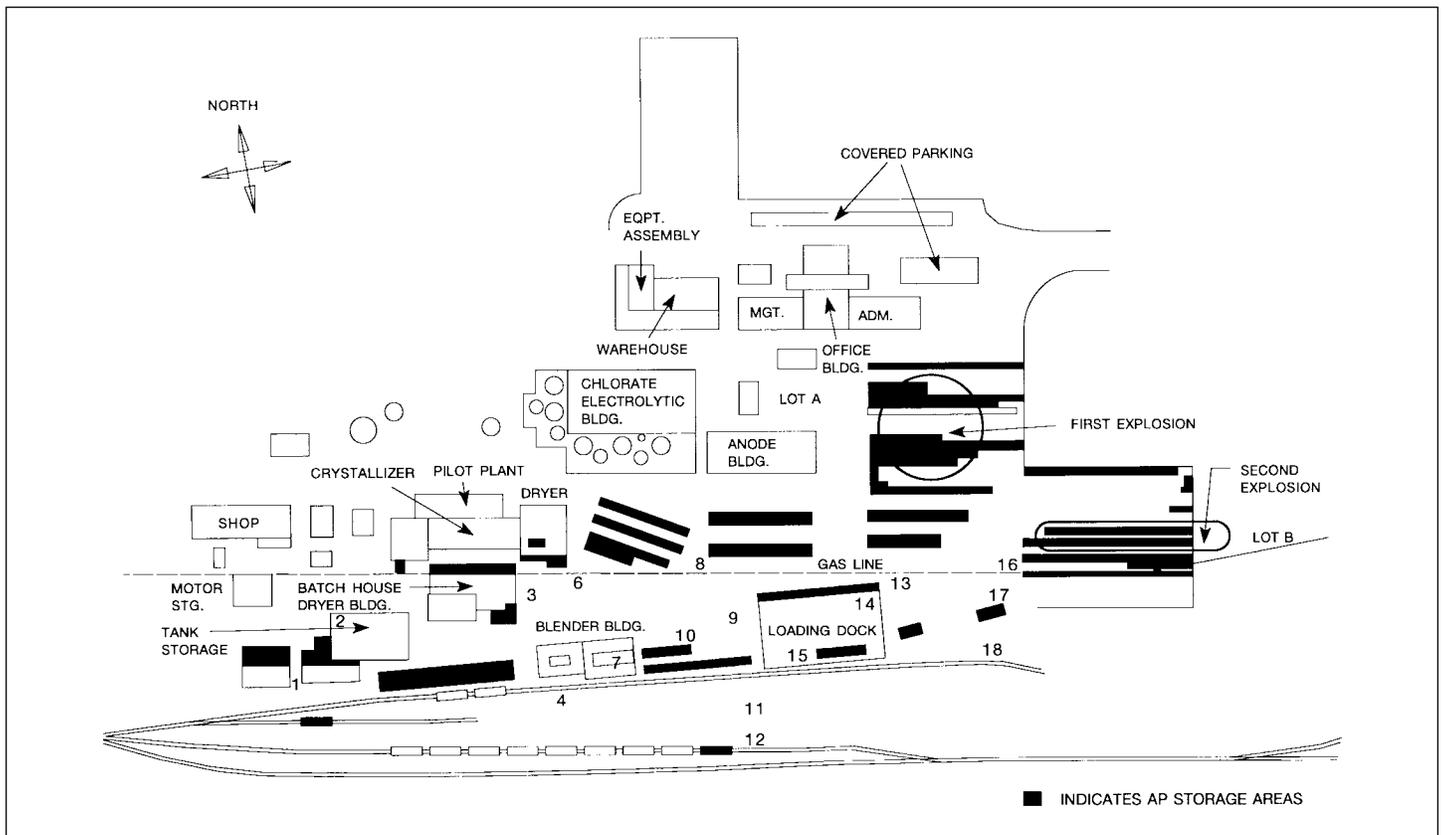
Figure 1. Pepcon Facilities and Features Map

A plan view of the plant is shown in Figure 1. The manufacturing process was composed of a four-step batch process. These steps included: (1) the electrolytic oxidation of sodium chloride to sodium chlorate, in the chlorate building, (2) the electrolytic oxidation of sodium chlorate to sodium perchlorate, also in the chlorate building, (3) reaction between the sodium perchlorate and ammonium chloride to produce ammonium perchlorate, in agitator tanks within the process building, and (4) AP crystallization, filtration, drying, screening and blending to client specifications in several buildings, including the crystallizer room, the large dryer building, the small dryer building (batch house) and the blender building.

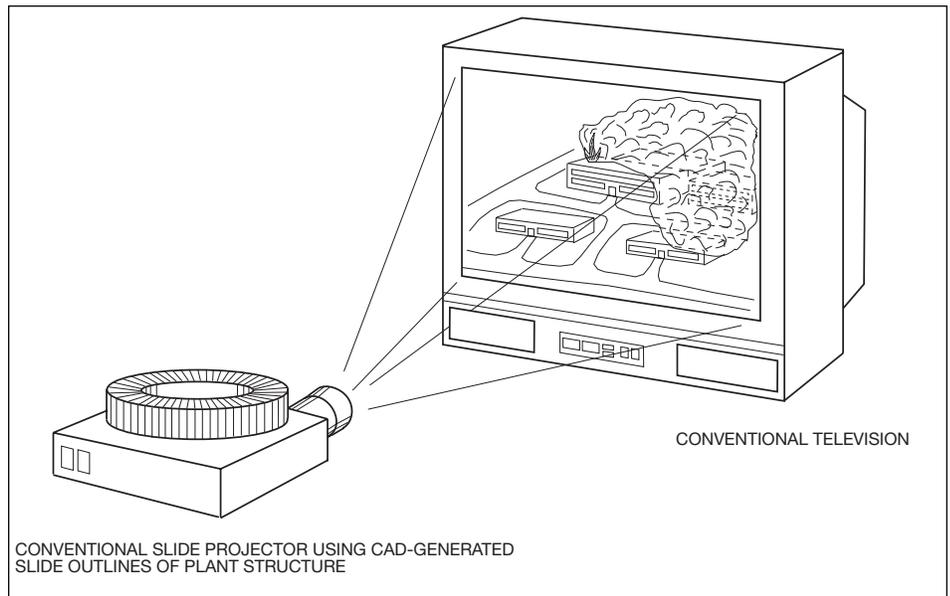
Figure 2. CAD Superimposition Process

Figure 2 illustrates the method utilized for overlaying CAD images on a video screen using a conventional slide projector. Of course, with the proper computer equipment, CAD images could be digitally superimposed upon a video image.

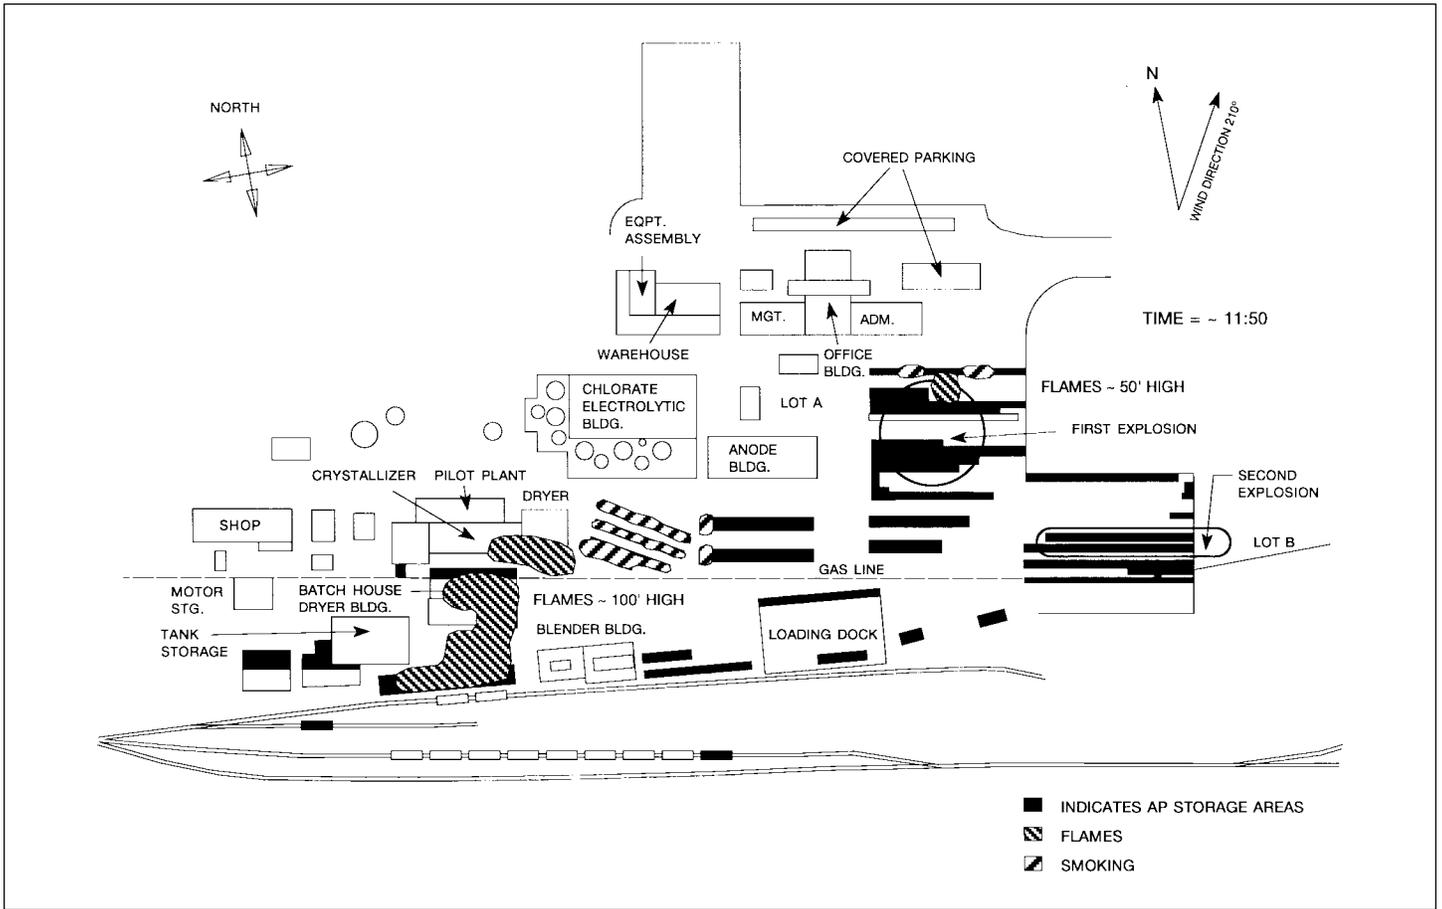
Figure 4b. Pepcon Fire Progress at 11:50 A.M.

Several small explosions or "pops" occurred before the two large explosions in the storage fields. Initiation of the first small explosion occurred in or near the batch dryer, within the batch dryer building. This explosion is thought to have originated in the batch dryer. Since several close observers were not knocked down or hearing impaired during this explosion, it is surmised that it was not a detonation, and probably was an AP deflagration pressure rupture of the batch dryer (due to external heating of the dryer, and subsequent AP decomposition gas buildup). A worker within 12 ft. of the batch dryer claimed he heard a hissing sound prior to the explosion and then saw the cover of the batch dryer fly off during the explosion. From a distance, this explosion probably sounded as a "pop". The time of this event was approximately 11:50.
