Power Loss

The 1999 Ford Power Plant Explosion:
A Study of Problems Encountered
During Large-Loss Fire Investigations

By **Kim Mniszewski, Hal Lyson, and Crispin Hales**

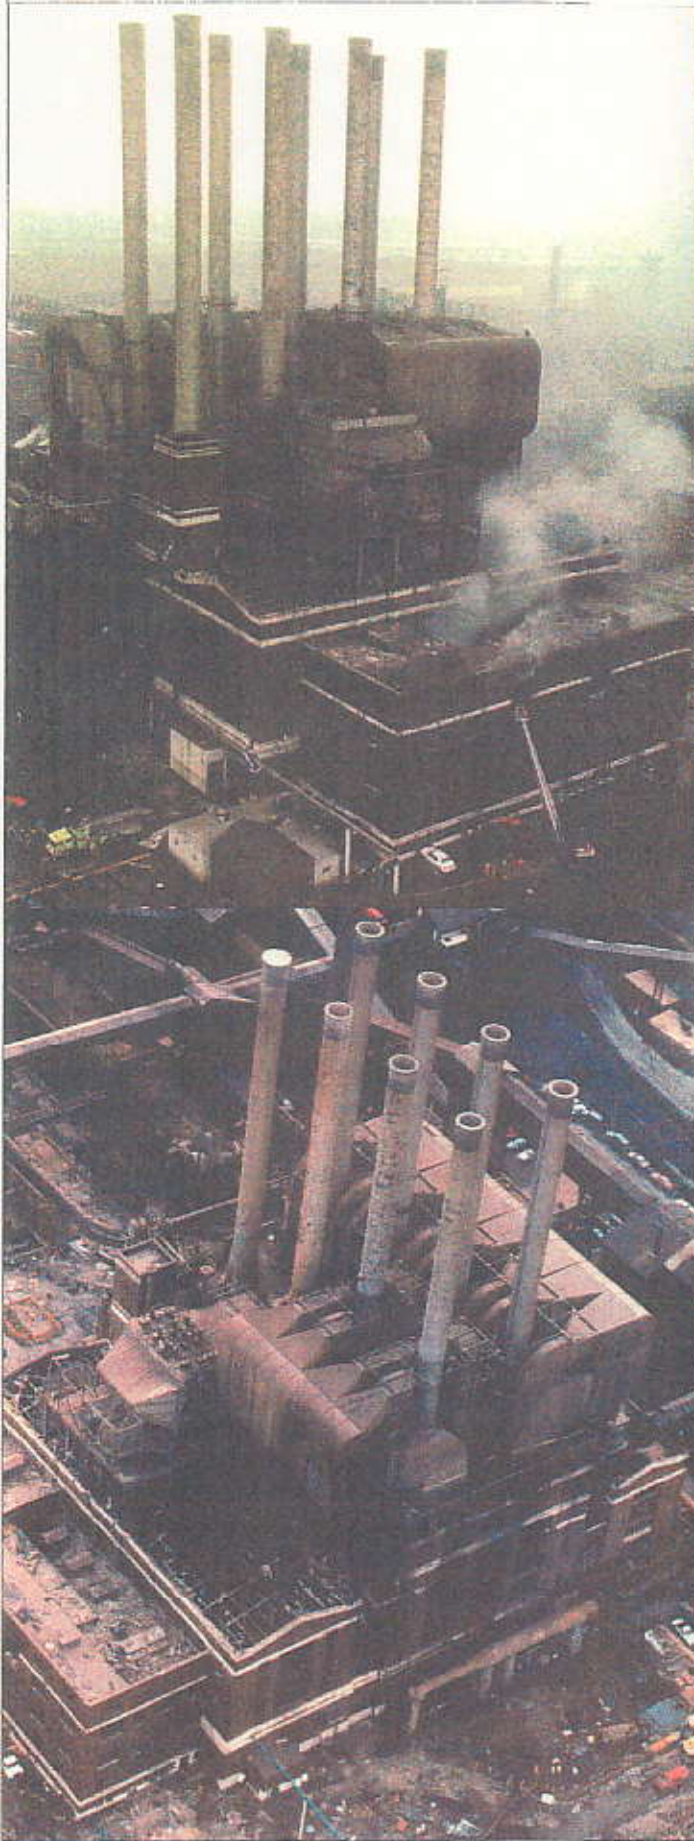
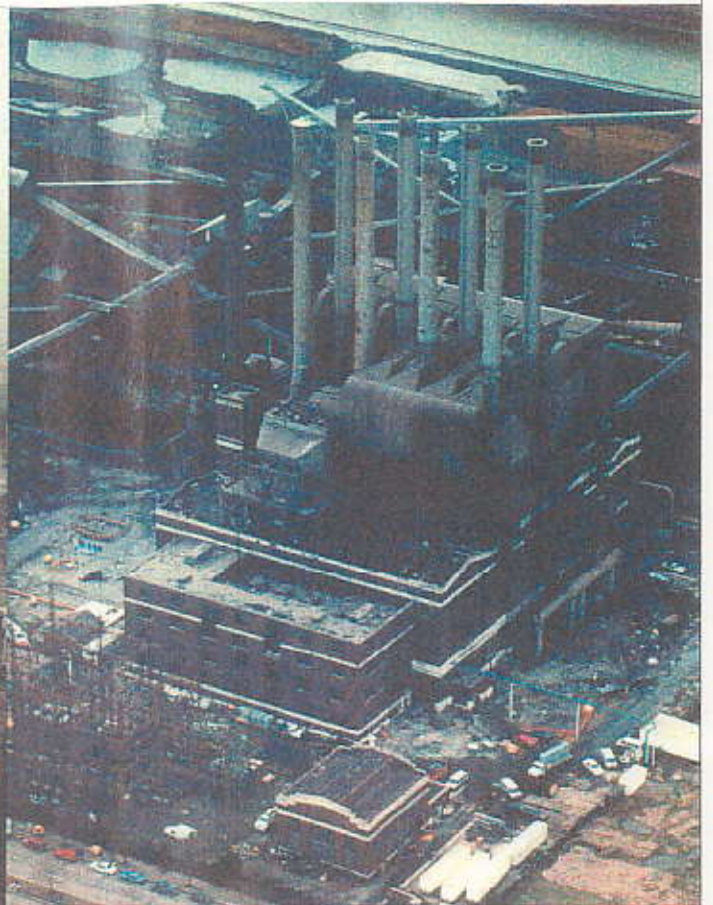
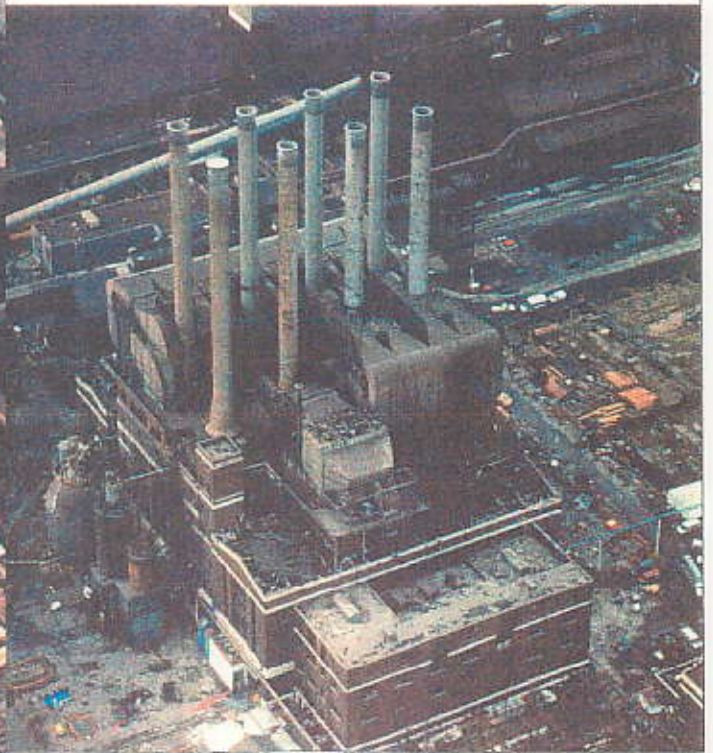
Several views of the Rouge complex of the Ford Motor Company in Dearborn, Michigan, including a view from the explosion site (top left) as two firefighters on a ladder truck pour water into the huge power plant on Monday, February 1, 1999.

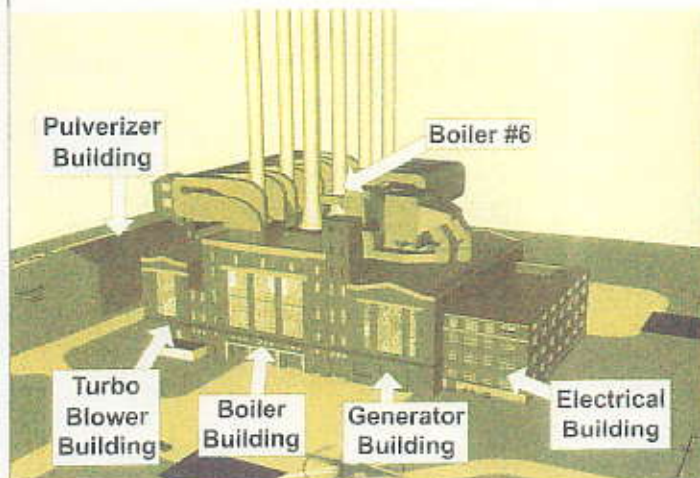
Figure 1: Ford Power Plant Facility

The unprotected, noncombustible structure covered a ground-floor area of 80,874 square feet (4,452 square meters), and included several distinct operational areas, separated by walls, creating smaller "buildings" within the overall structure (see Figure 1). Among these smaller buildings was the boiler house building, located in the center of the larger structure, and the turbo blower building to the west. The generator building was east of the boiler building, and the electrical building was to the east of the generator building.

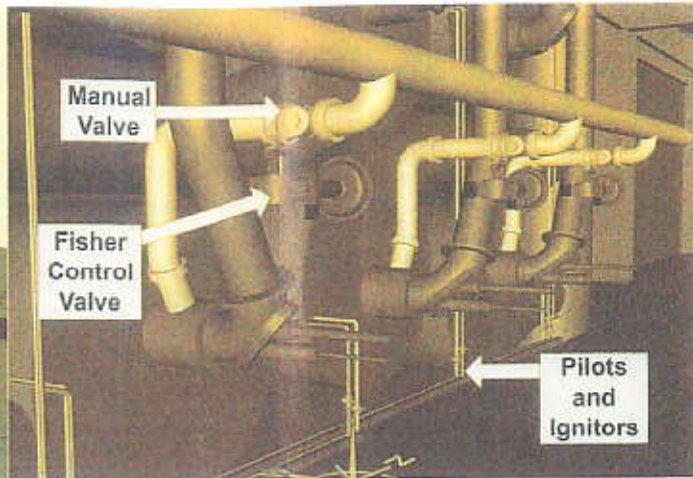
Figure 2: Three natural gas burners on each side of Boiler 6

the boiler (see Figure 2). These six feed lines each had a manual plug valve and a pneumatically controlled butterfly valve, the actuators for which were regulated by two controllers. The controllers, designated as the east and the west, regulated the three burners on one side of the boiler and were situated in the Boiler 6 control room on the third floor. They used a 30-psig (14-millibar) air supply to control the three 6-inch (15-centimeter) feed lines on the east and west sides of the burner as groups. Each burner was also fed from a blast furnace gas line 30 inches (76 centimeters) in diameter and a coal primary air line 12 inches (30 centimeters) in diameter.

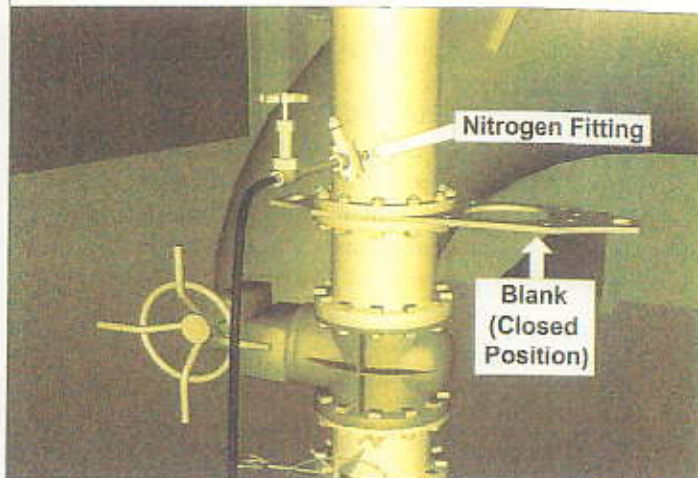
Figure 3: Valving and blanking hardware on natural gas piping

The risers had 10-inch (25-centimeter) manual valves on the second floor, above which "blanks" were located for a positive gas shut-off during maintenance. On the third floor, there was an 8-inch (20-centimeter) manual valve, next to which was a flame-sensing valve that had been manually wired in the open position. Crossovers from the east and west risers were connected to the igniter system below the third floor.

Employees in the final stages of inserting the blank opened the gas valves to the west burners and to the east natural gas burners. However, the manual natural gas valve on one of the main gas lines on the second and third floors had not been closed, and gas flowed into the boiler through the three east natural gas burners mixing with air from an operating forced-draft fan for 90 to 120 seconds before the flammable mixture was ignited, probably by hot fly ash residue or the discharge of the electrostatic precipitator. Moments before the explosion, an employee in the control room noticed the mistake and tried to alert the crew, but it was too late.

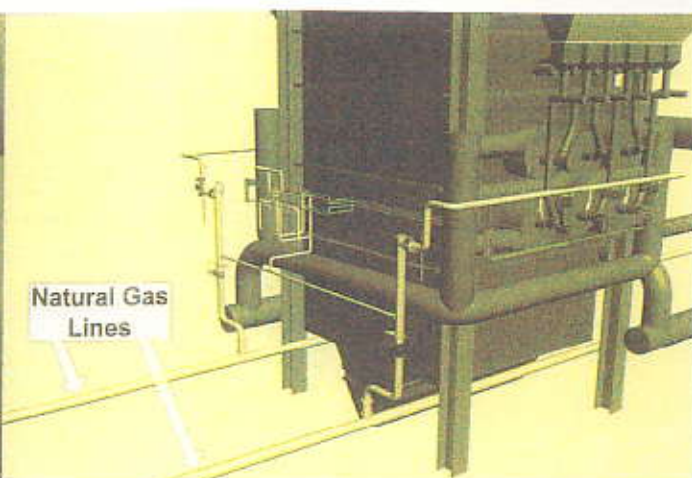
Figure 4: Two natural gas feed lines supplying Boiler 6

Around 1987, the fuel and fuel control systems of Boiler 6 were modified so that 6 of its 12 burners could be fired with natural gas, which the gas company supplied at about 25 psig from a meter house southeast of the facility through two ground-floor risers, one at the southwest corner of the boiler and one at the southeast corner (see Figure 4). The two risers had mirrored valve arrangements.

Both risers were 10 inches (25 centimeters) in diameter at the ground floor. They rose to the manual valves and blanking flanges on the second floor, narrowing to 8 inches (20 centimeters) in diameter as they extended to a manual valve on the third floor. From there, the risers narrowed to 6 inches (15 centimeters) in diameter as they ran to the burners on the east and west sides of the firebox.

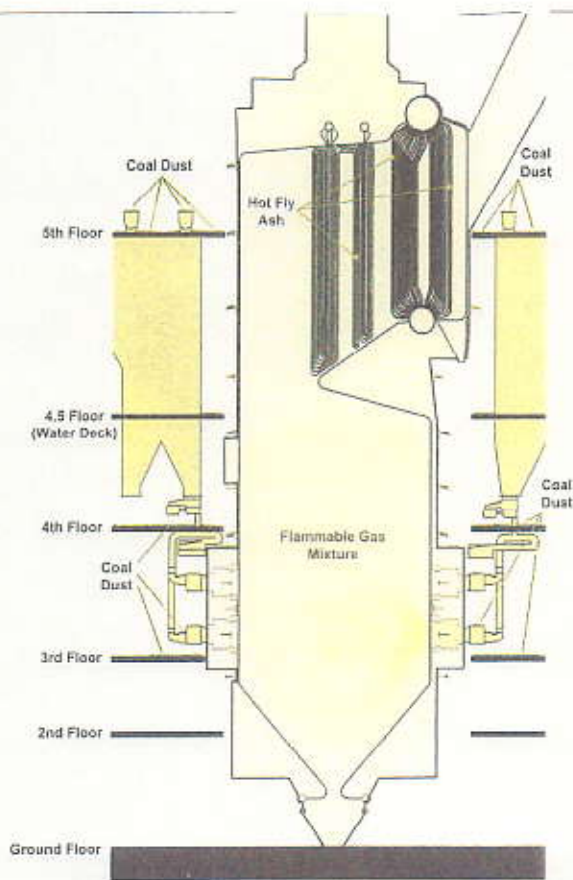
Figure 5: Cross-section of Boiler 6

To control the heating effect of the combustion gases and use them as efficiently as possible, the water walls on the rear side of Boiler 6 curved inward to form a "bull nose" that divided the unit into an upper and a lower chamber into which heated air for combustion was forced. After hot flue gases wove their way up through the boiler and its regenerative components, they passed through the electrostatic precipitator, which imparted an electrostatic charge to the dust particles in the flue gases allowing the dust and fly ash to precipitate out to provide clean emissions to the chimney (see Figure 5).

The examination of Boiler 6 showed evidence of an internal explosion, all four corners of the boiler having been ruptured at various levels. There was overpressure damage from the first floor through the flue gas ducts to the precipitator on the roof, and the damage patterns showed that the fire had vented at different areas of the boiler, projecting flames into the generator building's engine room, the electrical building, the turbo blower building, the conveyor area, and the pulverizer building.
