Protecting Your Family's Future Home!

1234 right street
Sauk Rapids, MN 56379

Prepared for: Clear Choice

Prepared by: Clear Choice Home Inspections, LLC
5542 Cameron Ave NE
Buffalo, MN 55313

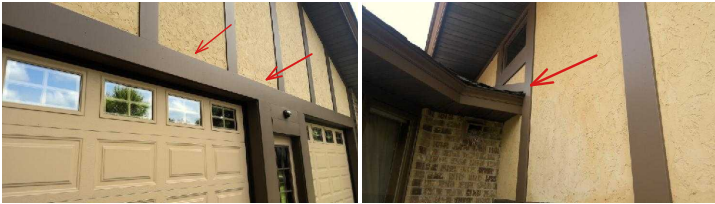
1. Entire Dwelling Exterior Surface Type: Stucco/Brick - **Suggest intrusive moisture testing to ensure that there is no damage not visible.**

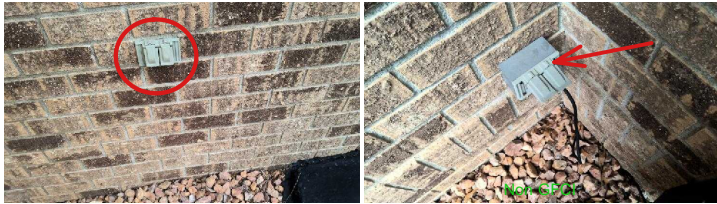
1. Exterior Electric Outlets: 110 GFCI/110 NON GFCI - **Inoperative at time of inspection, suggest further evaluation for require repairs**

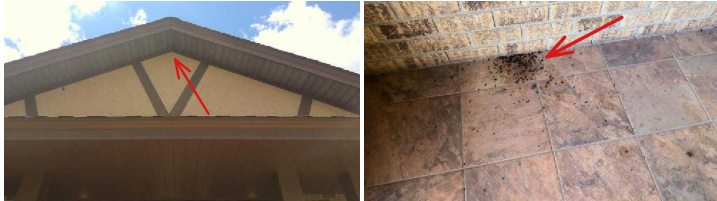
2. Insect Signs: Present - **Suggest further evaluation by an Exterminator any required services suggested.**

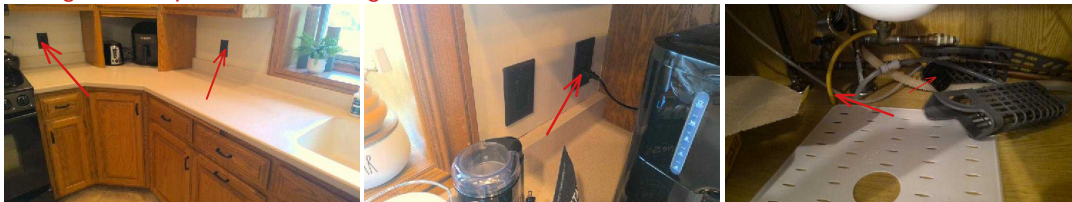
3. 1st Floor Kitchen Electrical Outlet(s): 110 VAC GFCI Outlets/ 110 VAC lighting circuits - **Outlets within 6' of any water source should be GFCI protected for safety. Suggest removal of "handy-man" wiring, extension cords are not designed for permanent usage and could considered a fire hazard**

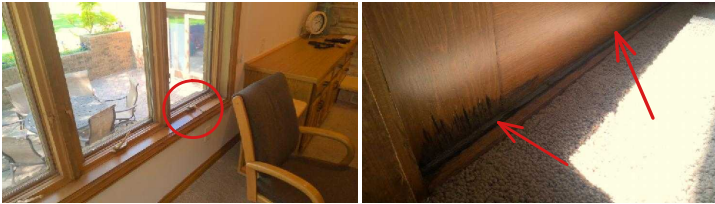
7. Family Room Living Space Windows: Wood Casement - Repair faulty operating hardware, Will not open-requires correction. Moisture damage noted, suggest monitoring and repair as required

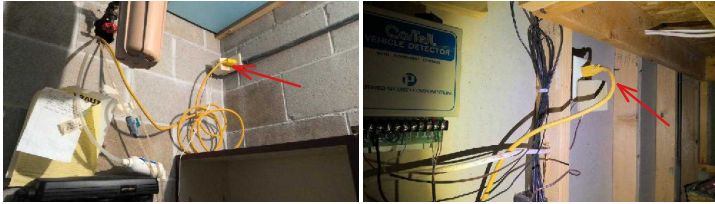
12. Basement family room Living Space Electrical: 110 VAC - Suggest removal of "handy-man" wiring, extension cords are not designed for permanent usage and could considered a fire hazard

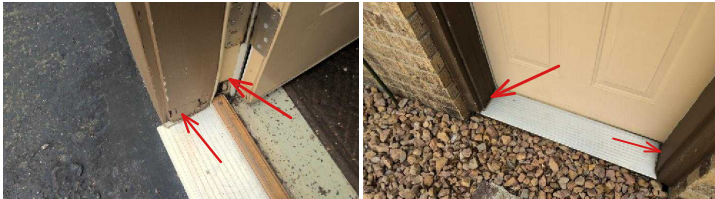
15. Attached Garage Service Doors: Metal - Wood rot noted, suggest repair/replace as required.

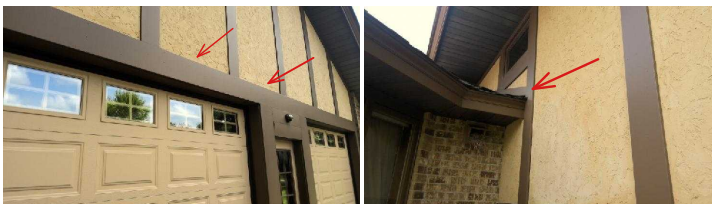
2. ☐ ☐ ☐ ☒ ☐ Type: Stucco/Brick - Suggest intrusive moisture testing to ensure that there is no damage not visible.

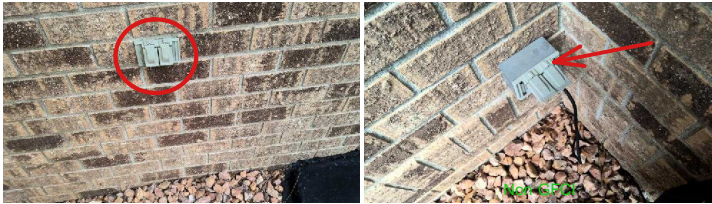
6. ☒ ☐ ☐ ☐ ☐ Door Bell: Present
7. ☒ ☐ ☐ ☐ ☐ Entry Doors: Fiberglass
8. ☒ ☐ ☐ ☐ ☐ Storm Door(s): None present
9. ☒ ☐ ☐ ☐ ☐ Patio Door: Wood sliding
10. ☐ ☐ ☐ ☒ ☐ Windows: Wood Casement - **Windows required maintenance to help extend product life.**
11. ☒ ☐ ☐ ☐ ☐ Storm Windows: None
12. ☒ ☐ ☐ ☐ ☐ Basement Windows: Wood Casement
13. ☒ ☐ ☐ ☐ ☐ Window Screens: Metal/vinyl
14. ☒ ☐ ☐ ☐ ☐ Exterior Lighting: Surface mount
15. ☐ ☐ ☐ ☐ ☒ Exterior Electric Outlets: 110 GFCI/110 NON GFCI - **Inoperative at time of inspection, suggest further evaluation for require repairs**

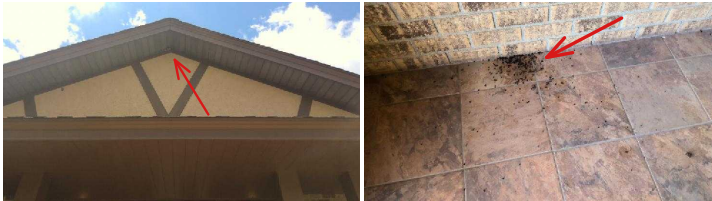
16. ☒ ☐ ☐ ☐ ☐ Exterior Electrical: Serviceable
17. ☒ ☐ ☐ ☐ ☐ Hose Bibs: Rotary
18. ☒ ☐ ☐ ☐ ☐ Service protrusions: Serviceable
19. ☒ ☐ ☐ ☐ ☐ Gas Meter: Propane
20. ☒ ☐ ☐ ☐ ☐ Main Gas Valve: Located at main line
21. ☒ ☐ ☐ ☐ ☐ Venting Terminations: Present
22. ☐ ☐ ☐ ☐ ☒ Insect Signs: Present - **Suggest further evaluation by an Exterminator any required services suggested.**

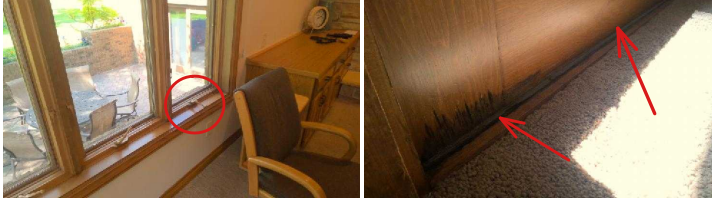
Windows: (continued)

10. ☒ ☐ ☐ ☐ ☐ Closet: None Present
11. ☒ ☐ ☐ ☐ ☐ Ceiling: Textured Paint
12. ☒ ☐ ☐ ☐ ☐ Walls: Paint/Stone
13. ☒ ☐ ☐ ☐ ☐ Floor: Carpet
14. ☒ ☐ ☐ ☐ ☐ Doors: None present
15. ☐ ☐ ☐ ☐ ☒ Windows: Wood Casement - Repair faulty operating hardware, Will not open-requires correction.
Moisture damage noted, suggest monitoring and repair as required

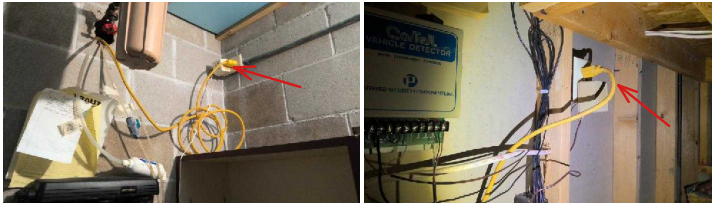
78. ☐ ☐ ☐ ☐ ☒ Electrical: 110 VAC - Suggest removal of "handy-man" wiring, extension cords are not designed for permanent usage and could considered a fire hazard

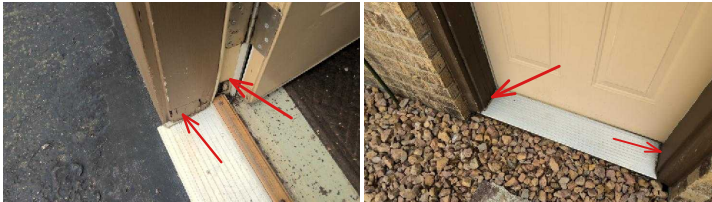
1. Type of Structure: Attached Car Spaces: 2
2. ☒ ☐ ☐ ☐ ☐ Garage Doors: Metal
3. ☒ ☐ ☐ ☐ ☐ Door Operation: Mechanized/manual
4. ☒ ☐ ☐ ☐ ☐ Door Opener: Present
5. ☒ ☐ ☐ ☐ ☐ Exterior Surface: Stucco/Brick
6. ☒ ☐ ☐ ☐ ☐ Roof: Asphalt shingle
7. ☐ ☐ ☒ ☐ ☐ Roof Structure: No Access
8. ☐ ☐ ☐ ☒ ☐ Service Doors: Metal - Wood rot noted, suggest repair/replace as required.
