**Dixon Sand  
Old Northern Road Quarry, Maroota**

**Addendum  
Annual Review  
2019 – 2020**

File Name: J16-001\_AR\_ONR\_2019-20 Addendum

Prepared by: Project Environmental Services Pty Ltd

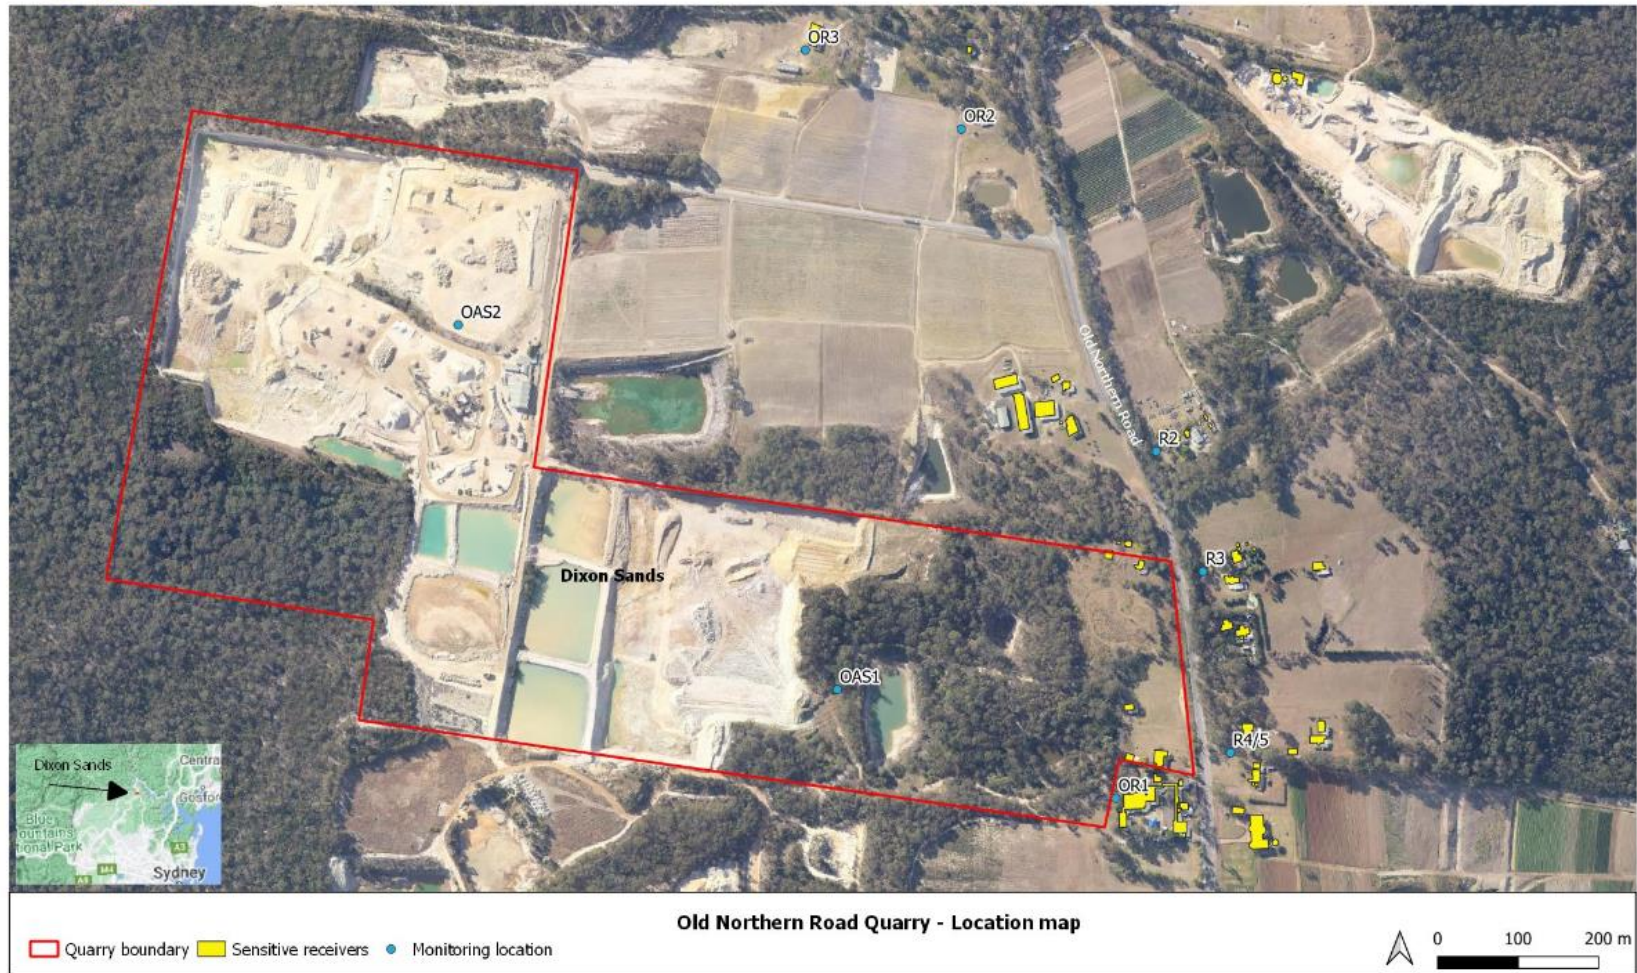
Figure 1: Noise Monitoring Locations at receivers (courtesy of Hutchison Weller, 2020).

Figure 1 depicts the locations of the attended noise monitoring locations at Maroota Public School (OR1) and other receivers (R2, R3, R4, R5, OR2 and OR3).

Noise monitoring undertaken on 3 December 2019 identified noise exceedances at receivers R3, R4 and R5 during the shoulder period. The cause of the noise exceedance was due to the trial use of a diamond tip blade attachment on an excavator for sandstone cutting operation on Lot 2. During breaks in traffic on the Old Northern Road, the rock saw was audible at the receivers and reached noise levels up to 45 – 46 dBA.

The identified noise exceedance resulted in a non-compliance against the shoulder noise criteria specified in Table 2 of Condition 3 of Schedule 3 of DA250-09-01.

To prevent any re-occurrence of such noise exceedance, the quarry will only utilise the diamond tip configured blade attachment after 7:00am.

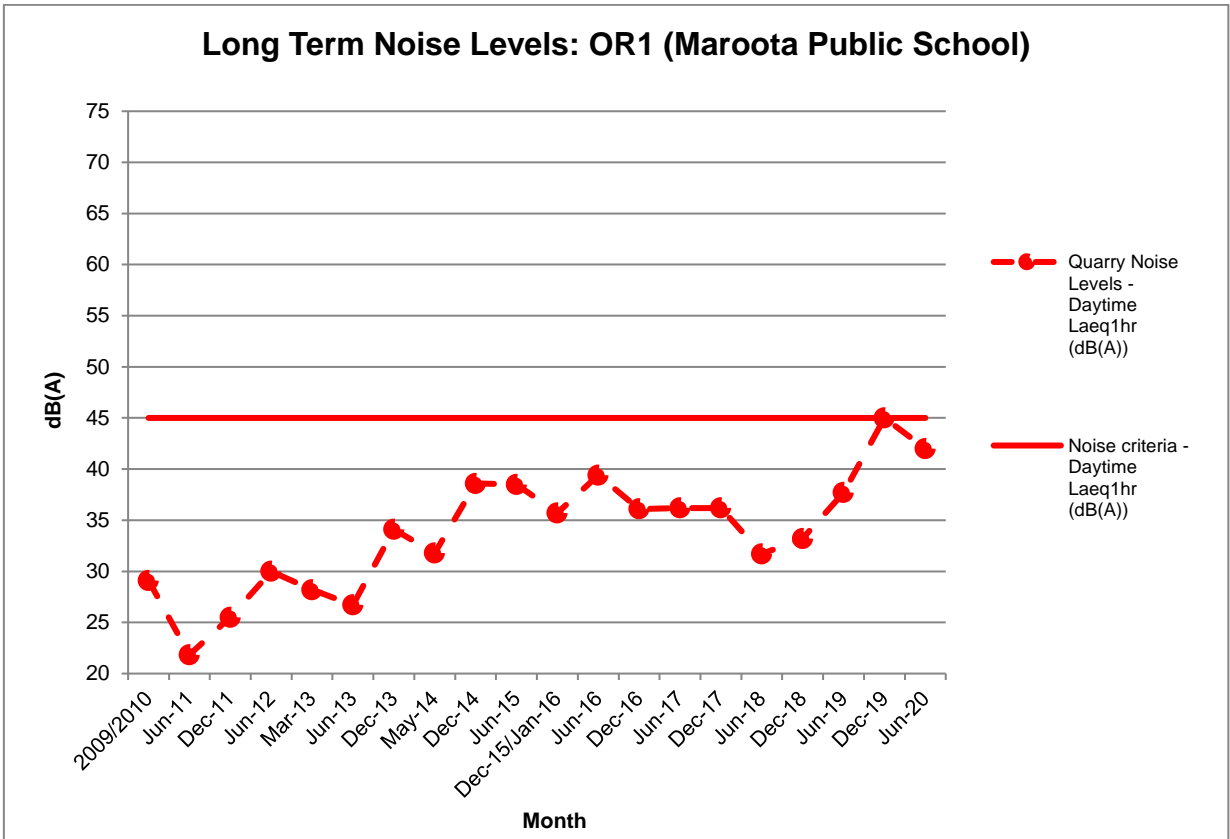
Chart 1 - Long term Noise Trend – Maroota Public School

It can be seen from Chart 1 that quarry noise levels fluctuations occurred at Maroota Public School over the ten-year period, with a general increasing trend with daytime noise level peaking in December 2015 at  $L_{Aeq1hr}$  45 dB(A).

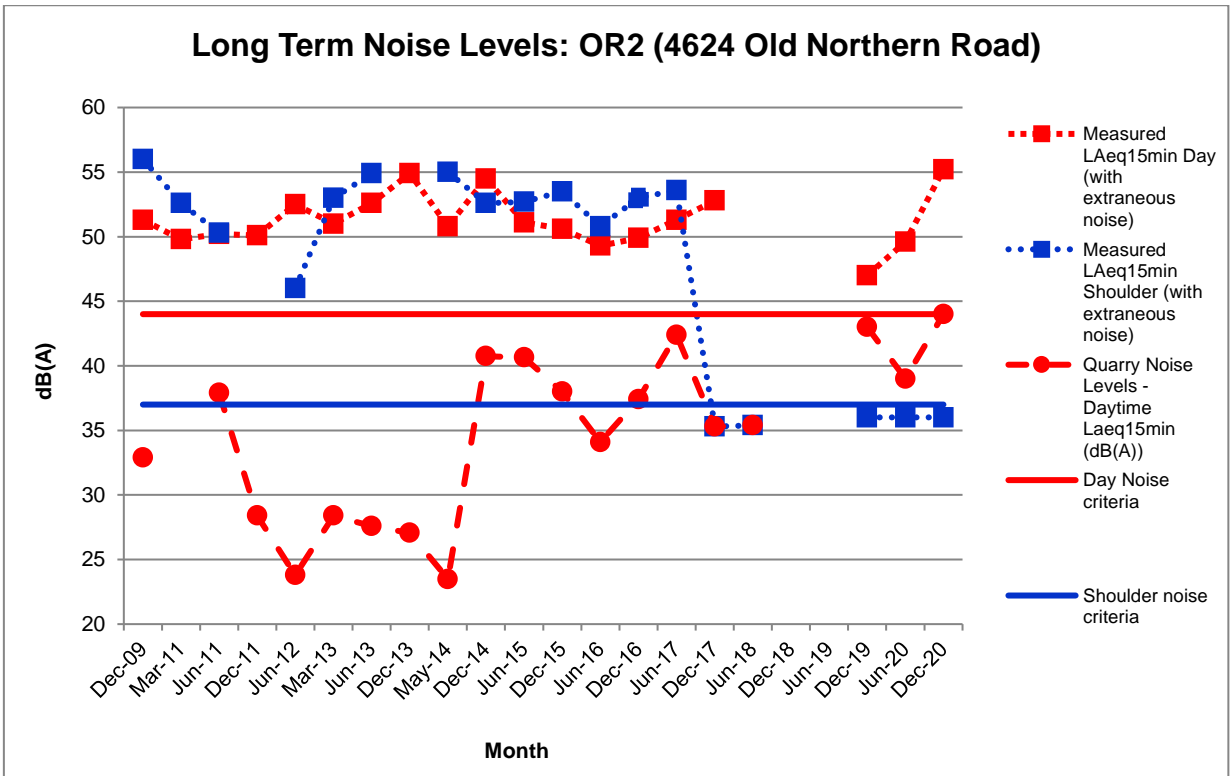
Chart 2 - Long term Noise Trend – OR2 (No. 4624 Old Northern Road)

Chart 2 provides long-term data for receiver OR2 at 4624 Old Northern Road. Fluctuations in daytime and shoulder noise levels can be observed where reduced daytime noise levels were recorded between December 2011 to May 2014, possibly a consequence of reduced quarry activities on Lots 29 and 196. From December 2014 to date, a general increasing daytime noise levels trend can be observed, with noise levels ranging from  $L_{Aeq15min}$  34.1 to 44 dB(A).

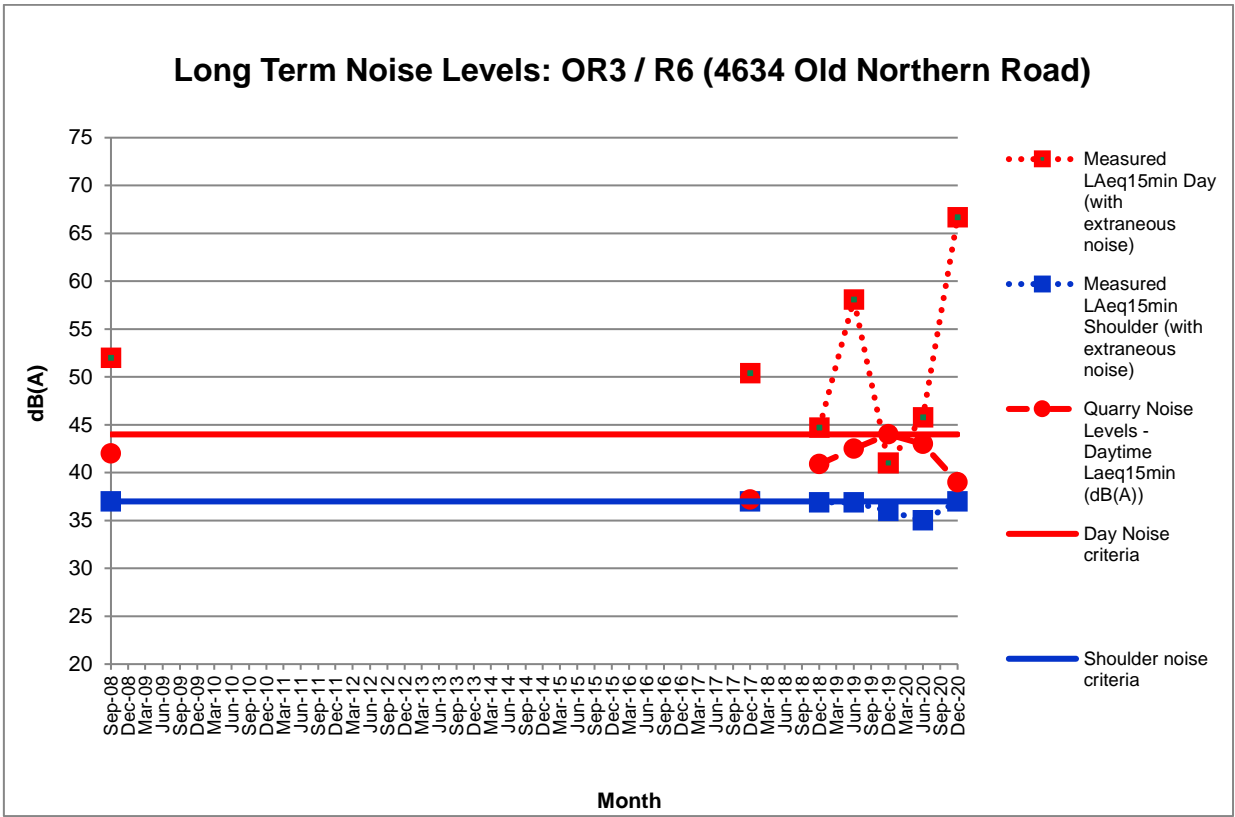
Chart 3 - Long term Noise Trend – OR3/R6 (No. 4634 Old Northern Road)

Chart 3 shows long term trend at receiver OR3 (R6) ranging between  $L_{Aeq15}$  37 and 44 dB(A).

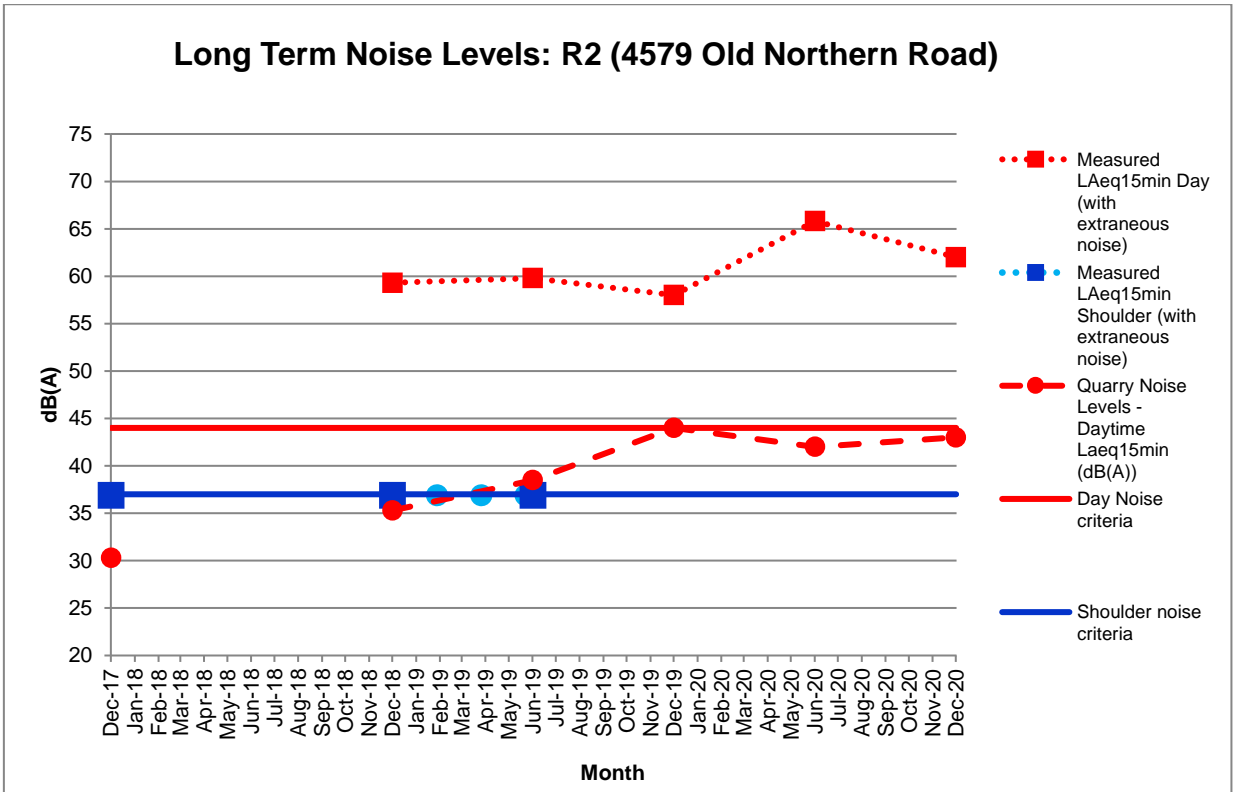
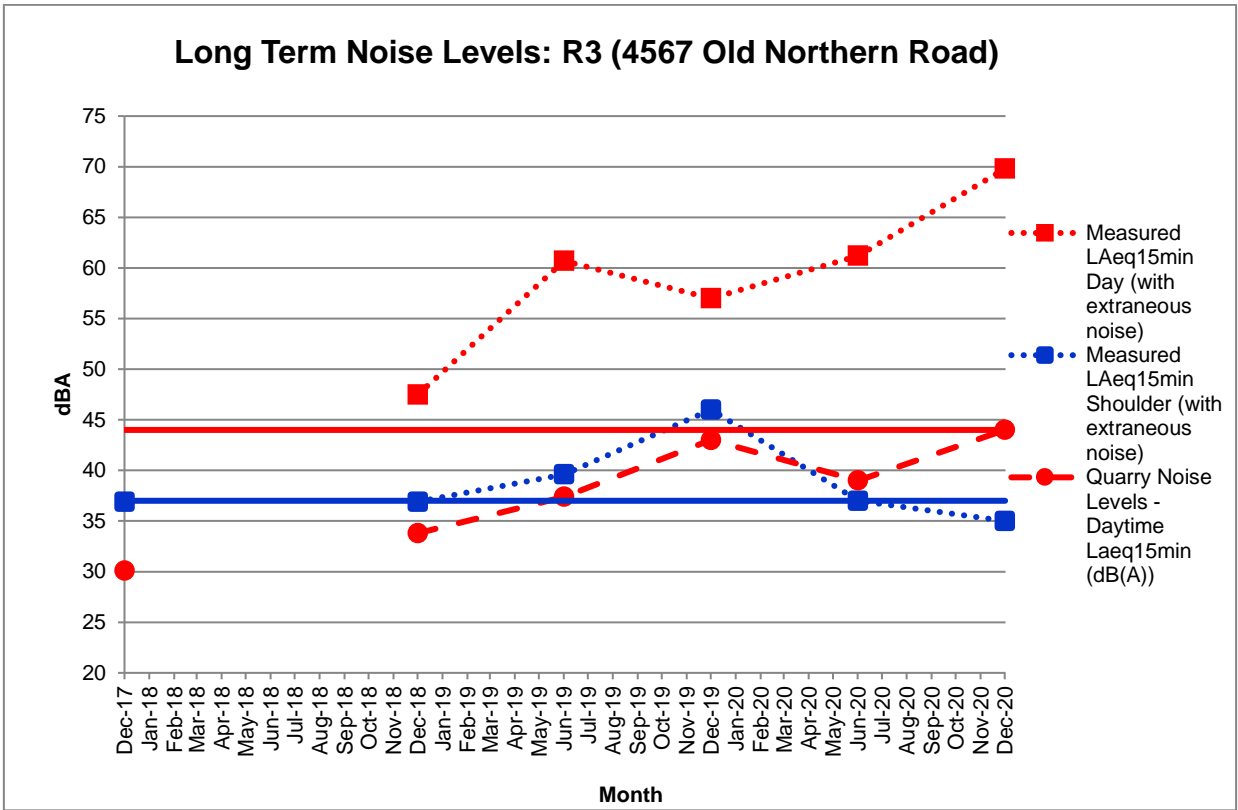
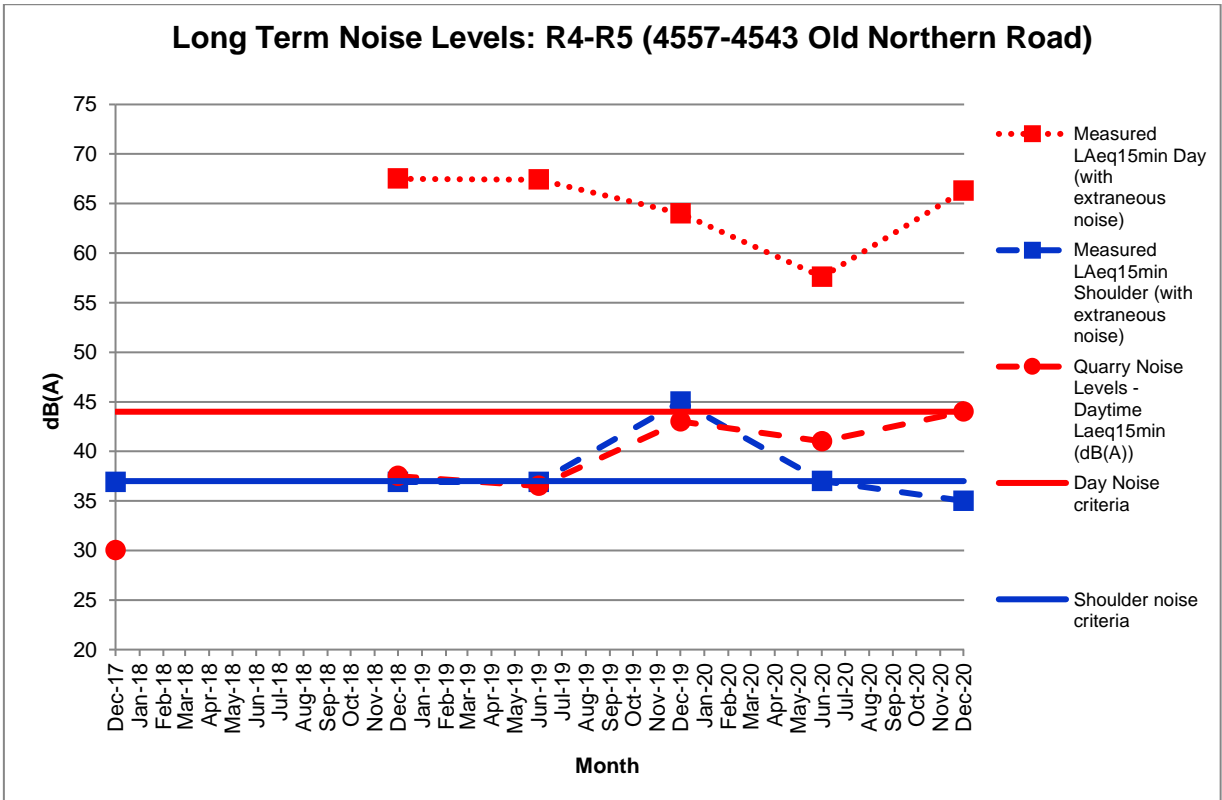
Charts 4 to 6 inclusive display an increasing trend in quarry noise levels at receivers R2, R3, R4 and R5, from December 2018 to date, peaking at  $L_{Aeq15}$  44 dB(A).

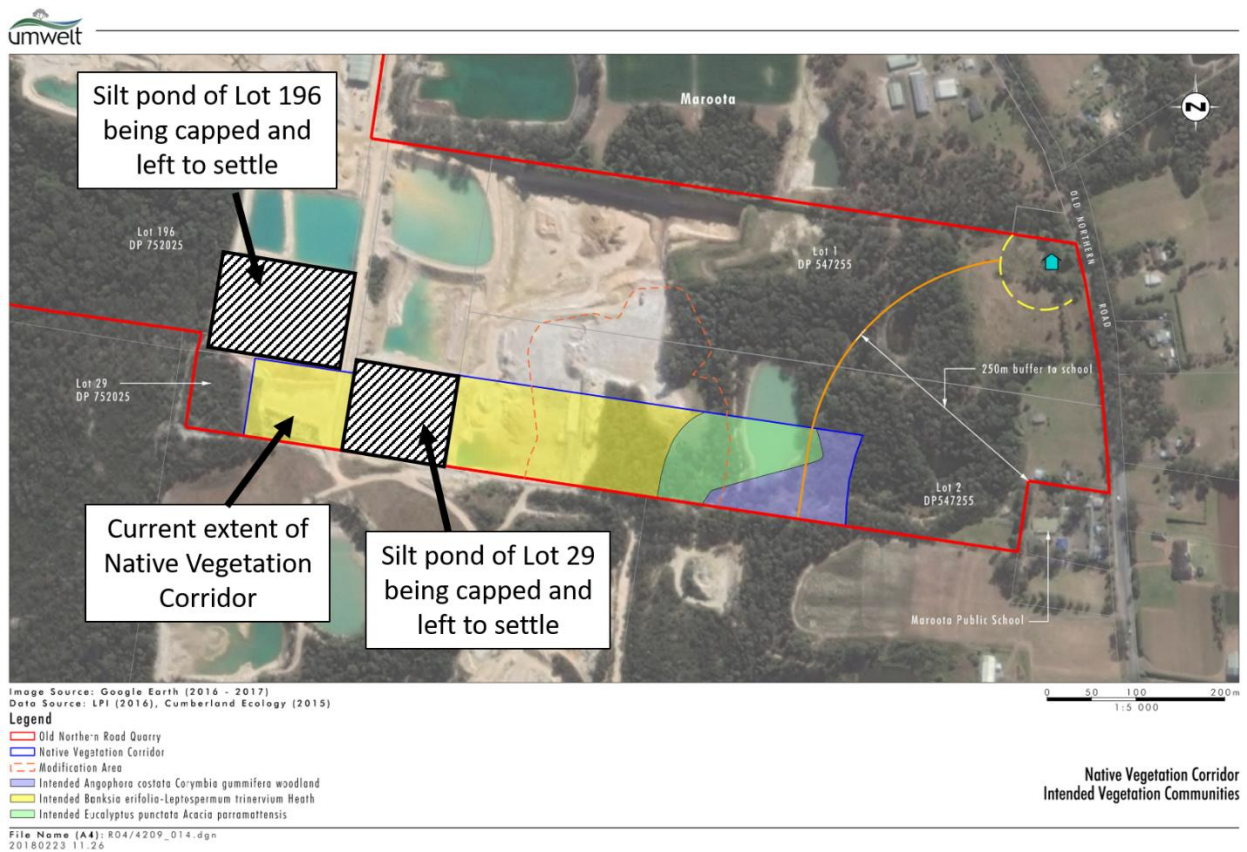
**Figure 2: Locations of capped and settling silt ponds, in preparation for future rehabilitation/revegetation.**

- capping and settlement of the silt pond located on Lot 196 directly north of the current Native Vegetation Corridor (NVC). Part of the silt pond will form the northern boundary of the NVC and the remainder will be revegetated to Class 4 Agriculture.
- Capping and settlement of the silt pond located on Lot 29 directly east of the current haul road separating Lots 29 and 196. Once optimal status is obtained, stockpiled windrows of material and topsoil will be applied to this area for rehabilitation of Banksia Heath Community, extending east from the current NVC on Lot 29.

The locations of the capped and settling silt ponds are shown in Figure 2 below.

No revegetation was carried out for rehabilitation during this reporting period. Revegetation of the silt ponds may occur in the next reporting period if ground conditions are deemed suitable.

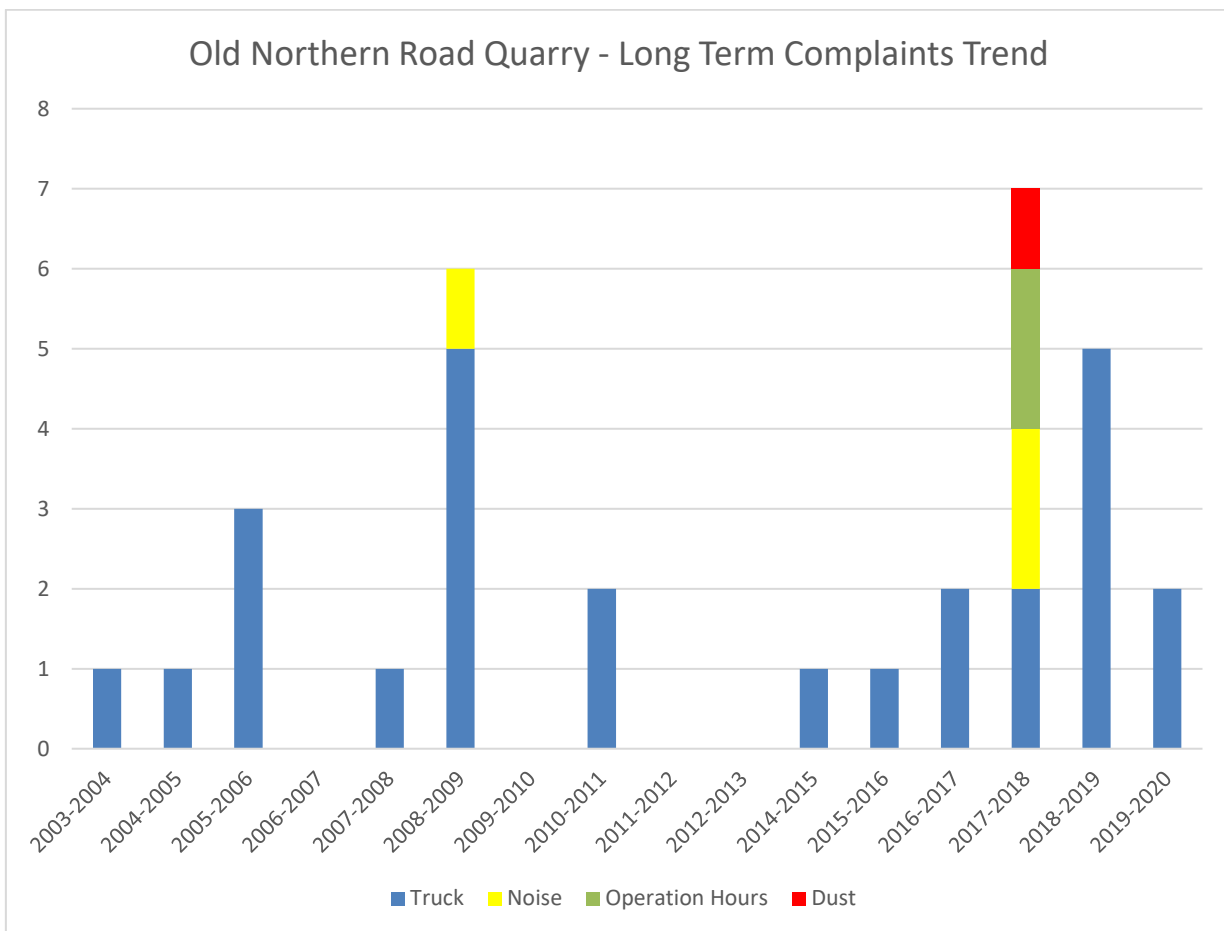
Chart 7 - Long term complaints monitoring data.

Long term complaints monitoring data commencing since the 2003 – 2004 monitoring period is depicted in Chart 7 below. It must be noted that complaints were recorded for the Old Northern Road and Haerses Road quarries combined from the 2006 – 2007 to 2017 – 2018 monitoring periods, with complaints recorded separately for individual quarries from hereon.

From this point, a downward trend in number of complaints was observed. The number of complaints received reduced to five haulage truck related complaints during the 2018 – 2019 monitoring period. The number of complaints further reduced to two truck related complaints (exceedance of speed limit) during this 2019 – 2020 monitoring period.

Dixon Sand implemented the steps to identify the validity of the complaints received and employed appropriate actions outlined in the complaints procedure and the Maroota Local Traffic Management Policy (inter-pit policy). Several complaints were identified to have been associated with other operations in or outside the local areas. All complaints have been closed out.
