1200 East First
Carterville Missouri 64835
1-417-673-1341
William L Cline
City Administrator

October 12, 2021
RE: DNR Inspection, Unsatisfactory Findings Response

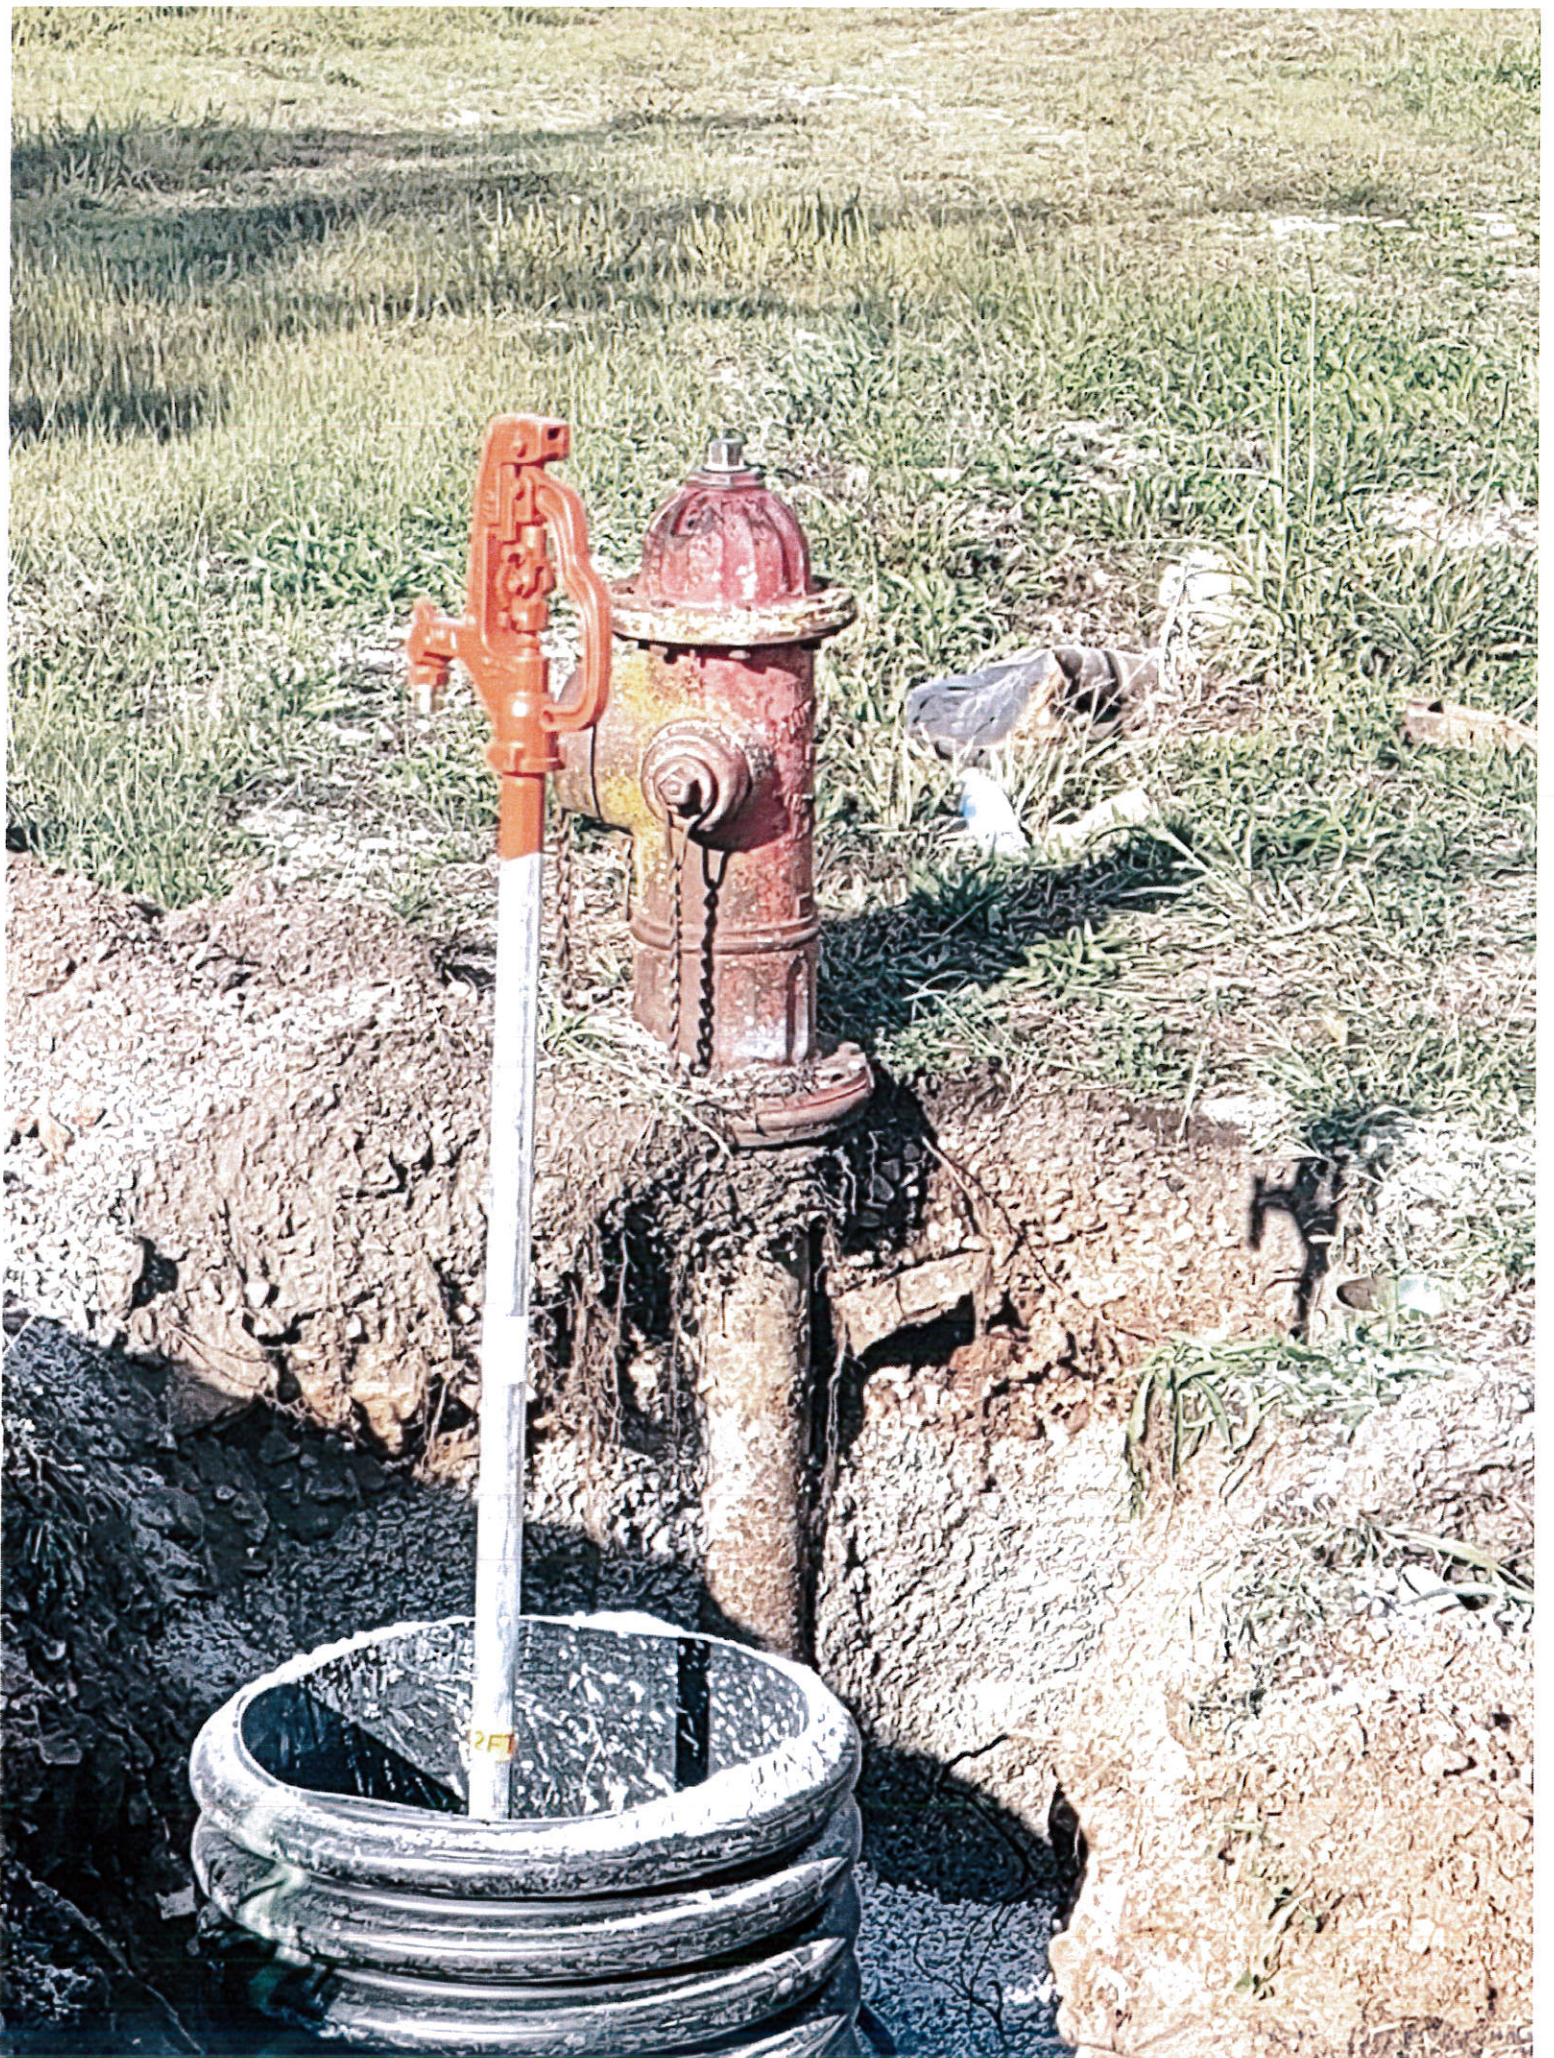
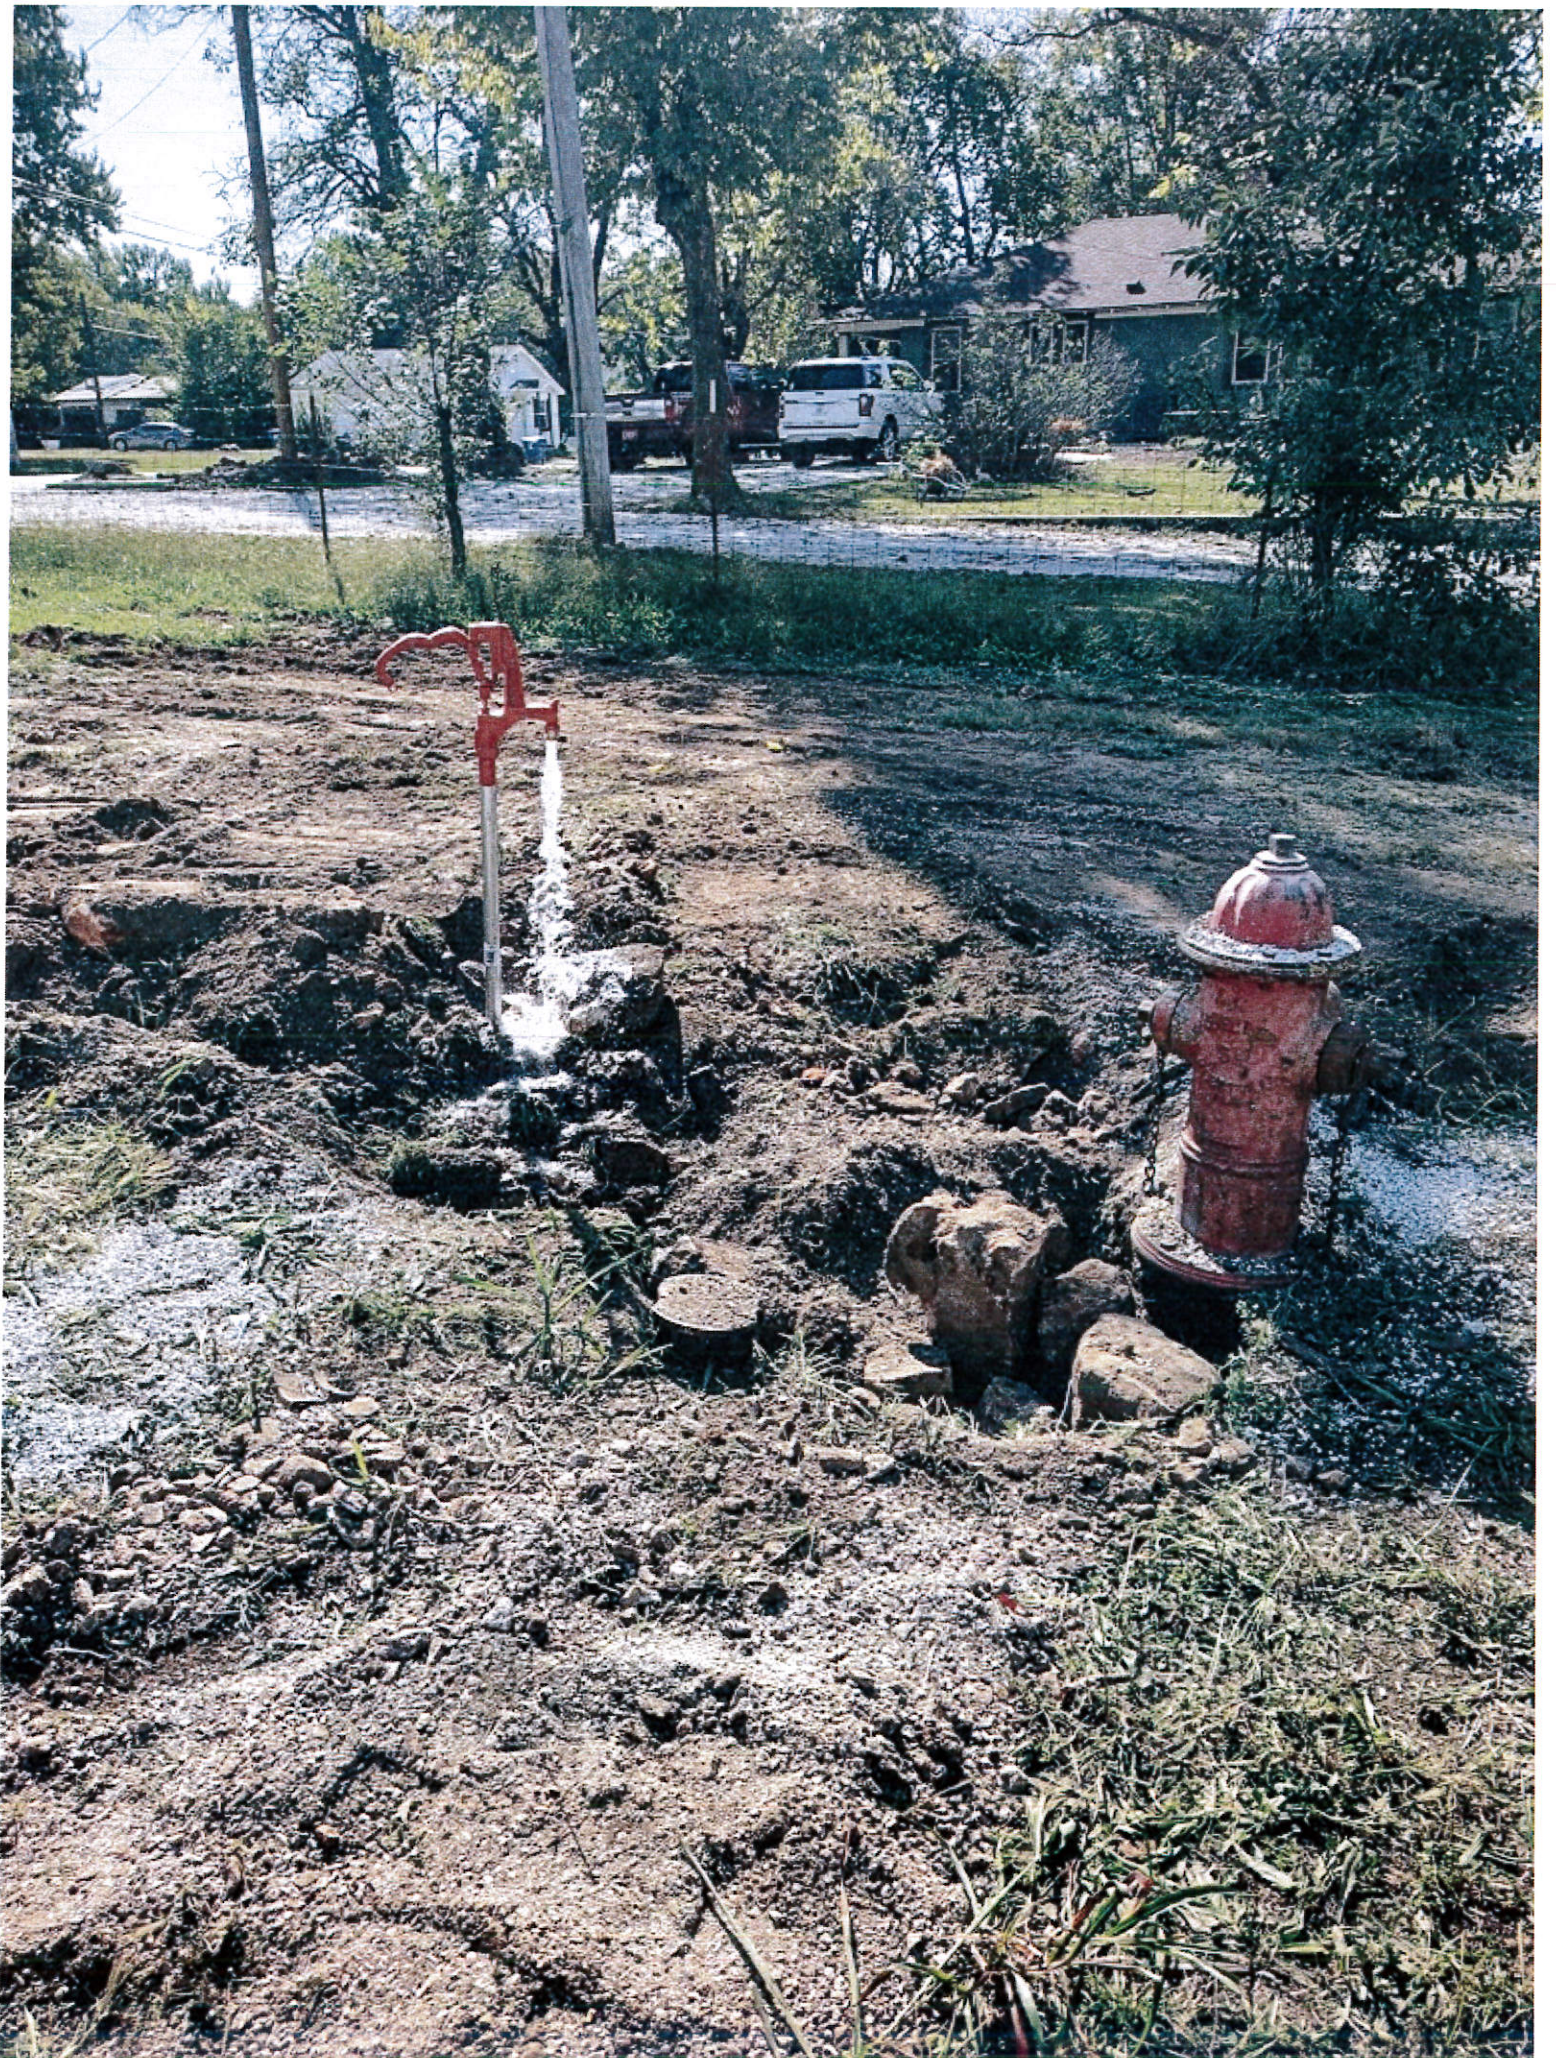
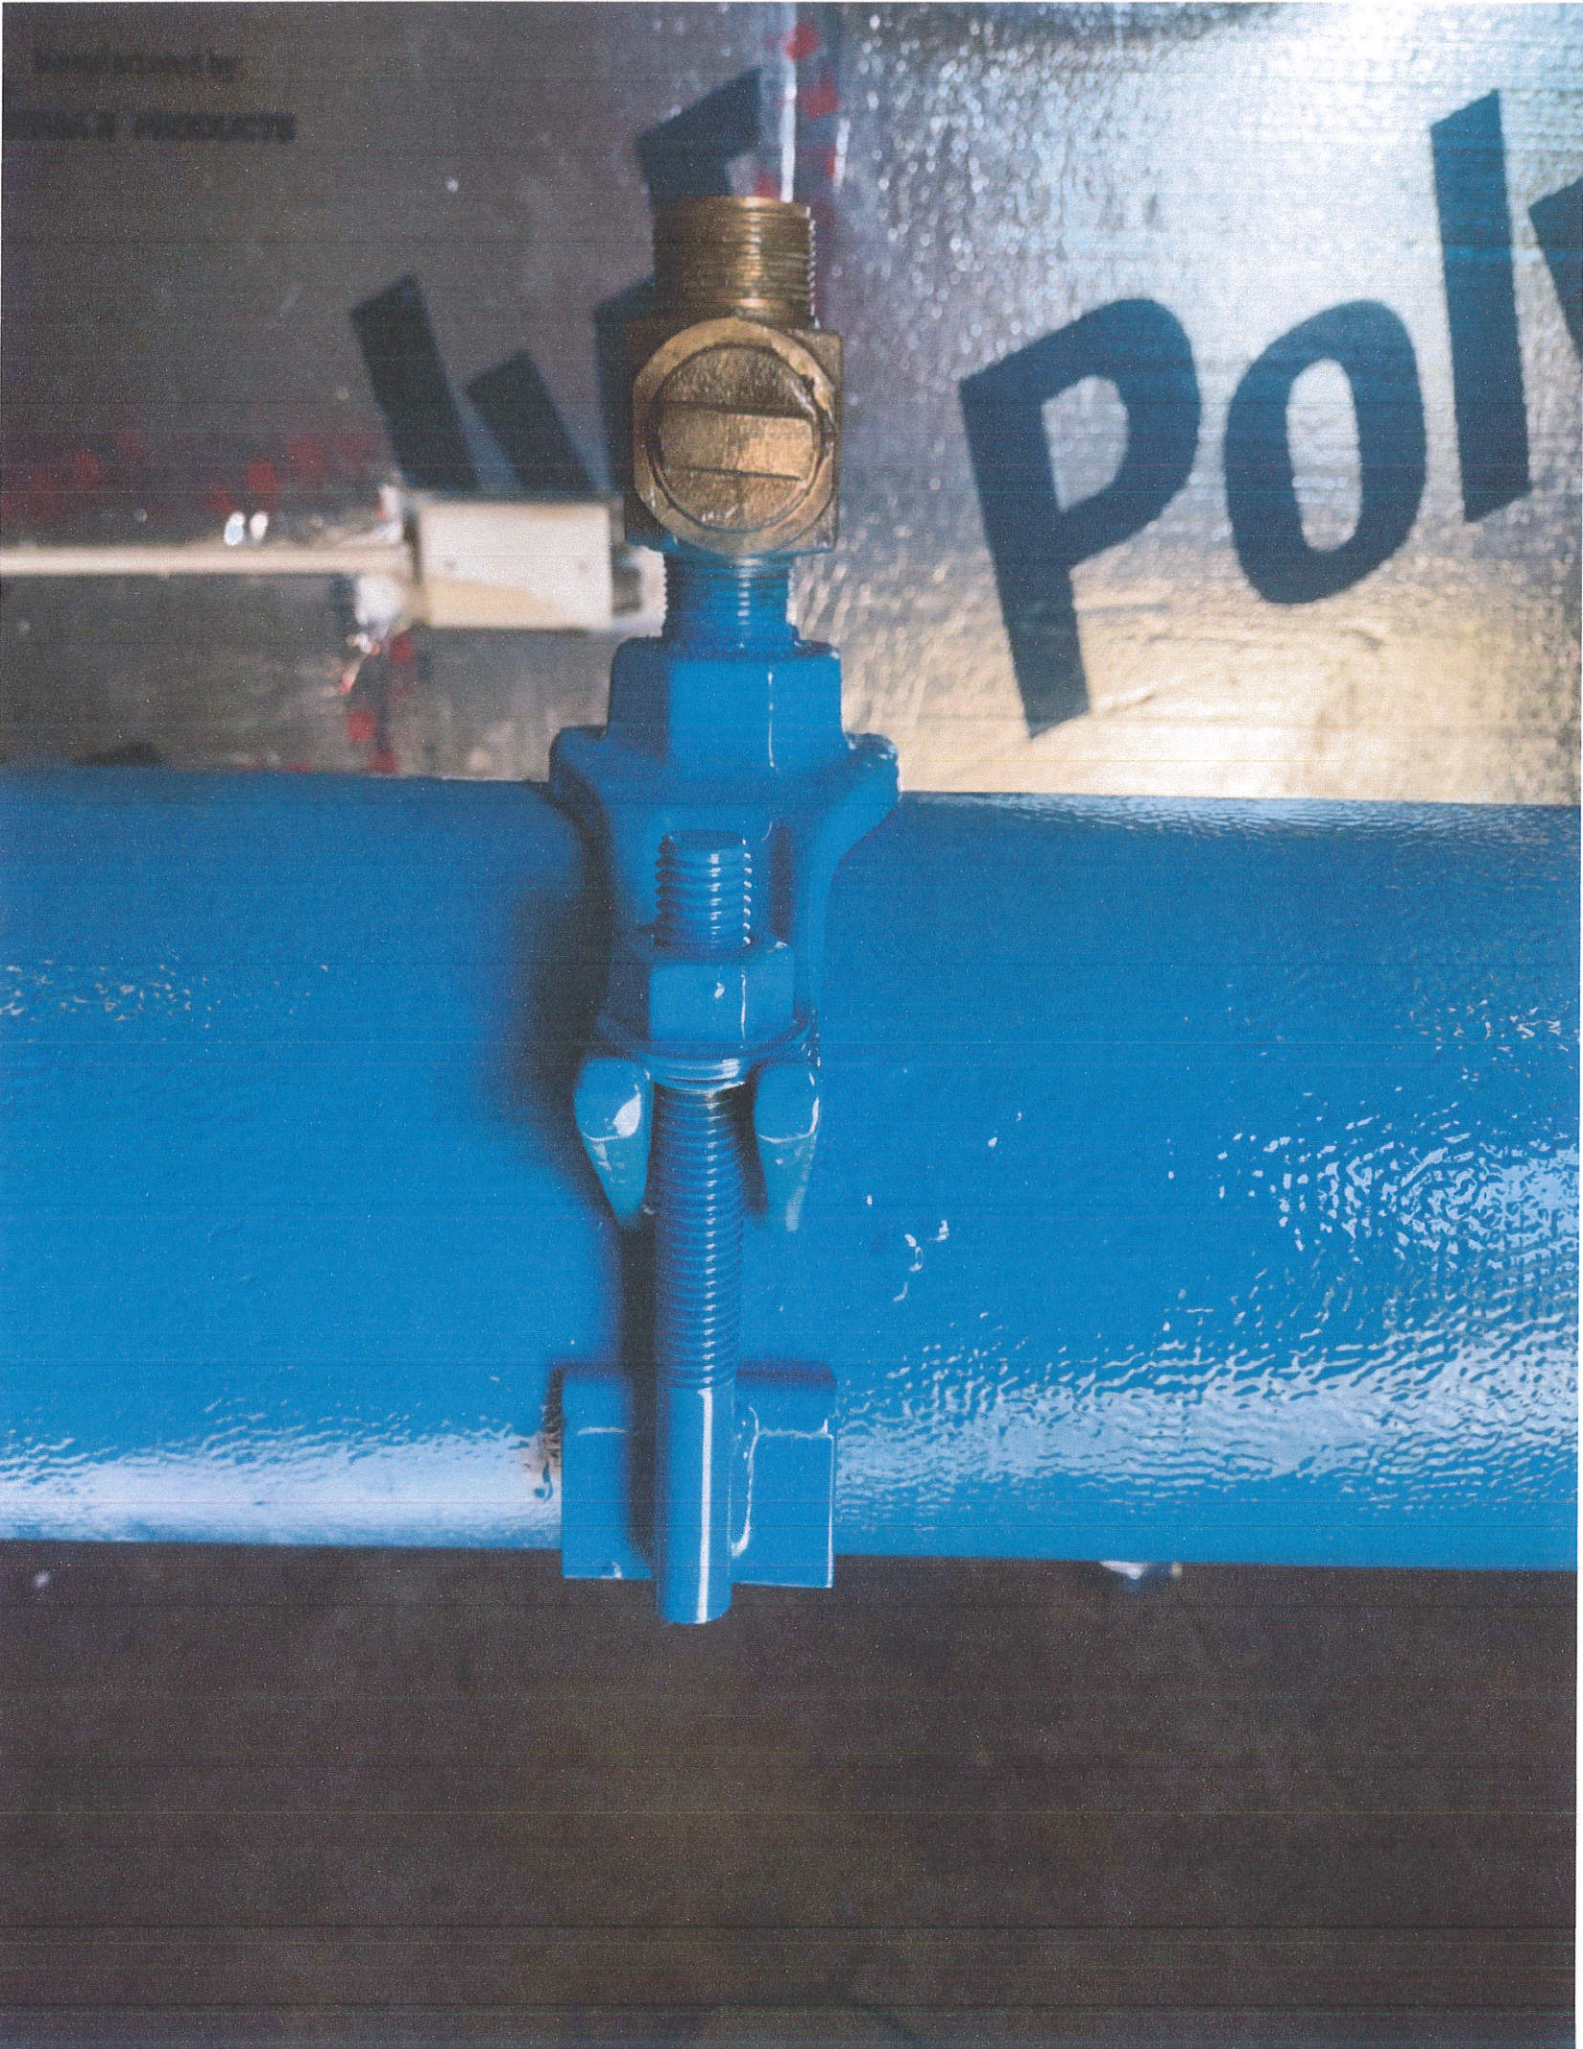
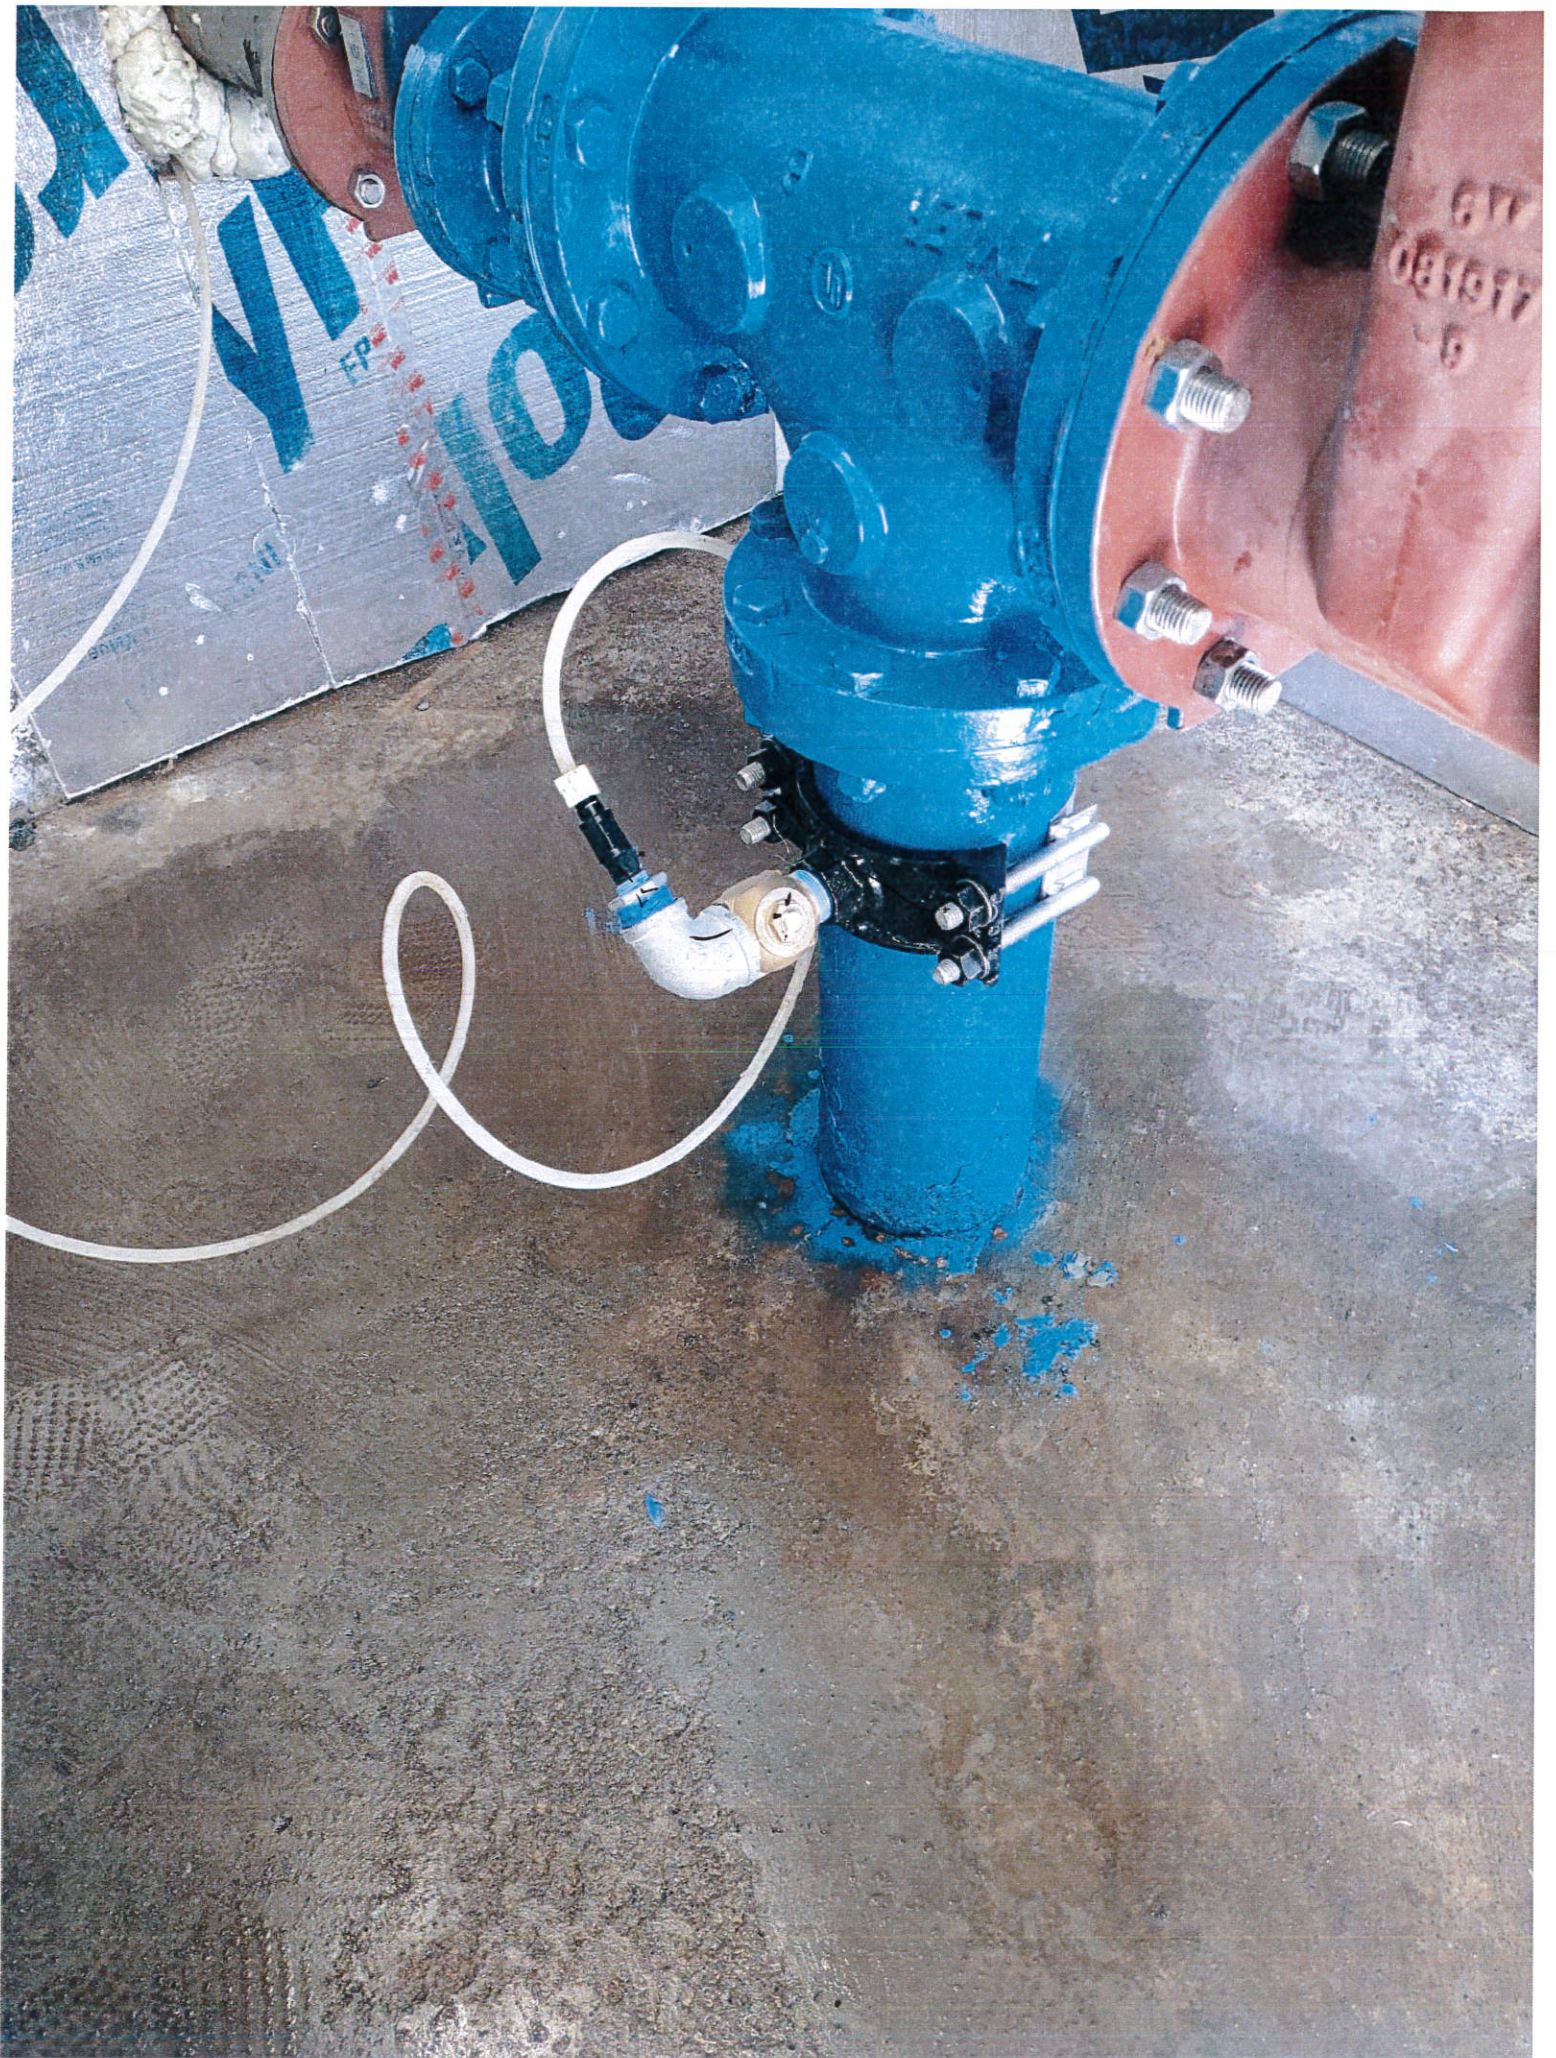
1. Discharge piping condition.

3. Sample tap at tower.

4. Raw water sample tap.

Our workers removed the chlorine injection system to clean, sand, and repaint the section of pipe that had rust and chlorine build up present. We believe the method used to inject disinfectant was poor in design as it allowed chlorine to run down this pipe anytime there was an issue with the line or the injector and leakage was present. We have installed a two inch offset saddle on this pipe to ensure if any future leaks arise, the chlorine will drip direct to the collection drain and not down the side of the piping until the leak may be repaired. (See attached photos)

Our crew has installed a sample tap on the discharge line leaving the elevated tower just before the treated water enters the distribution system. I have spoken with Yvonne Franklin as it appears #3 and #4 on your report are referring to the same sample tap. There was however, another need for a raw water tap inside the well house that we discussed during the inspection. I will address that under #4 below. (See attached photos)

We have installed a sample tap inside our well house on the main line just after the wellhead but prior to disinfection. (See attached photos)
