Windstone Colony CAI

Katy, TX

Report #: 37292-5

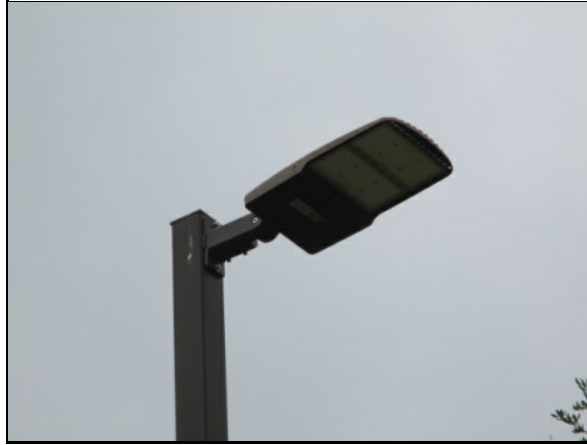
Comments: The fixtures were replaced in 2021 and are in good condition at this time. No reported issues at this time. Expect a full useful life.

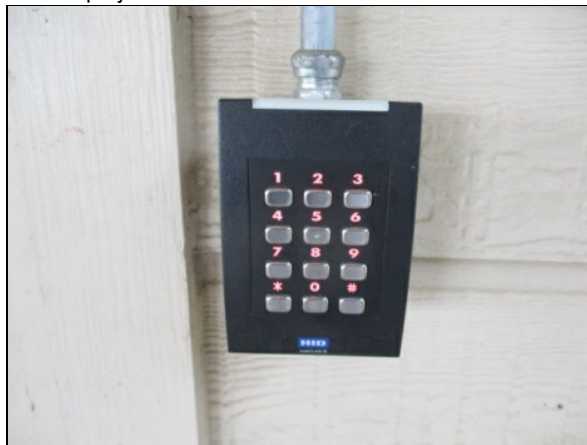
Comments: Card/fob reader devices are assumed to be functional. Due to use, exposure, and advancements in technology, plan to replace devices and control systems at the approximate interval shown here. Individual readers can often be replaced as an Operating expense due to damage or localized failures. To ensure a functional, compatible system and obtain better pricing, plan on replacing all devices together as one project.

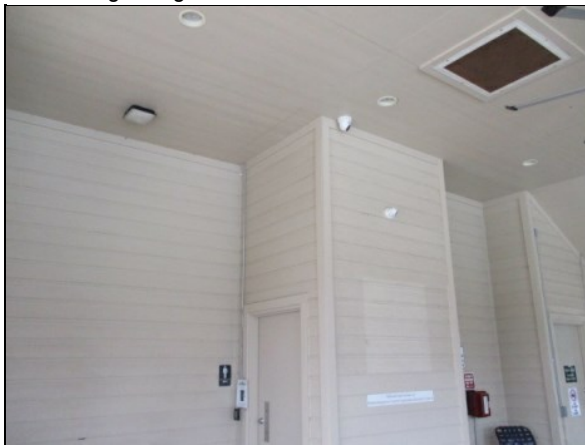
Association Reserves does not specifically endorse any products, manufacturers or vendors, but James Hardie Building Products, Inc. is the leading manufacturer of fiber cement siding, and their website (www.jameshardie.com) is an informative resource for proper care and maintenance of fiber cement siding. Their "Best Practices" guidelines offer specific guidelines for materials to be used; we strongly recommend complying with recommendations specific to your geographical area. We recommend that the Association consult with qualified exterior painting/waterproofing consultants and/or contractors to ensure that proper materials are used in painting and sealing the building siding.
