Windstone Colony CAI

Katy, TX

Report #: 37292-6

Beginning: January 1, 2026

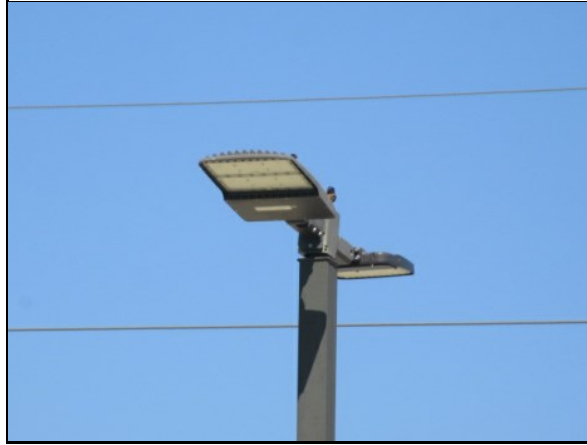
Comp #: 345 Lighting: Poles - Replace**Approx Quantity: 9 Poles****Location:** Pool and parking lot**Funded?:** Yes.**History:****Comments:** Fair condition: Poles determined to be in fair condition typically exhibit a somewhat faded/worn appearance but overall assembly is sturdy and aging normally. Serviceable physical condition and still appropriate for aesthetic standards.

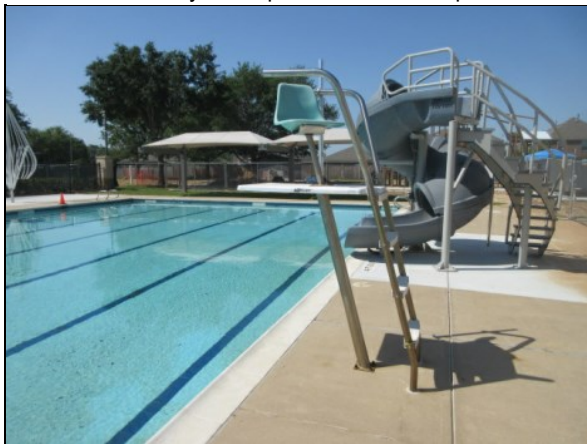
Comp #: 1215 Pool Coping - Replace**Approx Quantity: 333 LF****Location:** Pool perimeters**Funded?:** Yes.**History:****Comments:** Fair condition: Pool coping is in fair condition at this time. Local areas of deterioration evident. Minimal cracking.
