## Contractor 1 – Mid Trial Damage Report

### Running '*Ferobide*' discs only

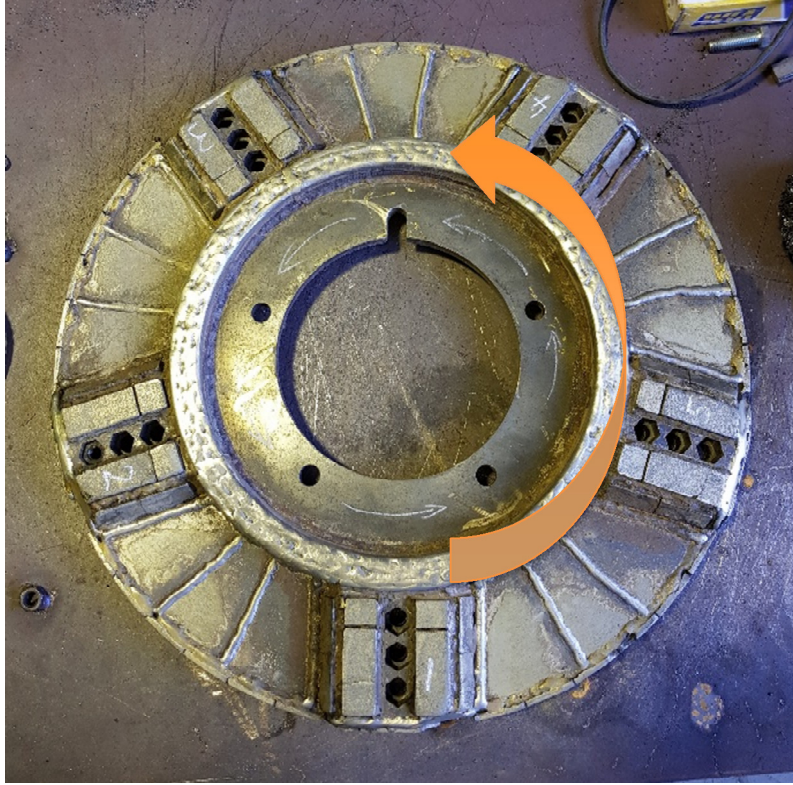
**Image 1.**

The arrows marked on the discs in images **1.** and **7.** depict the discs direction of rotation on the harvester. As identified in the images presented, the majority of the damage and lost tiles has been sustained on the lead side where the blade intersects the disc.

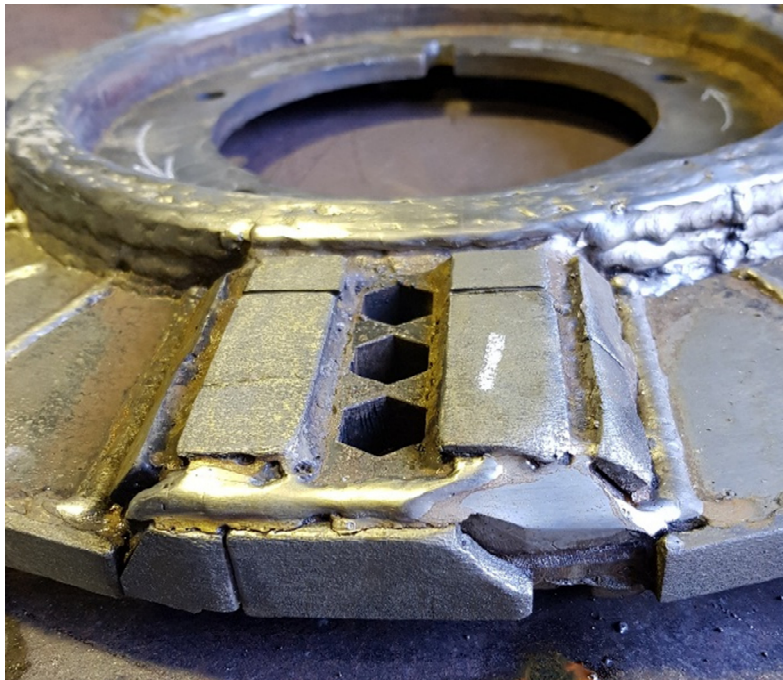
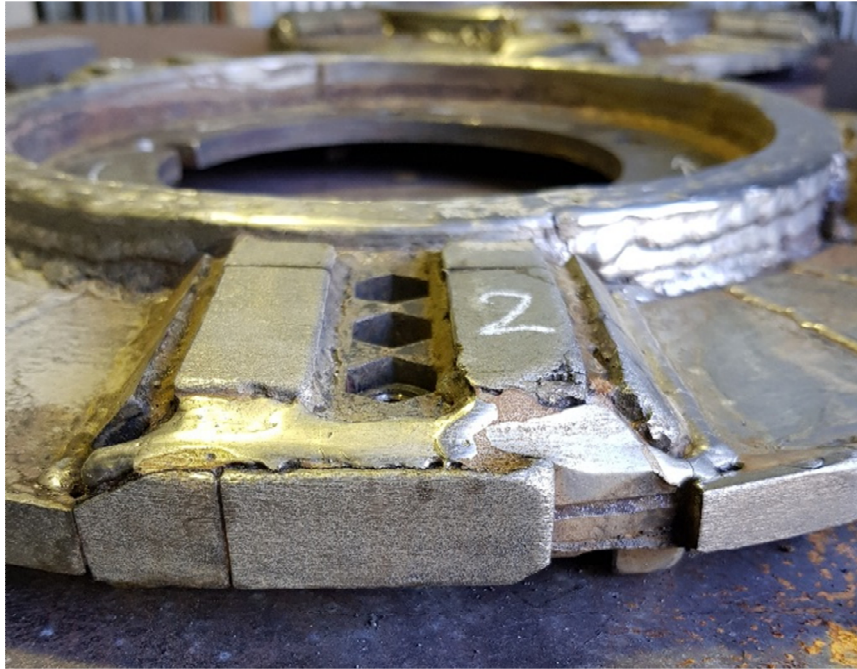
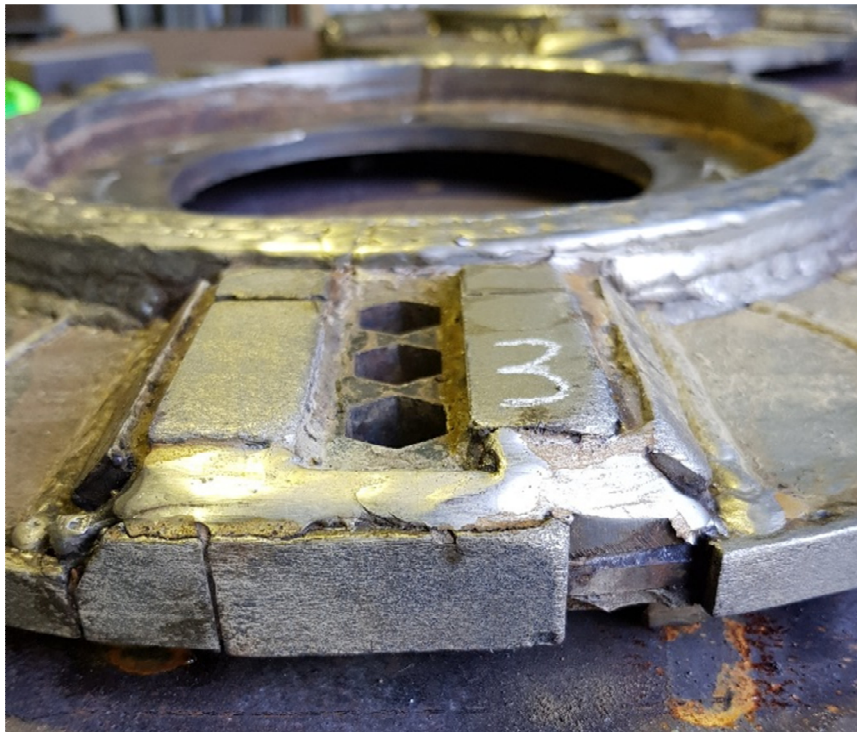
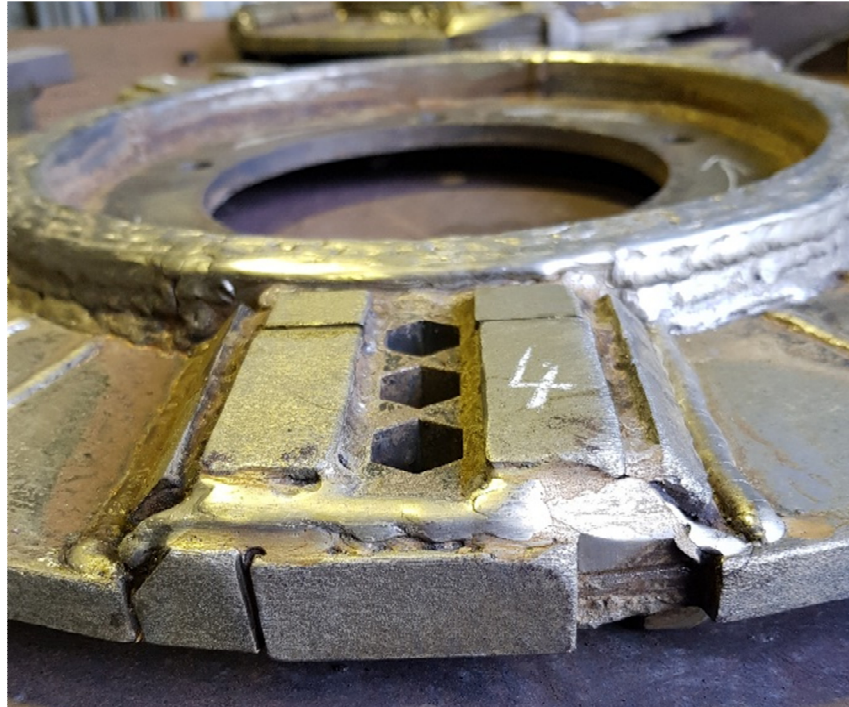
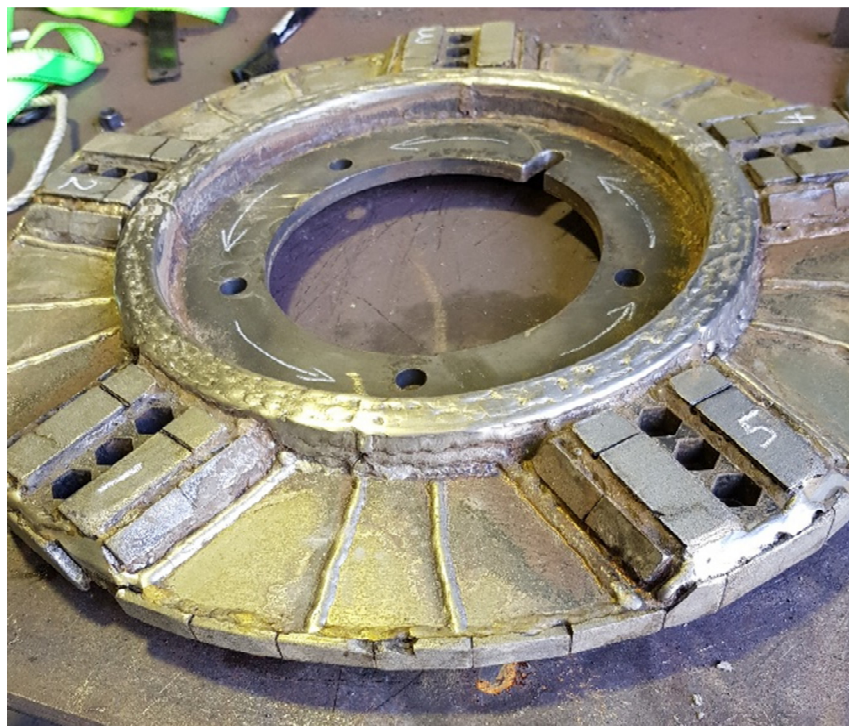
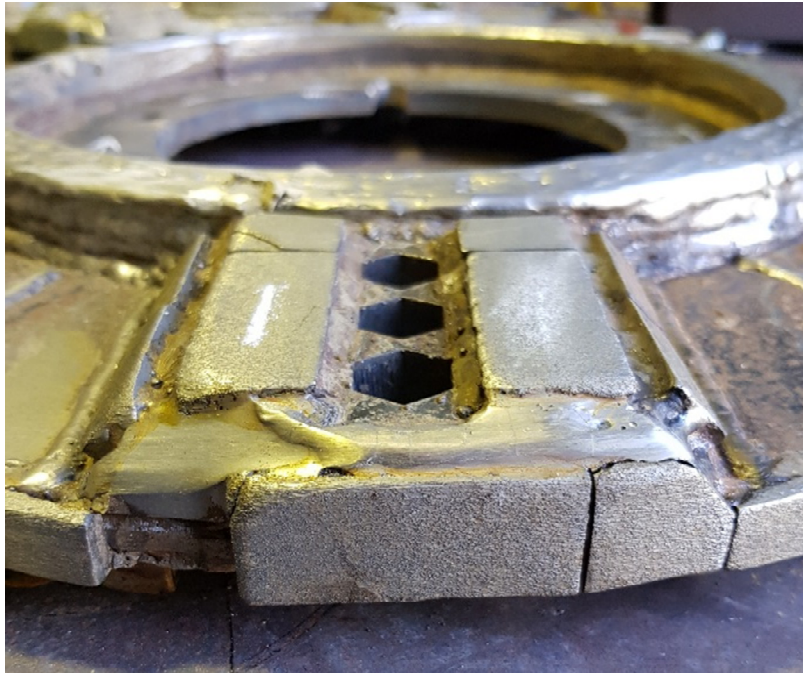
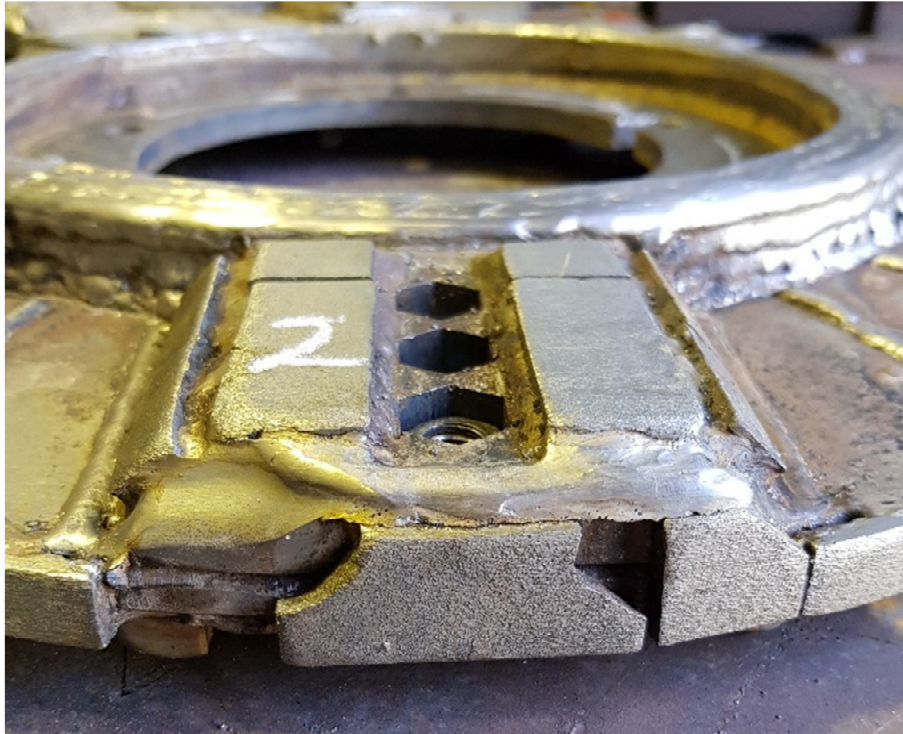
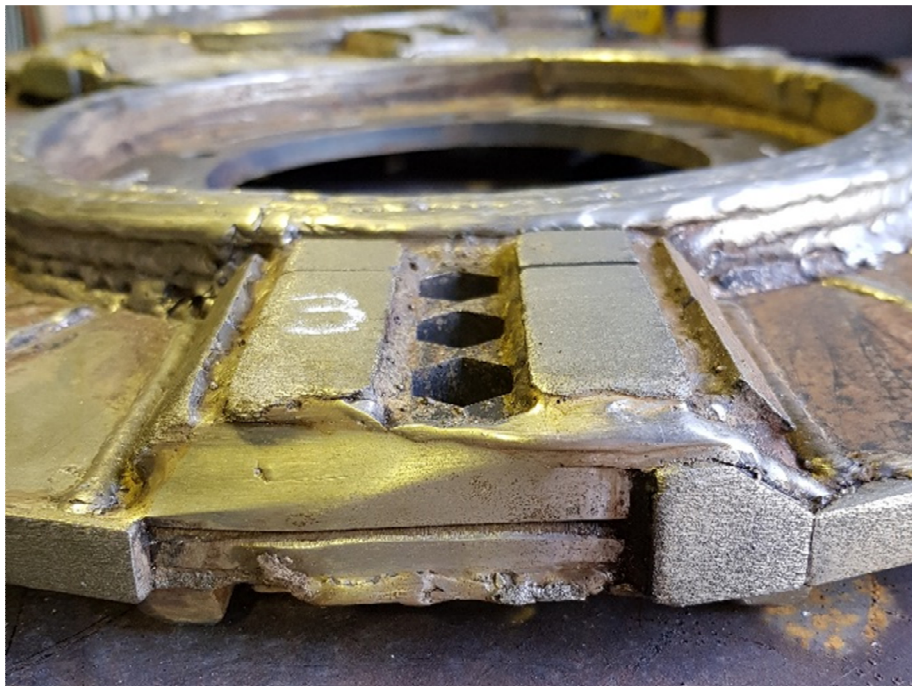
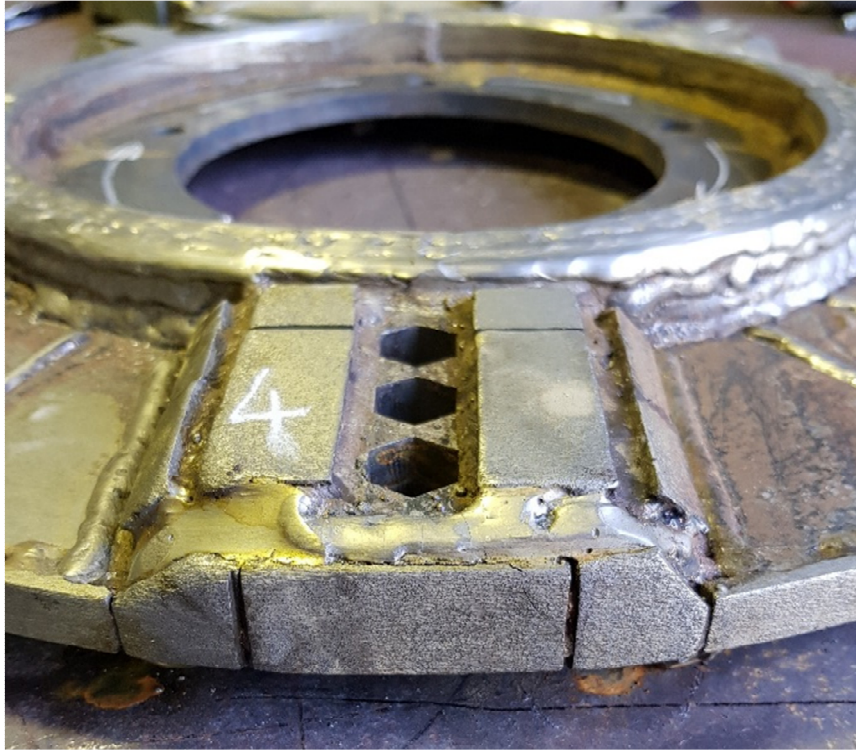
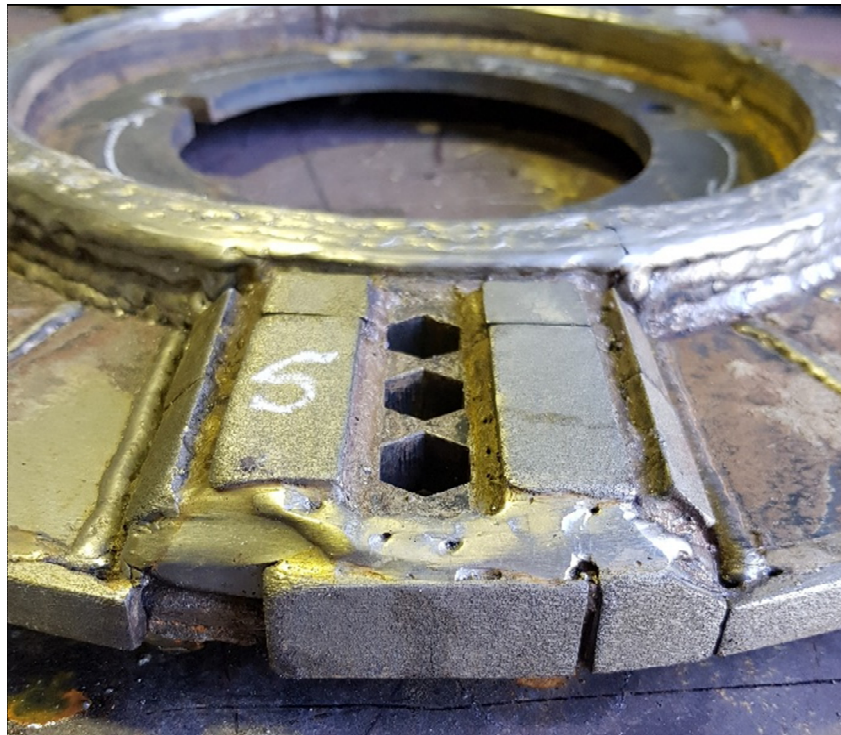
The damage sustained to the base cutter discs (as depicted in images 1 to 16) resulted from the disc coming into contact with residual subsurface irrigation from a previous crop (not sugar cane) being grown in this particular paddock. The contractor was engaged to cut cane in this paddock by the farmer and it was the first time he had cut in this particular area. Not only did the base cutters sustain reasonable damage, but the harvester also sustained damage to its drive and gear box components.

Repairs involved removing the damaged tiles, cutting replacements, re-prepping the disc as needed, re-welding the damaged blade retaining bar, welding tiles in place and hard-facing the areas worn up until this stage. These repairs took approx. 1 ½ hrs. With the use of current hard-facing wires / electrodes, this process would have taken anywhere up to half a day for the same repairs.

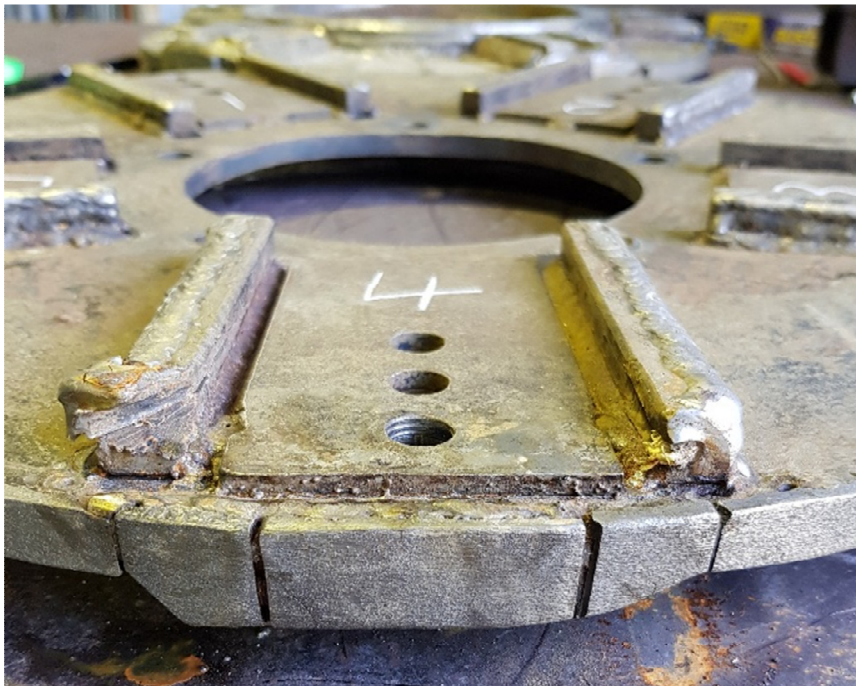
**Image 12.**

With the rotational speed of the base cutters, travel speed of the harvester and interaction with an immovable object such as large rocks, boulders or redundant fixtures as in this case, this damage is not surprising and will continue to happen in the future. Images **12.** to **15.** show the damage the cutting blade did to the blade retaining bars on the underside of the disc. These bars are 16mm square bar and the blade had no problems cutting through this section, again highlighting the shock / impact sustained in this case.
