RESERVE FUND STUDY UPDATE

**KEMPTON PARK
SUFFOLK, VIRGINIA**

Prepared for:
**KEMPTON PARK HOMEOWNER'S ASSOCIATION
C/O UNITED PROPERTY ASSOCIATES**

**On-Site Inspection August 23, 2012
*Submitted September 19, 2012***

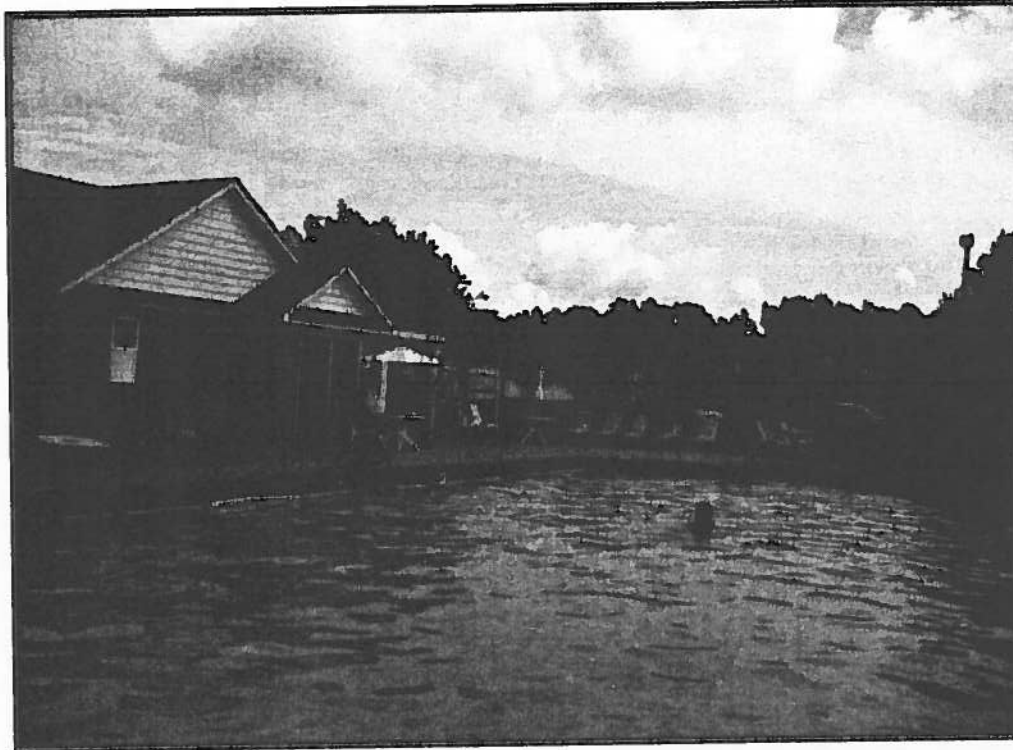
Photo Number
1

Description:
View of swimming
pool and pool
building

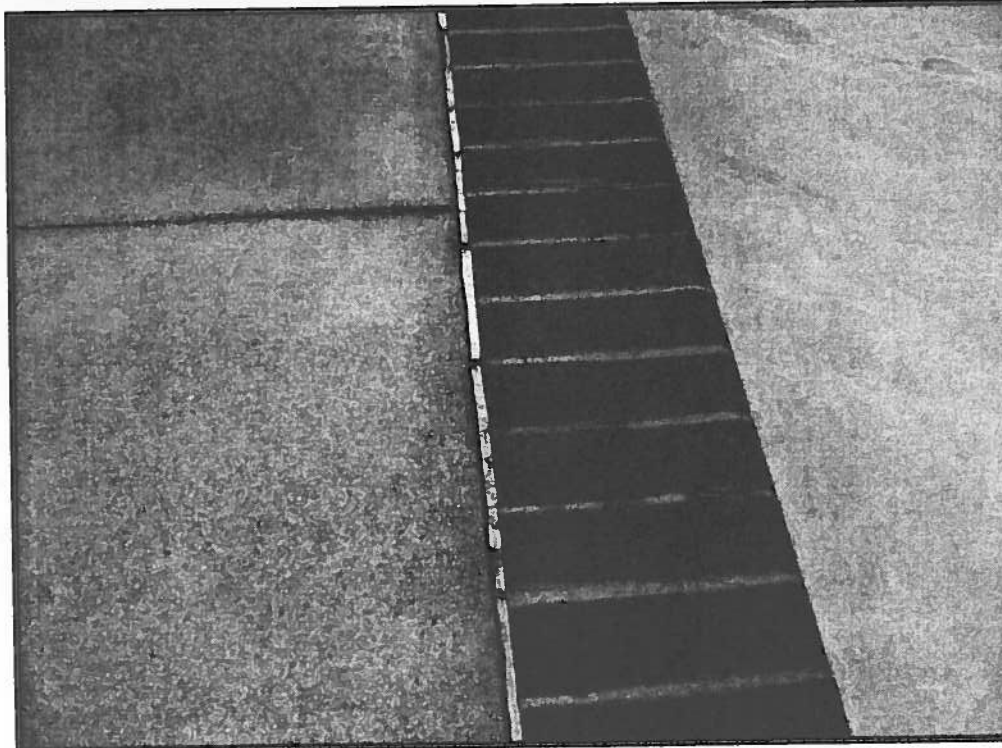
Photo Number
2

The main swimming pool and kiddie pool both appeared to be in fair-to-good condition. We noted deteriorated caulking between the tile and

concrete deck. Additionally, broken tiles were noted at the kiddie pool. The Property Manager advised that the general repairs to the coping/tiles and caulking would be completed this Fall. The pool surface will likely require repair and re-coating in the next 2-4 years and we have allocated funds to re-coat the pool surface in 2015 and on a 12-year cycle.

Description:
Caulk deteriorating
at tile to concrete
deck joint

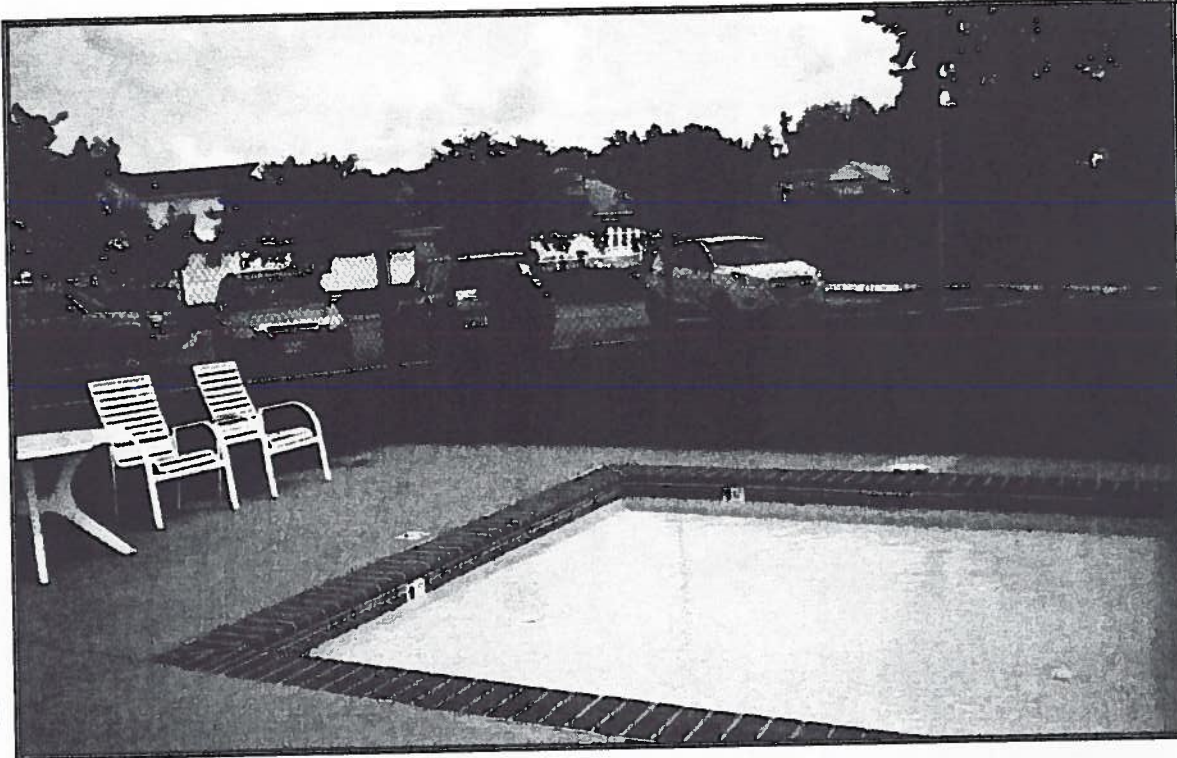
Photo Number
3

Description:
View of
"kiddie"
pool

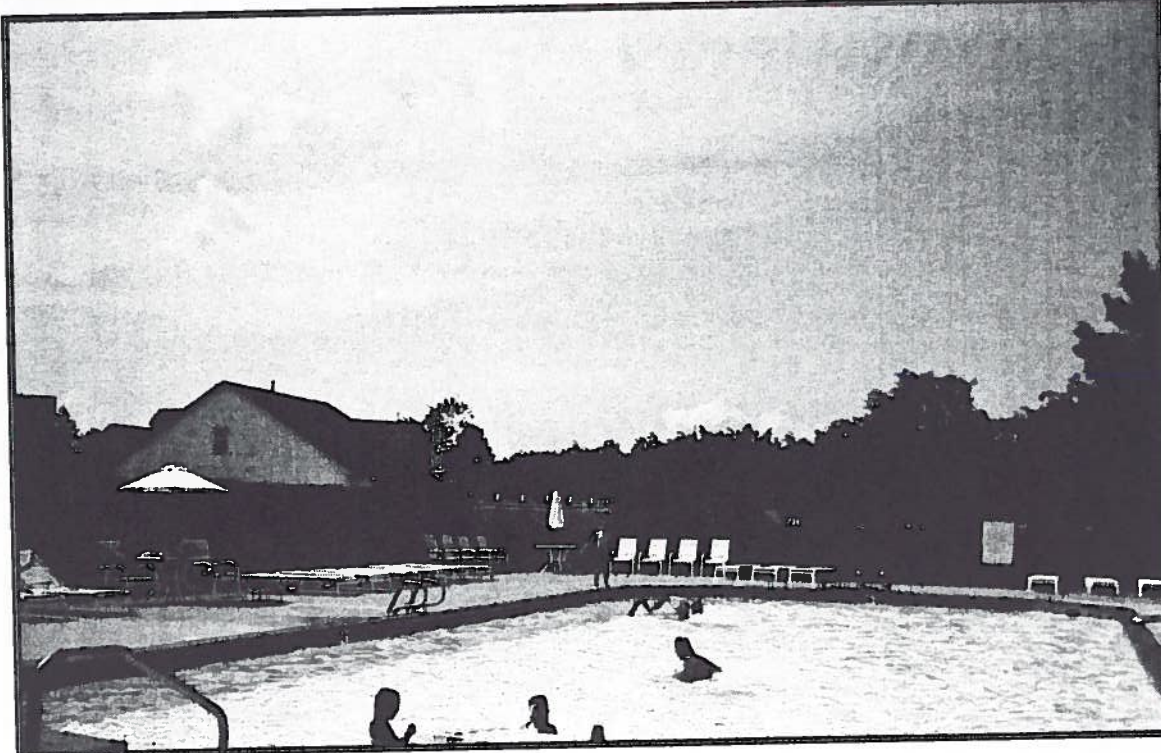
Photo Number
4

Description:
Another
view of main
pool

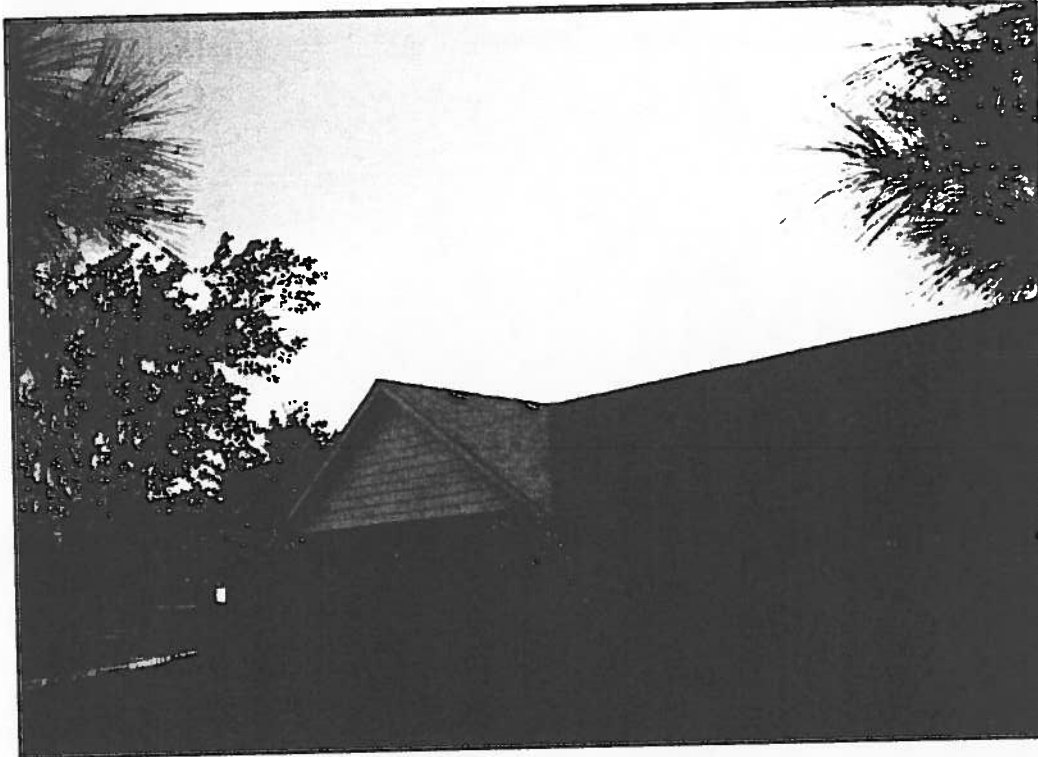
Photo Number
5

The pitched roof surface over the building is covered in 3-tab asphaltic fiberglass shingles. Roof surfacing is applied over plywood roof sheathing, and appears to be in fair-to-good condition. Typically, this type of roofing surface will last approximately twenty years and we have allocated funds to replace the shingles in 2023. We strongly recommend that any re-roofing project closely follow procedures outlined by the National Roofing Contractors Association's *Roofing and Waterproofing Manual*, Fourth Edition. A re-roofing sequence should include removal of the existing roofing material, replacement of any inadequate roof sheathing, replacement of any damaged flashing, and replacement of drip edge components.

Description:
View of pool
building roof

Note that repairs and maintenance to the vent boots and flashing components of the roof systems will likely be required in the interim. We have assumed these repairs will be funded from a general operating budget.

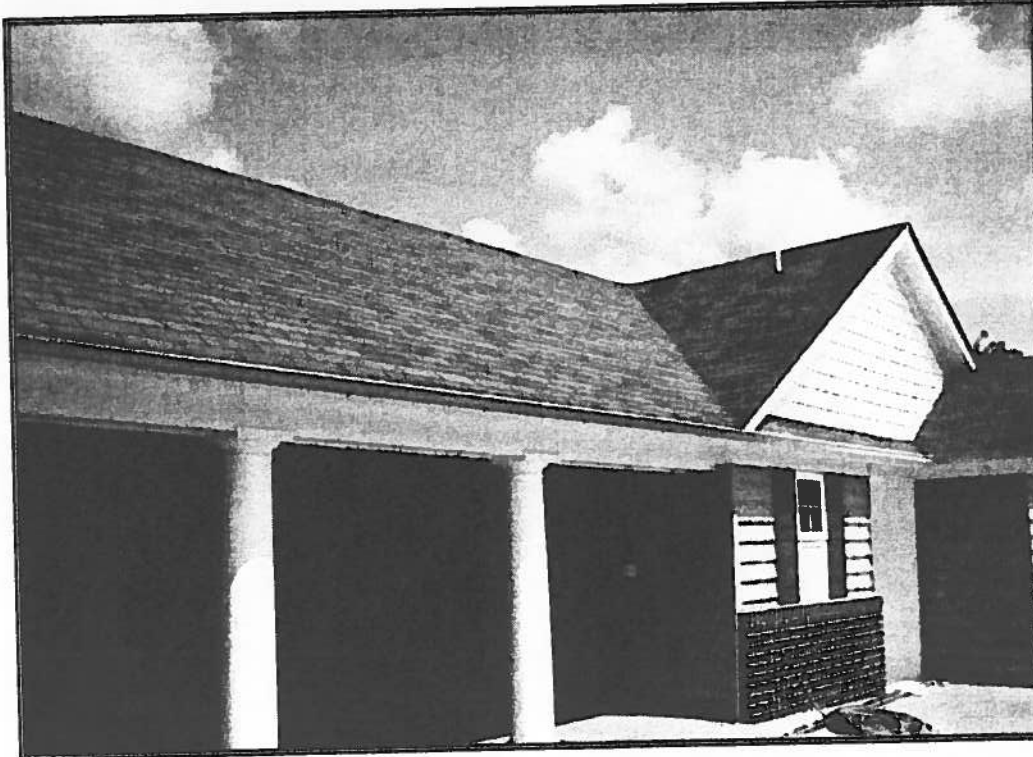
Photo Number
6

Description:
Another view of
pool building roof
and siding

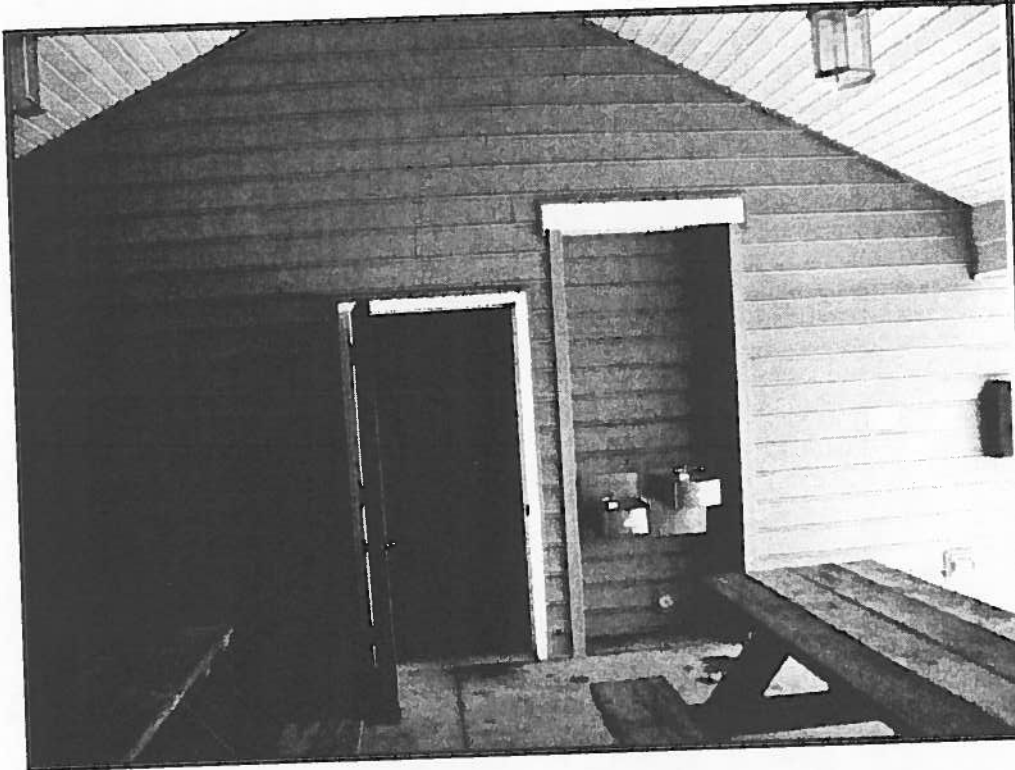
Photo Number
7

Description:
Note door leading
to restrooms,
benches and water
fountain in open
area under pool
building roof

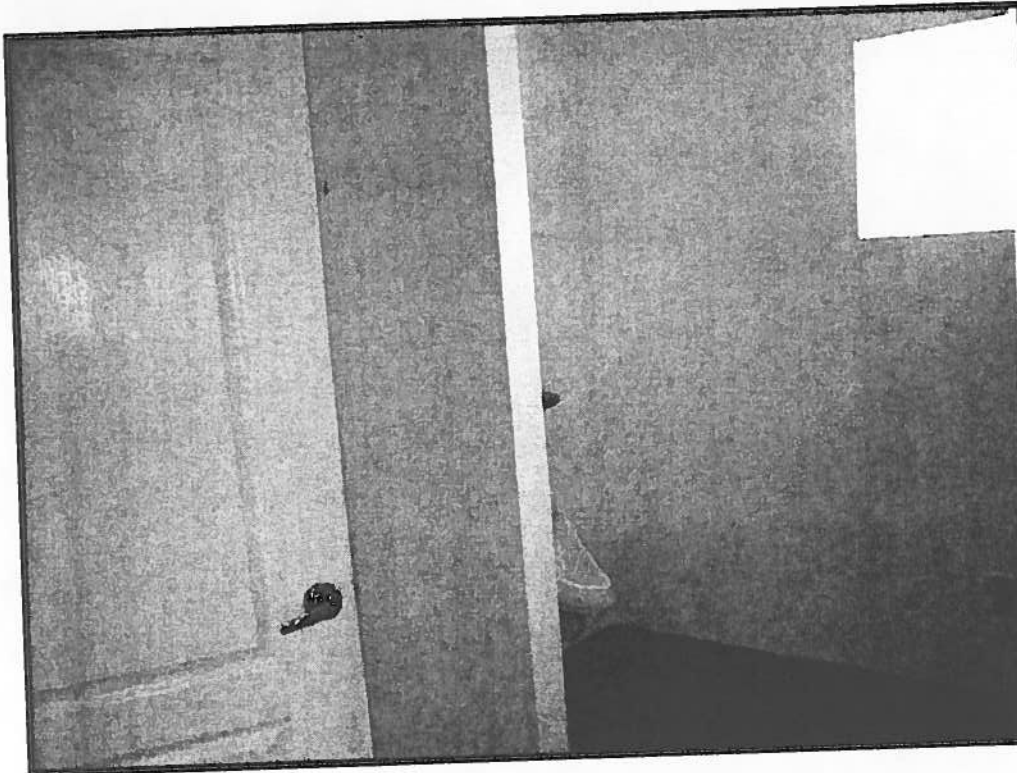
Photo Number
8

Description:
Interior view of
typical rest room

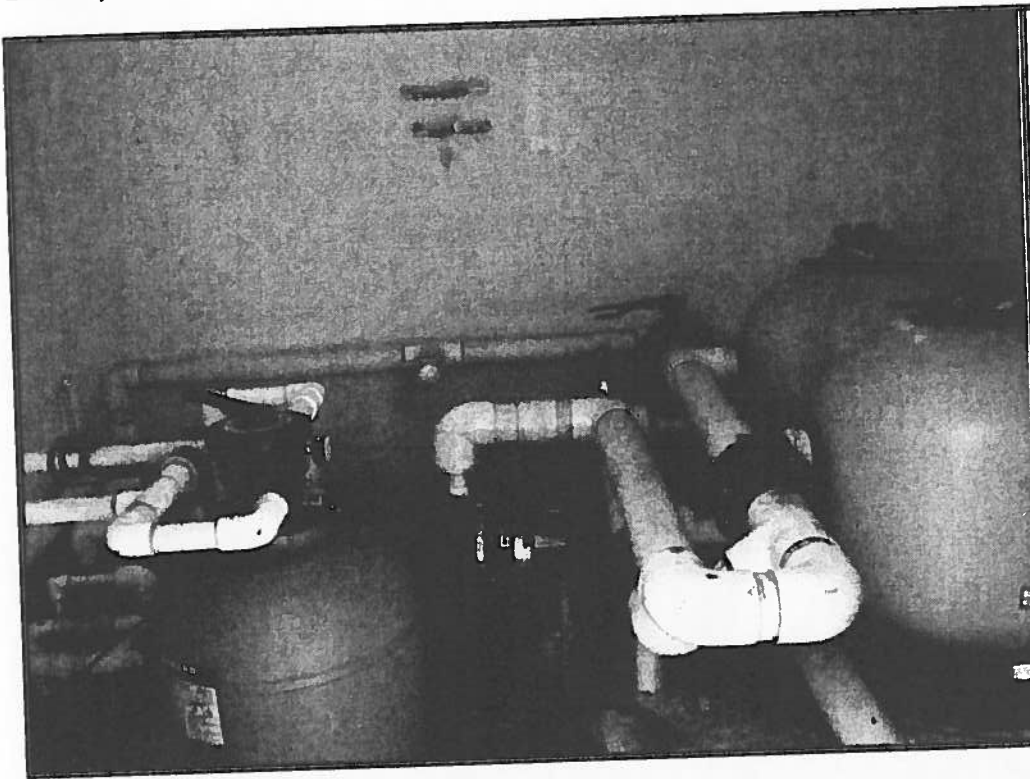
Photo Number
9

The swimming pool is served by a large 5-Horsepower electric pump, ¾-Horsepower pump (kiddie pool) and three sand filters. Chlorination equipment is also provided. We have allocated funds for major repairs of this equipment on a 12-year cycle beginning in 2015.

Description:
View of pool
filtration
equipment

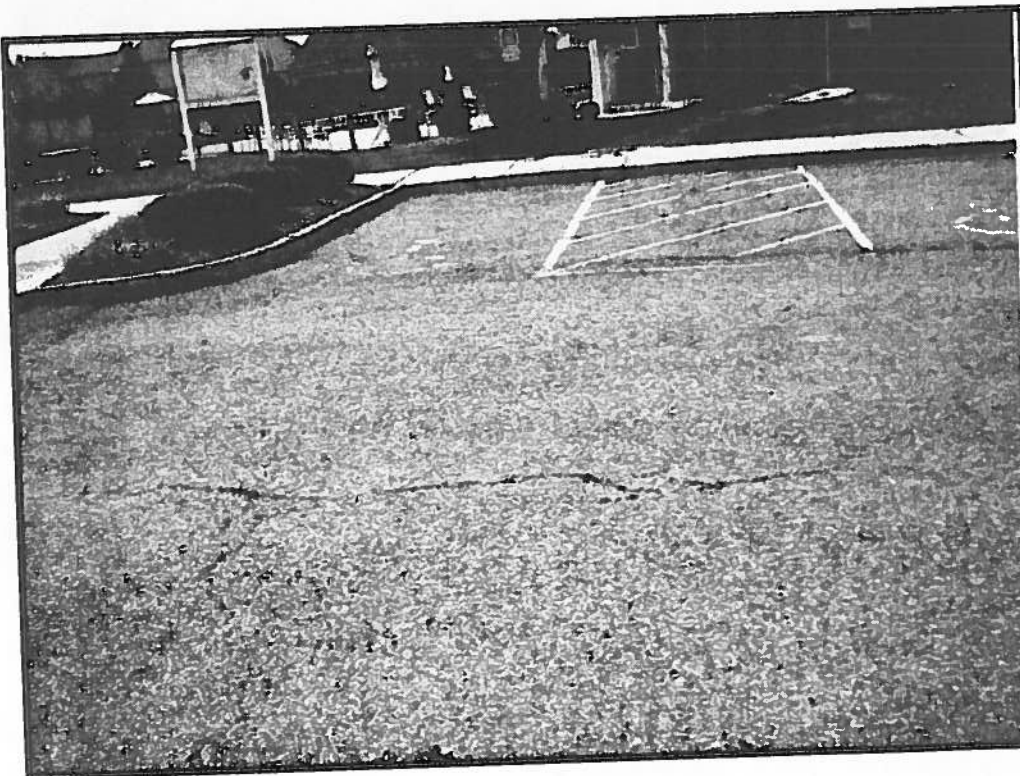
Photo Number
10

The roads throughout the community are public, but the asphalt-paved parking lot at the pool is the responsibility of the Association. No indications of major structural failure were observed in the parking lot asphalt paving; however, we did observe cracking and worn sealant/stripping in the lot.

Description:
Note cracking in
pool parking lot

Typically, we recommend the application of an oil resistant sealant to all asphalt paved surfaces on an approximately 5-year cycle. At this same time, all cracks and potholes should be properly filled, patched, and sealed. This cycle is scheduled to begin in 2013.

If sealant and crack repairs are accomplished in the interim, we anticipate the asphalt paving in the community to have an estimated useful life of approximately twenty years. We have allocated funds to resurface the asphalt paving in 2021.

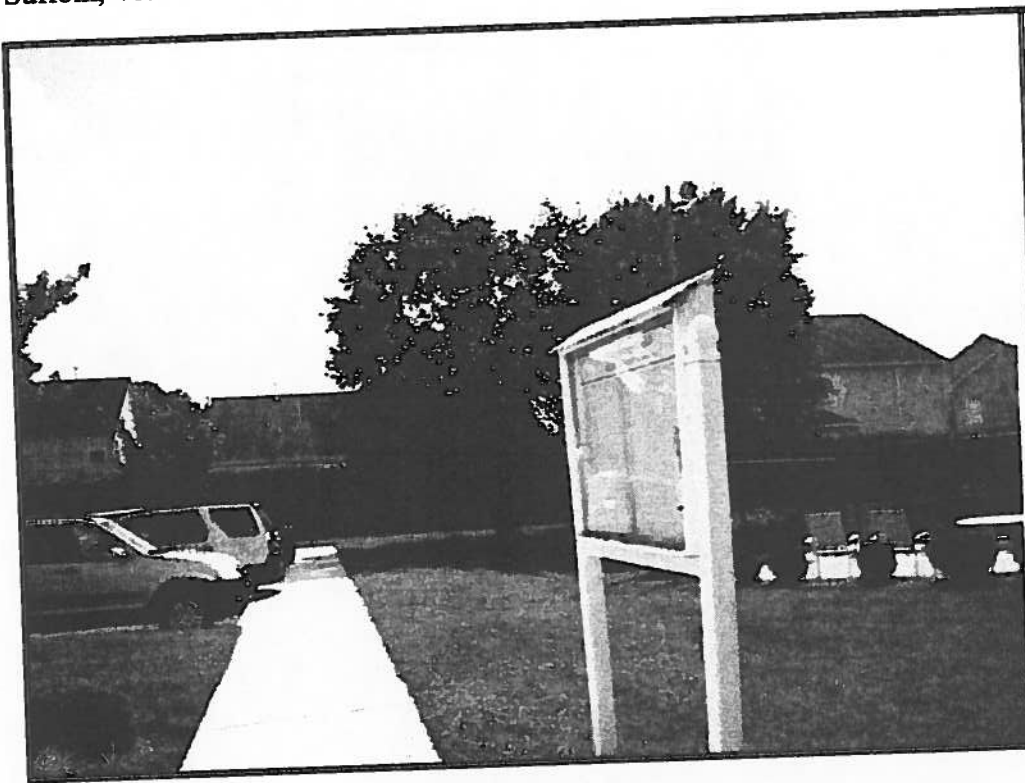
Photo Number
11

Description:
View of sidewalks
leading to pool and
bulletin board

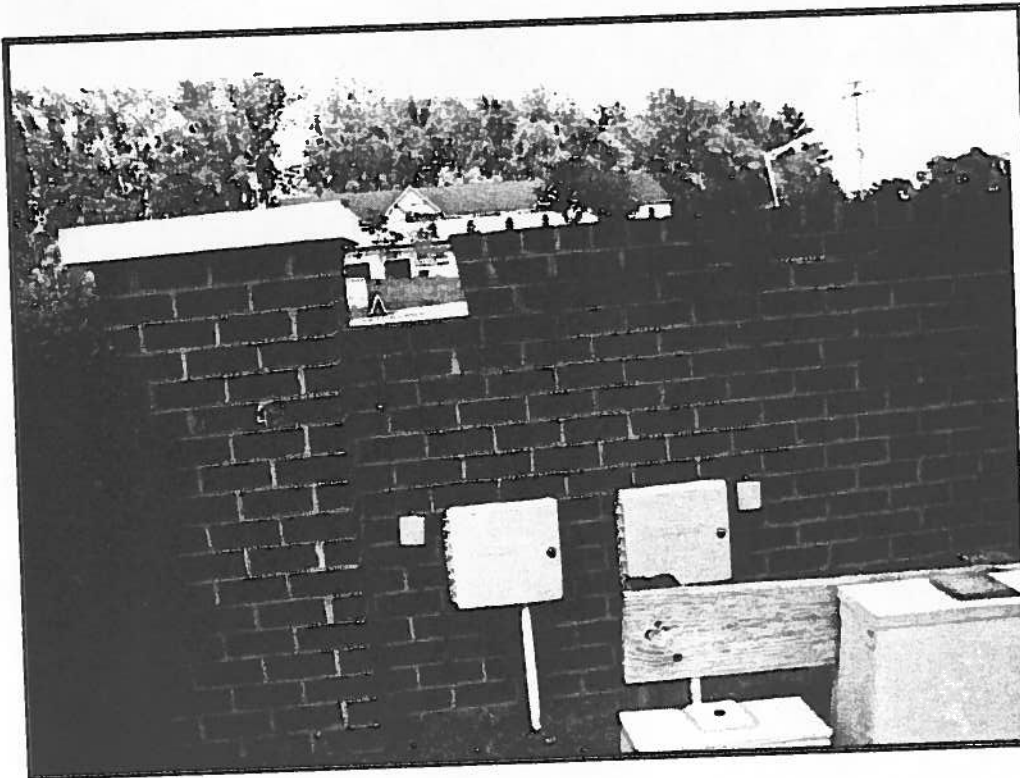
Photo Number
12

A landscape irrigation system has been installed around the common areas near the pool. We observed Hunter controls mounted on the back of the main entrance wall. Typically these systems required major repairs to heads, piping and controls on a 12-15 year cycle and we have allocated funds for major irrigation system repairs beginning in 2018. Minor repairs to damaged heads and piping should be funded from the Maintenance budget.

Description:
Sprinkler system
controls at rear of
brick monument

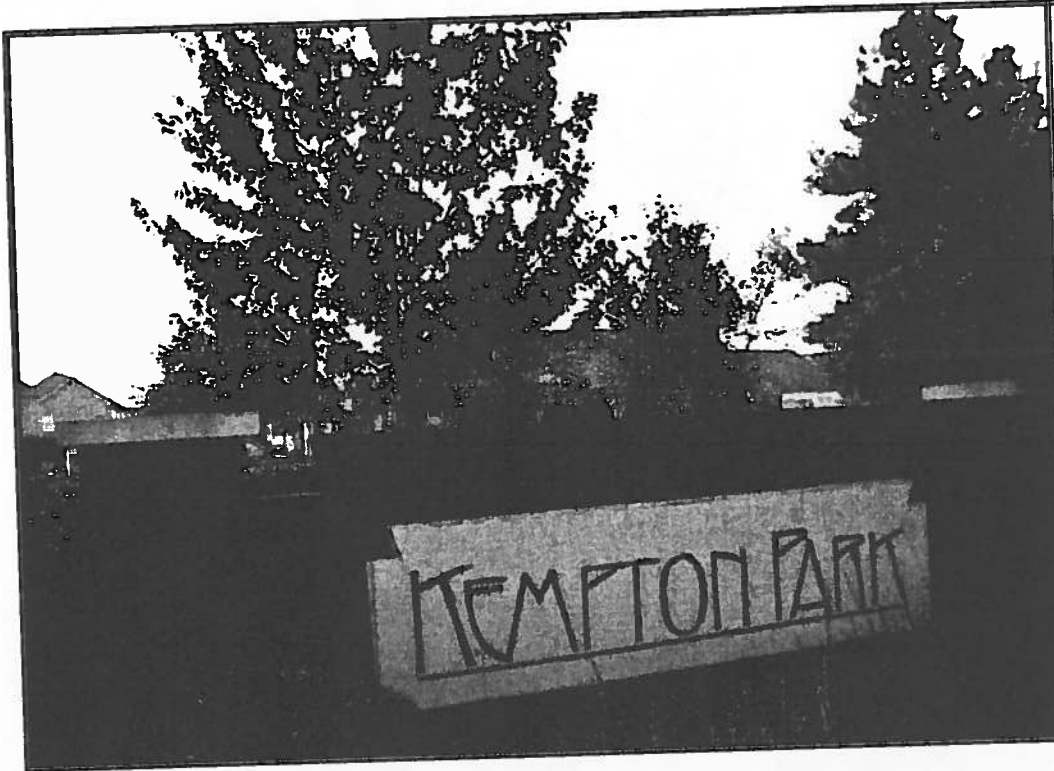
Photo Number
13

A brick entrance monument is located at the main entrance to the community at the corner of Bennetts Creek Park Road and Cheltenham Street. The sign mounted on the entrance wall monument is comprised of a painted wood/ composite material. The brick entrance wall and other brick monuments on Bennetts Creek Park Road have an expected life beyond the term of this analysis. The Kempton Park sign is showing signs of wear and we have scheduled replacement of the sign beginning in 2015.

Description:
View of
community
entrance signage
near pool

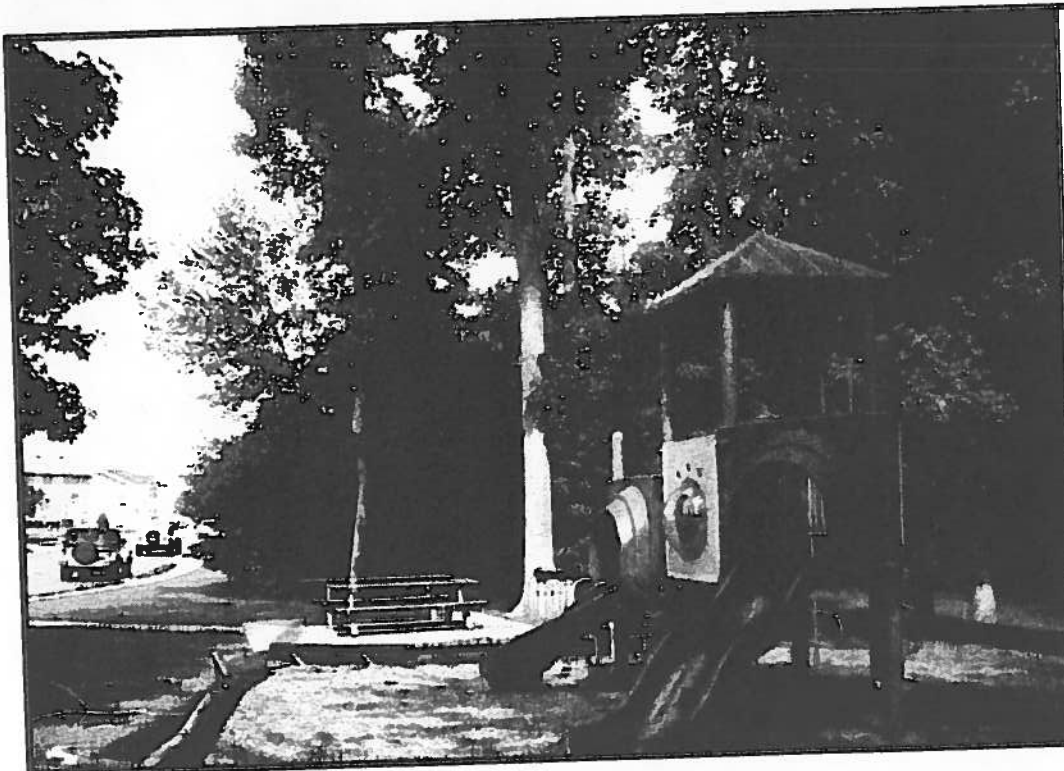
Photo Number
14

Description:
View of small
park and
playground
equipment

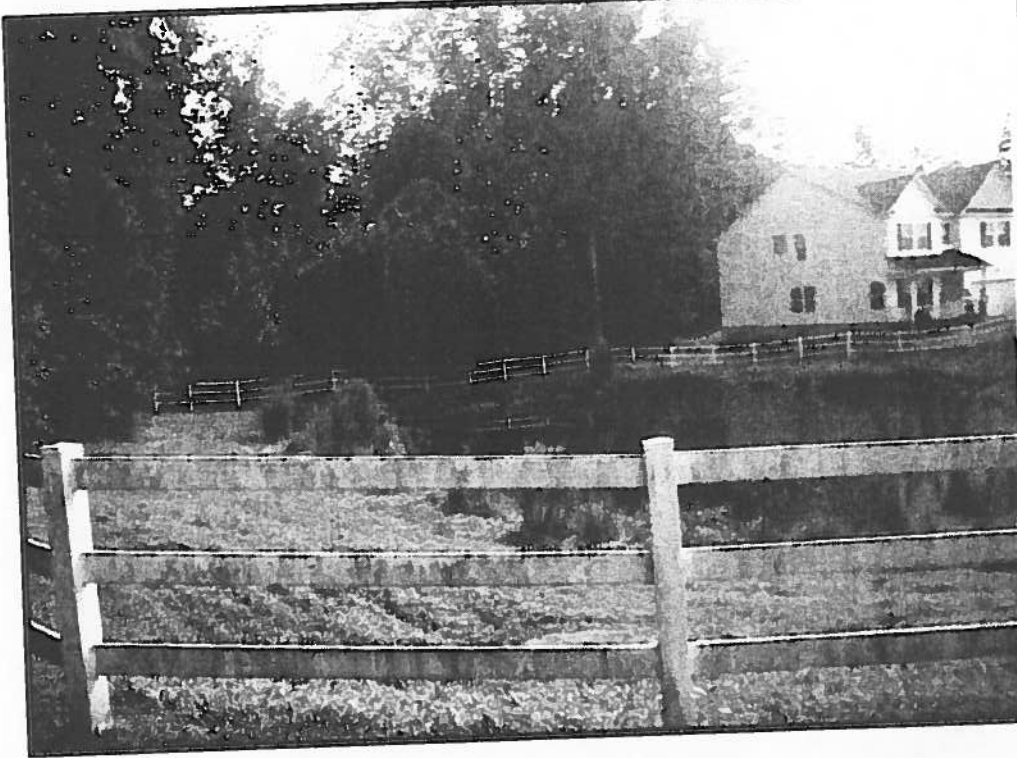
Photo Number
15

Description:
Stormwater pond
and PVC fence at
Kelso Street and
Kempton Park Rd

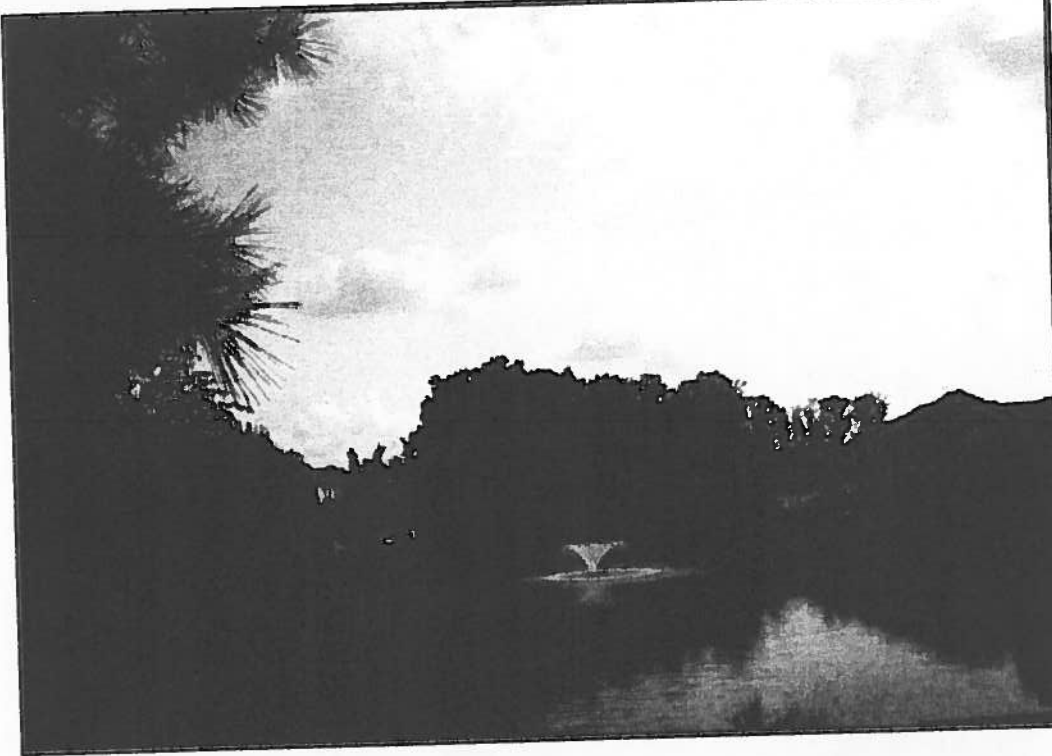
Photo Number
17

Description:
Pond with fountain
between subject
neighborhood and
adjacent
community

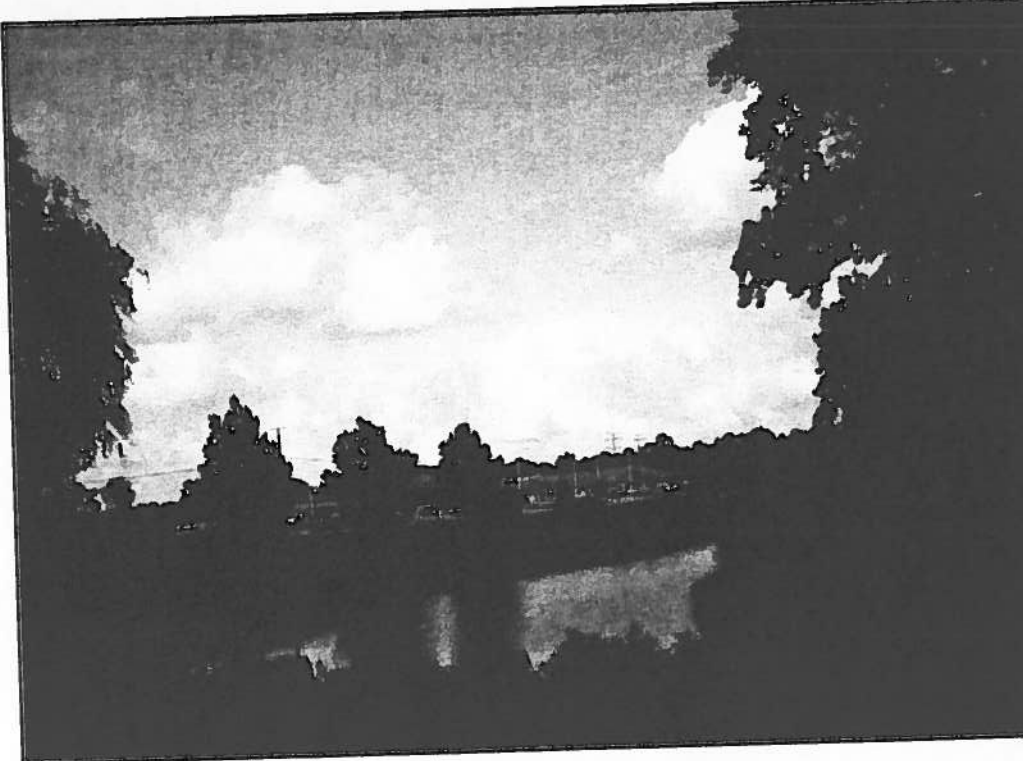
Photo Number
18

Description:
Stormwater pond
near 5000 Kelso
