Oil Hole Crack of Crankshaft During Induction Hardening

DANTE Solutions, Inc.

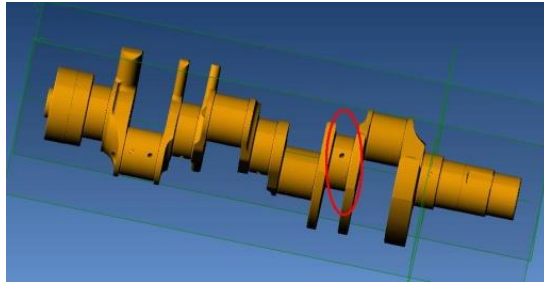
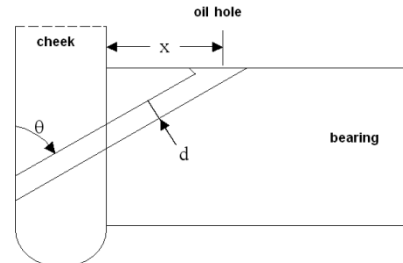
CAD Model Shows the Location of Oil Hole. Schematic Plot Shows the Hole Angle to Bearing Section Surface. During Induction Heating, the Power Density Around the Hole is Nonuniform.

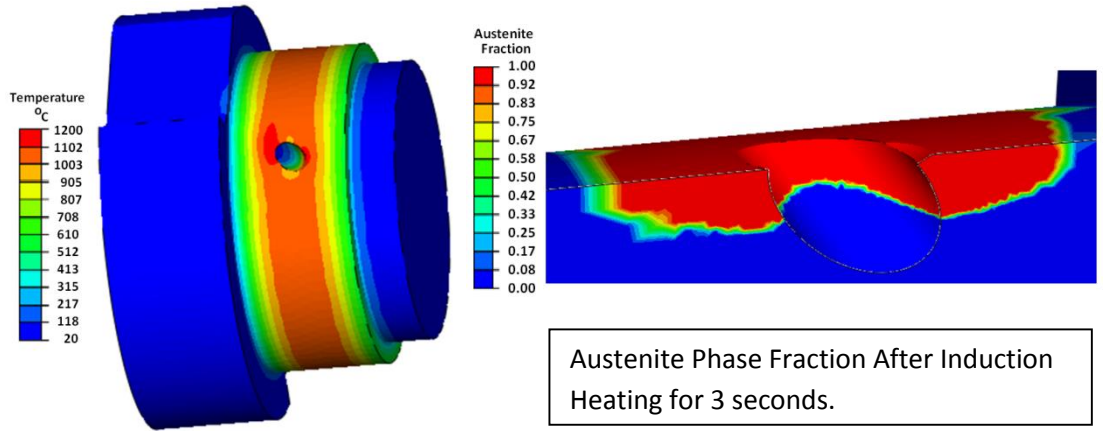
Temperature Distribution Showing Nonuniform Temperature Around Oil Hole.

Austenite Phase Fraction After Induction Heating for 3 seconds.

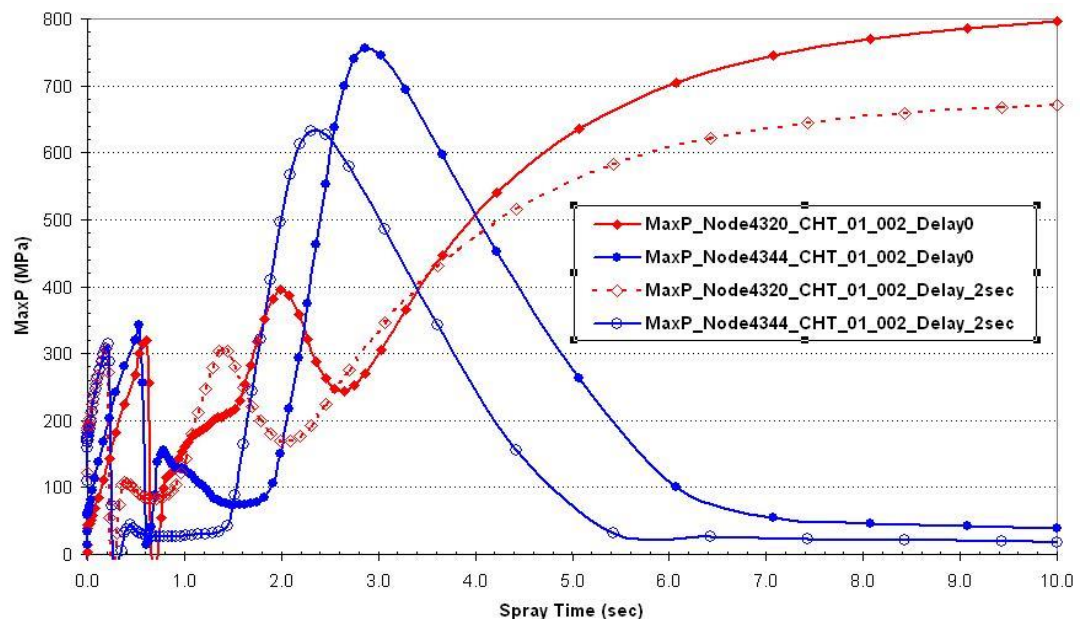
Comparison of Maximum Principal Stress at Two Locations Showing the Benefit of Quench Delay.

The nonuniform heating condition from an induction heating model is mapped into DANTE. Spray quenching and resultant thermal stresses and phase changes are then predicted. The process cycle and spray application were changed to reduce in-process stresses.
