**Three Horizons North C.A.  
SIRS Components  
*North Miami, FL***

Report #: 38214-1  
Beginning: January 1, 2025  
Expires: December 31, 2025

**RESERVE STUDY**  
**Update "With-Site-Visit"**

January 24, 2024

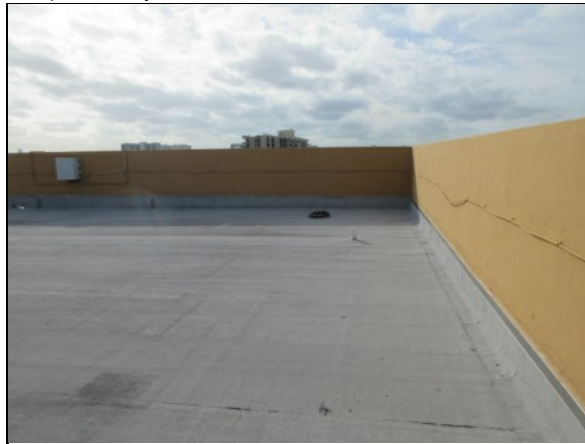
### Comp #: 2377 Roofing (Mod. Bitumen) - Replace

Useful Life:  
20 years

Remaining Life:  
15 years

Best Case: \$ 300,000

Worst Case: \$ 500,000
