RESERVE FUND STUDY
REPORT

***SIERRAS ON THE LAKE
CONDOMINIUM CORPORATION***

CONDOMINIUM PLAN No. 032 3690

April 2021
Final

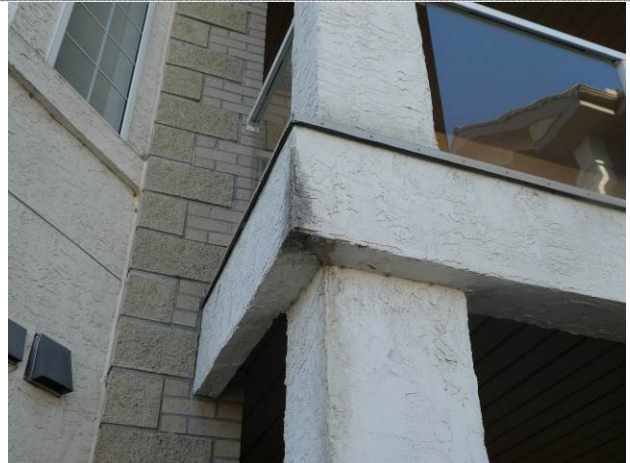
- The building is clad with stucco and brick.
- Stucco and brick are in fair condition with a few areas of premature deterioration.
 - Balcony fascia
 - Interior corners
- Complete replacement should not be required if maintenance is completed regularly.

Stained stucco on balcony fascia – indicative of poor water drainage

- Funds are allocated every 4 years to complete major repairs to stucco and brick. Repairs should be completed within the next year. Continuous patching and repairing will ensure the life of the stucco.
- Funds are allocated in 40 years to refurbish the stucco. Refurbishment would include further patching, cleaning and applying a thin fog coat over the existing stucco. It is not recommended that stucco be painted.

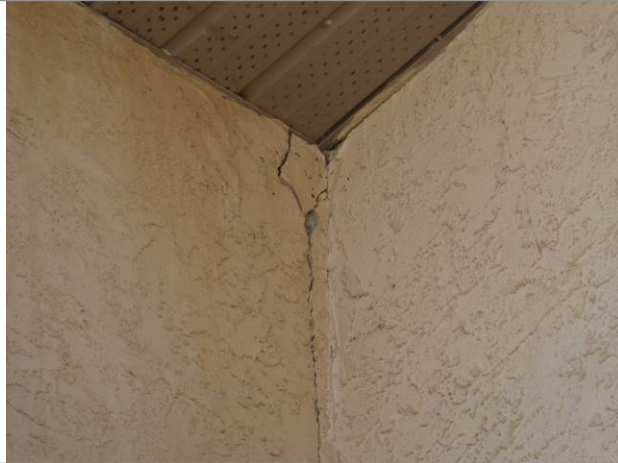
Damaged stucco at interior corner

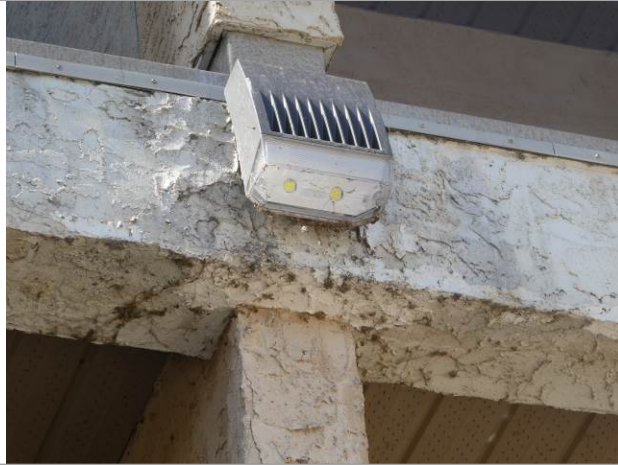
Stained stucco on balcony fascia – indicative of poor water drainage

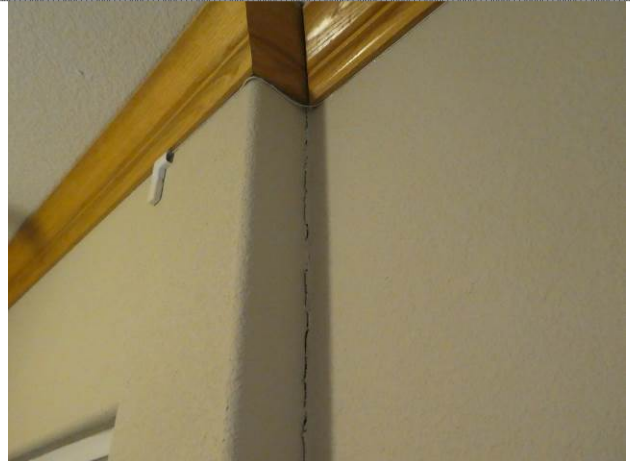
- Paint finishes include walls & ceilings. Some settlement cracking and wear were noted.
- The ceiling has been removed in the party room to repair a pipe leak.

Cracking in wall finish

- Repair ceiling in party room this year.
- All walls & ceilings in the hallways, main floor common rooms & pool should be painted within the next 5 – 8 years.

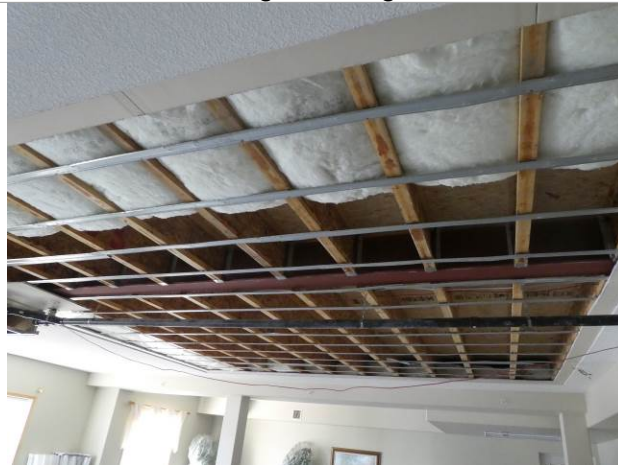
Missing ceiling in party room

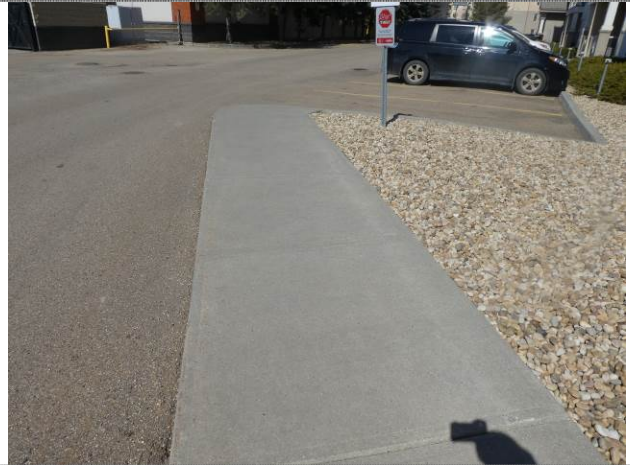
- Concrete walkways are in fair condition.
- Some minor deterioration was noted. Previous patch was noted.

Patched walkway

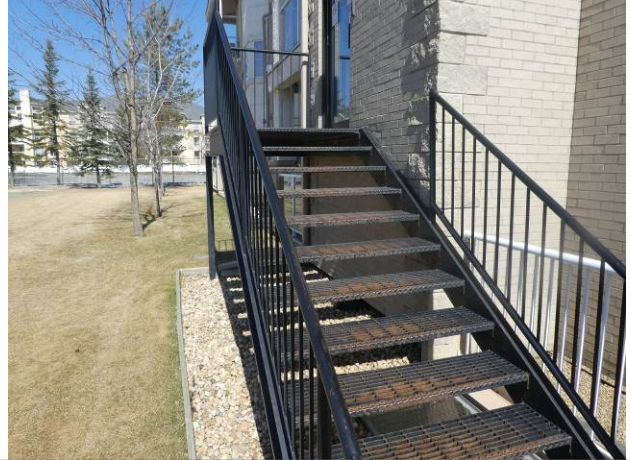
Metal stairs rusted
