## RESERVE FUND STUDY REPORT

# ***SIERRAS ON THE LAKE CONDOMINIUM CORPORATION***

CONDOMINIUM PLAN No. 022 6881

MAY 2026  
FINAL

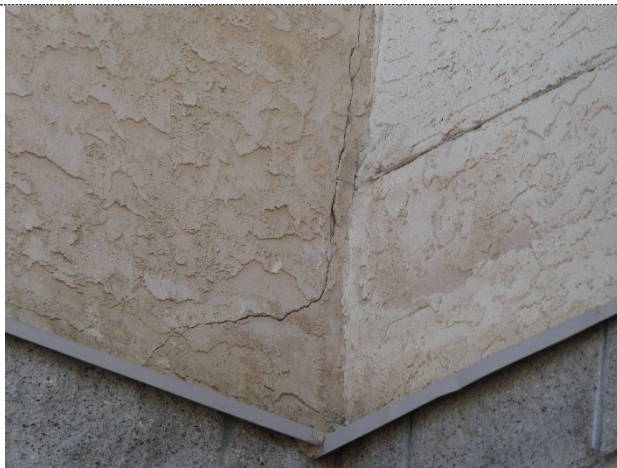
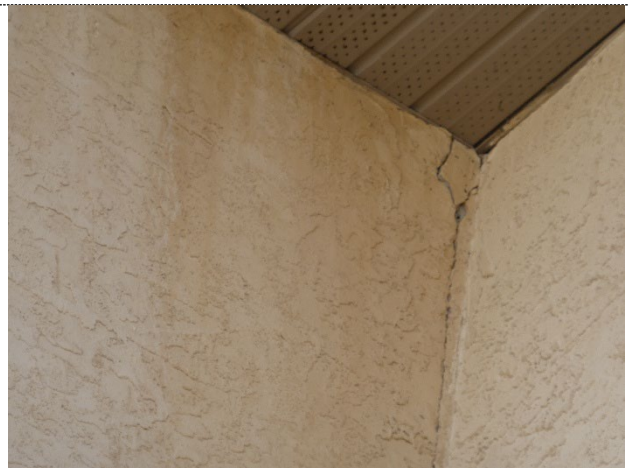
Cracked stucco

| Component # | Recommendation | Page # in Report |
|---|---|---|
| 4.0 | Building is clad with stucco & brick veneer. Stucco is evidencing some deterioration. Funds are allocated within the next 2 years and every 4 years to repair exterior finishes of the building. Ongoing repair is necessary to eliminate complete replacement of stucco & brick veneer. | <u>20</u> |

| <b>Exterior Finishes – Major Repair – continued</b> | |
|---|---|
| – Funds are allocated every 4 years to repair exterior finishes. Ongoing repair will ensure that complete replacement is not required. Repair damages within the next 2 years. | |

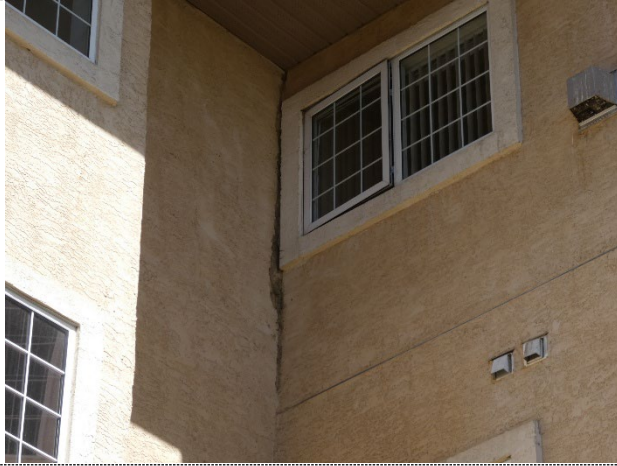
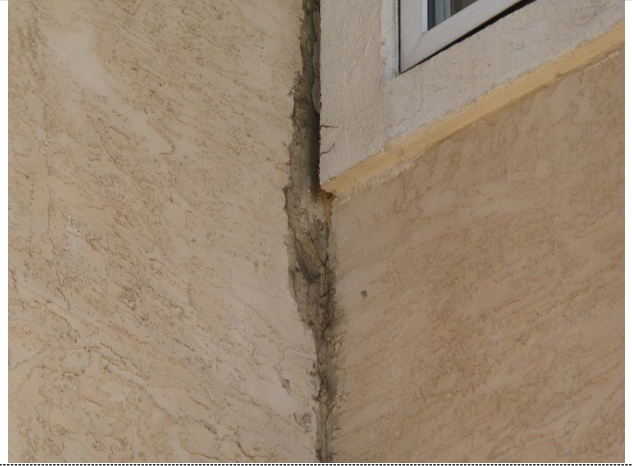
Cracked/damaged stucco

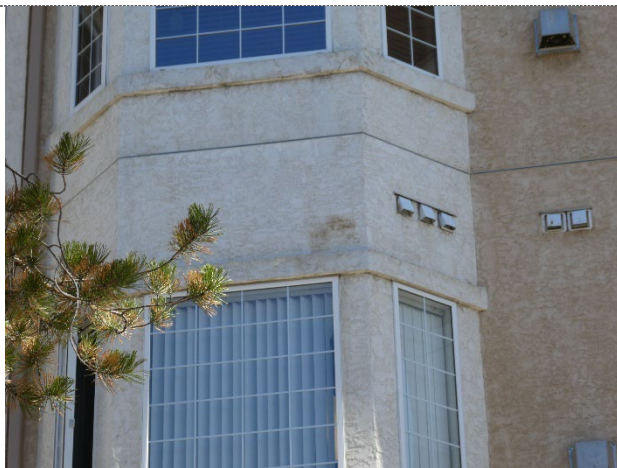
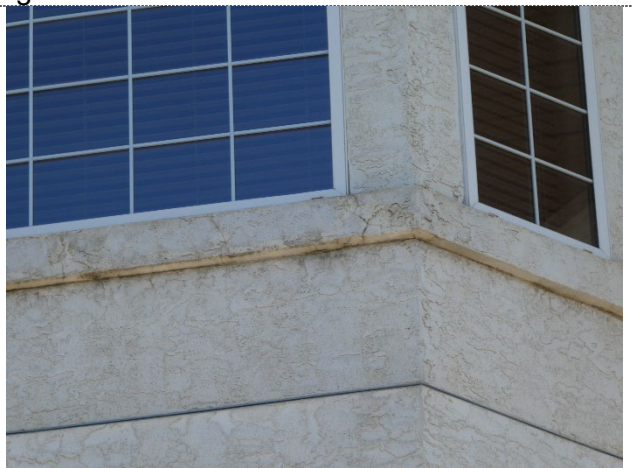
Deteriorated stucco – architectural reveals

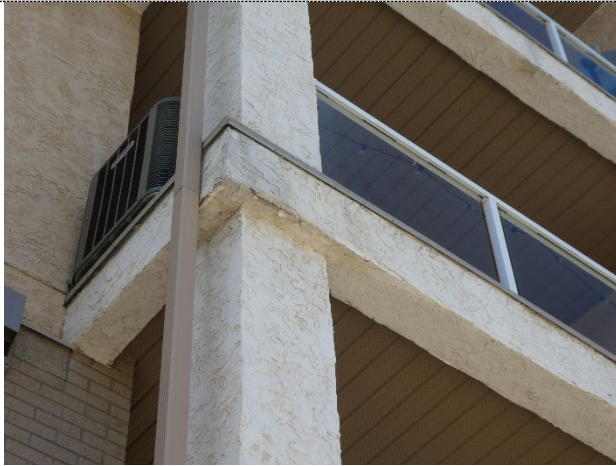
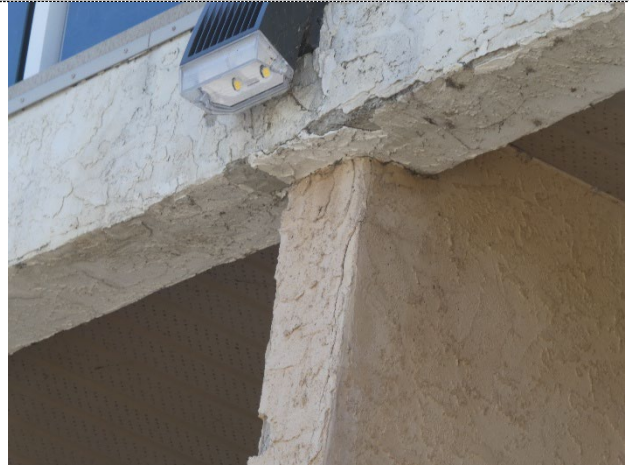
Deteriorated stucco on balcony fascia

- Balcony membranes will require replacement within the next 7 – 8 years.
- Stucco covered balcony posts & fascia should be replaced with vinyl/metal within the next 7 – 8 years in conjunction with membrane replacement.

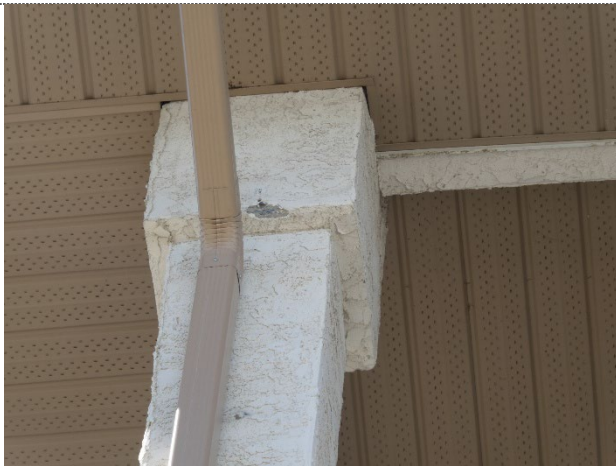
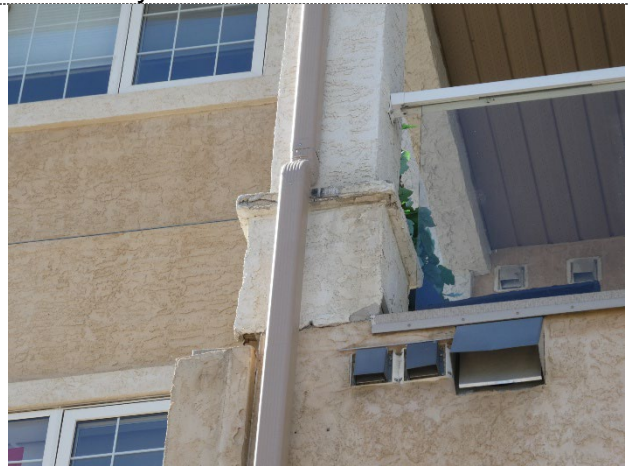
Deteriorated stucco

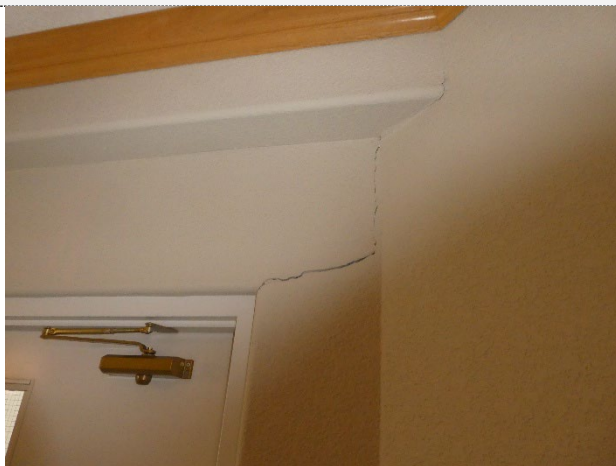
Settlement cracking (northwest corner)

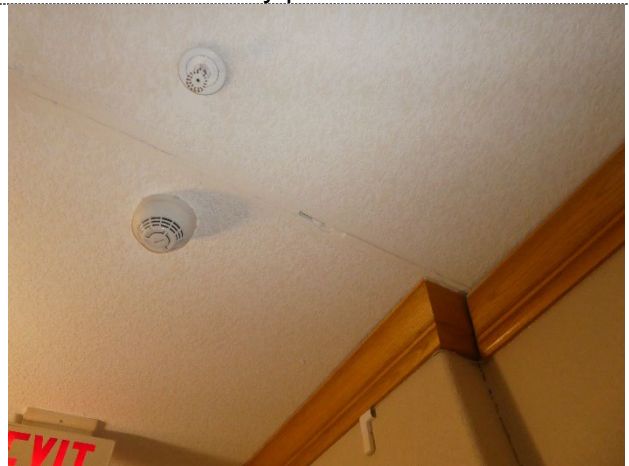
Cracking in ceiling

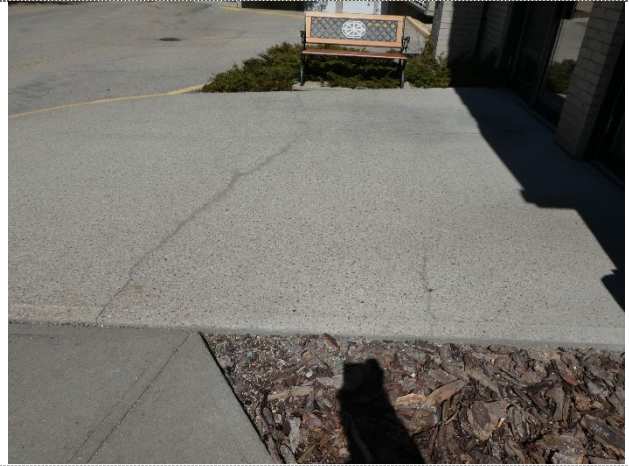
Cracking & spalling at entrance walkway

| Component # | Recommendation | Page # in Report |
|---|---|---|
| 24.0 | Approximately 1/3 (860 sqft) of concrete walkways should be replaced within the next 5 years. | <u>64</u> |

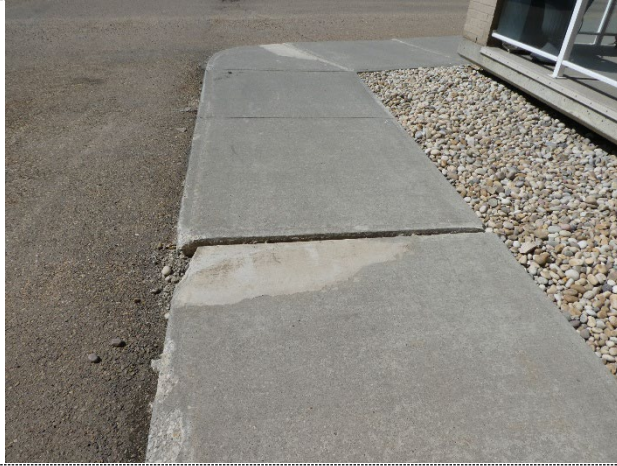
Damaged walkway

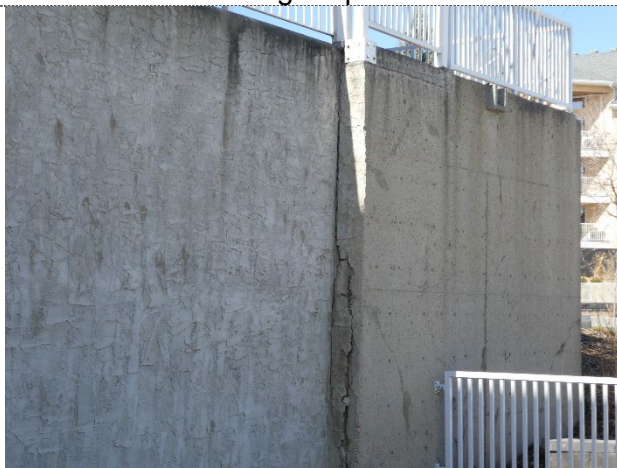
Damaged retaining wall
