National Transportation Safety Board

Aircraft Accident Brief

Accident Number:	CHI01MA011
Operator/Flight Number:	N/A
Aircraft and Registration:	Cessna 335, N8354N
Location:	Hillsboro, Missouri
Date:	October 16, 2000

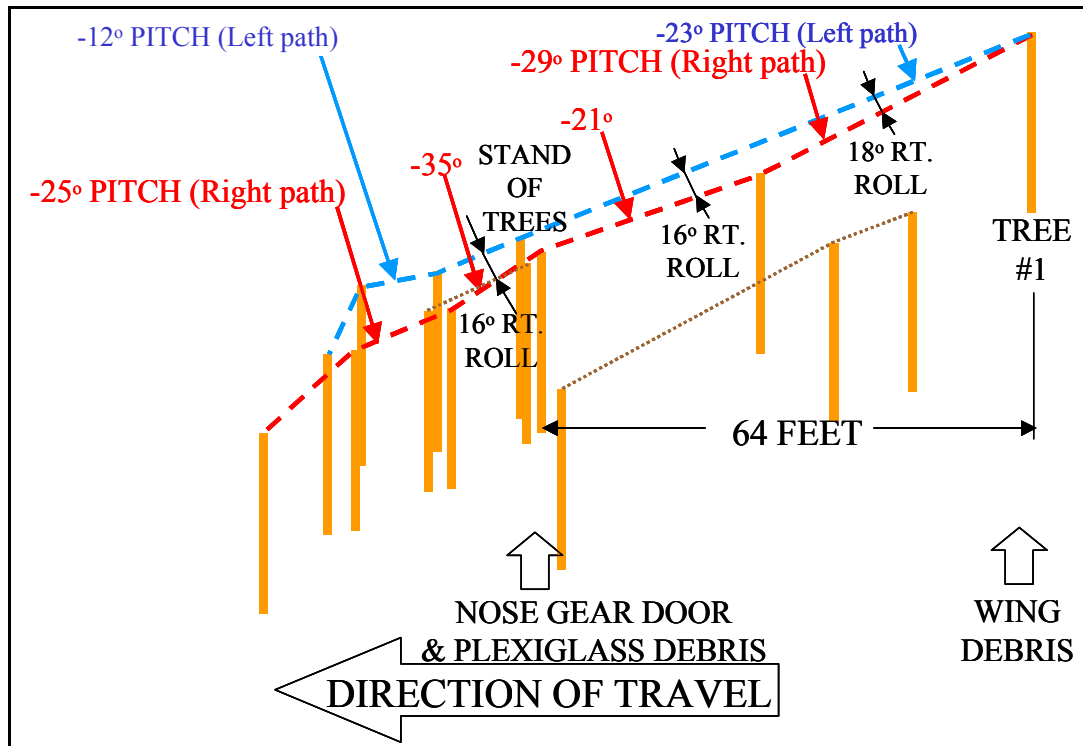
Figure 1. Diagram showing the side-view of the broken tree tops, construction lines that connect the trees along the direction of travel, and attitude lines with respect to a horizontal plane. Each vertical line represents the base and top of a remaining tree.

A laser-based measuring device was used to document the accident site. Data from the laser survey were used to create a three-dimensional model of the airplane's flightpath through the trees. The model and the inspection of the accident site revealed that the airplane was in a 16° to 18° right-wing-down attitude during its entry into the trees. (See figure 1.)

No evidence of an in-flight fire or in-flight structural failure was noted. All of the examined fracture surfaces exhibited evidence of overload failure.

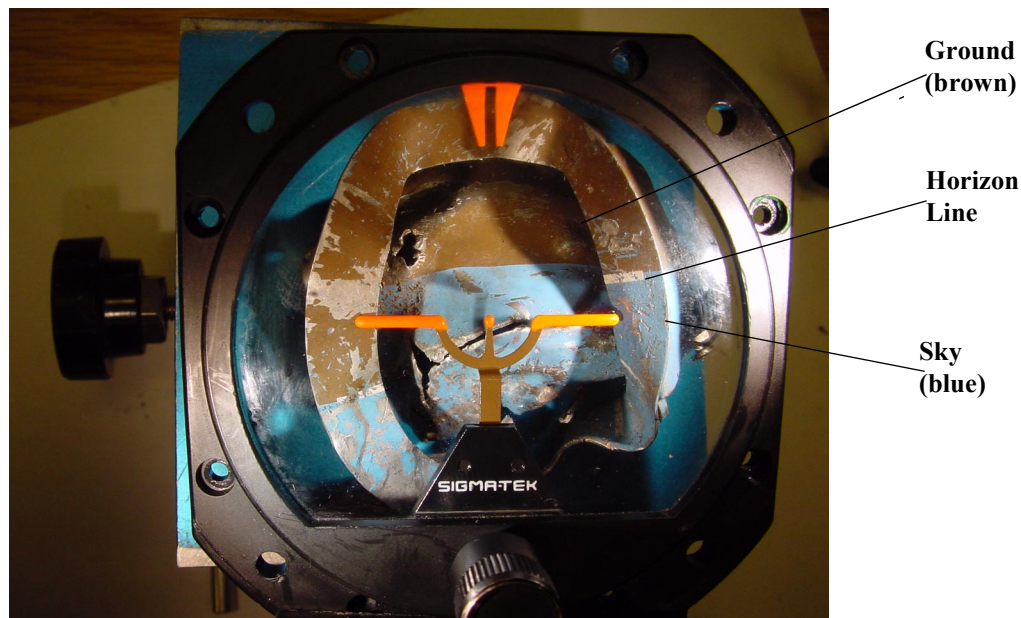
Figure 4. Photograph showing the face of the accident airplane's primary attitude indicator behind that of an exemplar instrument.

Damage on the facial roll ring resembled the shape of the triangular airplane support housing and the roll index that had been fixed to the instrument case. The relative positions of the damage resembling the triangular support and roll index were on the top and bottom of the ring, respectively, when it was placed at an inverted display of attitude. The face of the instrument was placed behind that of an exemplar instrument and, using the damage on the roll ring for alignment, the marks were within 2° of a wings-level inverted attitude. (See figure 4.)

On the basis of the examination of the left-side (primary) attitude indicator, it was determined that the rotor was most likely spinning, but not at a high enough rpm to keep the display erect (the wreckage fragments of the left-side attitude indicator clearly aligned in an inverted attitude), indicating that this attitude indicator was not displaying properly at the time of impact. Although the pilot reported that his primary attitude indicator had failed and examination of the attitude indicator supported that such a failure had occurred, the investigation could not determine the cause of the failure in that instrument.

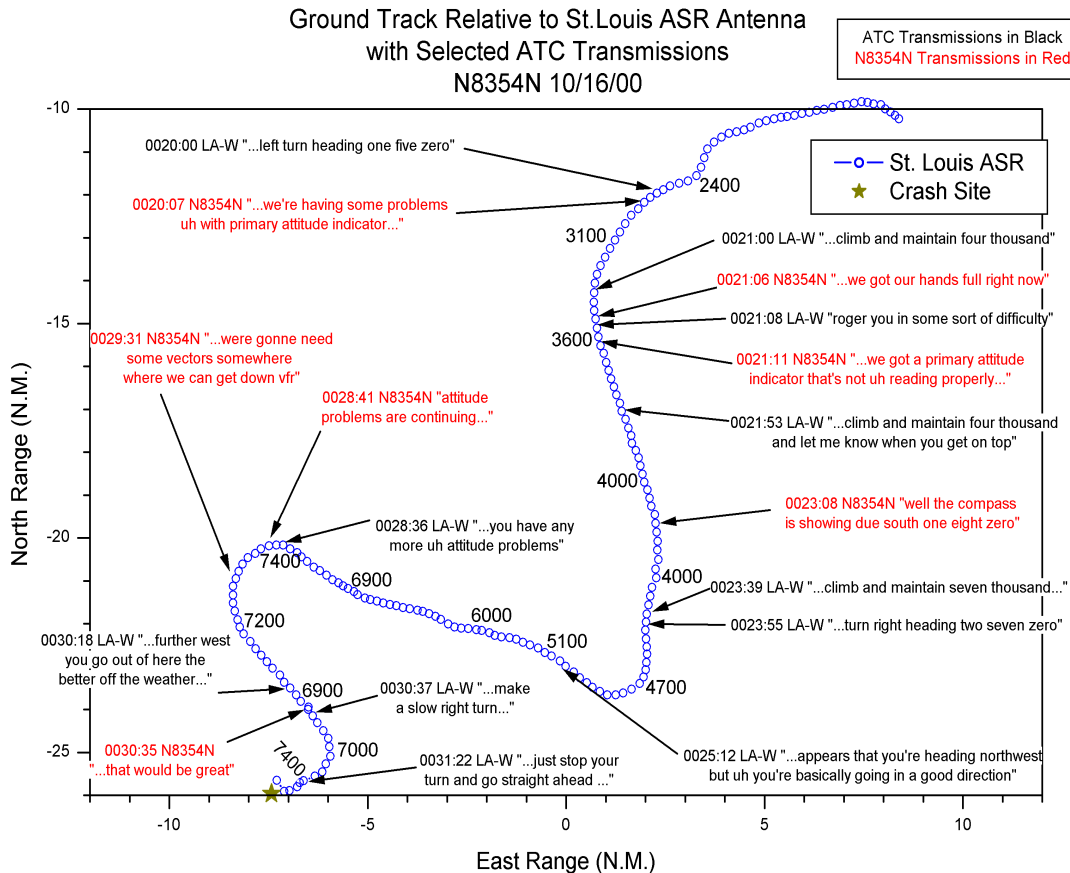
Figure 5. Ground track of the accident airplane's last 12 minutes of flight.

At 1923:55, the St. Louis LW controller instructed the pilot to turn right to a heading of 270°, and, at 1924:04, the controller instructed the pilot to climb to and maintain 7,000 feet. The airplane began the climb and turned right maintaining about a 3.5°-per-second heading change. Calculations show that this turn required an airplane bank angle of 30° and that the airspeed increased to greater than 150 knots. The turn was completed at an altitude of about 5,000 feet, and the airplane continued the climb at 120 knots. By 1928:00, the airplane reached 7,000 feet at a heading of about 300° as the airspeed accelerated to 150 knots. At 1928:30, the airplane began a left turn to the southeast to a heading of about 140° at an altitude that varied between 7,100 and 7,400 feet. The calculated bank angle in the turn was about 25°.

Following the LW controller's instruction to make a slow right turn at 1930:37, the airplane began turning to the right. Calculations reveal that, during the turn, the airplane descended to about 6,800 feet while maintaining an airspeed of about 150 knots. The airplane then descended to about 6,500 feet and then climbed at over 3,000 feet per minute (fpm) for the next several seconds. The airspeed was calculated to be about 120 knots during the climb, with a bank angle of approximately 25°. At 1931:31, the airplane reached its maximum altitude of 7,700 feet.
