# Inspection Report

Survey reference – 17

Adirondack Septic Tank, Inc.

# 1 Drain / Sewer Survey

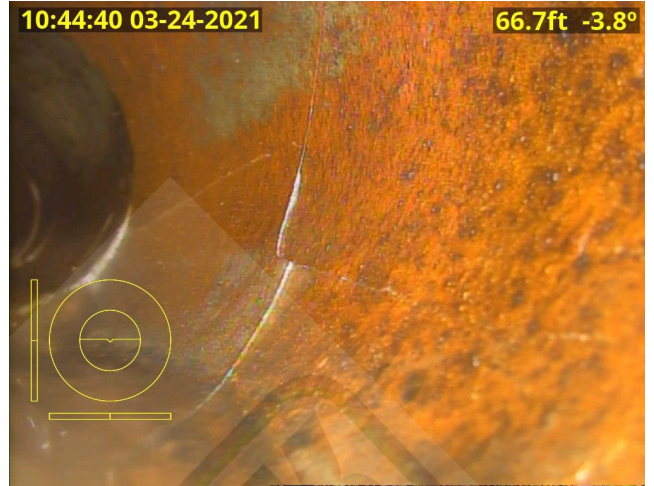
CM 2021\_03\_24-10\_44\_40\_519.jpg

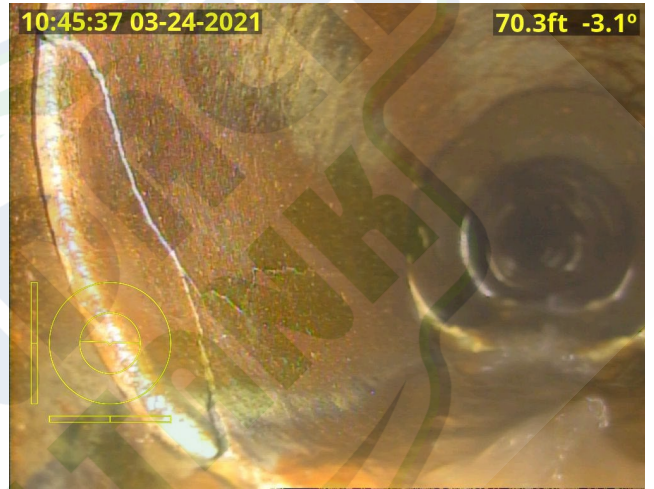
CC 2021\_03\_24-10\_45\_37\_842.jpg

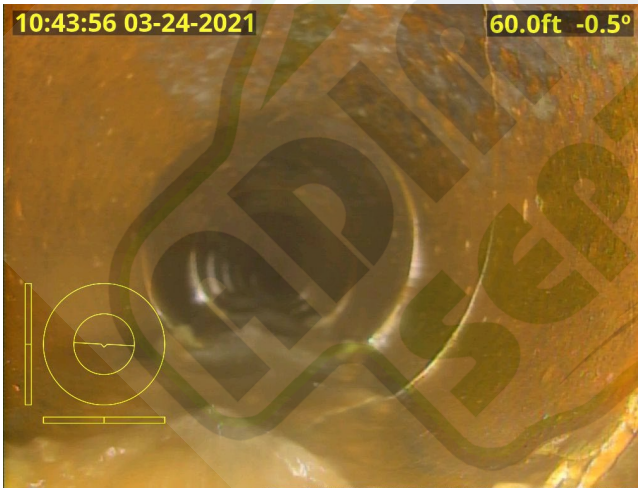
CC 2021\_03\_24-10\_43\_56\_970.jpg

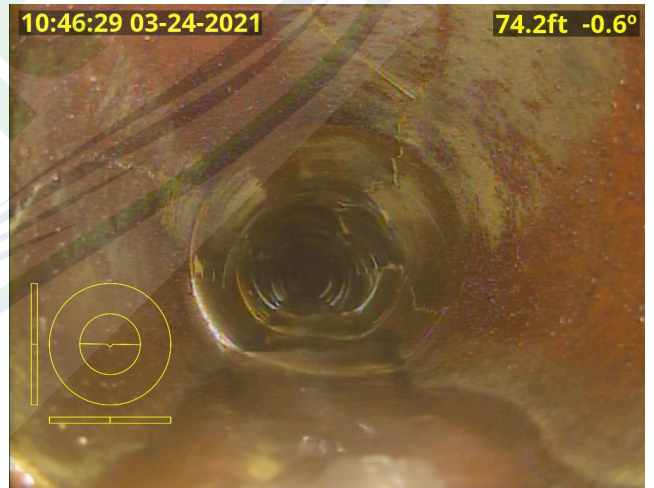
CM 2021\_03\_24-10\_46\_29\_294.jpg

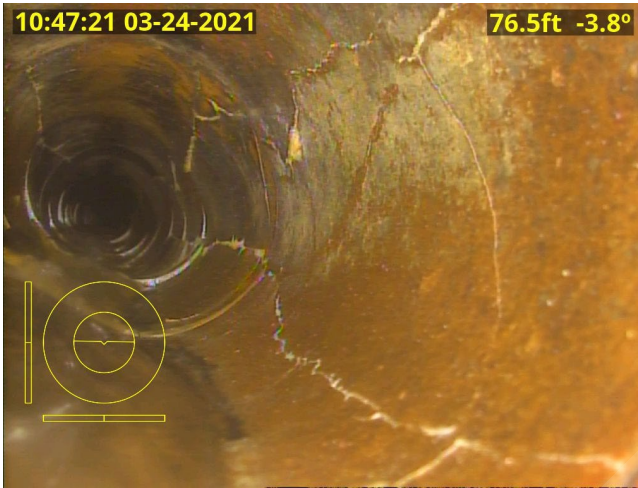
CM 2021\_03\_24-10\_47\_21\_277.jpg

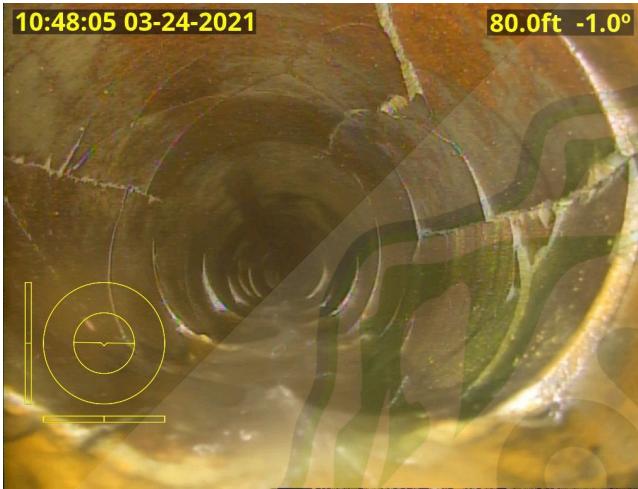
CM 2021\_03\_24-10\_48\_05\_855.jpg

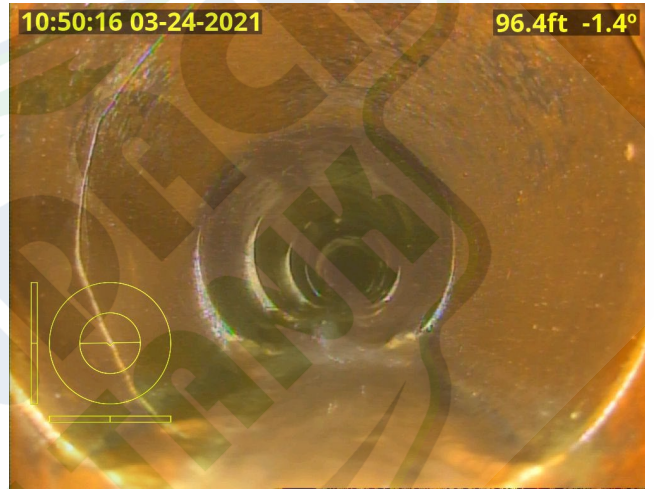
CC 2021\_03\_24-10\_50\_16\_300.jpg

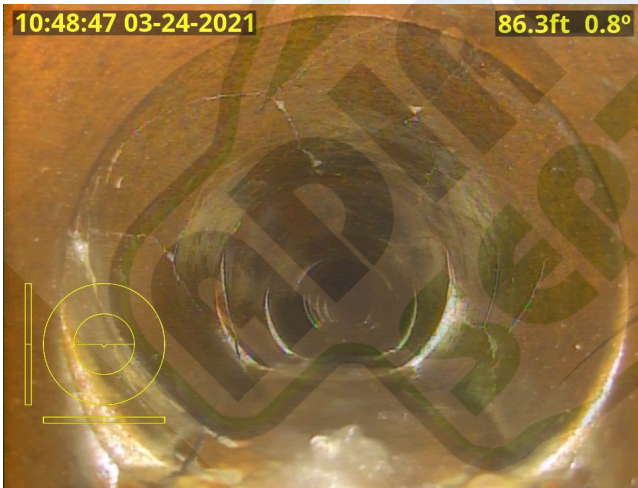
CM 2021\_03\_24-10\_48\_47\_819.jpg

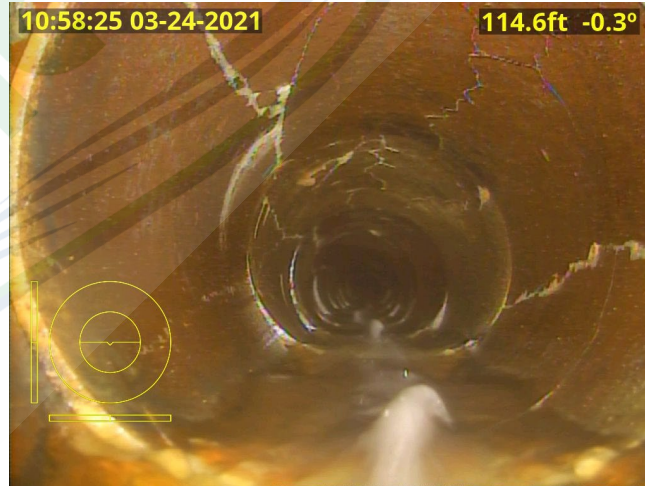
12	12			
0:17:56	114.6		CM	2021_03_24-10_58_25_387.jpg

CM 2021\_03\_24-10\_58\_25\_387.jpg

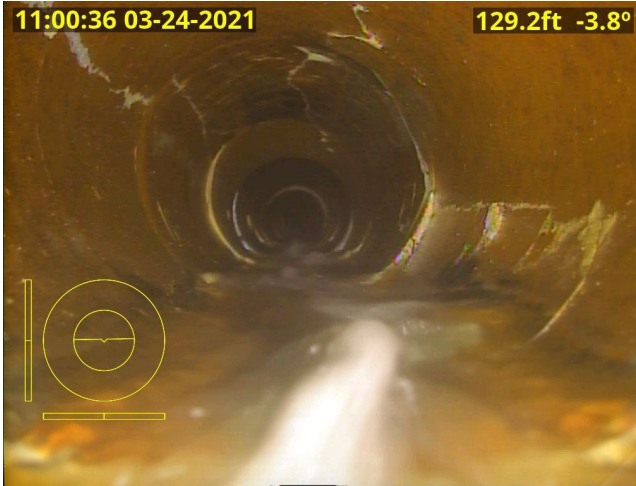
12	12			
0:19:41	129.2		CM	2021_03_24-11_00_36_949.jpg

CM 2021\_03\_24-11\_00\_36\_949.jpg

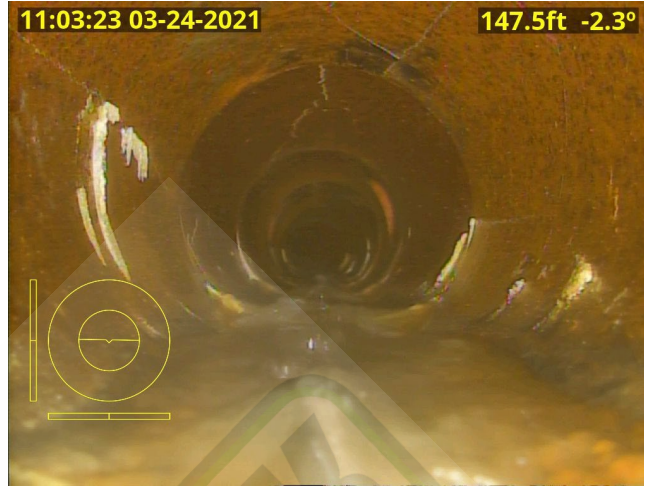
4"	12				OFFSET LATERAL CONNECTION
0:21:28	147.5		CM	2021_03_24-11_03_23_741.jpg

CM 2021\_03\_24-11\_03\_23\_741.jpg
