# Inspection Report

Produced on behalf of – SAMPLE

Site location – CITY STREET

Adirondack Septic Tank, Inc.

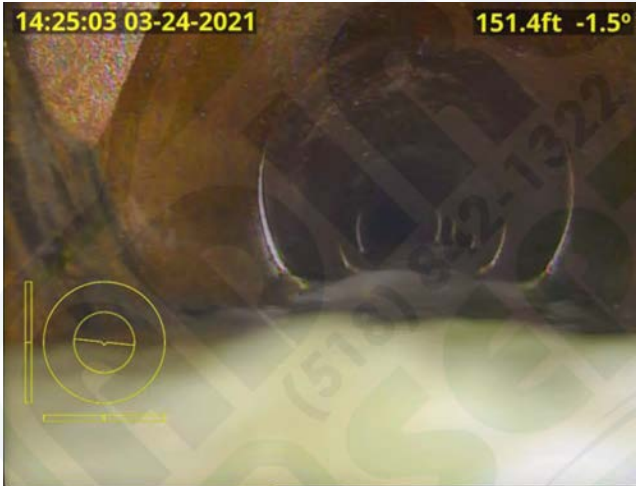
CN 2021\_03\_24-14\_25\_03\_840.jpg

4"	12				CRACKS AT LATERAL CONNECTION
0:12:55	151.4		CN	2021_03_24-14_25_03_840.jpg

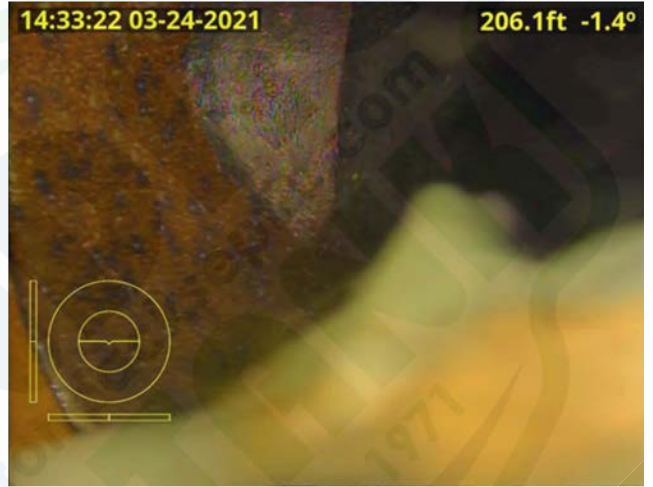
CN 2021\_03\_24-14\_33\_22\_566.jpg

4"	12				CONSISTENT FLOW - DEBRIS IN LATERAL CONNECTION
0:18:42	206.1		CN	2021_03_24-14_33_22_566.jpg

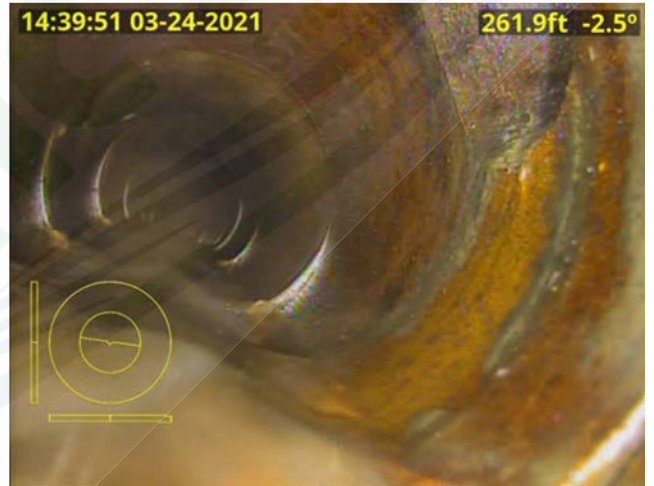
CN 2021\_03\_24-14\_39\_51\_885.jpg

4"	12				SEALED
0:23:31	261.9		CN	2021_03_24-14_39_51_885.jpg
