April 28, 2021

Kari DuPrat
Property Management Associates
287 Baycrest Drive
South Burlington, VT 05403

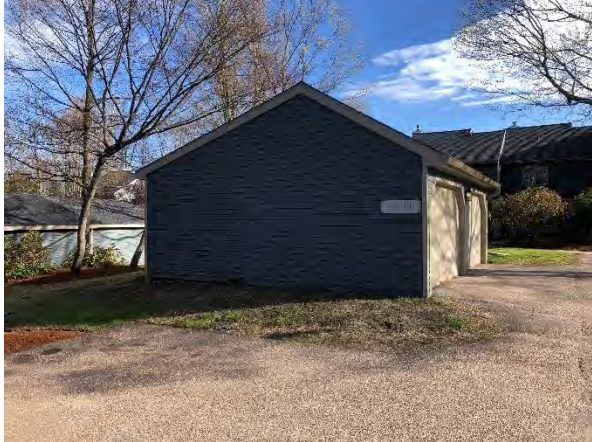
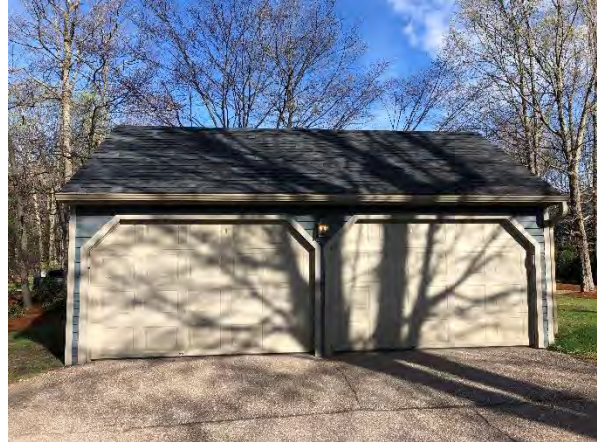
**Building containing units 1-4
Photo Documentation:**

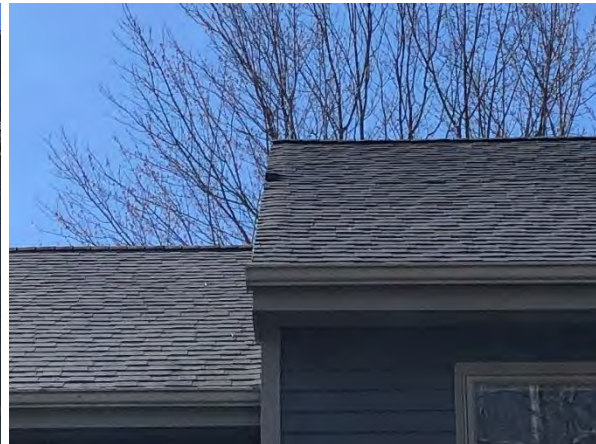
Damaged shingles above unit 50
