**US ROOFING**  
SYSTEMS

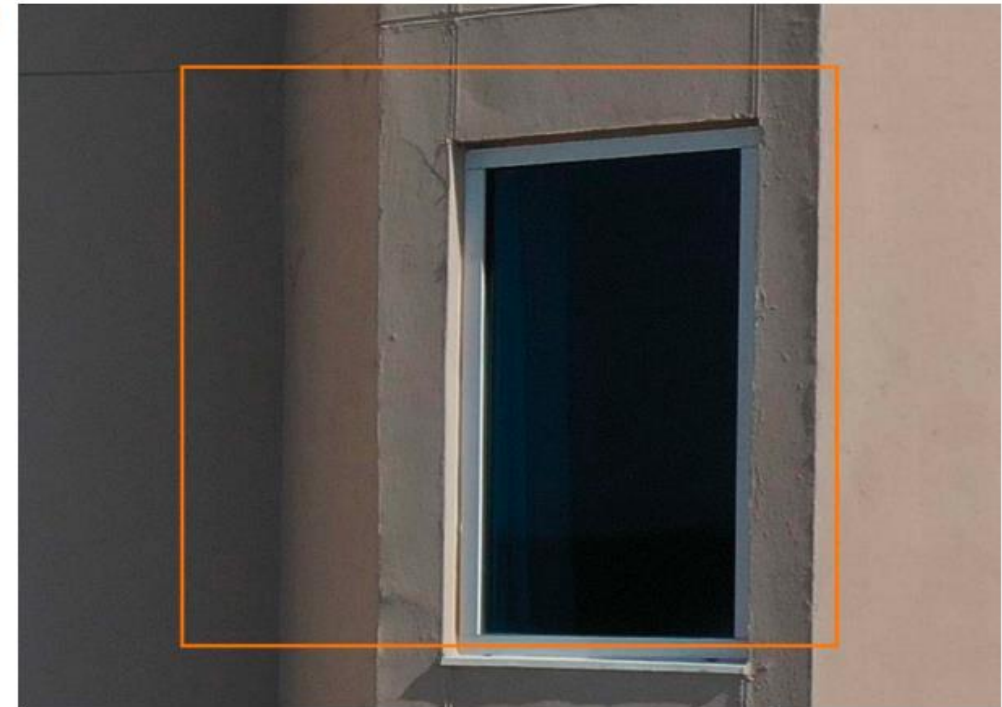
#### 21 - Crack

| No. | Summary | Type | Created | Lat,Lng | Status |
|---|---|---|---|---|---|
| 21 | 7th floor - minor crack in stucco at window frame | Crack | May 14, 2021, 1:16pm | 30.38893,-88.99492 | Open |
